**FINAL
ANNUAL MONITORING REPORT
YEAR 4 (2013)
MCINTYRE CREEK RESTORATION SITE
AT HORNETS NEST PARK
MECKLENBURG COUNTY, NORTH CAROLINA
(EEP Project No. 243, Contract No. 004499)**

December 2013

Prepared by:
Axiom Environmental, Inc.
218 Snow Avenue
Raleigh, North Carolina 27603

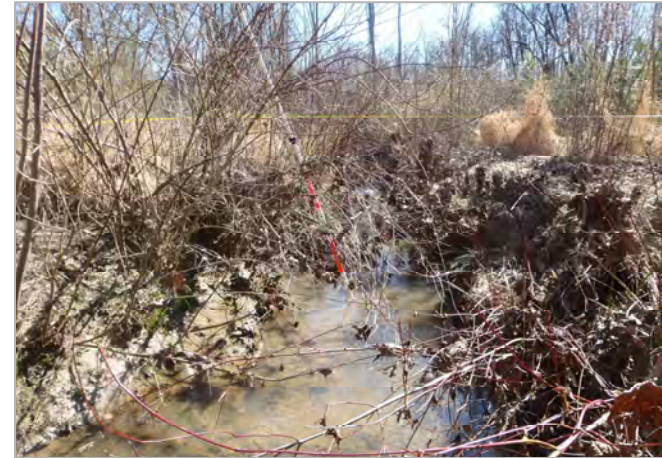
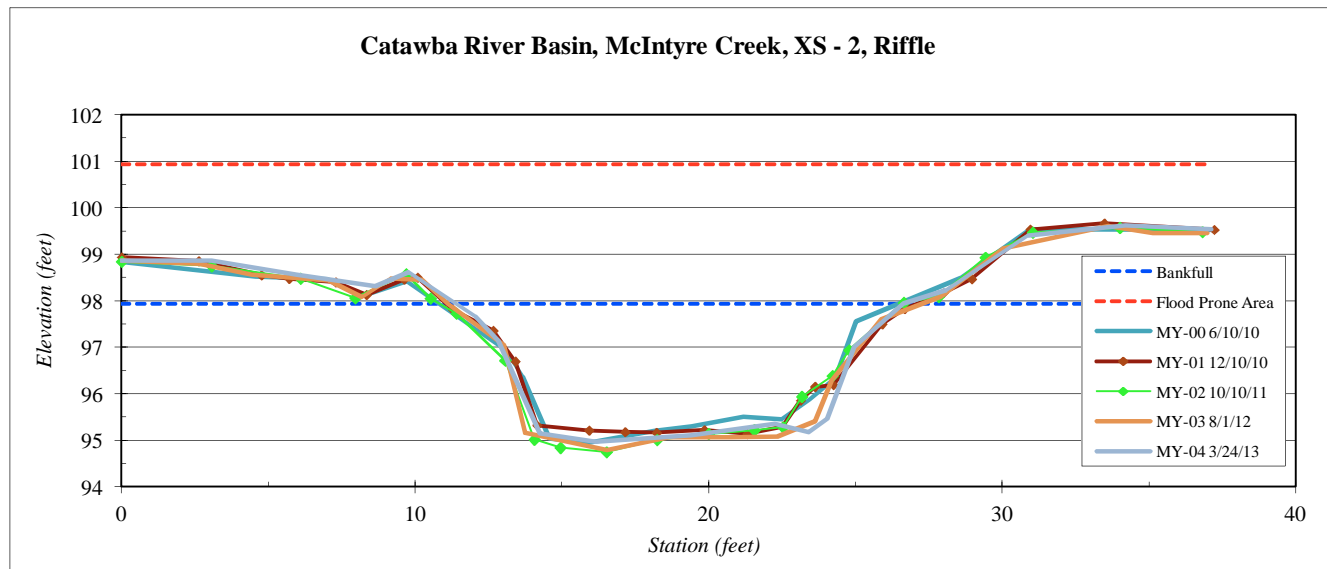
River Basin:	Catawba
Watershed:	McIntyre Creek
XS ID	XS - 2, Riffle
Feature	Riffle
Date:	3/25/2013
Field Crew:	Perkinson, Jernigan

SUMMARY DATA	
Bankfull Elevation:	97.9
Bankfull Cross-Sectional Area:	32.6
Bankfull Width:	15.2
Flood Prone Area Elevation:	100.9
Flood Prone Width:	150.0
Max Depth at Bankfull:	3.0
Mean Depth at Bankfull:	2.1
W / D Ratio:	7.1
Entrenchment Ratio:	9.9
Bank Height Ratio:	1.0

Stream Type	E
--------------------	---

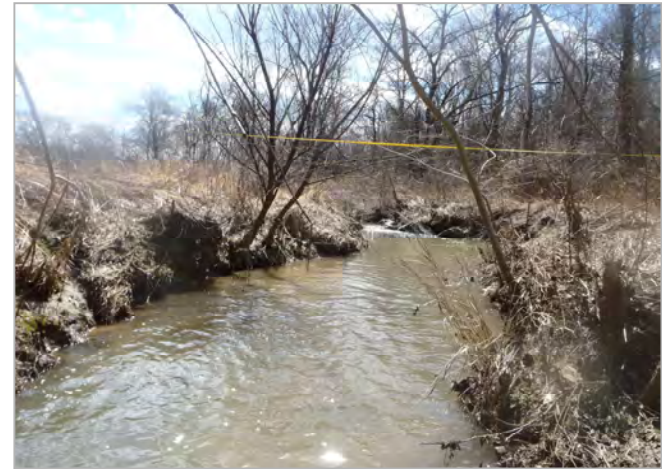
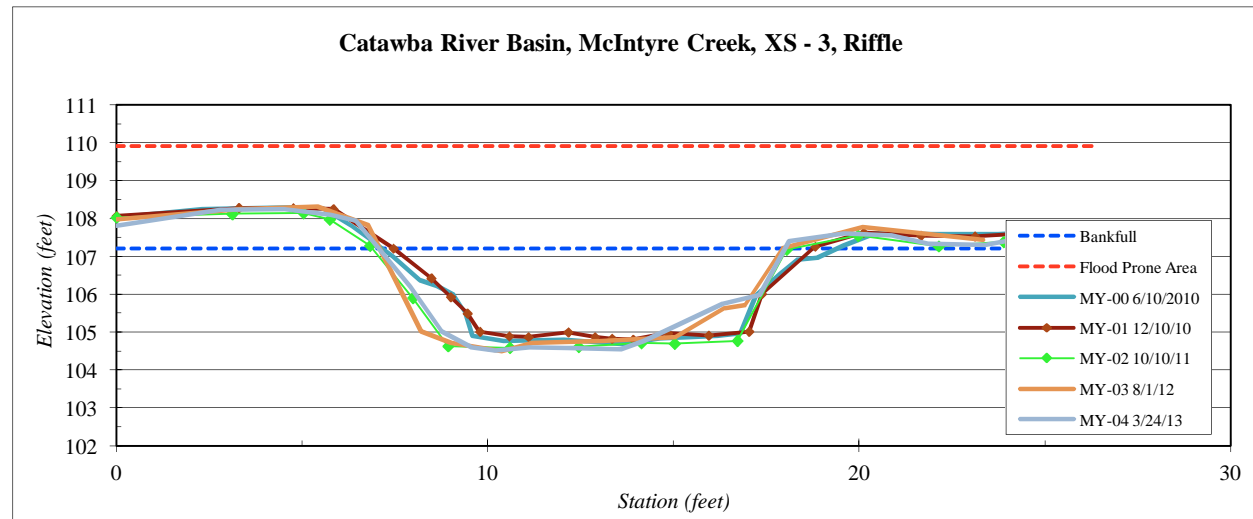
River Basin:	Catawba
Watershed:	McIntyre Creek
XS ID	XS - 3, Riffle
Feature	Riffle
Date:	3/25/2013
Field Crew:	Perkinson, Jernigan

SUMMARY DATA	
Bankfull Elevation:	107.2
Bankfull Cross-Sectional Area:	21.9
Bankfull Width:	10.9
Flood Prone Area Elevation:	109.9
Flood Prone Width:	150.0
Max Depth at Bankfull:	2.7
Mean Depth at Bankfull:	2.0
W / D Ratio:	5.4
Entrenchment Ratio:	13.8
Bank Height Ratio:	1.0

Stream Type	E
--------------------	---

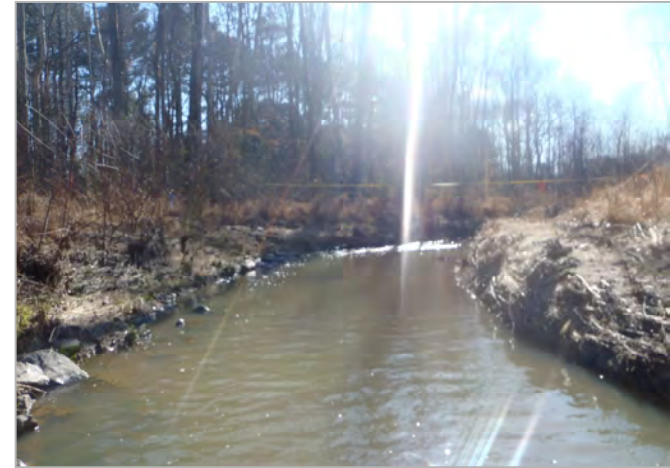
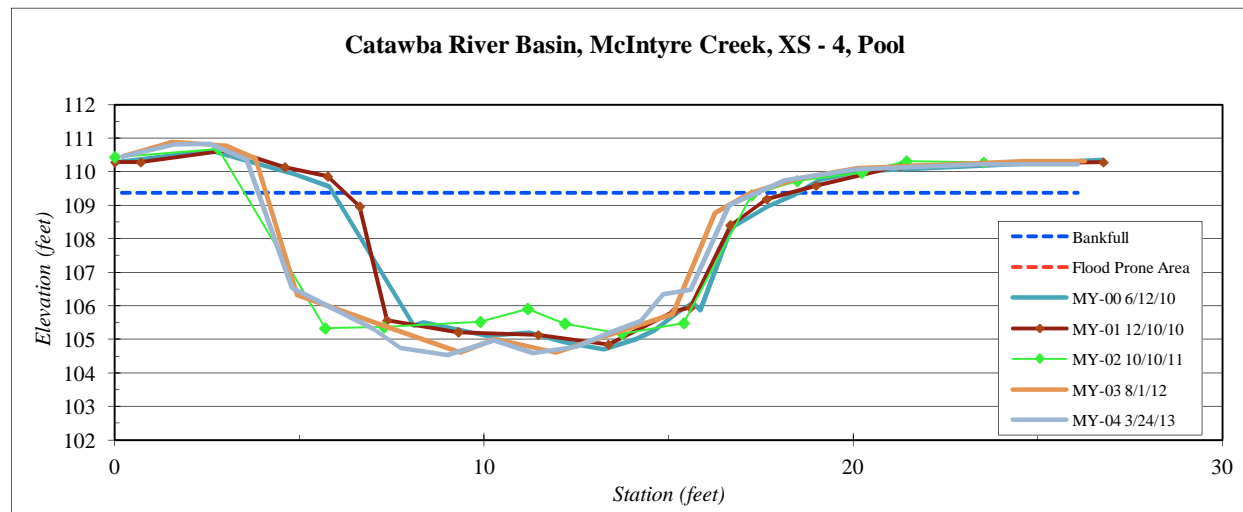
River Basin:	Catawba
Watershed:	McIntyre Creek
XS ID	XS - 4, Pool
Feature	Pool
Date:	3/25/2013
Field Crew:	Perkinson, Jernigan

SUMMARY DATA	
Bankfull Elevation:	109.4
Bankfull Cross-Sectional Area:	47.6
Bankfull Width:	13.5
Flood Prone Area Elevation:	NA
Flood Prone Width:	NA
Max Depth at Bankfull:	4.8
Mean Depth at Bankfull:	3.5
W / D Ratio:	NA
Entrenchment Ratio:	NA
Bank Height Ratio:	1.0

Stream Type	C/E
--------------------	-----

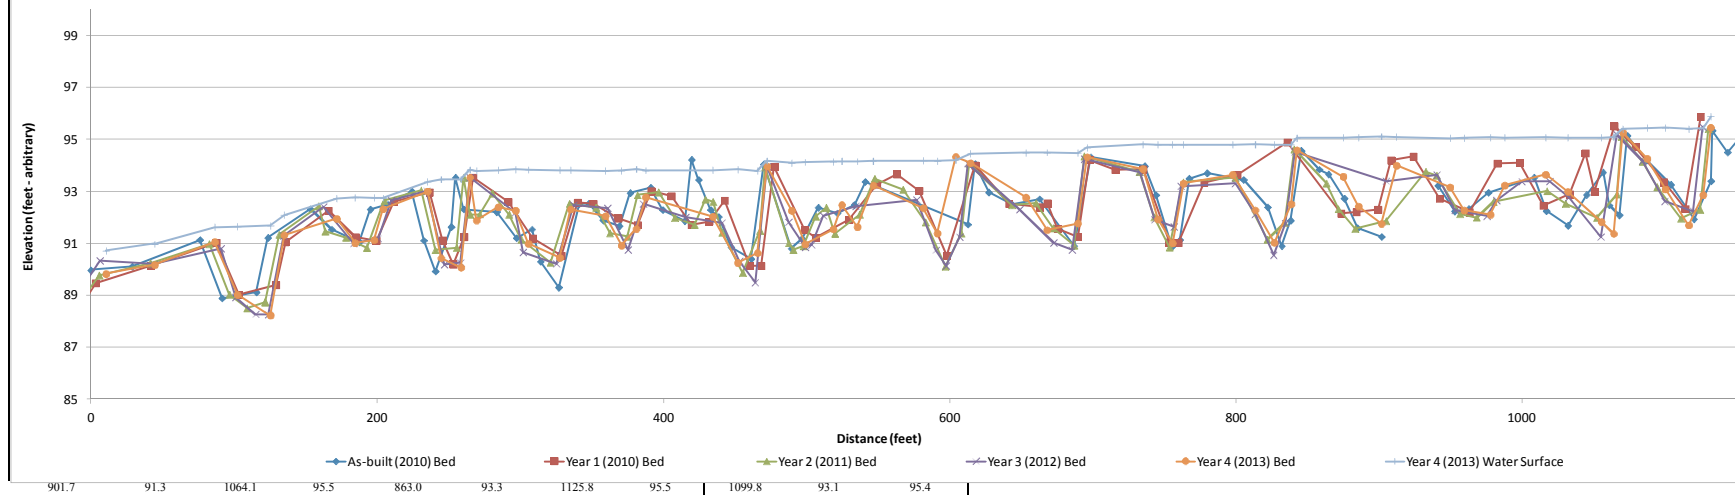
McIntyre Creek Year 4 (2013) Profile - Reach 00+00 to 11+50

As-built	2010	2011	2012	2013	2014
Avg. Water Surface Slope	0.0035	0.0042	0.0041	0.0043	0.0046	
Rifle Length	32	26	27	34	34	
Avg. Rifle Slope	0.0042	0.0047	0.0023	0.0034	0.0040	
Pool Length	16	19	20	18	17	
Avg. Pool Slope	76	76	0.0023	0.0033	0.0008

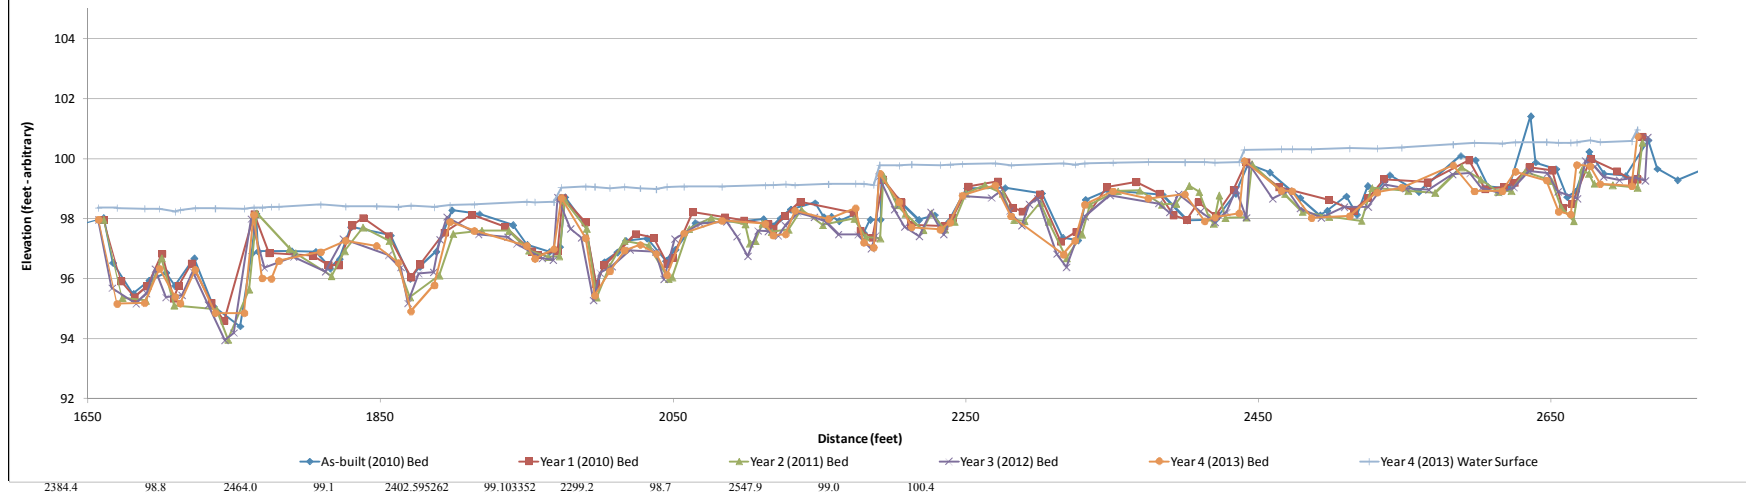
McIntyre Creek Year 4 (2013) Profile - Reach 16+50 to 27+50

As-built	2010	2011	2012	2013	2014
Avg. Water Surface Slope	0.0035	0.0022	0.0020	0.0026	0.0025	
Riffle Length	32	30	25	28	38	
Avg. Riffle Slope	0.0042	0.0010	0.0010	0.0012	0.0014	
Pool Length	16	15	10	15	17	
Avg. Pool Slope	76	76	0.0000	0.0011	0.0018

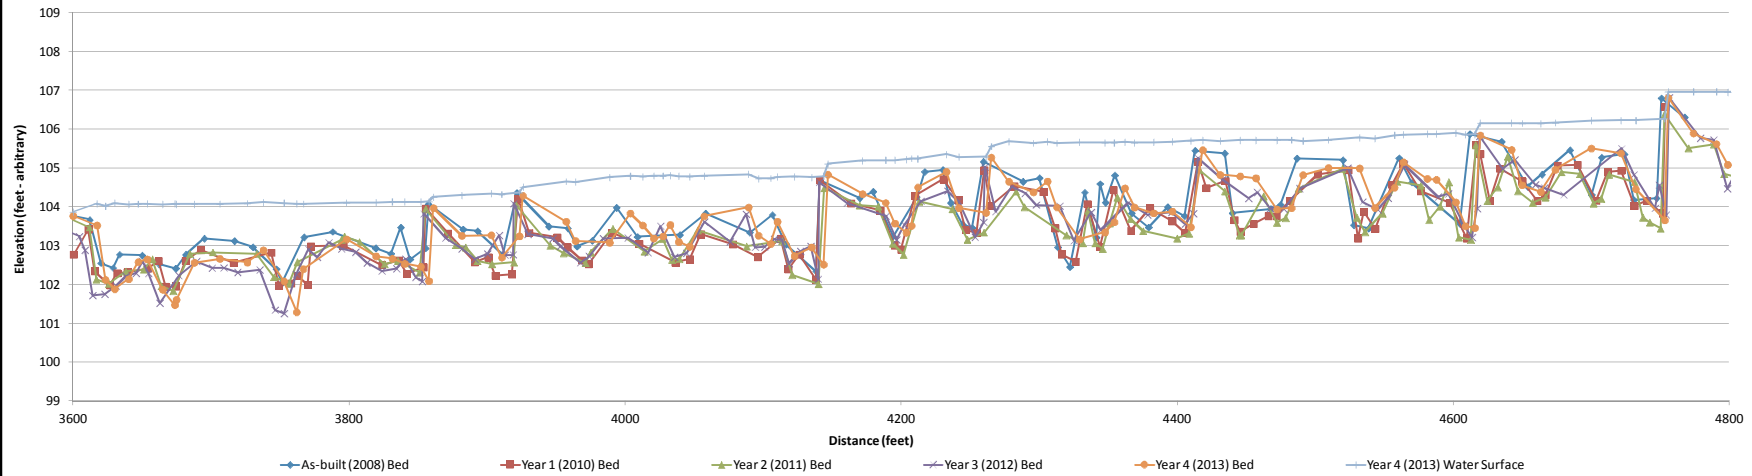
McIntyre Creek Year 4 (2013) Profile - Reach 36+00 to 47+55

As-built	2010	2011	2012	2013	2014
Avg. Water Surface Slope	0.0035	0.0020	0.0025	0.0029	0.0027	
Riffle Length	32	35	28	29	30	
Avg. Riffle Slope	0.0042	0.0027	0.0003	0.0022	0.0021	
Pool Length	16	12	16	16	17	
Pool to Pool Spacing	76	76	0.0005	0.0018	0.0014
