**FINAL  
ANNUAL MONITORING REPORT  
YEAR 5 (2014)  
MCINTYRE CREEK RESTORATION SITE  
AT HORNETS NEST PARK  
MECKLENBURG COUNTY, NORTH CAROLINA  
(EEP Project No. 243, Contract No. 004499)**

December 2014

Prepared by:  
Axiom Environmental, Inc.  
218 Snow Avenue  
Raleigh, North Carolina 27603

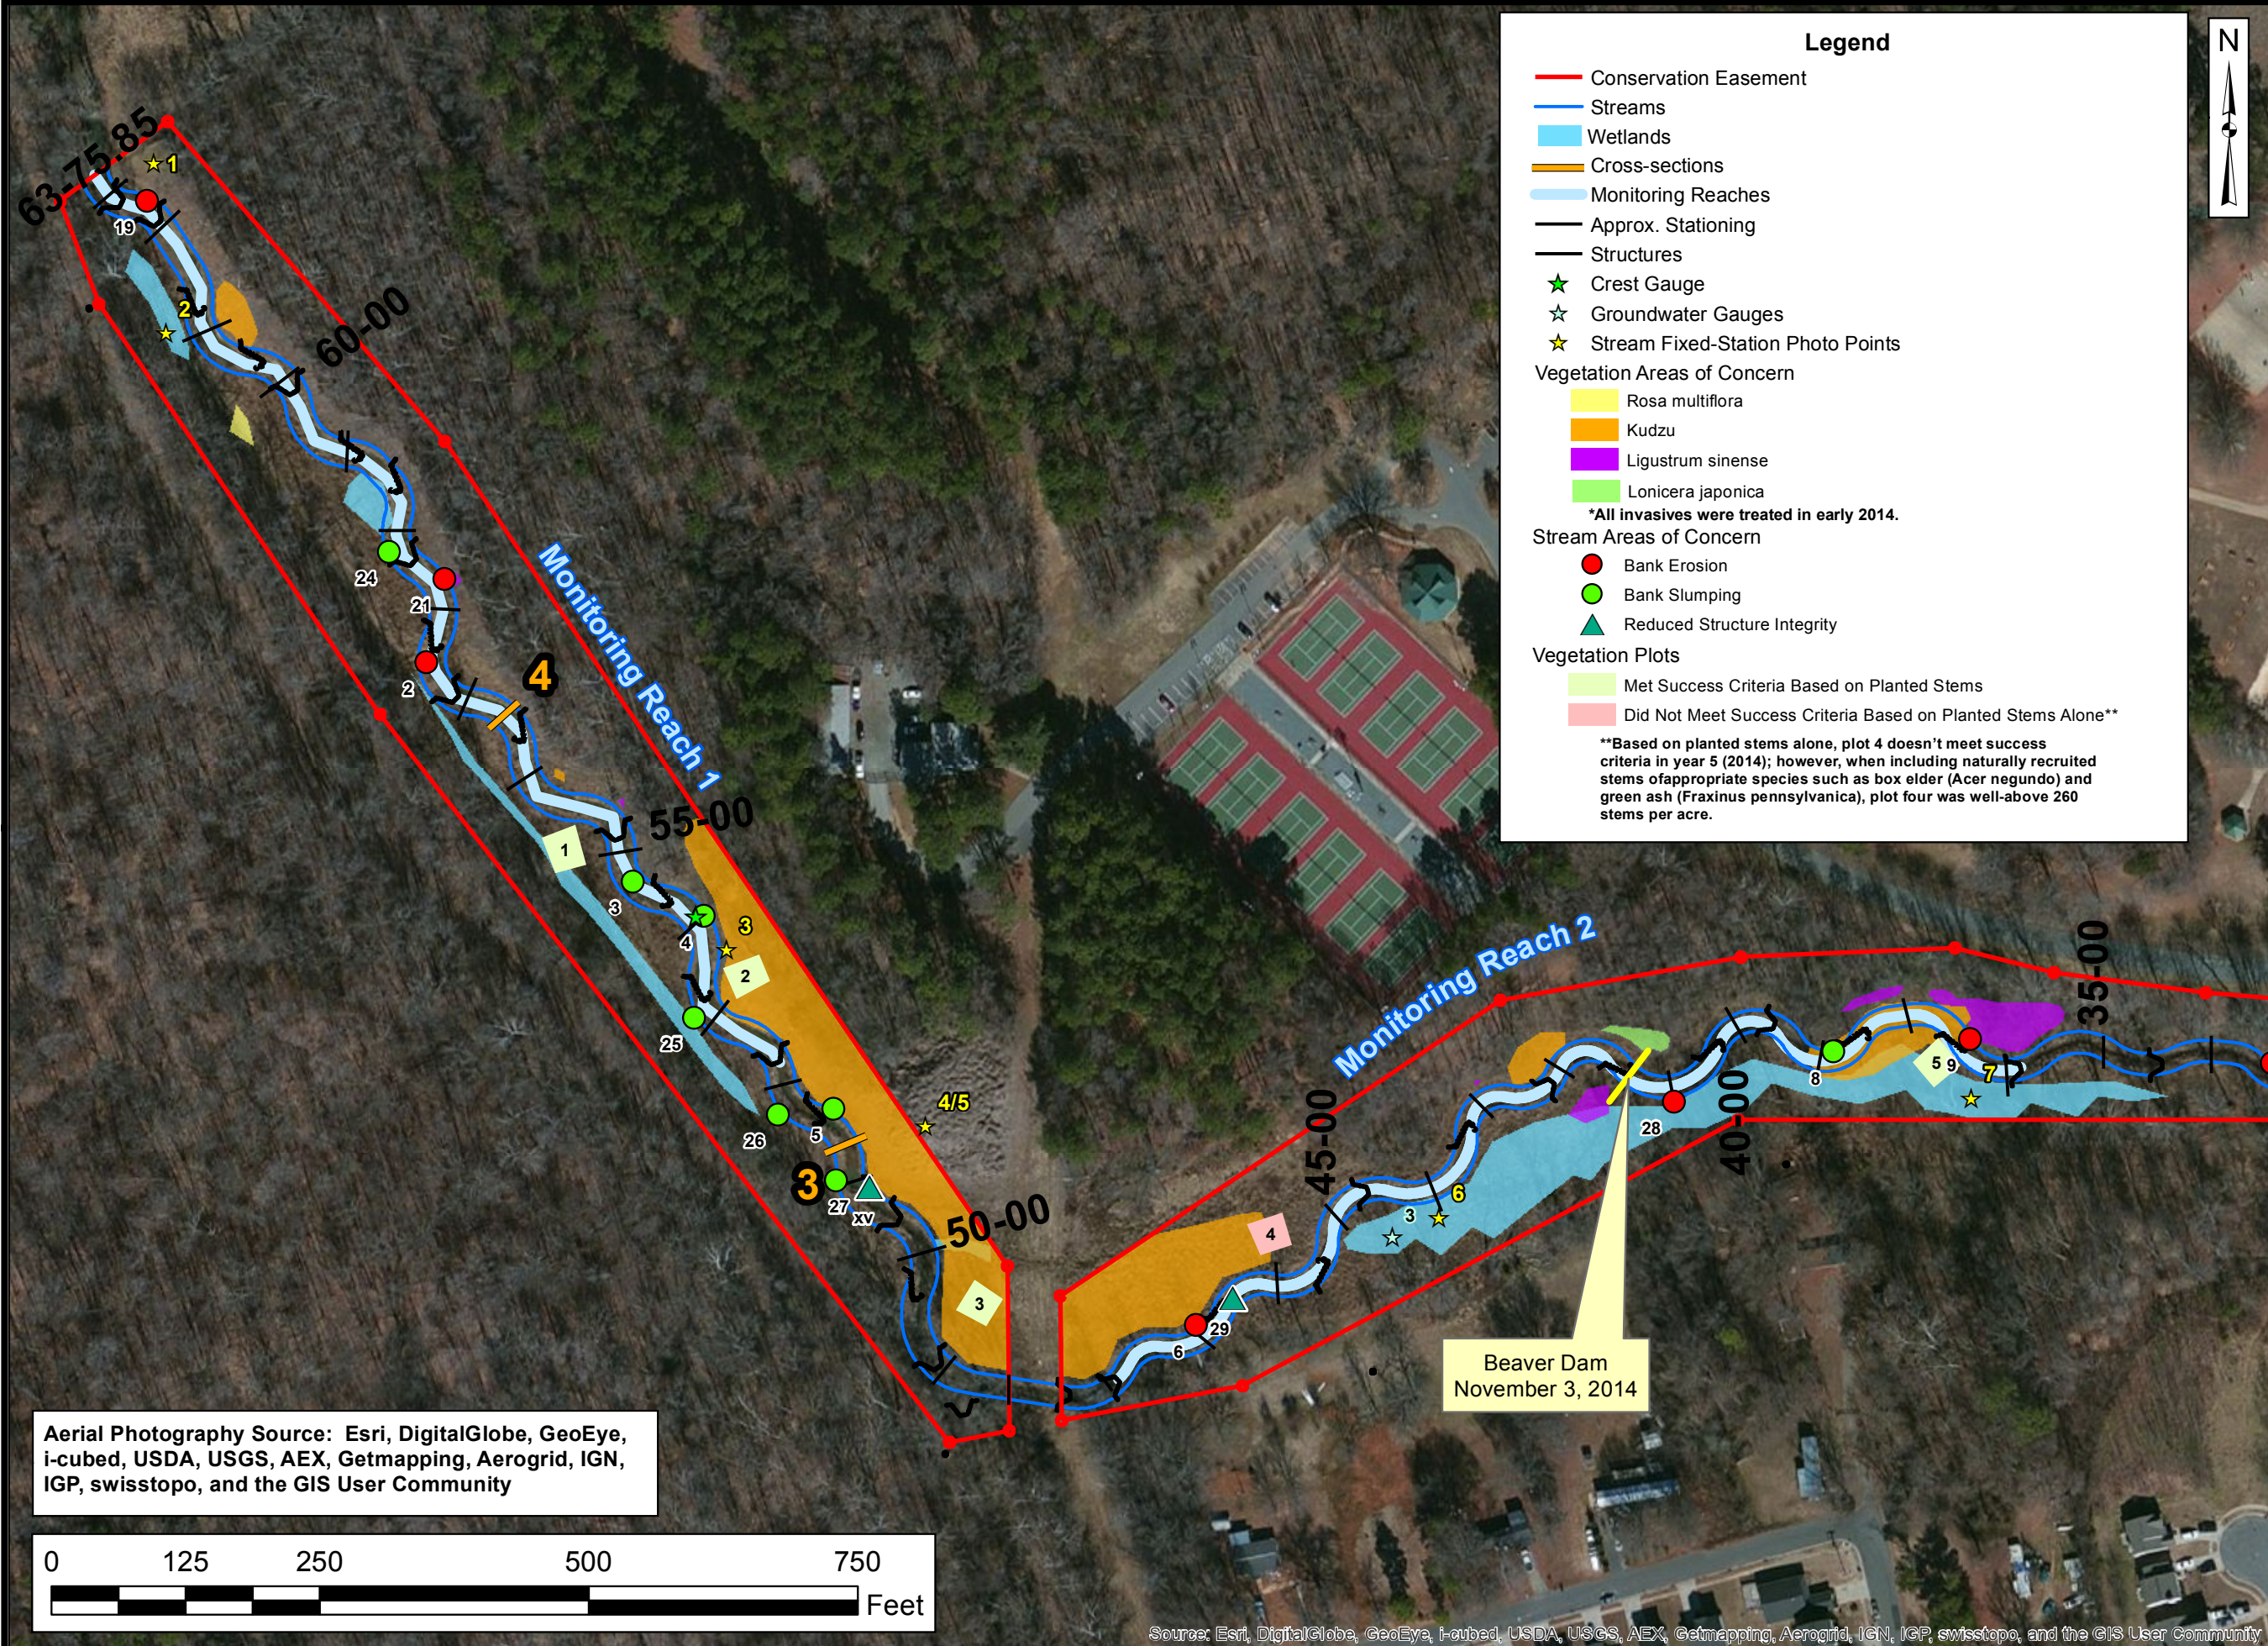
**CURRENT CONDITIONS PLAN VIEW**

Additionally, several large patches of Kudzu (*Pueraria lobata*) were observed within the Site (depicted on Figures 2A-2B, Appendix B). A treatment of all invasive species occurred in late October 2013 and again in early 2014; these treatments initially appeared to be successful, however, several areas of kudzu have spread during the 2014 growing season resulting in some tree mortality. EEP will continue to treat invasive species within the Site as needed.

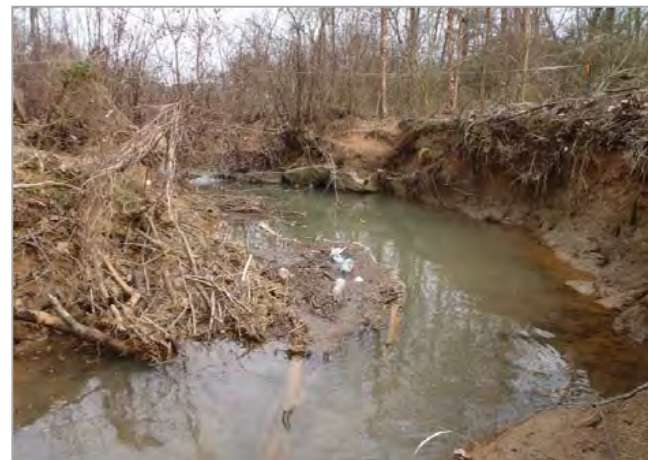
<b>River Basin:</b>	Catawba
<b>Watershed:</b>	McIntyre Creek
<b>XS ID</b>	XS - 1, Pool
<b>Feature</b>	Pool
<b>Date:</b>	2/27/2014
<b>Field Crew:</b>	Perkinson, Jernigan

SUMMARY DATA	
<b>Bankfull Elevation:</b>	96.5
<b>Bankfull Cross-Sectional Area:</b>	76.1
<b>Bankfull Width:</b>	20.3
<b>Flood Prone Area Elevation:</b>	NA
<b>Flood Prone Width:</b>	NA
<b>Max Depth at Bankfull:</b>	6.3
<b>Mean Depth at Bankfull:</b>	3.7
<b>W / D Ratio:</b>	NA
<b>Entrenchment Ratio:</b>	NA
<b>Bank Height Ratio:</b>	1.0

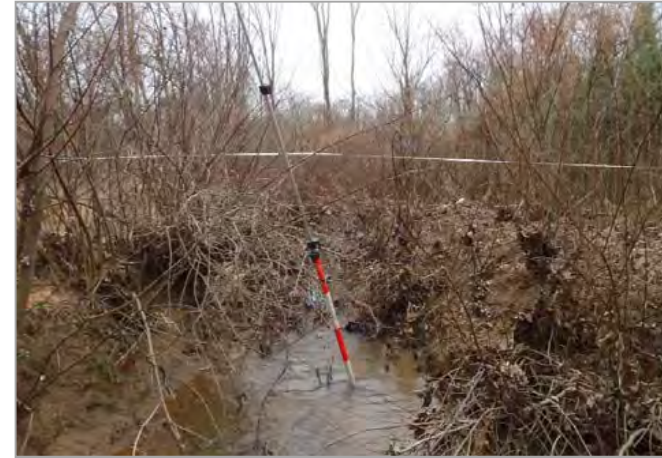
<b>River Basin:</b>	Catawba
<b>Watershed:</b>	McIntyre Creek
<b>XS ID</b>	XS - 2, Riffle
<b>Feature</b>	Riffle
<b>Date:</b>	2/27/2014
<b>Field Crew:</b>	Perkinson, Jernigan

SUMMARY DATA	
<b>Bankfull Elevation:</b>	97.6
<b>Bankfull Cross-Sectional Area:</b>	33.6
<b>Bankfull Width:</b>	14.7
<b>Flood Prone Area Elevation:</b>	100.6
<b>Flood Prone Width:</b>	150.0
<b>Max Depth at Bankfull:</b>	3.0
<b>Mean Depth at Bankfull:</b>	2.3
<b>W / D Ratio:</b>	6.4
<b>Entrenchment Ratio:</b>	10.2
<b>Bank Height Ratio:</b>	1.0

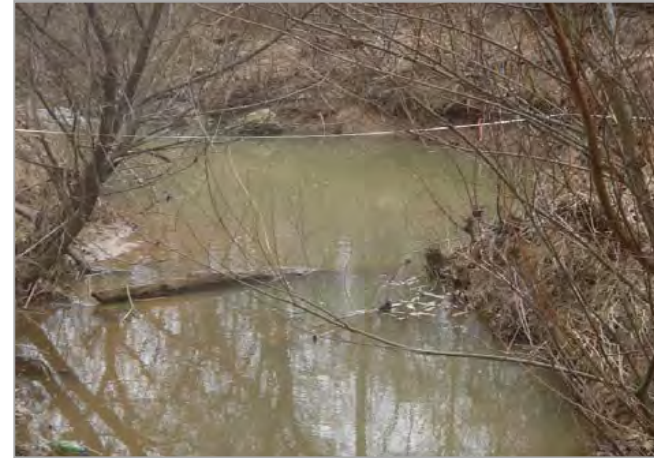
<b>River Basin:</b>	Catawba
<b>Watershed:</b>	McIntyre Creek
<b>XS ID</b>	XS - 3, Riffle
<b>Feature</b>	Riffle
<b>Date:</b>	2/27/2014
<b>Field Crew:</b>	Perkinson, Jernigan

SUMMARY DATA	
<b>Bankfull Elevation:</b>	107.2
<b>Bankfull Cross-Sectional Area:</b>	20.9
<b>Bankfull Width:</b>	11.2
<b>Flood Prone Area Elevation:</b>	109.7
<b>Flood Prone Width:</b>	150.0
<b>Max Depth at Bankfull:</b>	2.5
<b>Mean Depth at Bankfull:</b>	1.9
<b>W / D Ratio:</b>	6.0
<b>Entrenchment Ratio:</b>	13.4
<b>Bank Height Ratio:</b>	1.0

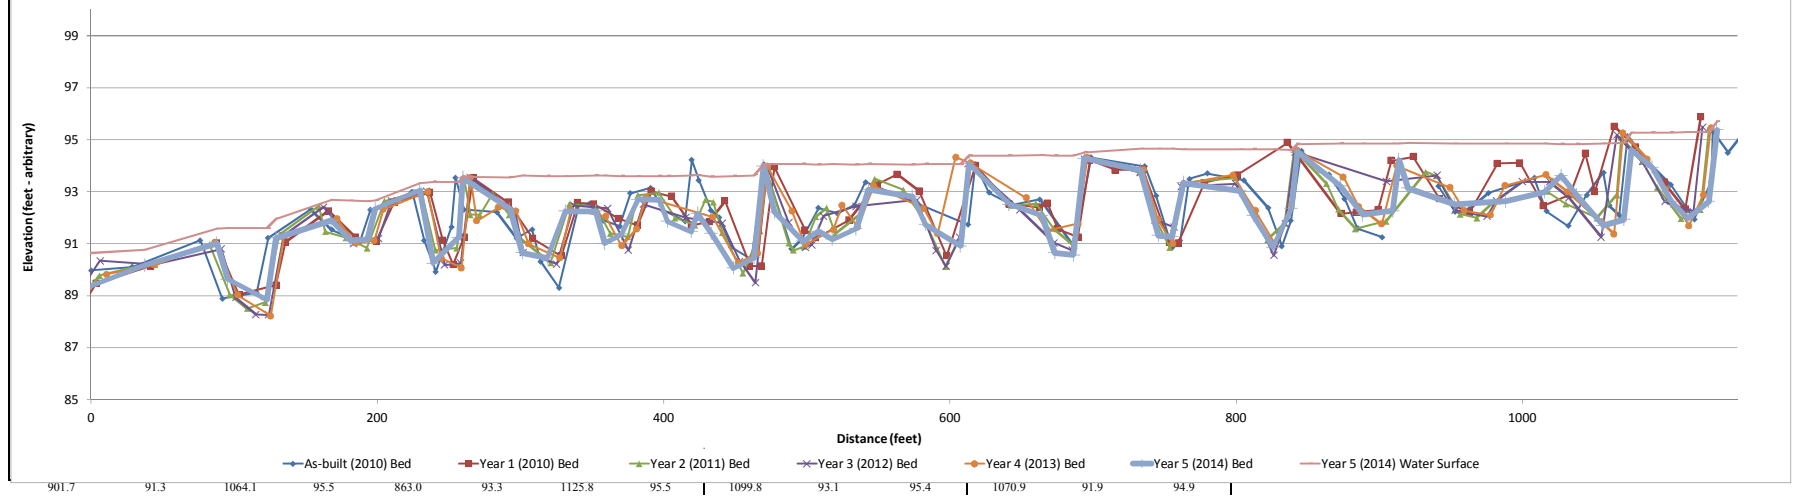
McIntyre Creek Year 5 (2014) Profile - Reach 00+00 to 11+50

As-built	2010	2011	2012	2013	2014
Avg. Water Surface Slope	0.0035	0.0042	0.0041	0.0043	0.0046	0.0045
Rifle Length	32	26	27	34	34	36
Avg. Rifle Slope	0.0042	0.0047	0.0023	0.0034	0.0040	0.0048
Pool Length	16	19	20	18	17	25
Avg. Pool Slope	76	76	0.0023	0.0033	0.0008	0.0003

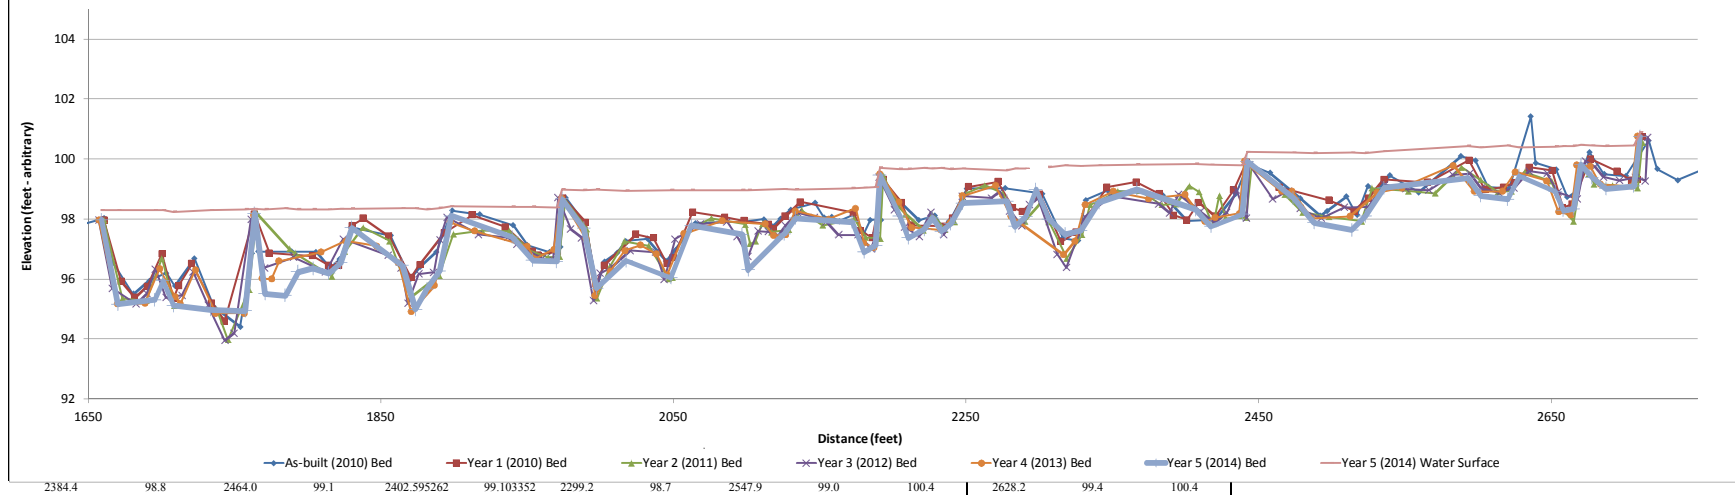
McIntyre Creek Year 5 (2014) Profile - Reach 16+50 to 27+50

As-built	2010	2011	2012	2013	2014
Avg. Water Surface Slope	0.0035	0.0022	0.0020	0.0026	0.0025	0.0021
Rifle Length	32	30	25	28	38	31
Avg. Rifle Slope	0.0042	0.0010	0.0010	0.0012	0.0014	0.0005
Pool Length	16	15	10	15	17	20
Avg. Pool Slope	76	76	0.0000	0.0011	0.0018	0.0013

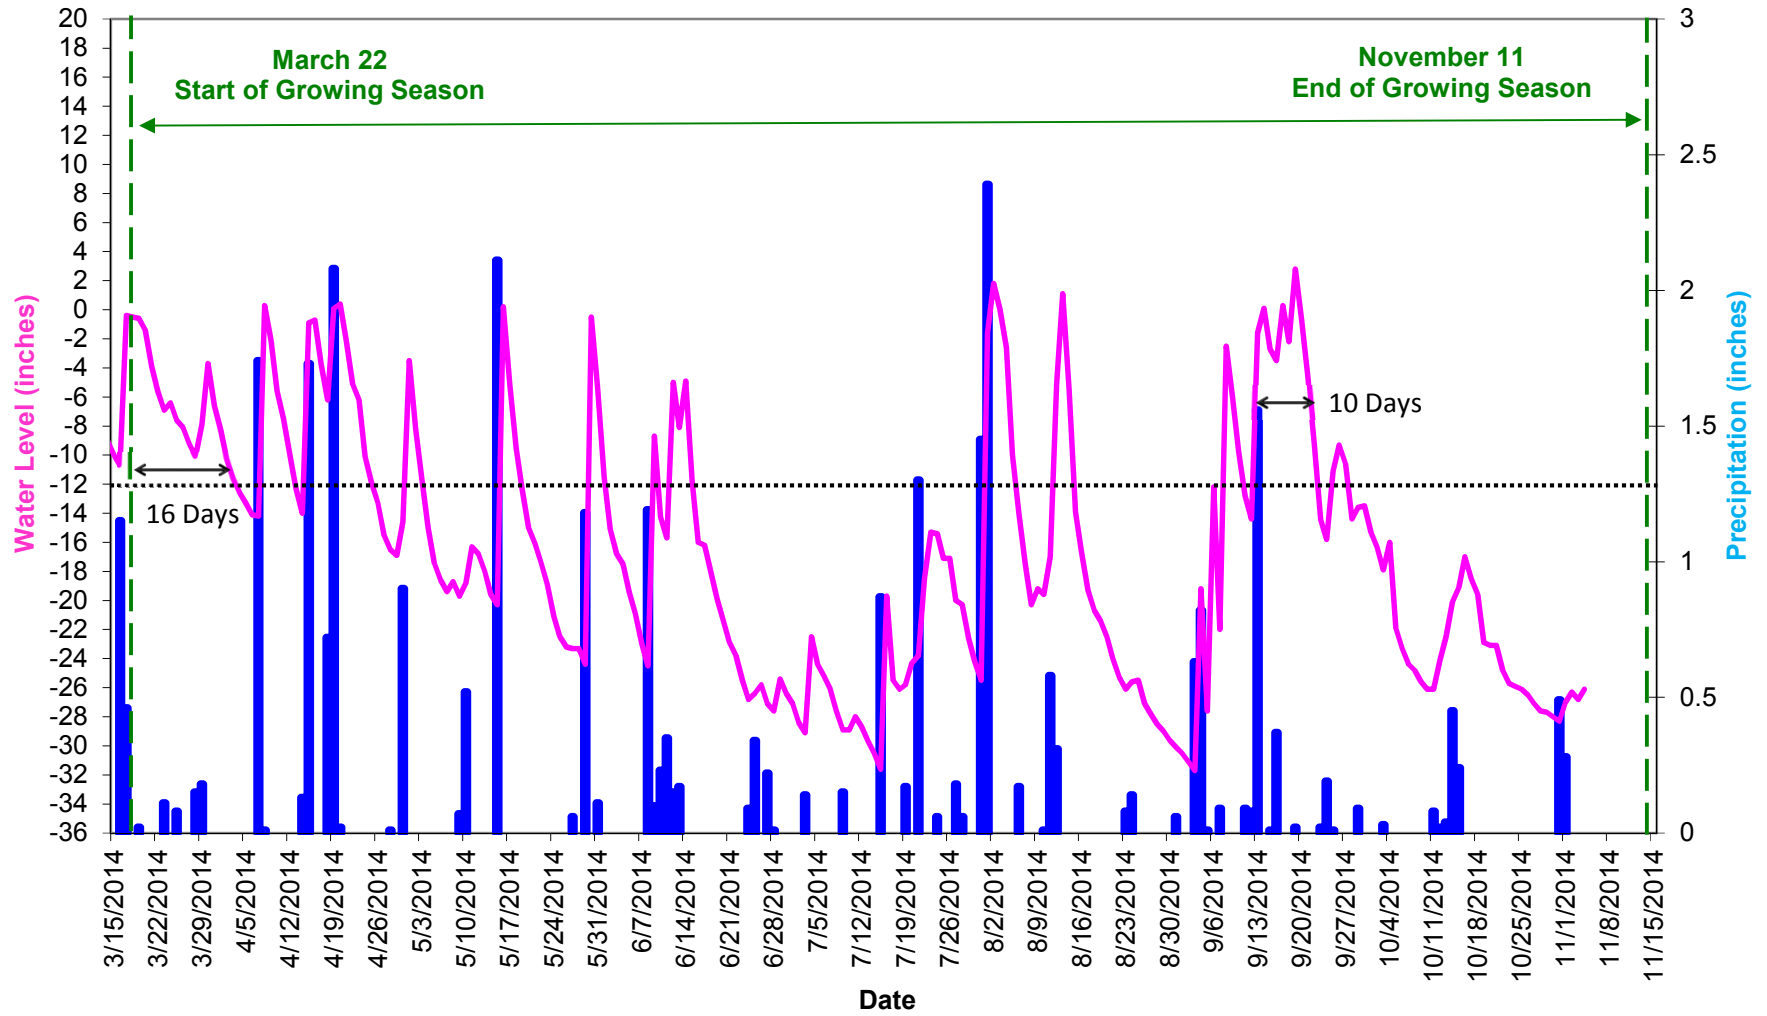
### McIntyre Creek Gauge 1 Year 5 (2014 Data)

Gauge	Success Criteria Achieved/Max Consecutive Days During Growing Season (Percentage)				
	Year 1 (2010)*	Year 2 (2011)*	Year 3 (2012)	Year 4 (2013)	Year 5 (2014)
1	--	No/7 day (3.0 %)	No/8 day (3.4 %)	Yes/23 day (10.0 %)	No/16 days (6.8%)
2	--	Yes/38 day (16.3 %)	Yes/23 day (10 %)	Yes/34 day (15.2 %)	Yes/72 Days (30.6%)
3	--	Yes/41 day (17.6 %)	No/22 day (9.4 %)	Yes/36 day (16.1 %)	Yes/63 Days (26.8%)
