**FINAL
ANNUAL MONITORING REPORT
YEAR 7 (2016)
MCINTYRE CREEK RESTORATION SITE
AT HORNETS NEST PARK
MECKLENBURG COUNTY, NORTH CAROLINA
(DMS Project No. 243, Contract No. 004499)**

November 2016

Prepared by:
Axiom Environmental, Inc.
218 Snow Avenue
Raleigh, North Carolina 27603

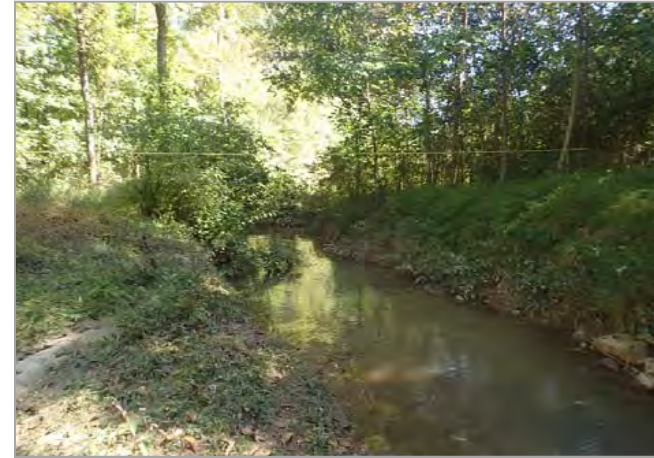
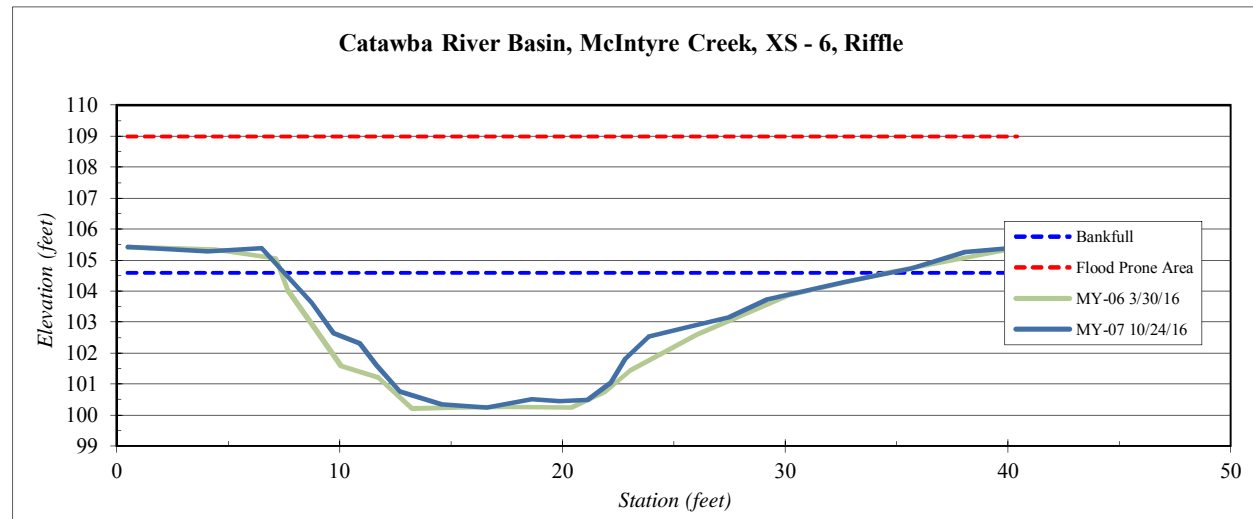
River Basin:	Catawba
Watershed:	McIntyre Creek
XS ID	XS - 6, Riffle
Feature	Riffle
Date:	10/24/2016
Field Crew:	Perkinson, Jernigan

SUMMARY DATA	
Bankfull Elevation:	104.6
Bankfull Cross-Sectional Area:	64.3
Bankfull Width:	27.2
Flood Prone Area Elevation:	109.0
Flood Prone Width:	150.0
Max Depth at Bankfull:	4.4
Mean Depth at Bankfull:	2.4
W / D Ratio:	11.5
Entrenchment Ratio:	5.5
Bank Height Ratio:	1.0

* Note: Cross Section was established after repairs conducted at the Site.

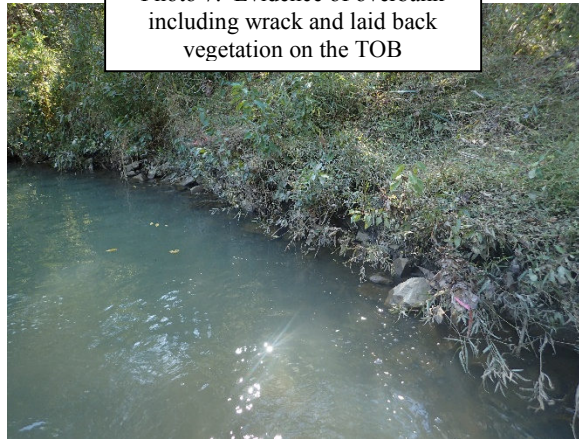
Photo 7: Evidence of overbank including wrack and laid back vegetation on the TOB
