**McKee Creek Stream Restoration
Monitoring Report – Year 2 of 5
Final**

**Contract # 004391
EEP Project # 92573
Cabarrus County, North Carolina**

**Collected October 2013
Completed 2013
Report December 19, 2013
Revise January 28, 2014**

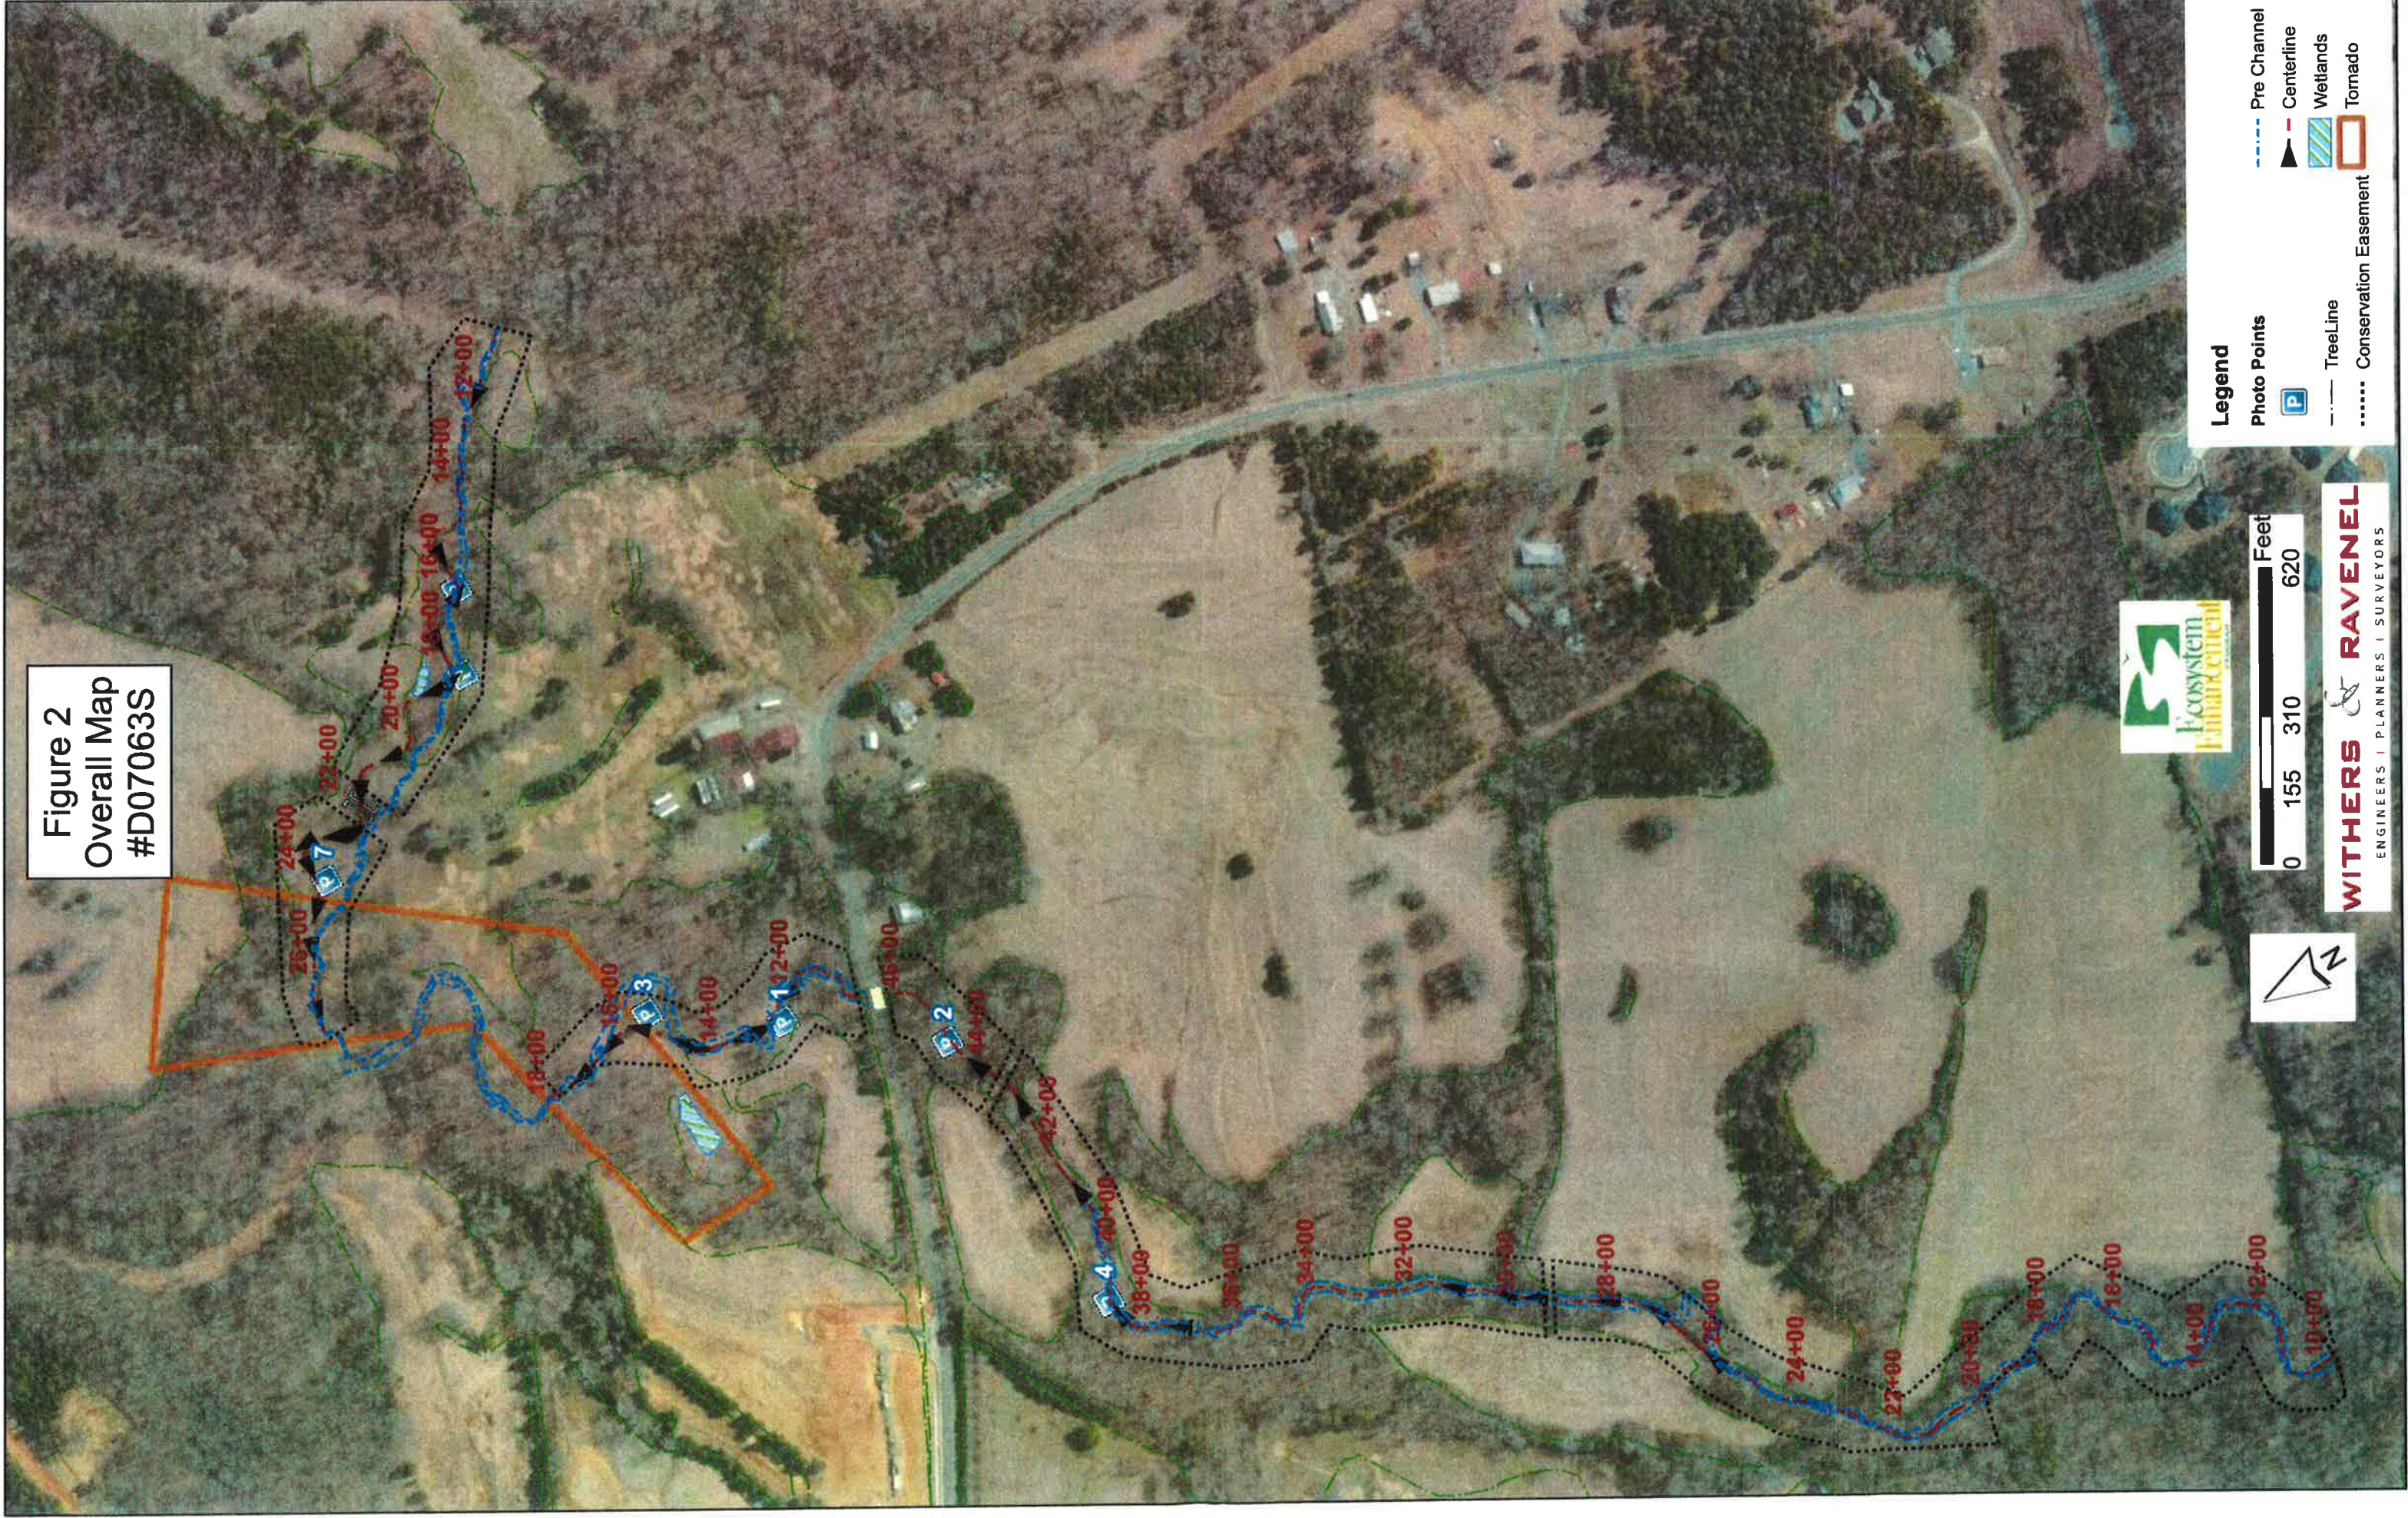
Figure 2
Overall Map
#D07063S

In addition to the delayed initiation of monitoring, several other factors have been detrimental to the goals of this mitigation. Approximately a month prior to the initial visual site assessment, a tornado caused damage in the area off the confluence of Clear Creek and McKee Creek. See Figure 2. The tornado downed large diameter trees with many spanning McKee and Clear Creek. These downed trees have been cleared across Clear Creek but remain an obstacle to access on the south bank. Many of the fallen trees on McKee Creek remain from the edge of the project limits down to Clear Creek.

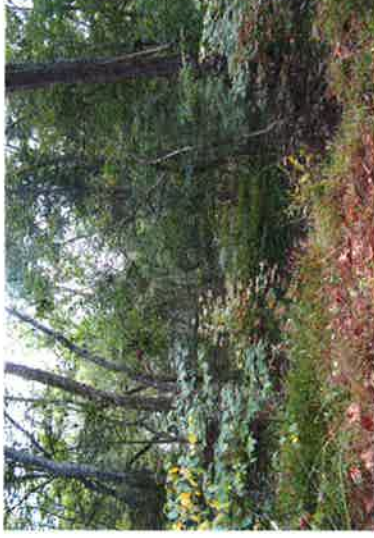
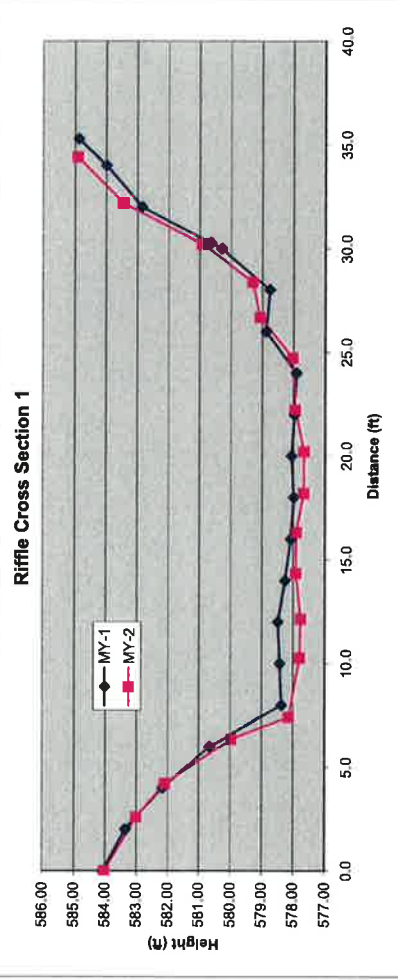
River Basin	Yadkin Pee-Dee
Watershed	McKee MY-02
XS-ID	RX-1
Drainage Area	6.42 sq. mi
Date	10/16/2013
Field Crew	D. Wiebke, J. Burley

Summary Data	
Bankfull Elevation	581
Bankfull Cross-Sectional Area	51.4
Bankfull Width	22
Flood Prone Area Elevation	584.05
Flood Prone Width	33
Max Depth at Bankfull	2.849
Mean Depth at Bankfull:	1.98
W/D Ratio:	11.11
Entrenchment Ratio:	1.50
Bank Height Ratio:	2.23

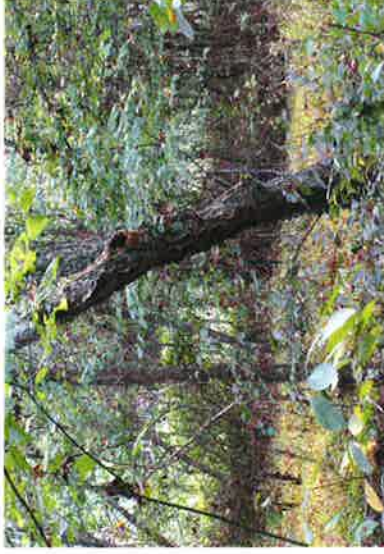
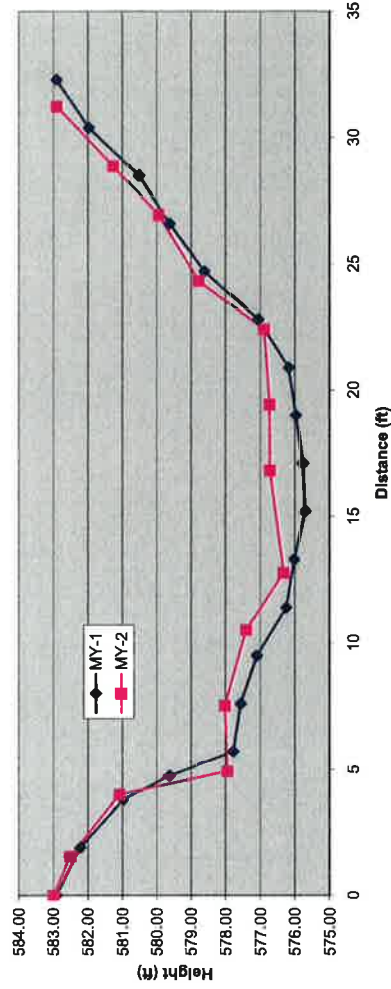
River Basin	Yadkin Pee-Dee
Watershed	McKee MY-02
XS-ID	PXS-1
Drainage Area	6.42 sq. mi
Date	10/16/2013
Field Crew	D. Wiebke, J. Burley

Summary Data	
Bankfull Elevation	580
Bankfull Cross-Sectional Area	58.5
Bankfull Width	23
Flood Prone Area Elevation	583.7
Flood Prone Width	36
Max Depth at Bankfull	3.69
Mean Depth at Bankfull:	2.37
W/D Ratio:	9.70
Entrenchment Ratio:	1.57
Bank Height Ratio:	1.81

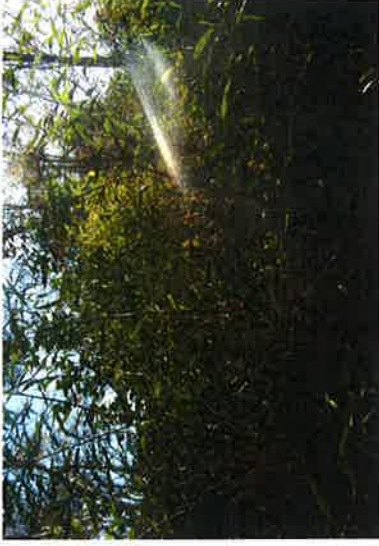
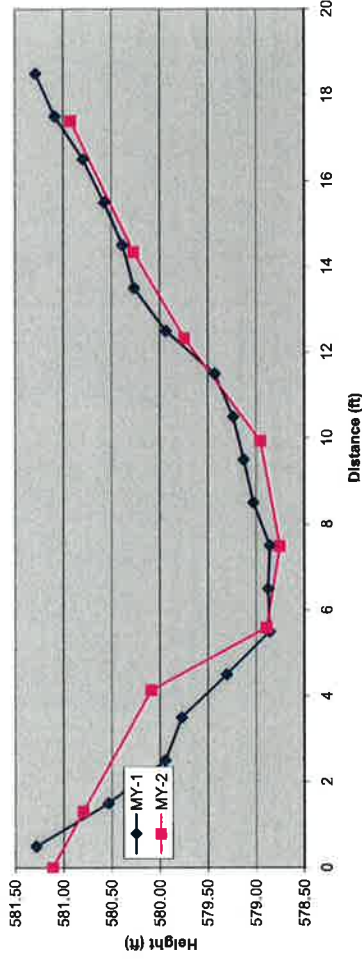
River Basin	Yadkin Pee-Dee
Watershed	Clear MY-02
XS-ID	RXS-2
Drainage Area	0.95
Date	10/16/2013
Field Crew	D. Wiebke, J. Burley

Summary Data	
Bankfull Elevation	580.5
Bankfull Cross-Sectional Area	13.4
Bankfull Width	13
Flood Prone Area Elevation	382.25
Flood Prone Width	150
Max Depth at Bankfull	1.75
Mean Depth at Bankfull:	1.05
W/D Ratio:	12.33
Entrenchment Ratio:	11.54
Bank Height Ratio:	1.20

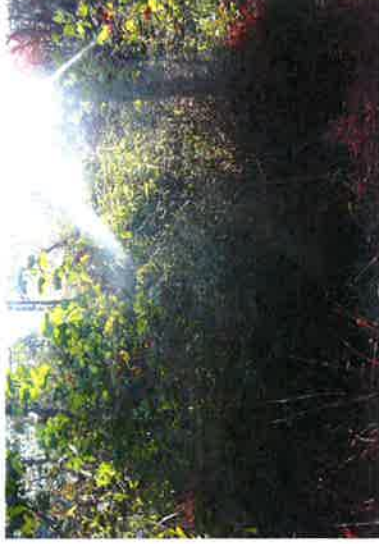
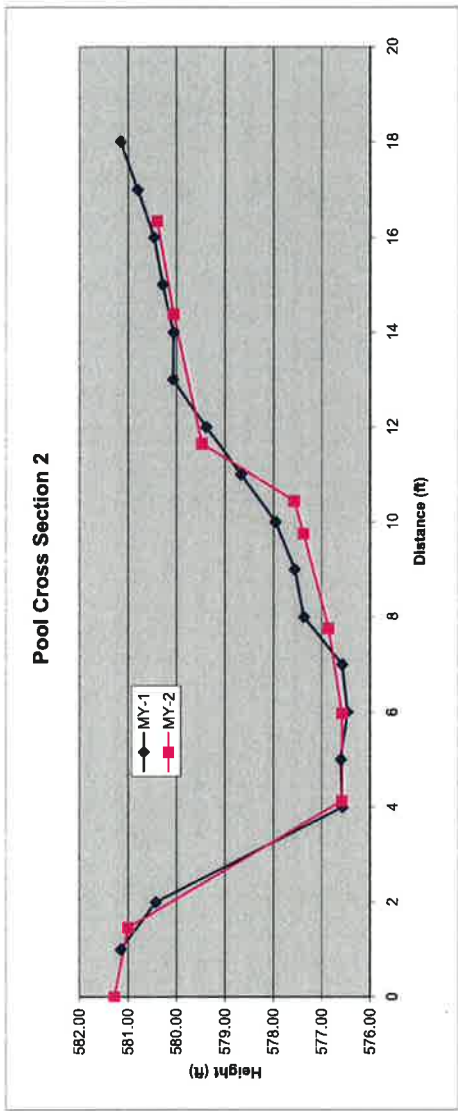
Cross-section Plot Exhibit	
River Basin	Yadkin Pee-Dee
Watershed	Clear MY-02
XS-ID	PXS-1
Drainage Area	0.95
Date	10/16/2013
Field Crew	D. Wiebke, J. Burley

Summary Data	
Bankfull Elevation	580.39
Bankfull Cross-Sectional Area	31.6
Bankfull Width	14.3
Flood Prone Area Elevation	584.2
Flood Prone Width	150
Max Depth at Bankfull	3.82
Mean Depth at Bankfull	2.62
W/D Ratio:	5.46
Entrenchment Ratio:	10.49
Bank Height Ratio:	1.00

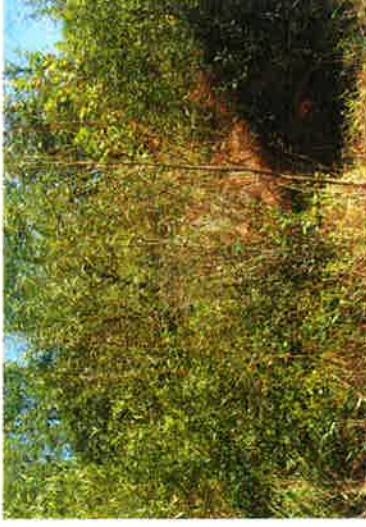
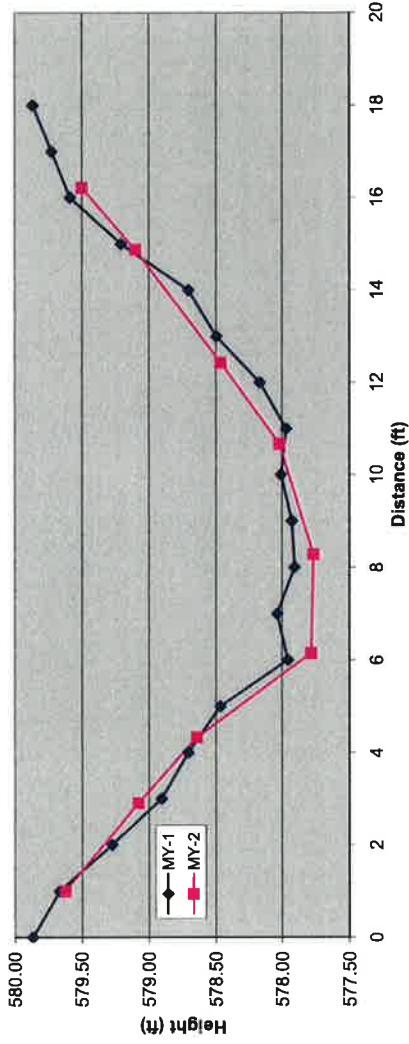
River Basin	Yadkin Pee-Dee
Watershed	Clear MY-02
XS-ID	RXS-3
Drainage Area	0.95
Date	10/16/2013
Field Crew	D. Wiebke, J. Burley

Summary Data	
Bankfull Elevation	579.6
Bankfull Cross-Sectional Area	14.73
Bankfull Width	13.88
Flood Prone Area Elevation	581.43
Flood Prone Width	200
Max Depth at Bankfull	1.84
Mean Depth at Bankfull:	0.96
W/D Ratio:	14.51
Entrenchment Ratio:	14.41
Bank Height Ratio:	1.01

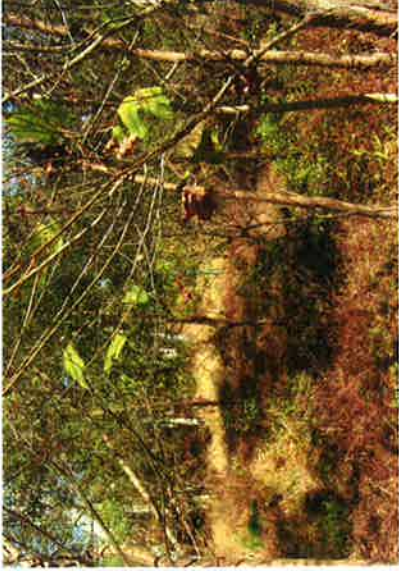
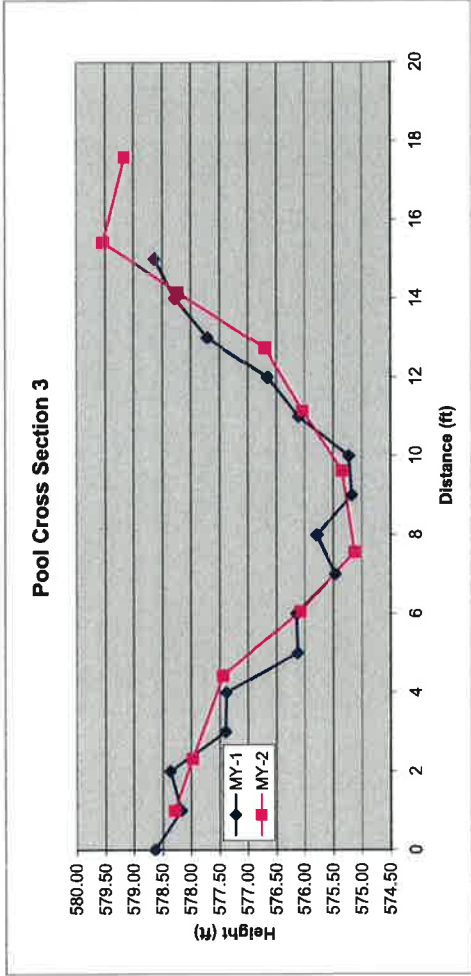
River Basin	Yadkin Pee-Dee
Watershed	Clear MY-02
XS-ID	PXS-3
Drainage Area	0.95
Date	10/16/2013
Field Crew	D. Wiebke, J. Burley

Summary Data	
Bankfull Elevation	578.29
Bankfull Cross-Sectional Area	21.35
Bankfull Width	13.2
Flood Prone Area Elevation	581.46
Flood Prone Width	200
Max Depth at Bankfull	3.17
Mean Depth at Bankfull:	1.678125
W/D Ratio:	7.87
Entrenchment Ratio:	15.15
Bank Height Ratio:	1.00
