McKee Creek Stream Restoration

Monitoring Report – Year 4 of 5

Contract #004391

DMS Project #92573

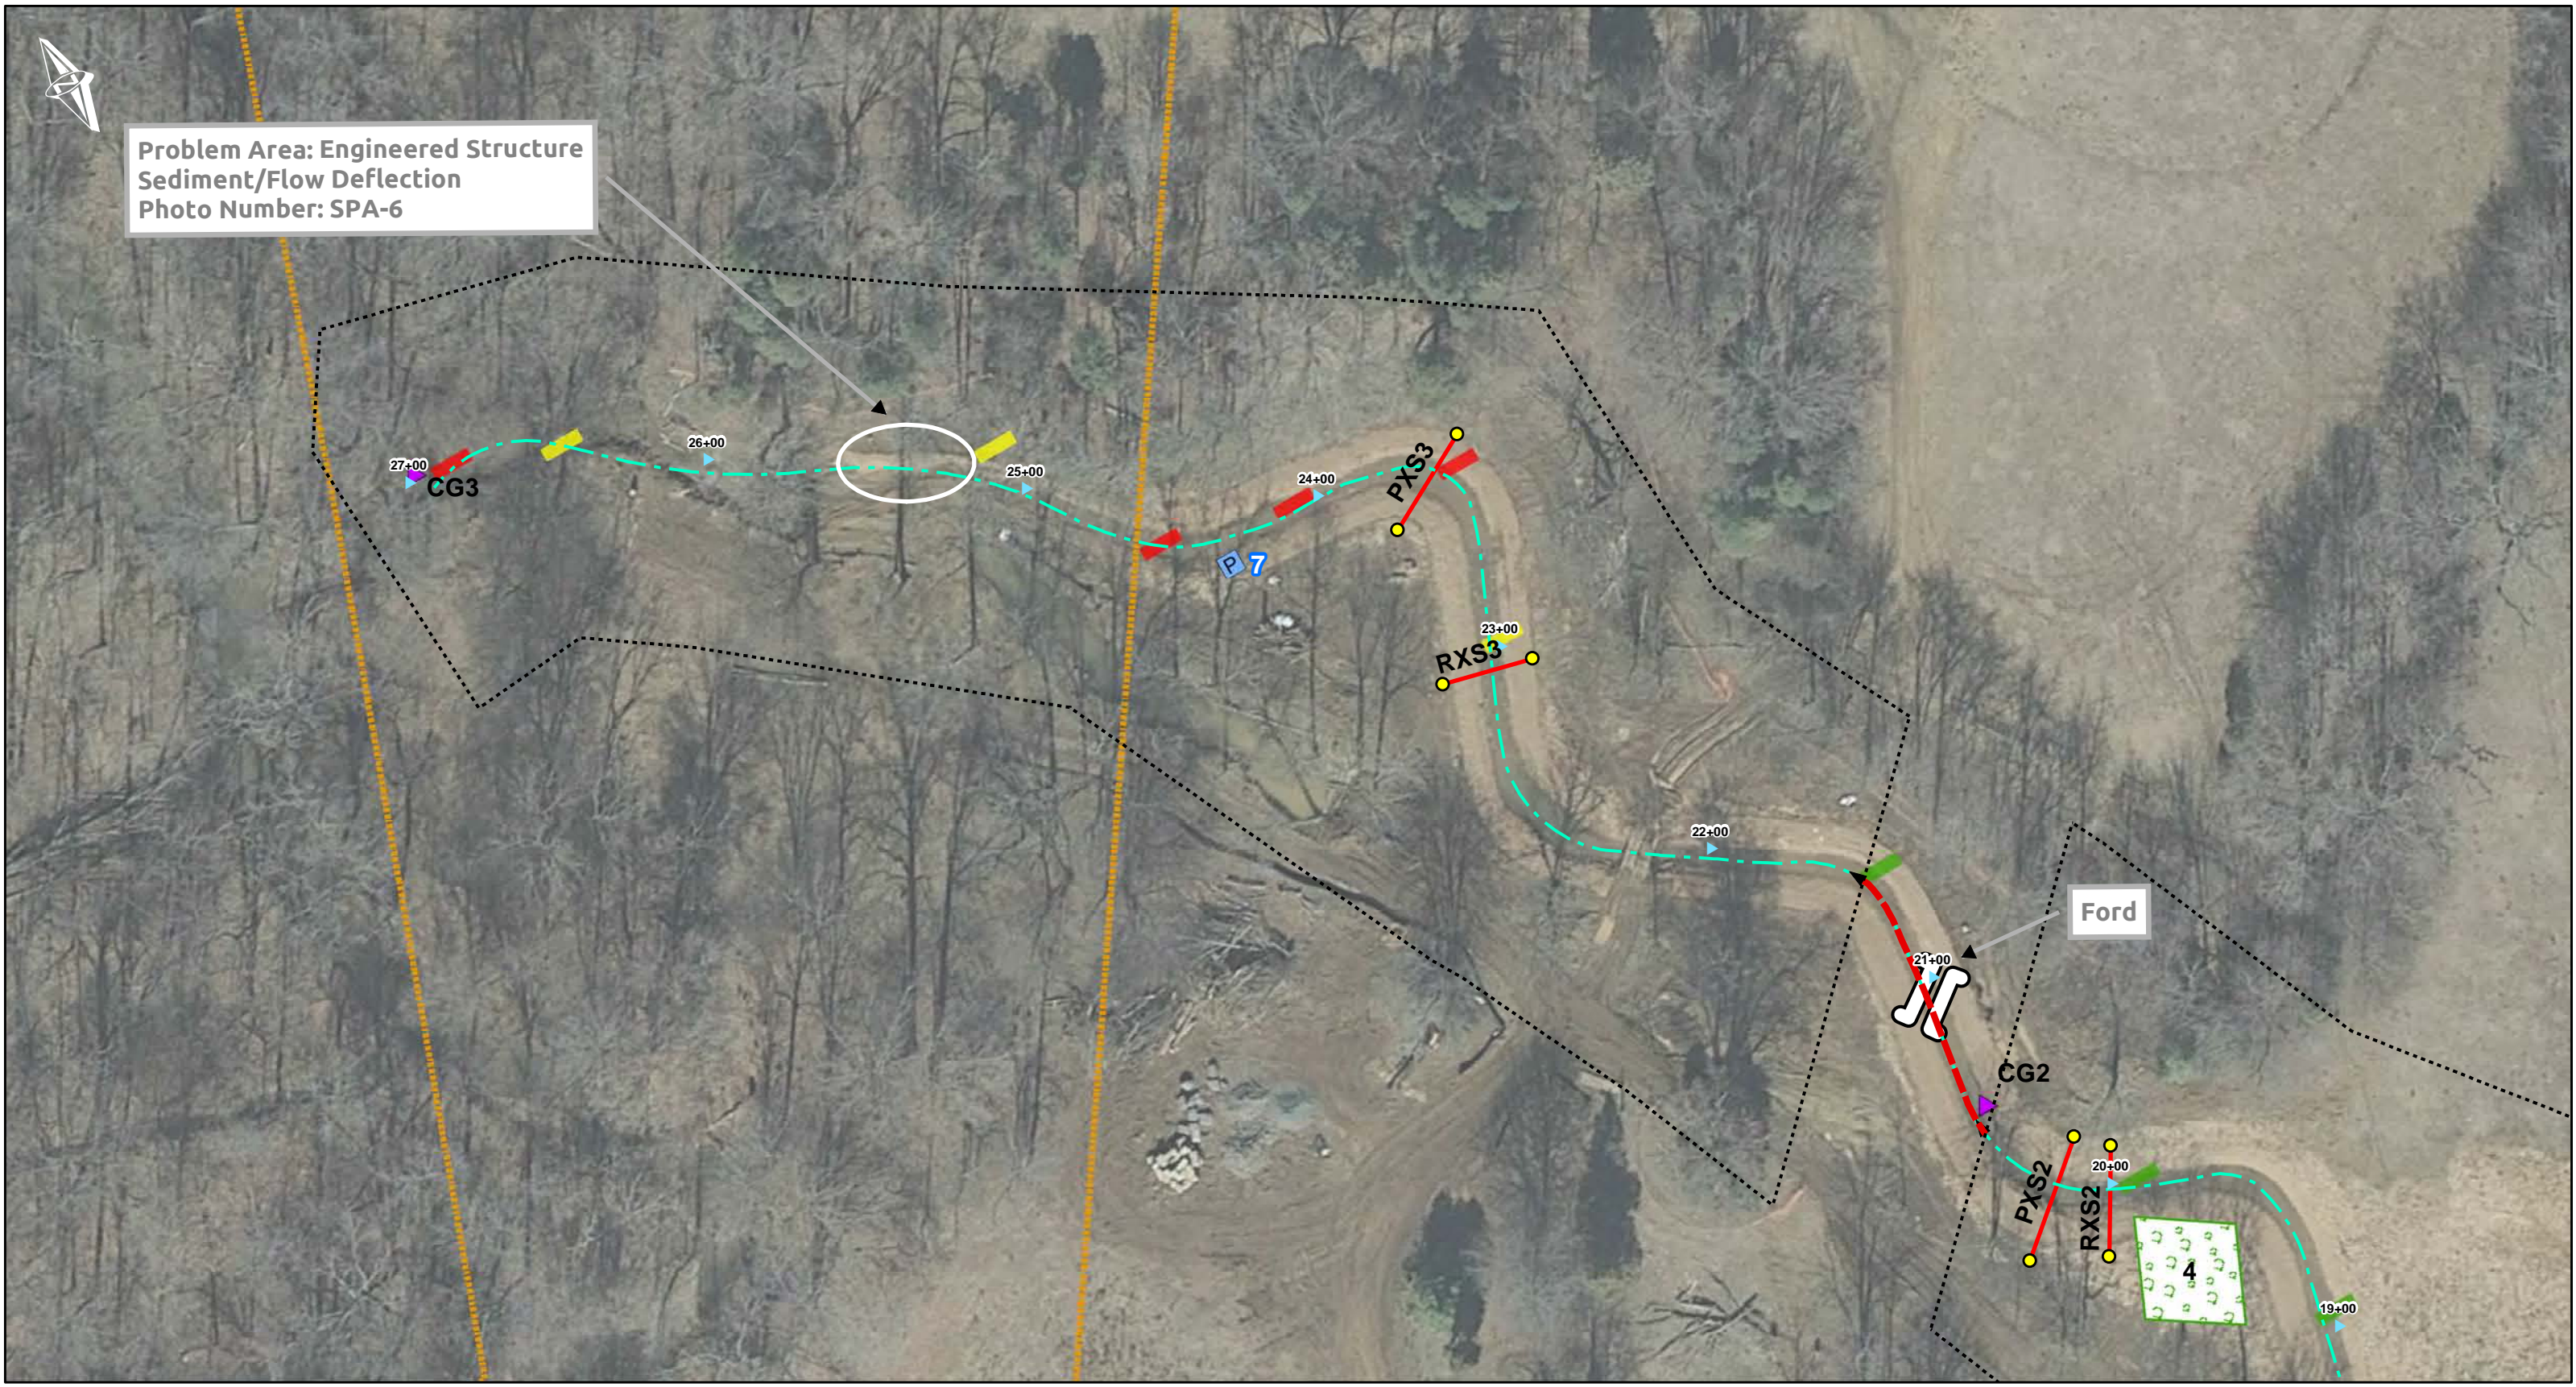
**Figure
2E**

**Problem Area: Engineered Structure
Sediment/Flow Deflection
Photo Number: SPA-6**

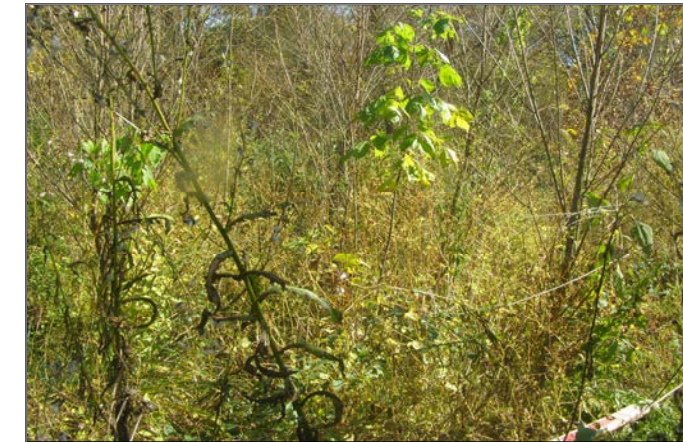
Cross-section Plot Exhibit	
River Basin	Yadkin Pee-Dee
Watershed	Clear MY-04
XS-ID	RXS-3
Drainage Area	0.95
Date	10/25/2015
Field Crew	Richmond/Burley

- ▶ Elevation data from the two cross-sections within the Clear Creek reach (Cross-sections RXS-3 and PXS-3) show variations from previous surveys. A review of raw survey data confirmed the elevations collected during the survey. The variations noted may be the result of stabilization and changes within the channel; however, it should be noted the survey was conducted during high flow, and the data may reflect abnormalities in the in-stream positioning of the equipment. It is anticipated that the variations in data will either be confirmed as changes in the channel or possible data collection abnormalities during the MY5 survey.
