**Meadowbranch Swamp Wetland Restoration
2012 Final Monitoring Report
Monitoring Year One**

**Ecosystem Enhancement Program Project Number 92351
Ecosystem Enhancement Program Contract Number 004800**

Submitted: January 2, 2013

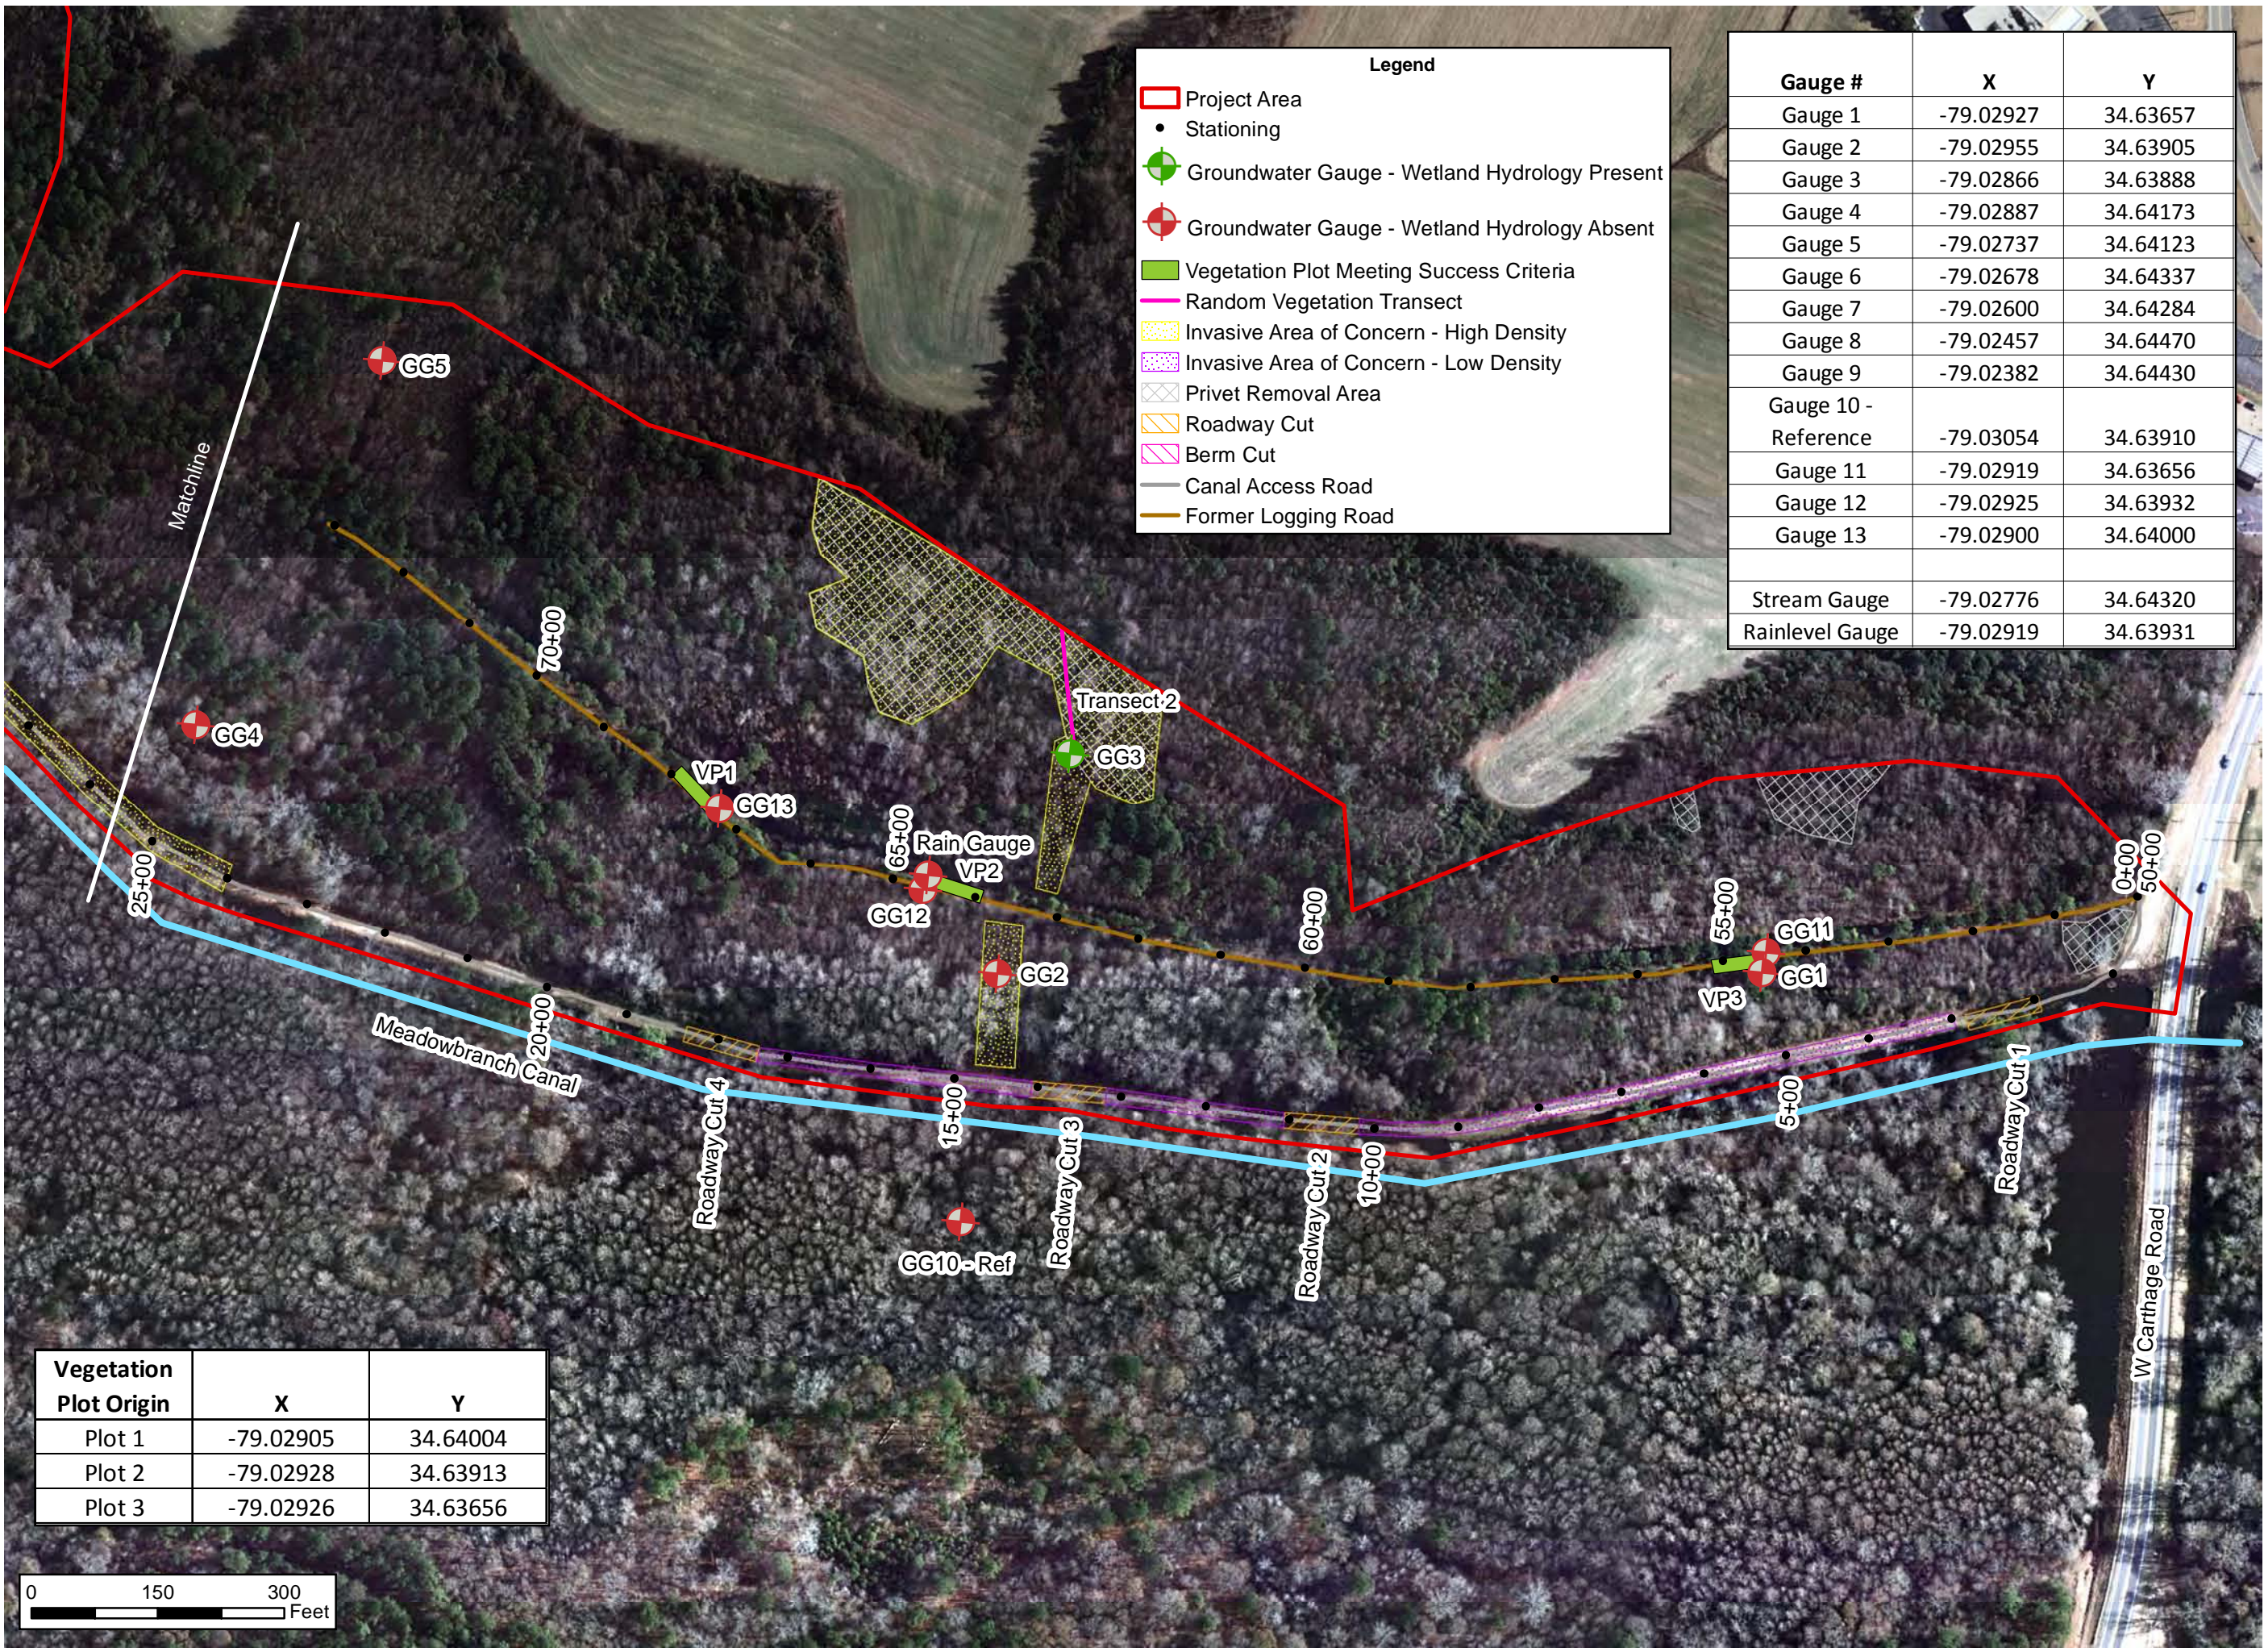
Figure 2
 Current Condition
 Plan View
 Project Overview

Overall, the site is in good condition, with the exception of the presence of Chinese privet. Chinese privet was observed scattered along the entirety of the canal road. It appeared to be most problematic within the transect areas leading to the groundwater gauges. This could be due to the clearing that took place in the transect areas. The northern portions of the site support the largest populations. The Chinese privet is particularly abundant between berm cuts 8 and 9 and along the canal road and removal areas. Very large specimens (20-30 feet) were observed in this area.

Prior erosion was noted at Roadway Cut 1 and Roadway Cut 2. Erosion was evident behind the matting at both sites. It was unclear whether these events had happened prior to the placement of the matting, however, both sites appear to be stable. Photos have been included, but these were not identified as problem areas at this time. These two sites will be monitored for changes during future monitoring events.

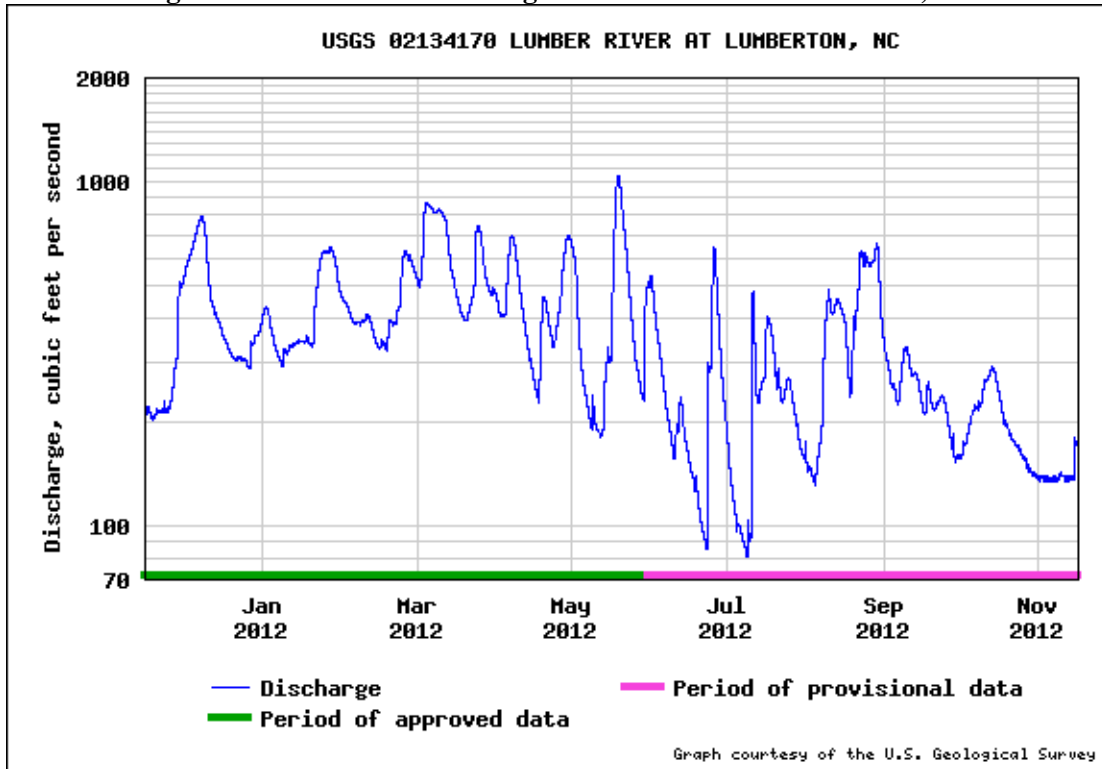
Figure 5: USGS Proximal Gauge Lumber River at Lumberton, NC

On-site stream gauge data, as well as USGS stream gauge data support the lack of rainfall during the past 12 months. Neither recorded a bankfull event.

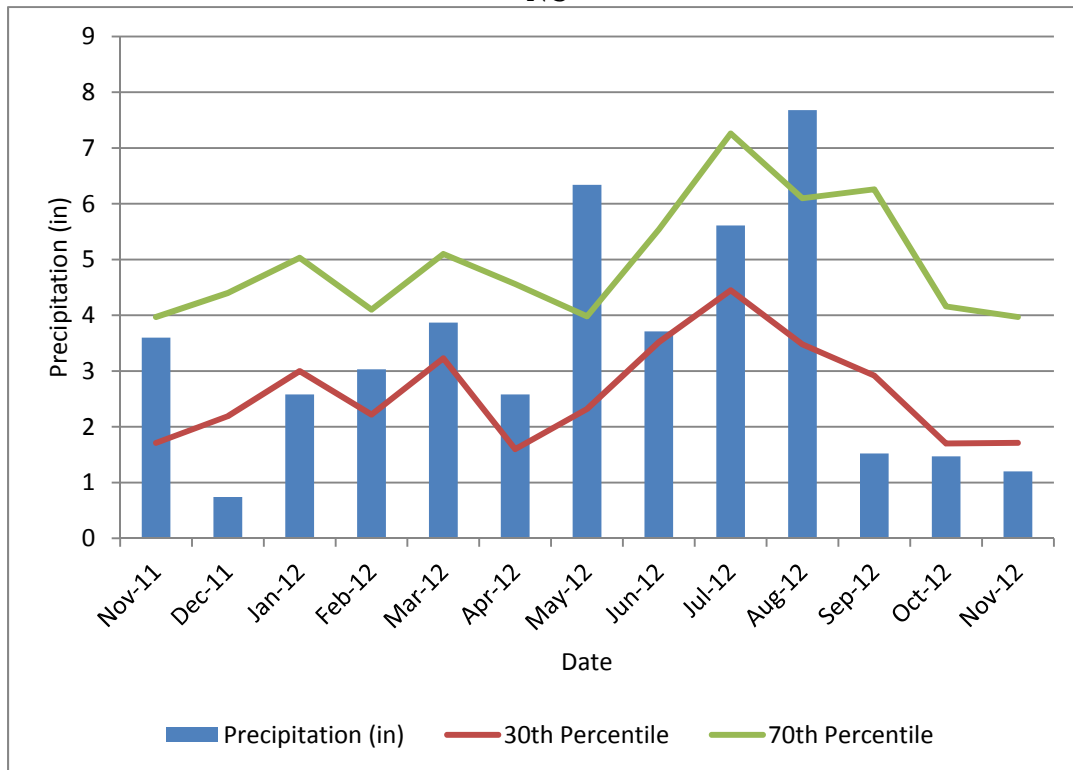
Figure 6: Meadowbranch Swamp Canal 30-70 Percentile Graph for Rainfall in 2012, Lumberton, NC

A rain gauge was installed on the site in October of 2006, but does not appear to be functioning properly. Data were downloaded on November 16, 2012 and resulted in readings for two days only. The NC Climate Retrieval and Observations Network of the Southeast (NC CRONOS) database was used to generate rainfall data for the site (NC CRONOS, 2012). Station 315177 – Lumberton was used. This station is less than two miles southeast (downstream) of the site. Normal annual precipitation for the station is 47.9 inches. Rainfall over the past 12 months totaled 43.9 inches, indicating that the past year has been dryer than an average year. The

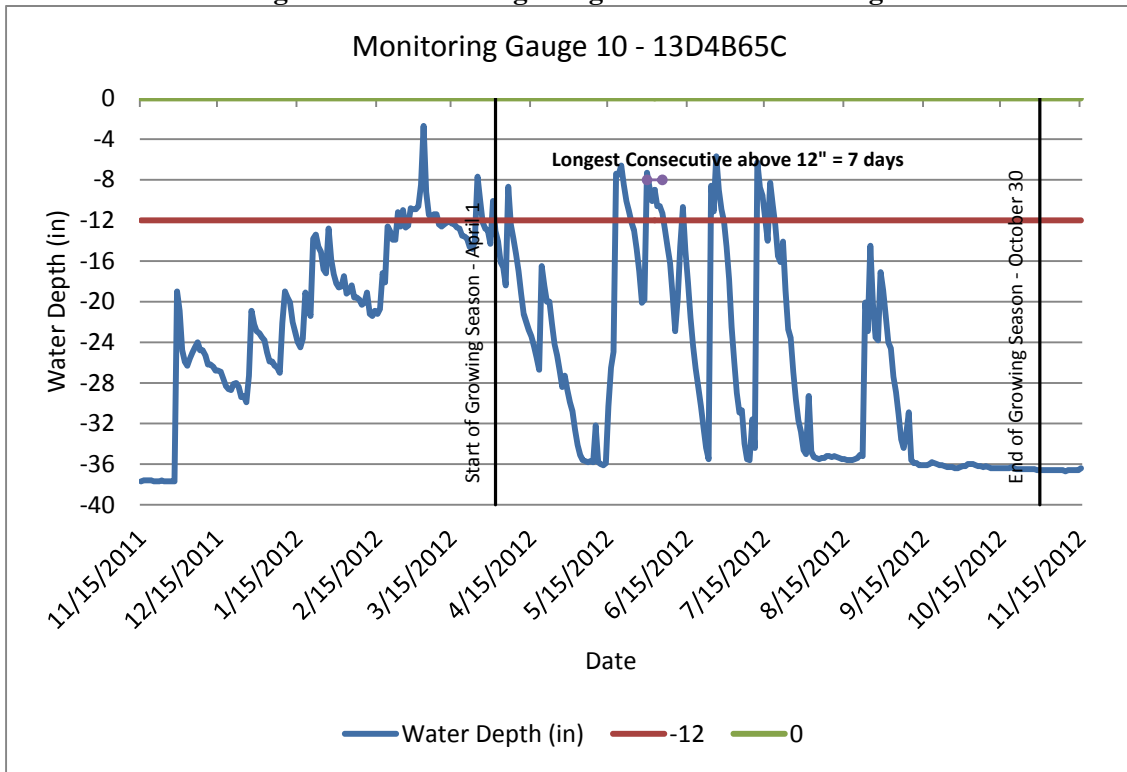
Figure 16: Monitoring Gauge 10 – Reference Gauge

The growing season is 213 days, and has been set from April 1 to October 30. Criteria established for the site state that groundwater levels must be at or above 12 inches of the ground surface for 10 percent of the growing season, or 21 days. Only one (GG3) of the 13 groundwater gauges installed on-site met the hydrologic success criteria established for the site. One of the 13 gauges (GG10) is a reference gauge, which also did not meet success criteria.
