**Meadowbranch Swamp Wetland Restoration  
2013 Final Monitoring Report  
Monitoring Year Two**

**Ecosystem Enhancement Program Project Number 92351  
Ecosystem Enhancement Program Contract Number 004800**

Submitted: November 11, 2013

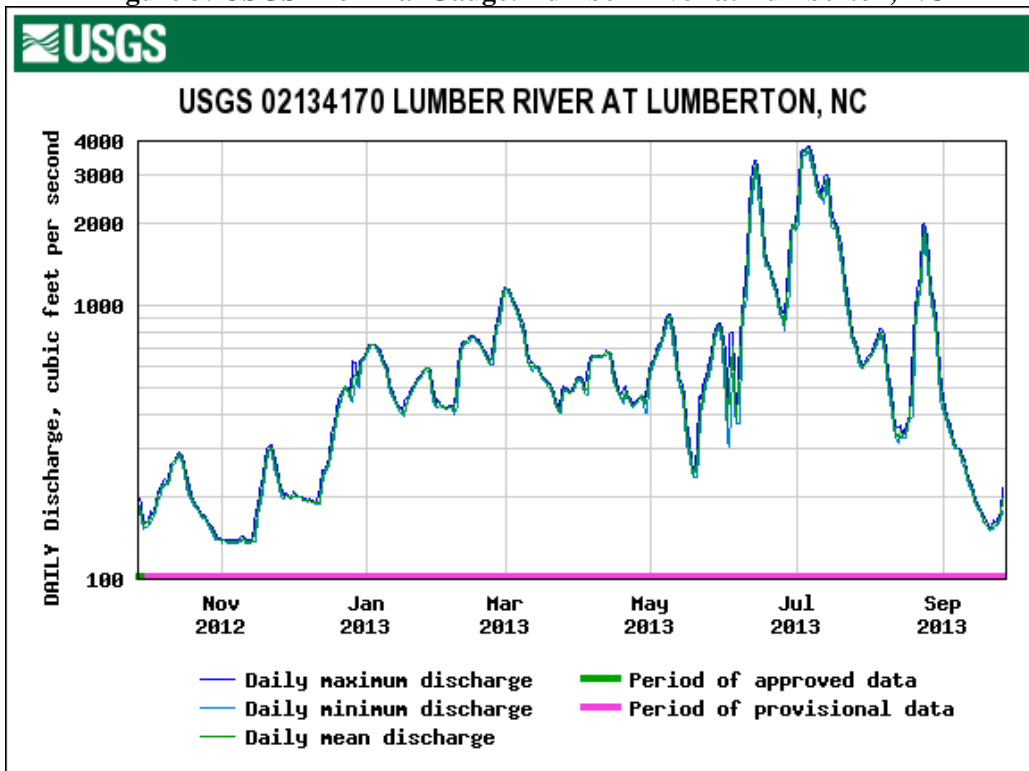
Figure 3: USGS Proximal Gauge: Lumber River at Lumberton, NC

The data logger on-site recorded two bankfull events between September 16, 2012 and September 16, 2013. Proximal USGS gauge data support this finding. Potential bankfull occurrence for the entire year (September 16, 2012 to September 16, 2013) was extrapolated based on USGS stream gauge discharge data for the Lumber River at Lumberton, NC. The USGS gauge plot is shown below (Figure 3). The gauge is located less than two miles downstream from the project site and has a drainage area of 708 square miles.

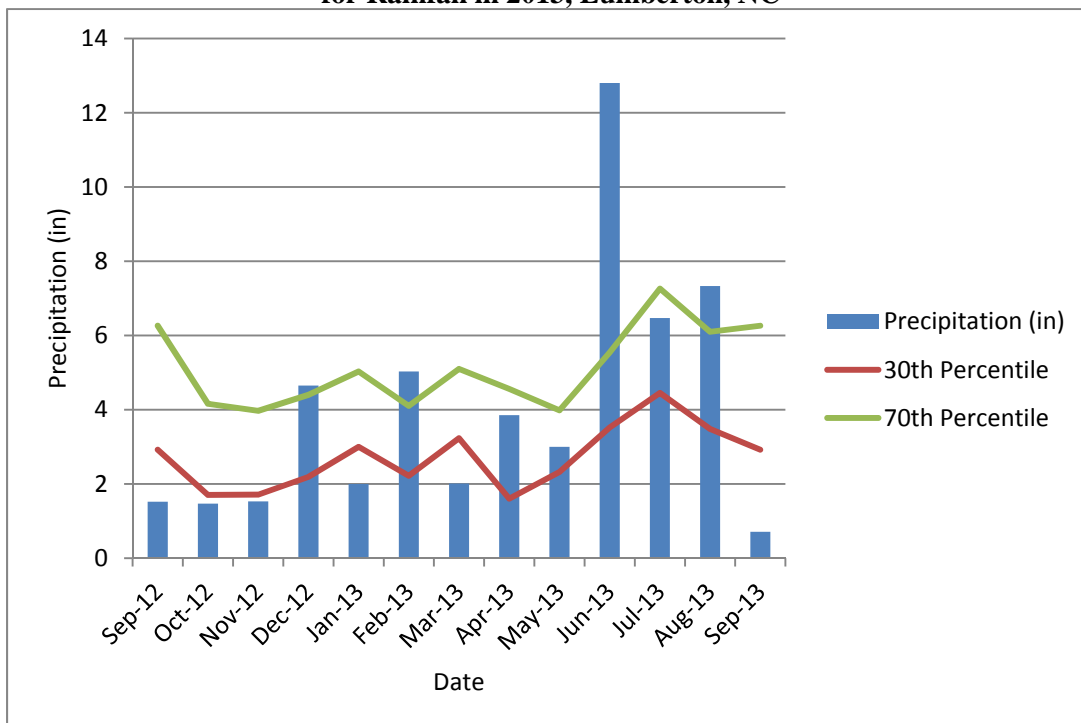
Figure 4: Meadowbranch Swamp Canal 30-70 Percentile Graph for Rainfall in 2013, Lumberton, NC

A rain gauge was installed on the site in October of 2006. During MY1, it was discovered that the gauge was not functioning properly. Data were downloaded on November 16, 2012 and resulted in readings for two days only. A replacement gauge was installed on the site on April 24, 2013. A data download was attempted during MY2 (on September 17, 2013) and the device could not be read due to an empty battery. The device will be re-installed on the site at the beginning of the 2014 growing season. The NC Climate Retrieval and Observations Network of the Southeast (NC CRONOS) database was used to generate rainfall data for the site (NC CRONOS, 2013). Station 315177 – Lumberton was used. This station is less than two miles southeast (downstream) of the site. Normal annual precipitation for the station is 47.9 inches. Rainfall over the past 12 months totaled 52.4 inches, indicating that the past year has been slightly above normal.
