**Meadowbranch Swamp Wetland Restoration
2014 Final Monitoring Report
Monitoring Year Three**

**Ecosystem Enhancement Program Project Number 92351
Ecosystem Enhancement Program Contract Number 004800**

Submitted: November 6, 2014

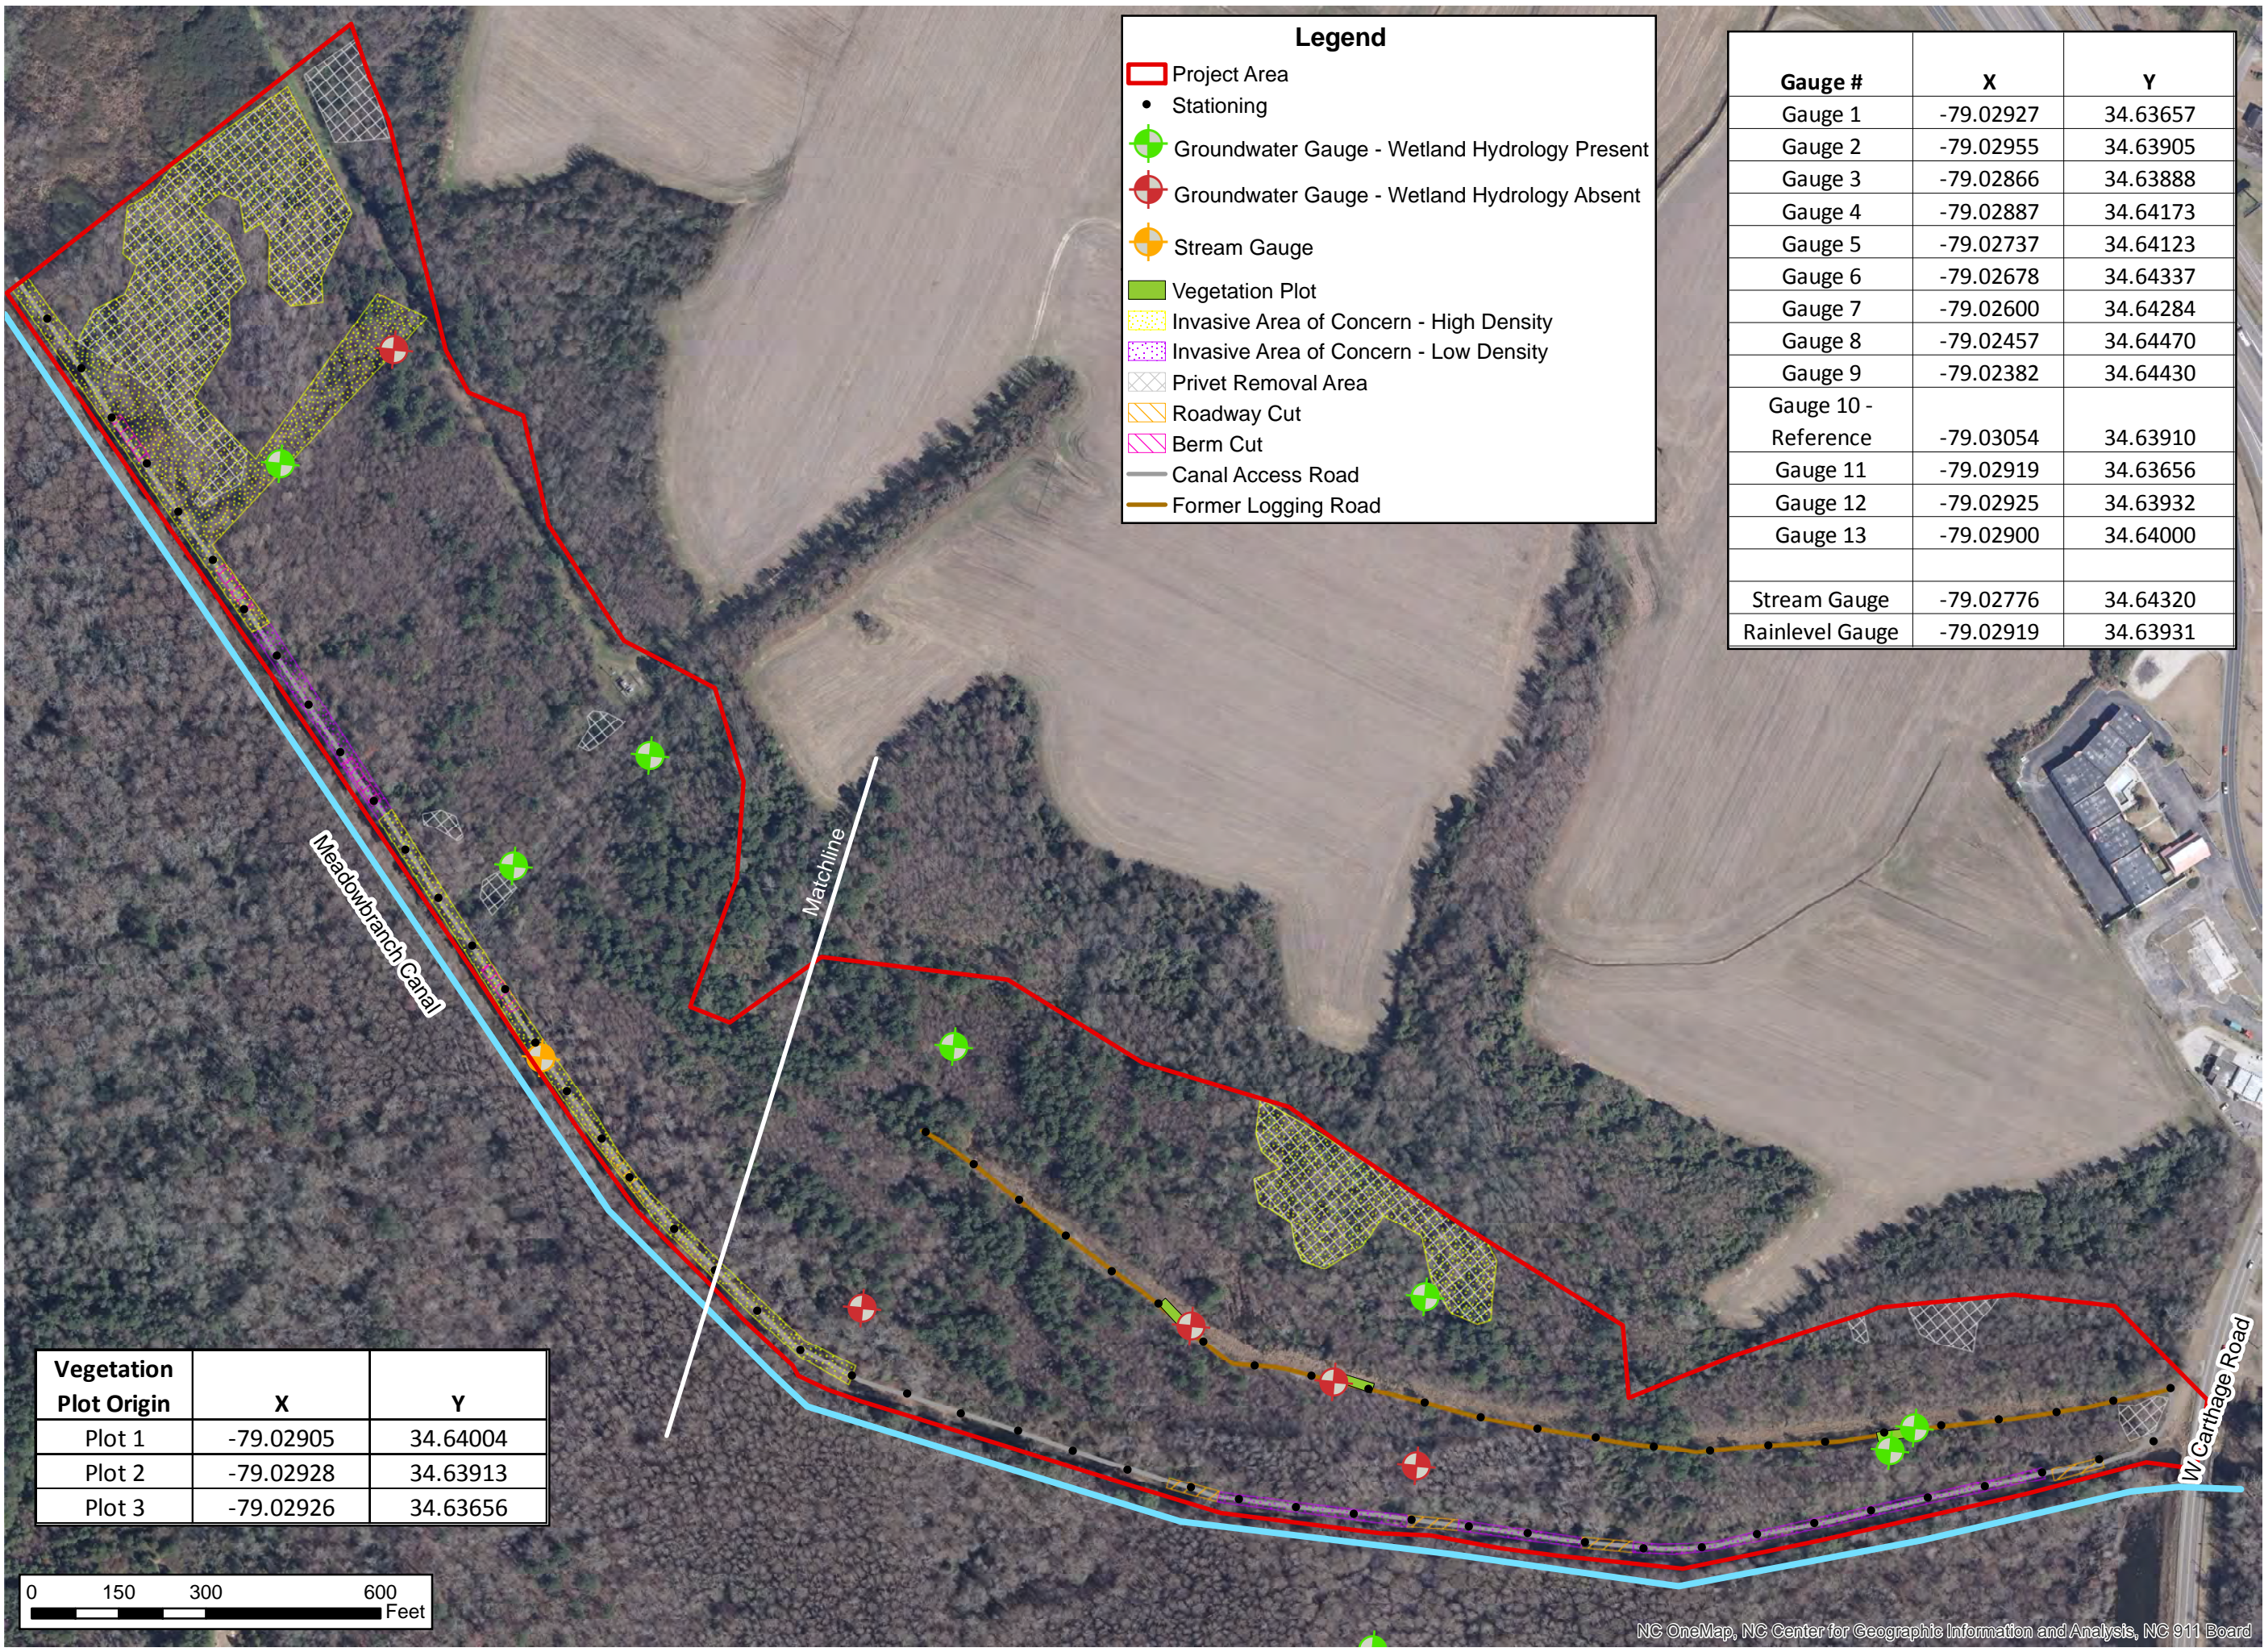
Figure 2
 Current Condition
 Plan View
 Project Overview

Overall, the site is in good condition, with the exception of the presence of Chinese privet. Chinese privet was observed scattered along the entirety of the canal road, and is still present in these areas. While the Chinese privet is still present, the limits do not appear to be expanding. The northern portions of the site continue to support the largest populations. The Chinese privet is particularly abundant between berm cuts 8 and 9 and along the canal road and removal areas. Very large specimens (20-30 feet) were observed in these areas.

Erosion was noted behind the matting at Roadway Cuts 1 and 2 during MY1. The erosion in these areas is still present, but has not changed since MY1. More recent erosion was noted along the banks of Meadowbranch Canal in the vicinity of Roadway Cuts 3 and 4 during MY2. Erosion is still evident behind the matting at both of these areas. A new area of bank erosion was noted during the annual site assessment in May of 2014. This area is located just downstream of the stream gauge and was present during MY3 monitoring. Photographs have been included with electronic files, but these areas were not identified as a problem at this time. The roadway cuts and bank condition will be monitored for changes during future monitoring events.

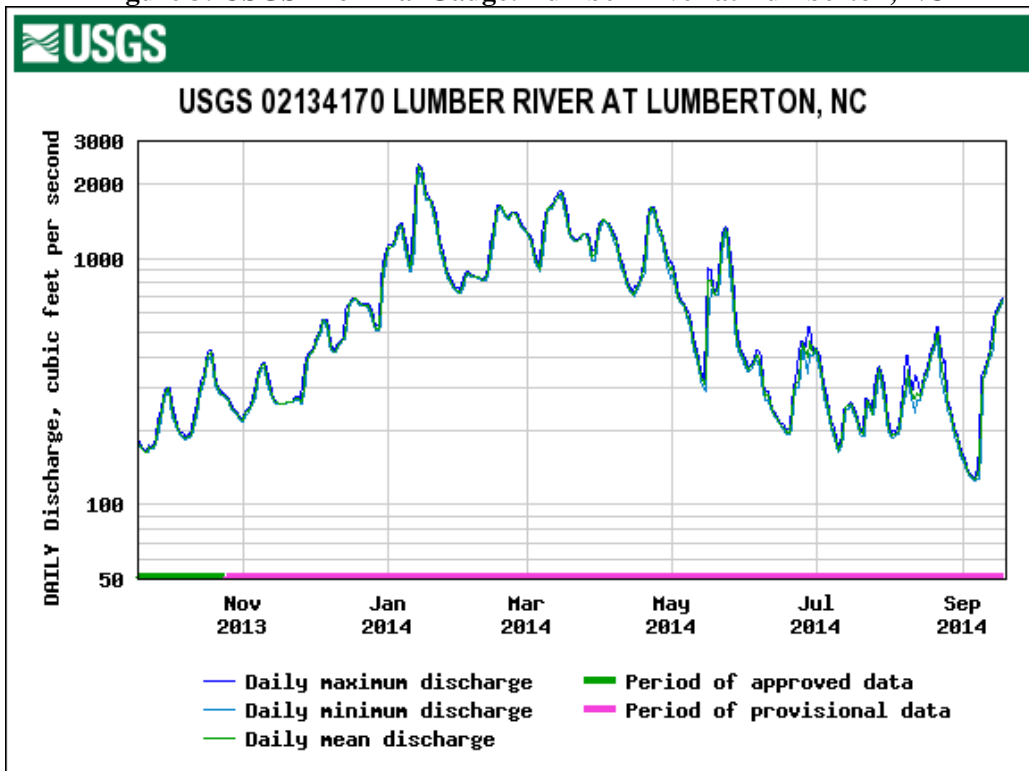
Figure 3: USGS Proximal Gauge: Lumber River at Lumberton, NC

The data logger on-site recorded one extended bankfull event (January 13, 2014 to January 15, 2014) and one single-day bankfull event (May 16, 2014) between September 25, 2013 and September 25, 2014. Proximal USGS gauge data support this finding. Potential bankfull occurrence for the entire year (September 25, 2013 to September 25, 2014) was extrapolated based on USGS stream gauge discharge data for the Lumber River at Lumberton, NC. The USGS gauge plot is shown on (Figure 3). The gauge is located less than two miles downstream from the project site and has a drainage area of 708 square miles.

An estimate of the number of bankfull events between September 25, 2013 and September 25, 2014 was made by comparing the stream discharges from the USGS data in cubic feet per second (cfs) against the bankfull discharge estimated from the drainage area on the Coastal Plain Regional Curve. According to the regional curve, a bankfull event occurs on a stream with a 708-square mile drainage area when the discharge is about 2,000 cfs. This discharge was exceeded once during the past year, and coincides the results from the on-site data logger. On January 13, 2014, the USGS gauge reached 2,050 cfs, it peaked during this event at 2,370 cfs on January 14, 2014 and receded below 2,000 cfs on January 16, 2014. Rainfall data are presented in Figure 4.

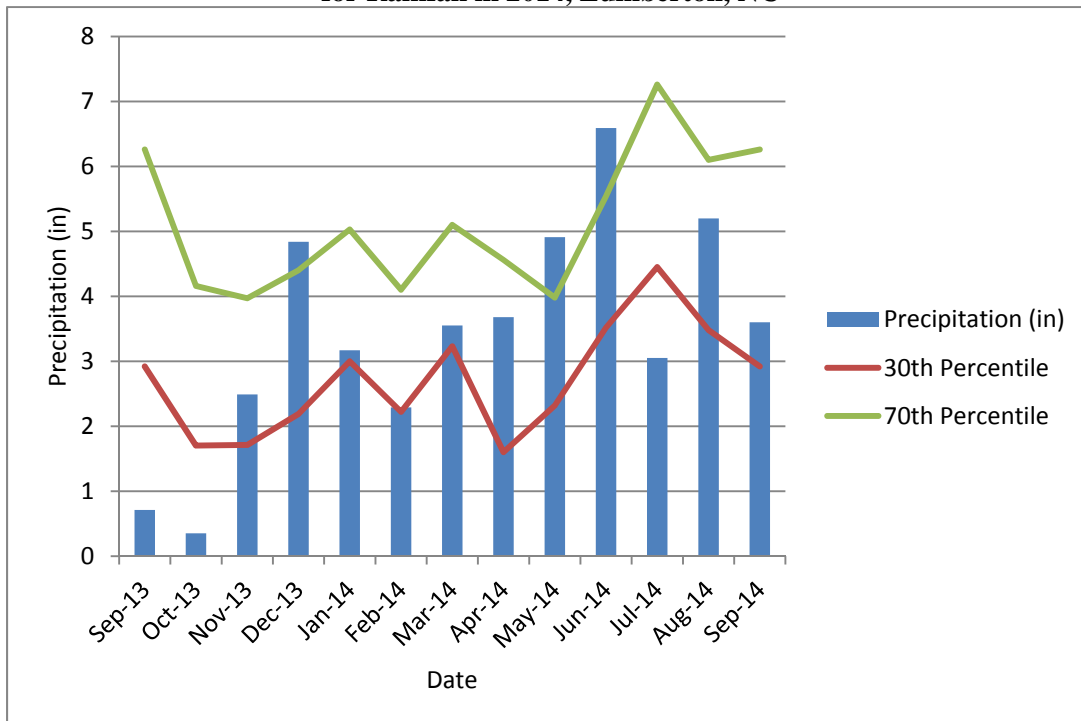
Figure 4: Meadowbranch Swamp Canal 30-70 Percentile Graph for Rainfall in 2014, Lumberton, NC

A rain gauge was installed on the site in October of 2006. During MY1, it was discovered that the gauge was not functioning properly. Data were downloaded on November 16, 2012 and resulted in readings for two days only. A replacement gauge was installed on April 24, 2013. A data download was attempted during MY2 (on September 17, 2013). The unit connected, but had not been recording data accurately. The unit was repaired and replaced in January of 2014. URS attempted to download data from the rain gauge on May 6, 2014. The unit connected, but had not been recording data. URS reset the unit and attempted to download again during MY3 on September 25, 2014. The unit would not connect to the data logger. To date, rainfall estimates have been provided through the NC Climate Retrieval and Observations Network of the Southeast (NC CRONOS) Lumberton station (315177), which is in close proximity (less than 0.6 miles) to the site. Due to persistent problems with the gauge, NC CRONOS data will be relied upon to provide reasonable estimates for site rainfall totals. Normal annual precipitation for the station is 47.9 inches. Rainfall over the past 12 months totaled 44.4 inches, indicating that the past year has been slightly below normal.
