**Meadowbranch Swamp Wetland Restoration
2015 Monitoring Report
Monitoring Year Four**

**DMS Project Number 92351
DMS Contract Number 004800**

Submitted: March 14, 2016

URS Corporation – North Carolina
701 Corporate Center Drive, Suite 475
Raleigh, NC 27607

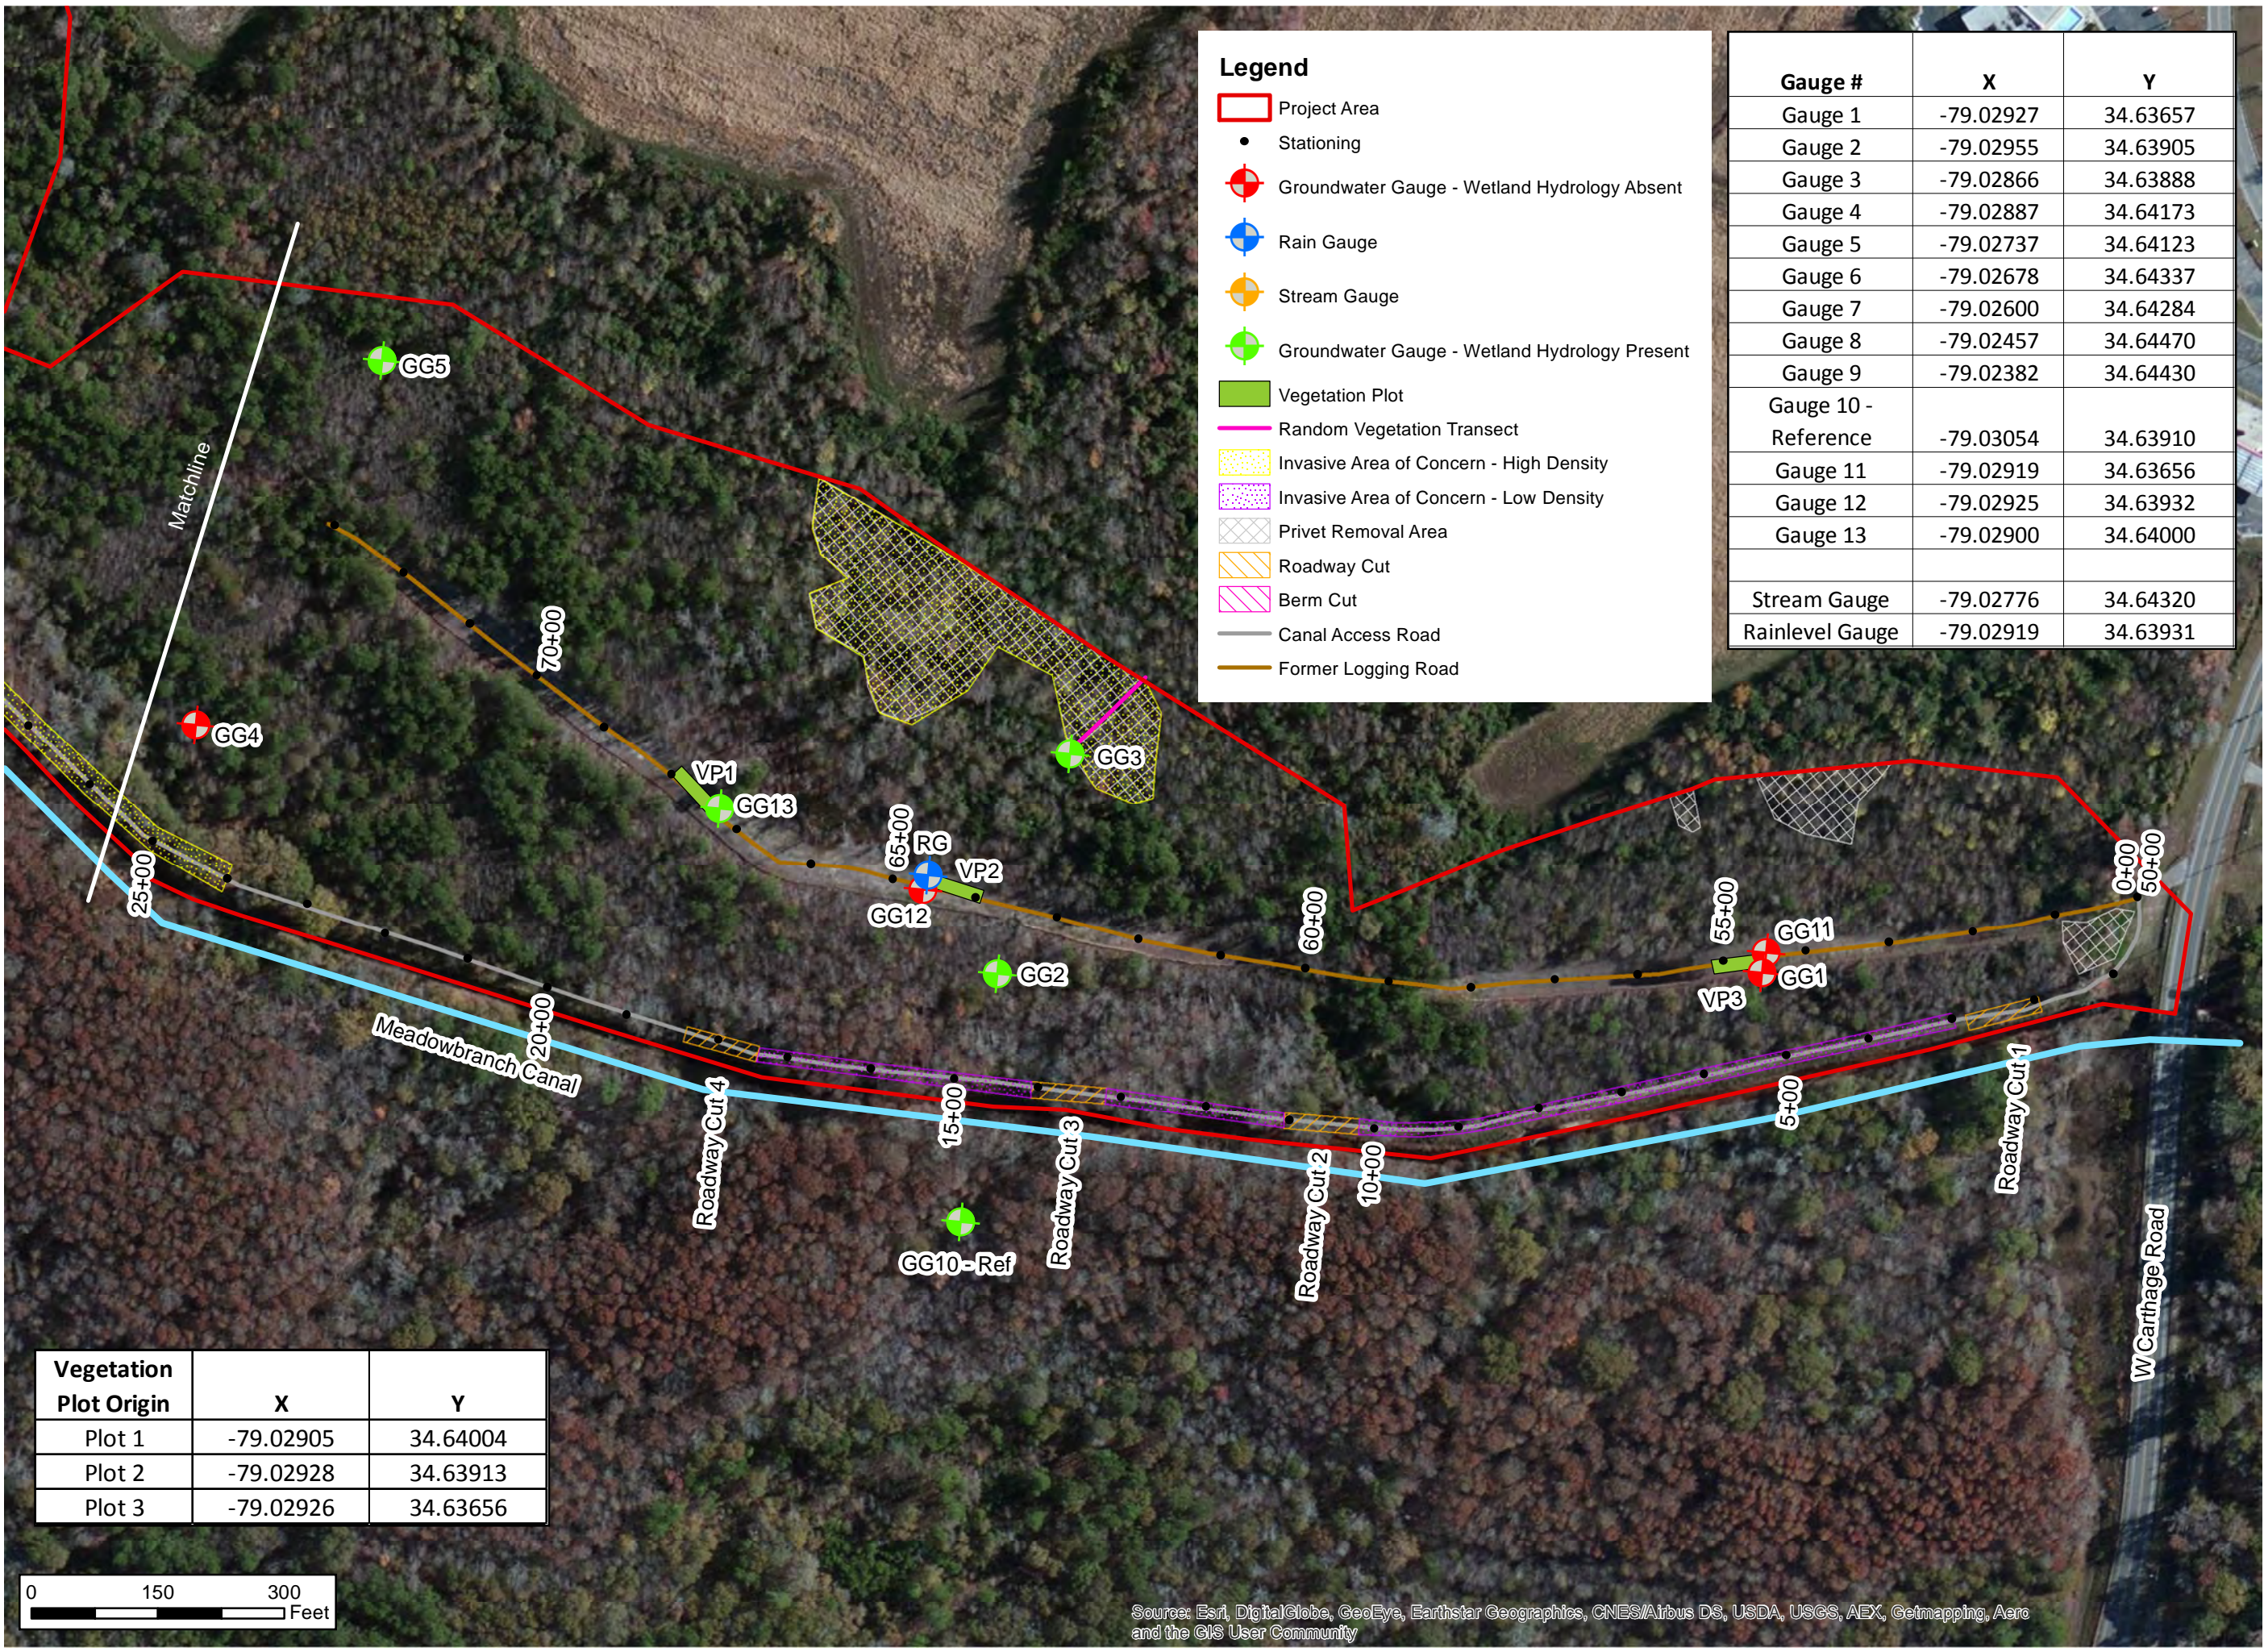
Figure 2
 Current Condition
 Plan View
 Project Overview

Erosion was first noted behind the matting at Roadway Cuts 1 and 2 during MY1. The erosion in these areas is still present, but has not changed since MY1. More recent erosion has been noted along the banks of Meadowbranch Canal in the vicinity of Roadway Cuts 3 and 4 during MY2. Erosion is still evident behind the matting at both of these areas. A new area of bank erosion was noted during the annual site assessment in May of 2014. This area is located just downstream of the stream gauge and was present during MY3 monitoring. During the annual site assessment (May 2015) a washout area was observed along the bank of the canal between stations 25+00 and 30+00, which appears to be due to water movement over the canal access road. Bank erosion was observed behind the matting of Berm Cut 2 and Road Cut 2. The roadway cuts and bank condition will continue to be monitored for changes during future monitoring events.

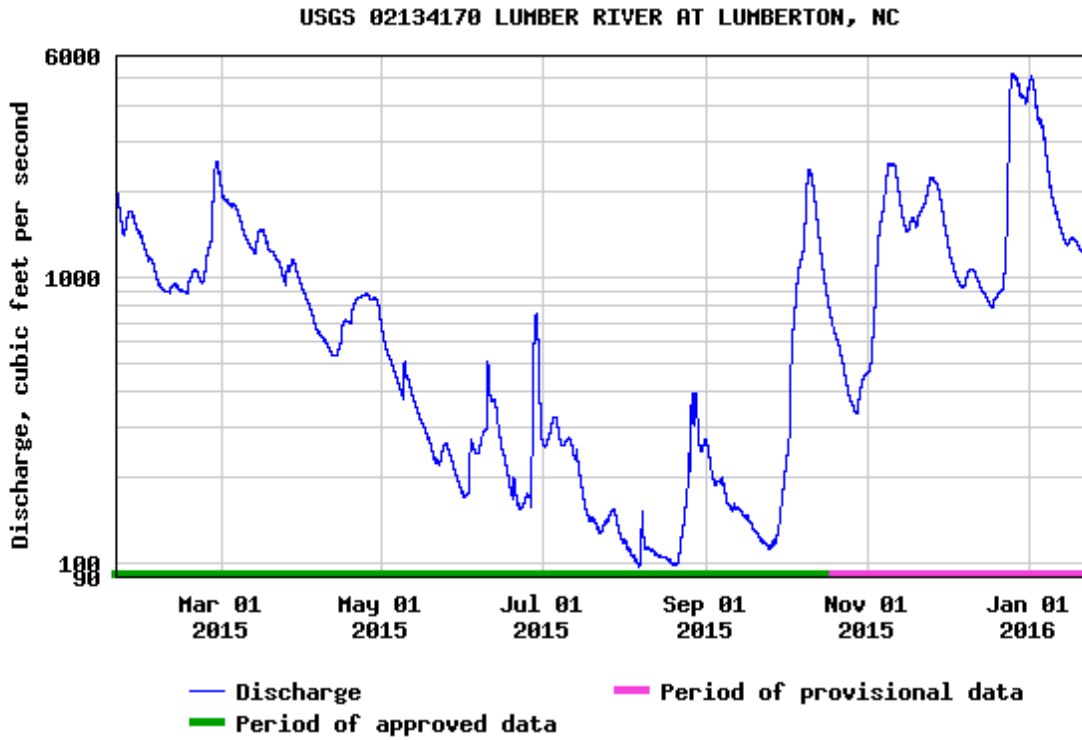
Figure 3: USGS Proximal Gauge: Lumber River at Lumberton, NC

The data logger on-site recorded three bankfull events in 2015. A single-day bankfull event on February 27, 2015, a three-day event from November 9 to November 11, 2015, and a multi-day event that began on December 24, 2015 and continued into 2016. Proximal USGS gauge data supports these findings. Potential bankfull occurrence from September 25, 2014 to January 1, 2016 was extrapolated based on USGS stream gauge discharge data for the Lumber River at Lumberton, NC. The USGS gauge plot is shown on Figure 3. The gauge is located less than two miles downstream from the project site and has a drainage area of 708 square miles.

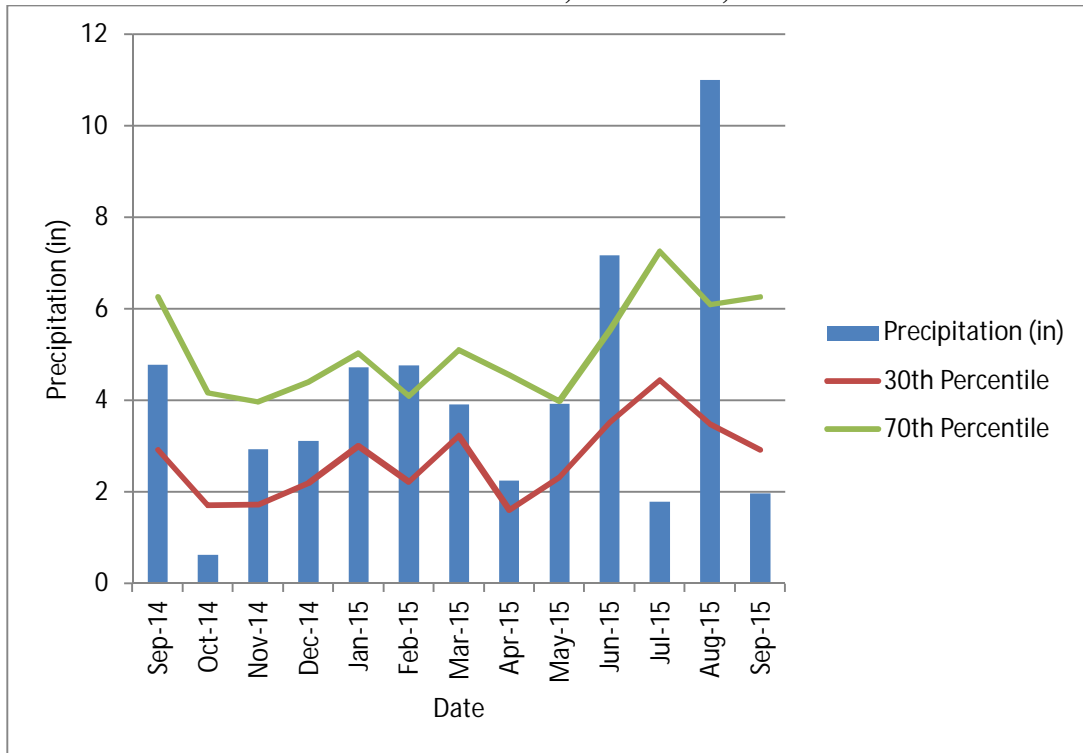
Figure 4: Meadowbranch Swamp Canal 30-70 Percentile Graph for Rainfall in 2015, Lumberton, NC

A rain gauge was installed on the site in October of 2006. During MY1, it was discovered that the gauge was not functioning properly. Data were downloaded on November 16, 2012 and resulted in readings for two days only. A replacement gauge was installed on April 24, 2013. A data download was attempted during MY2 (on September 17, 2013). The unit connected, but had not been recording data accurately. The unit was repaired and replaced in January of 2014. URS attempted to download data from the rain gauge on May 6, 2014. The unit connected, but had not been recording data. URS reset the unit and attempted to download again during MY3 on September 25, 2014 and during MY4 on January 15, 2016. The unit would not connect to the data logger. To date, rainfall estimates have been provided through the NC Climate Retrieval and Observations Network of the Southeast (NC CRONOS) Lumberton station (315177), which is in close proximity (less than 0.6 miles) to the site. Due to persistent problems with the gauge, NC CRONOS data will be relied upon to provide reasonable estimates for site rainfall totals. Normal annual precipitation for the station is 47.9 inches. Rainfall over the past 12 months totaled 52.99 inches, indicating that the past year has been above normal.
