**Meadowbranch Swamp Wetland Restoration
2016 Monitoring Report
Monitoring Year Five**

DMS Project Number 92351

USACE Action ID#: SAW2007-0400-078 DWR Project# N/A

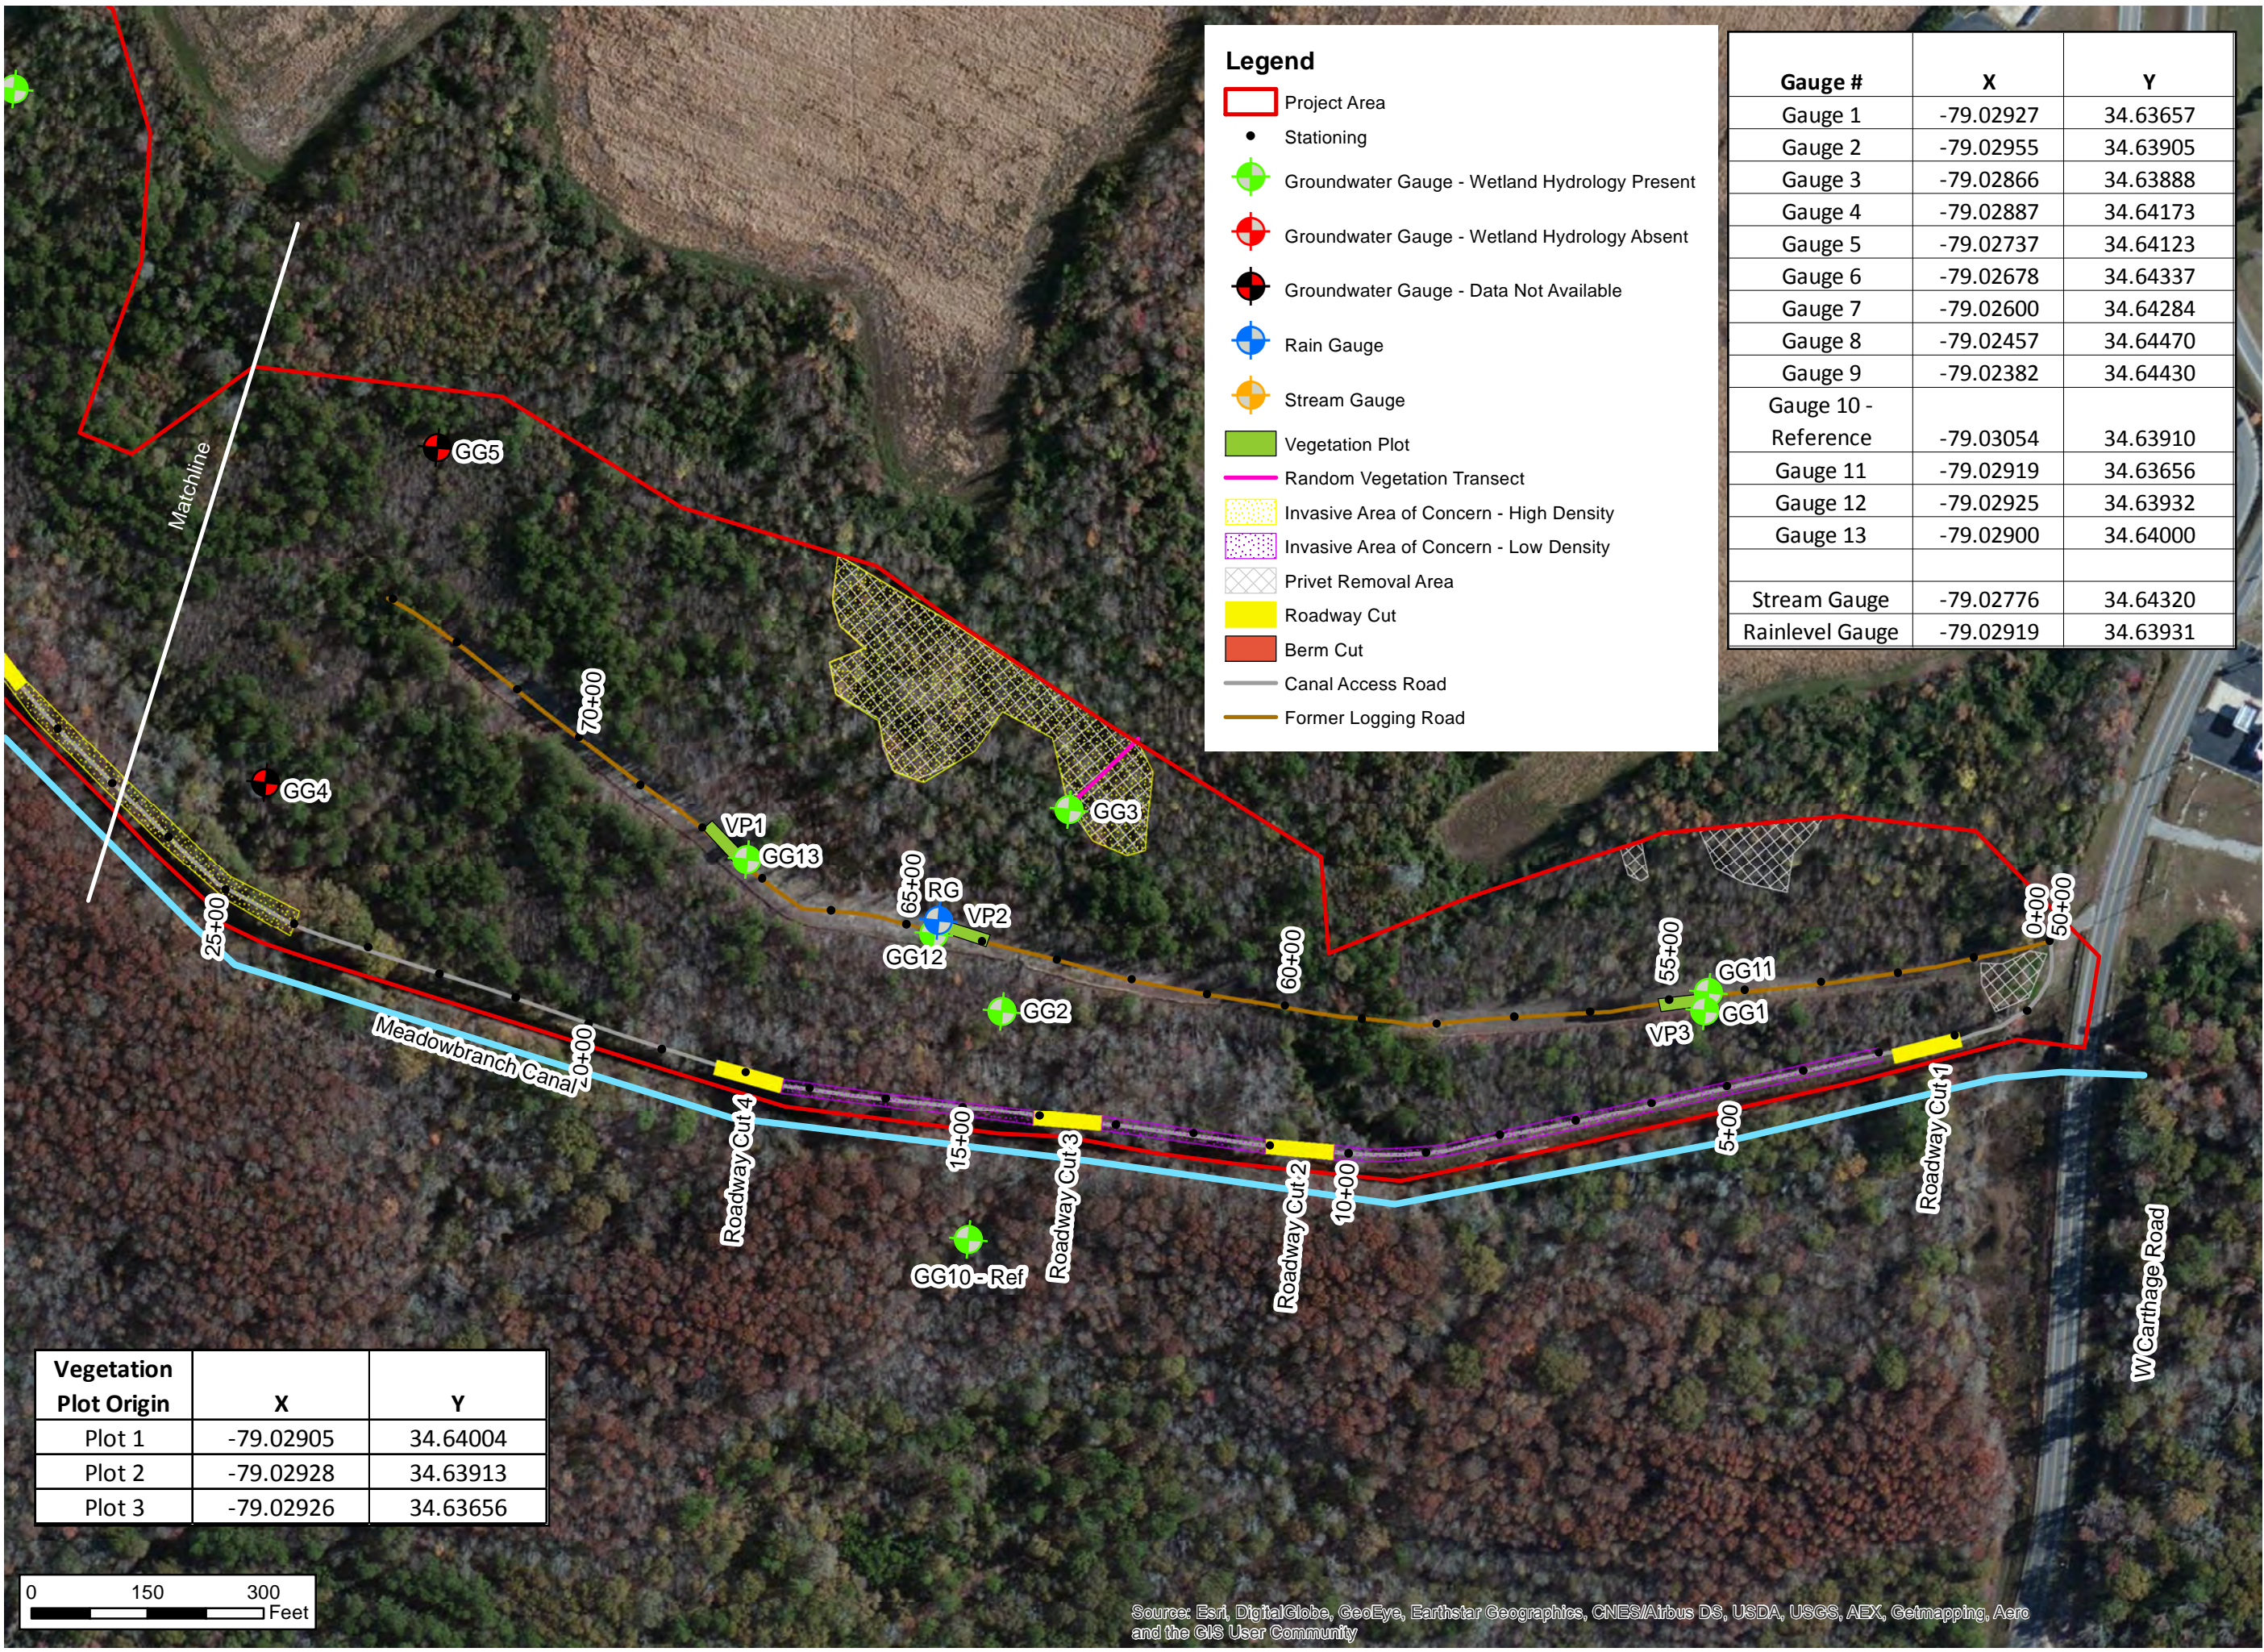
Figure 3
 Current Condition
 Plan View
 Project Overview

The presence of Chinese privet continues to be a problem at the site, especially along the canal access road and in the cut lines leading to the groundwater gauges between the former logging road and the canal access road. Treatment areas are notable in that there are large patches of stems that appear dead; however, upon closer observation, new growth is present on some of these stems. Treatment was successful in some areas, but not all. Chinese privet is still present in very dense patches along the canal access road in the northern portions of the site. Areas identified as invasive areas of concern during previous monitoring years remain on the Current Condition Plan View.

Overall, the site is in good condition, with the exception to the presence of Chinese privet. While the Chinese privet is still present, the limits do not appear to be expanding. The northern portions of the site continue to support the largest populations.

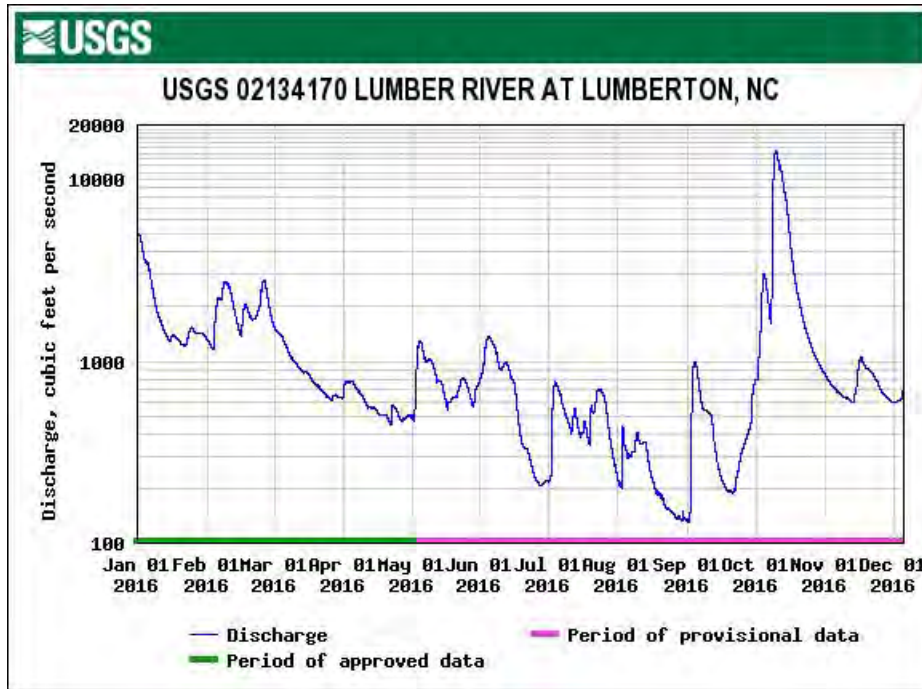
Figure 4: USGS Proximal Gauge: Lumber River at Lumberton, NC

The data logger on-site recorded four bankfull events in 2016. A multi-day event that began on December 24, 2015 and continued to January 8 2016, two small events in February, and a large event in October 2016 following hurricane Matthew. Proximal USGS gauge data supports these findings. Potential bankfull occurrence from January 1 to November 30, 2016 was extrapolated based on USGS stream gauge discharge data for the Lumber River at Lumberton, NC. The USGS gauge plot is shown on Figure 3. The gauge is located less than two miles downstream from the project site and has a drainage area of 708 square miles.

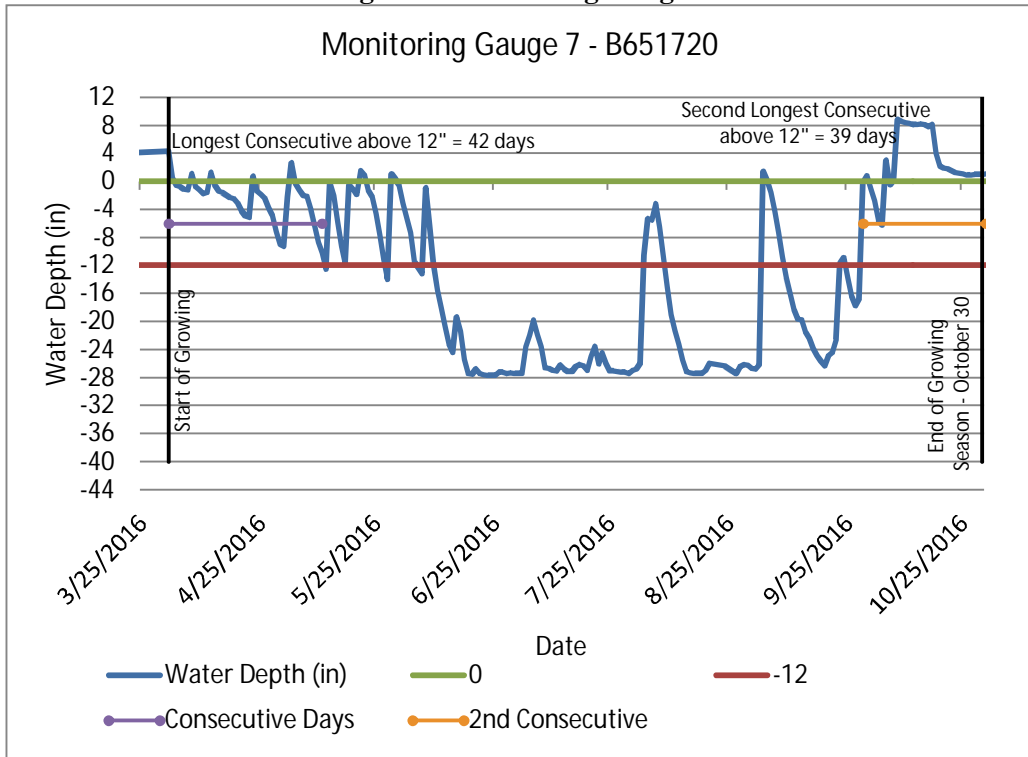
Figure 3: Monitoring Gauge 7

*Note: Water depths were adjusted five inches, calibration point was five inches above ground surface.

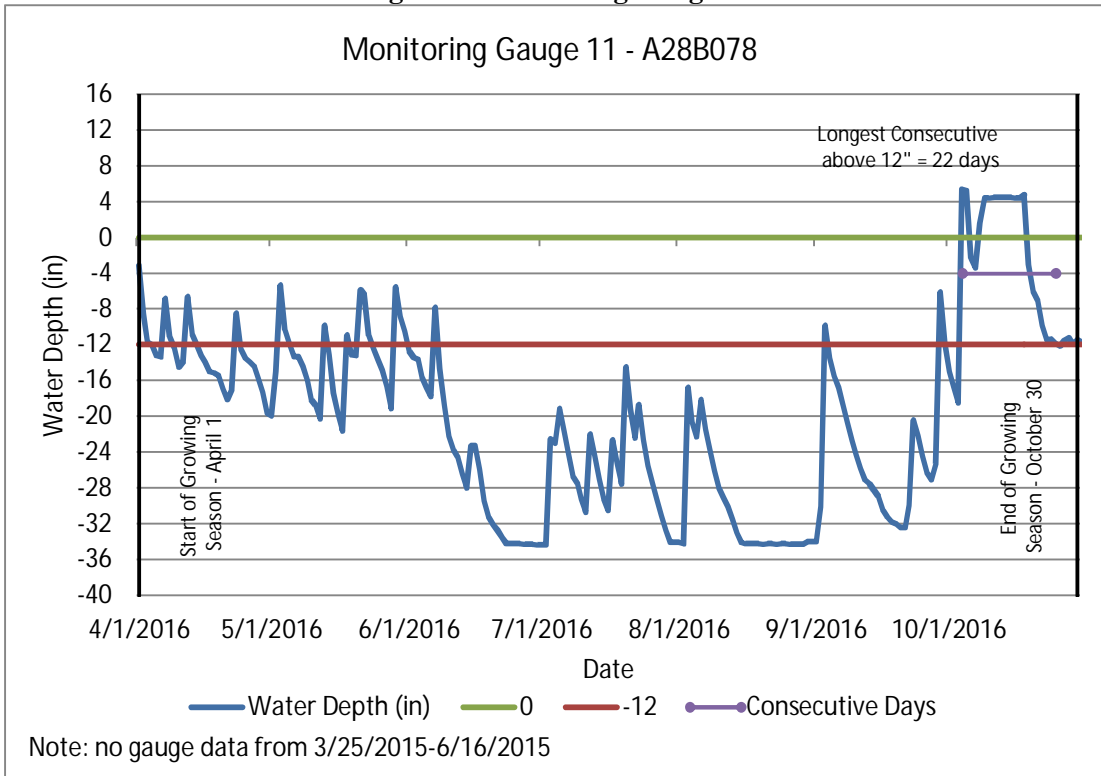
Figure 7: Monitoring Gauge 11

*Note: Water depths were adjusted six inches, calibration point was six inches above ground surface.
