Monitoring Year 1 Report
FINAL
Meadow Brook Stream Restoration Project
Yadkin County, North Carolina
Yadkin River Basin, Hydrologic Unit Code (HUC) 03040101

Data Collection Period:
September 2020 -October 2020

Submission Date:
December 2020

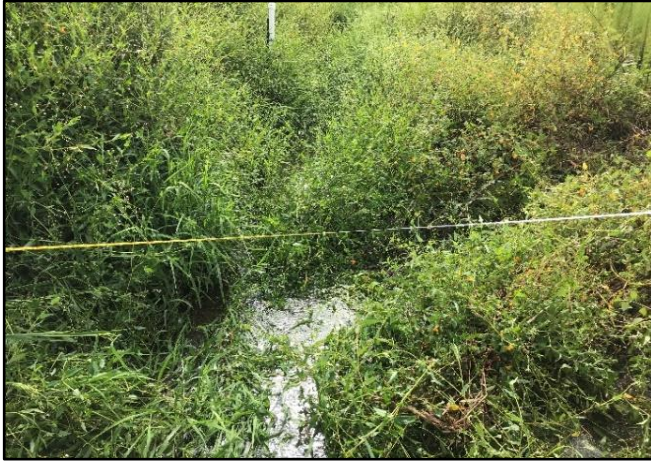
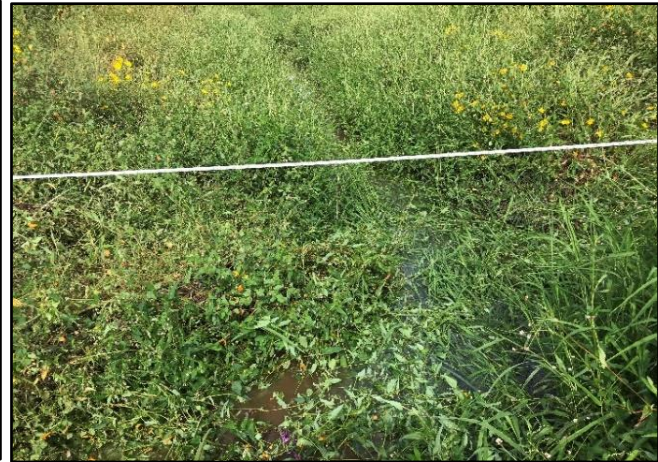
Cross Section Plot - MY1
XS5 - Reach 1
Station 21+77 - Riffle

MY0	MY1	MY2	MY3	MY4	MY5	MY+
Bankfull Elevation - Based on AB Bankfull Area	1039.55	1039.65					
Bank Height Ratio - Based on AB-Bankfull Area	1.00	0.94					
Thalweg Elevation	1037.61	1037.74					
LTOB Elevation	1039.55	1039.53					
LTOB Max Depth	1.94	1.79					
LTOB Cross Sectional Area	20.68	18.54					
Entrenchment Ratio	>3.06	>2.90

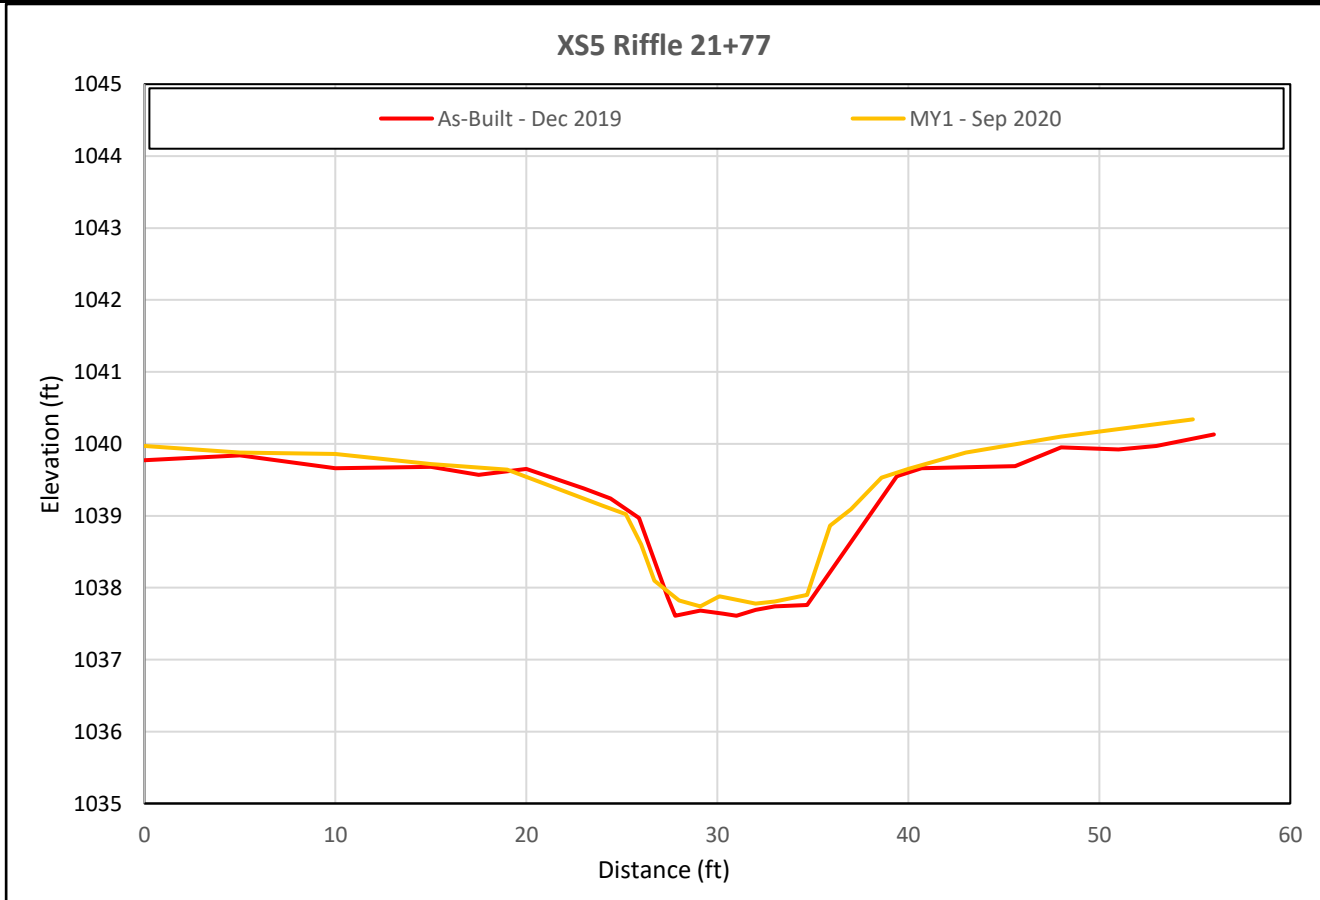
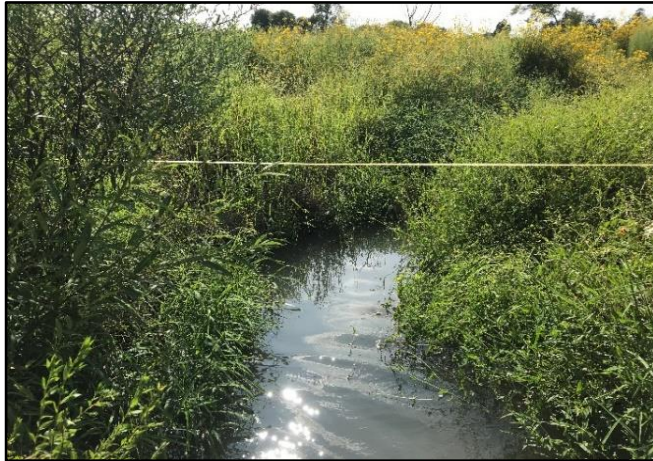
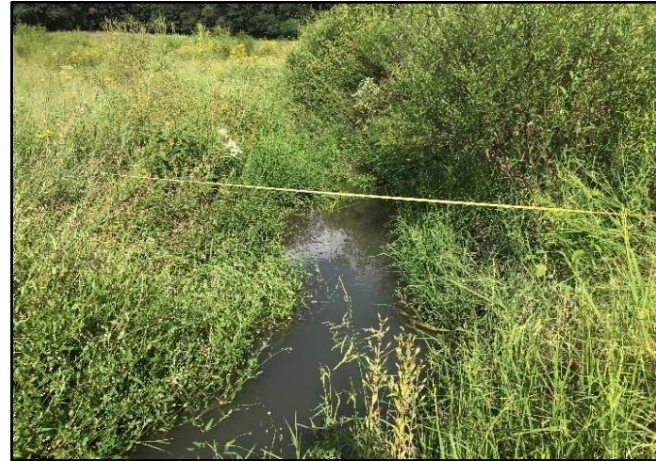
Cross Section Plot - MY1
XS6 - Reach 1
Station 25+74 - Pool

MY0	MY1	MY2	MY3	MY4	MY5	MY+
Bankfull Elevation - Based on AB Bankfull Area	1037.06	1037.03					
Bank Height Ratio - Based on AB-Bankfull Area	1.00	1.11					
Thalweg Elevation	1034.33	1034.21					
LTOB Elevation	1037.06	1037.34					
LTOB Max Depth	2.73	3.13					
LTOB Cross Sectional Area	21.82	26.18					
Entrenchment Ratio	-	-

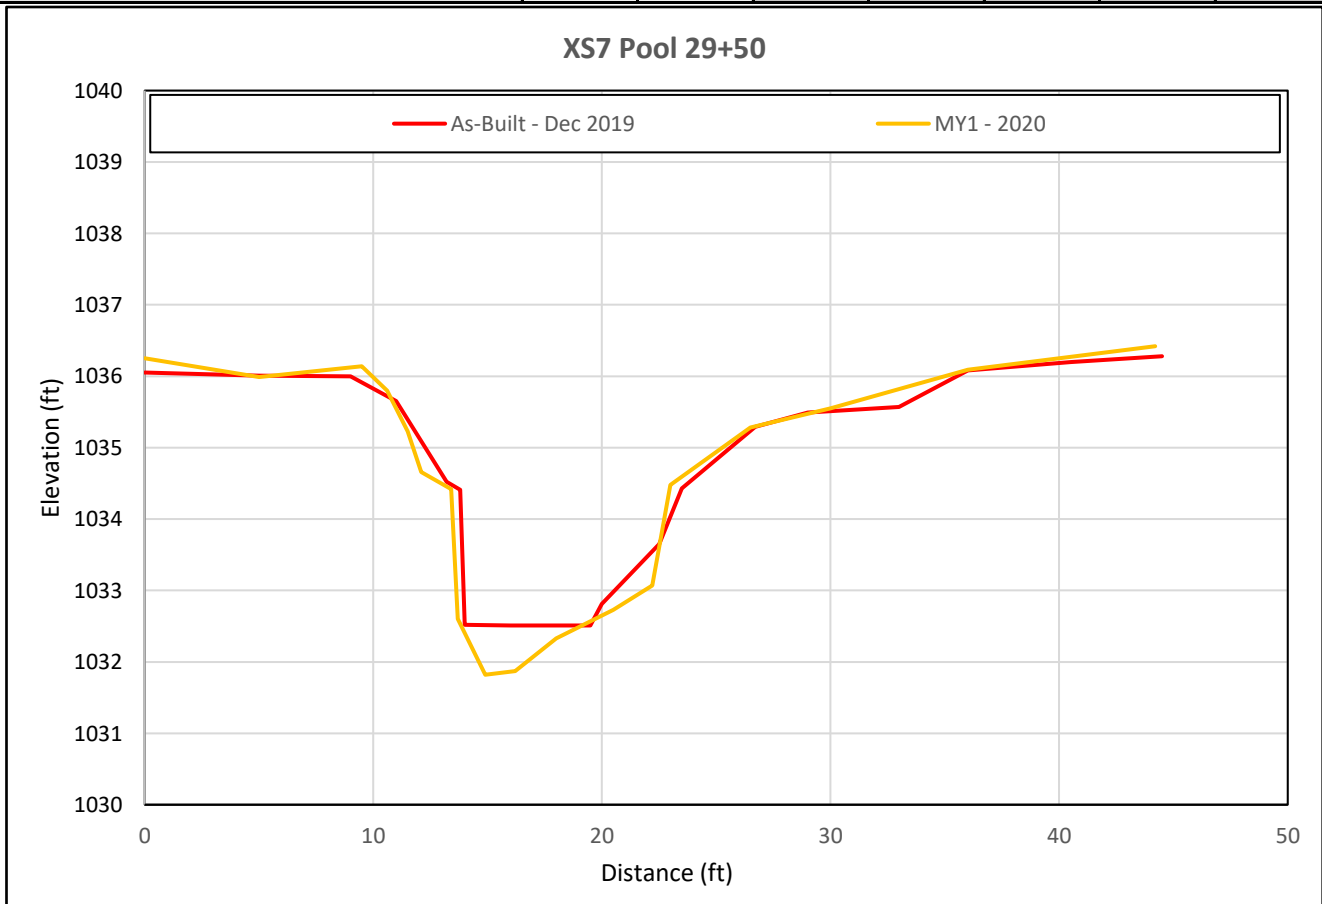
MY0	MY1	MY2	MY3	MY4	MY5	MY+
Bankfull Elevation - Based on AB Bankfull Area	1035.65	1035.48					
Bank Height Ratio - Based on AB-Bankfull Area	1.00	1.09					
Thalweg Elevation	1032.51	1031.82					
LTOB Elevation	1035.65	1035.80					
LTOB Max Depth	3.14	3.98					
LTOB Cross Sectional Area	32.43	38.84					
Entrenchment Ratio	-	-

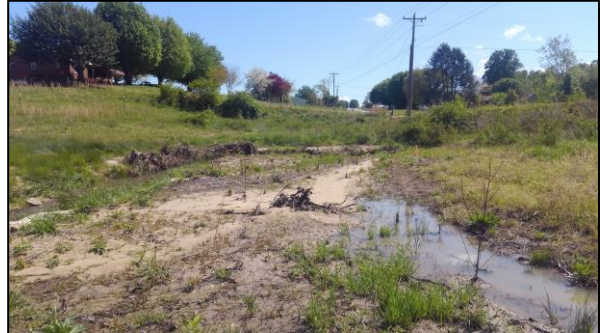
Photo 2 – Meadow Brook sediment deposition on
floodplain (4/20/2020)

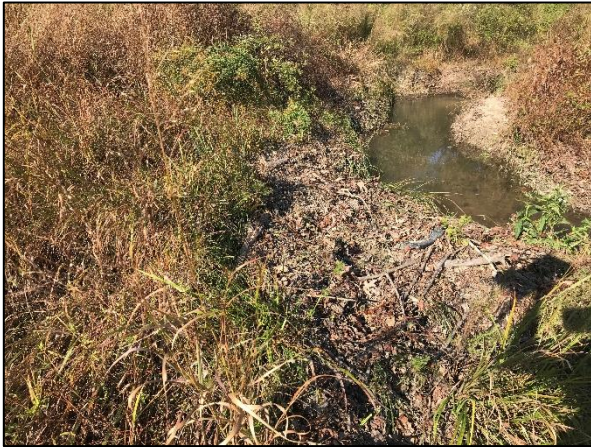
Photo 3 – UT to Meadow Brook Bankfull Wrack Line
(10/27/2020)

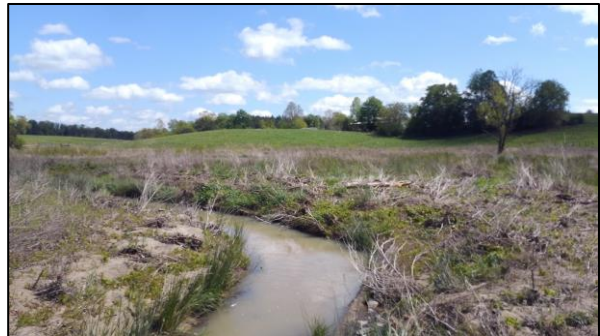
Photo 4 – UT to Meadow Brook sediment deposition on
floodplain, washed vegetation Bankfull Wrack Line
(4/20/2020)
