**Monitoring Year 3 Report**  
**FINAL**  
**Meadow Brook Stream Restoration Project**  
**Yadkin County, North Carolina**  
**Yadkin River Basin, Hydrologic Unit Code (HUC) 03040101**

**Submission Date:**  
December 2022

**Meadow Brook Stream Restoration Project**

Monitoring Year 3 Report - FINAL

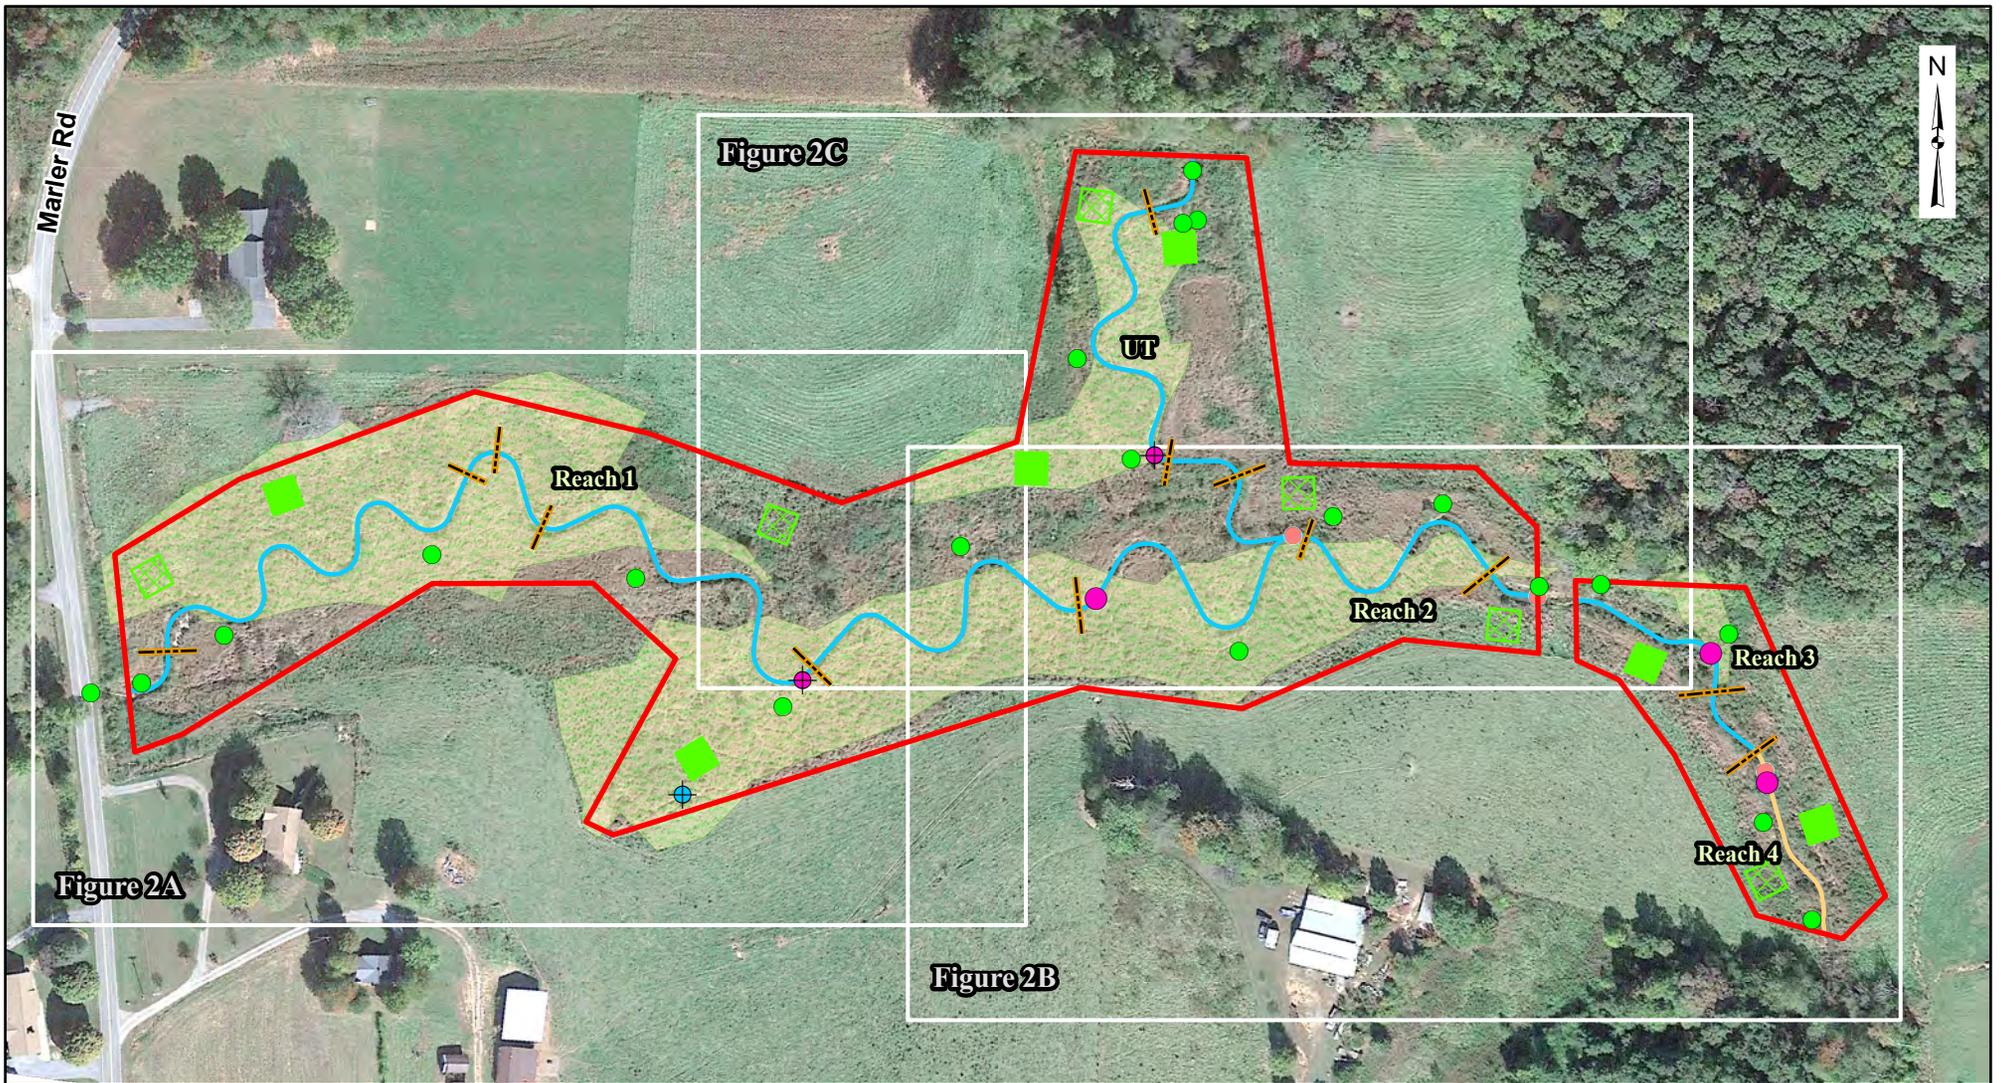
CURRENT CONDITION PLAN VIEW: OVERVIEW  
MY3: 2022

Three beaver dams were found over the course of MY3. These dams backed up water and caused very minor bank scour and channel widening in pools. One dam was found on Reach 1 and two dams were found on Reach 3. These dams were removed and the beavers were trapped and removed from site. Meadowbrook will be continued to be monitored for beaver activity to ensure that no new dams are constructed. Exact locations of dams can be found in the CCPV (Figure 2).

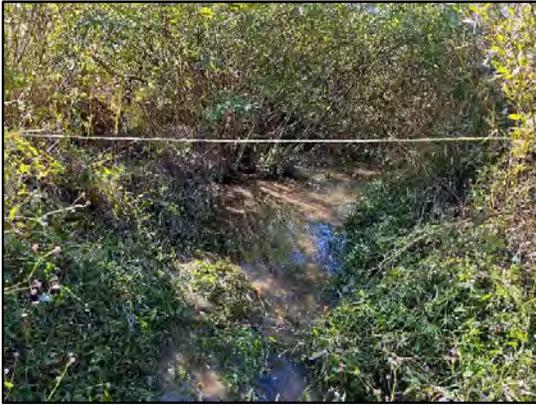
XS1 looking upstream

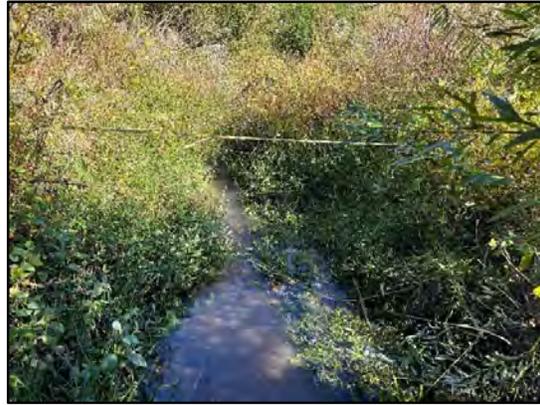
XS1 looking downstream

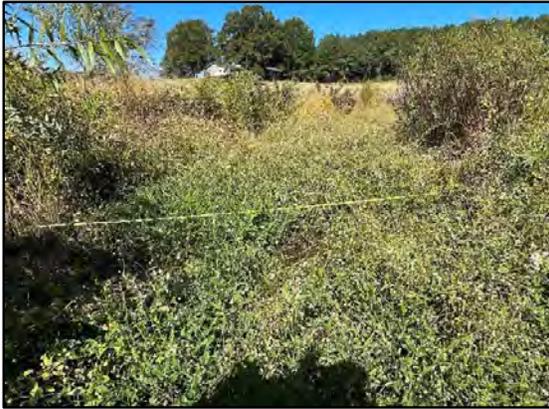
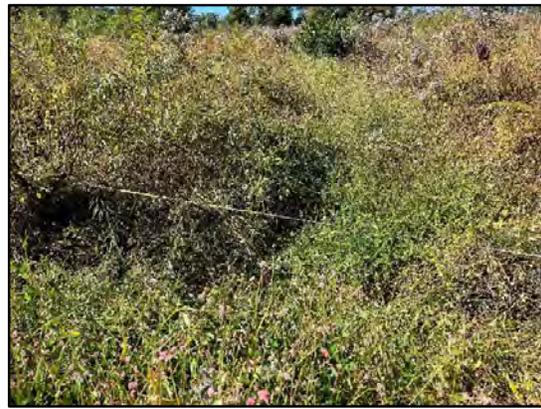
XS4 looking upstream

Two pool cross-sections (XS4, XS13) show aggradation as compared to As-Built conditions. EPR believes this accrual of sediment is primarily due to channel vegetation, which should become less of an issue in future years as the channel becomes more and more shaded. Most of the infilling in these two pools occurred in the first year of monitoring but the pools appear to have stabilized since then. EPR will monitor these cross-sections in future monitoring years to ensure that the channels continue to clear and remain stable.
