Monitoring Year 4 Report
Final
Meadow Brook Stream Restoration Project
Yadkin County, North Carolina
Yadkin River Basin, Hydrologic Unit Code (HUC) 03040101

Monitoring Year 4 Report – Final

DMS Project ID #100024

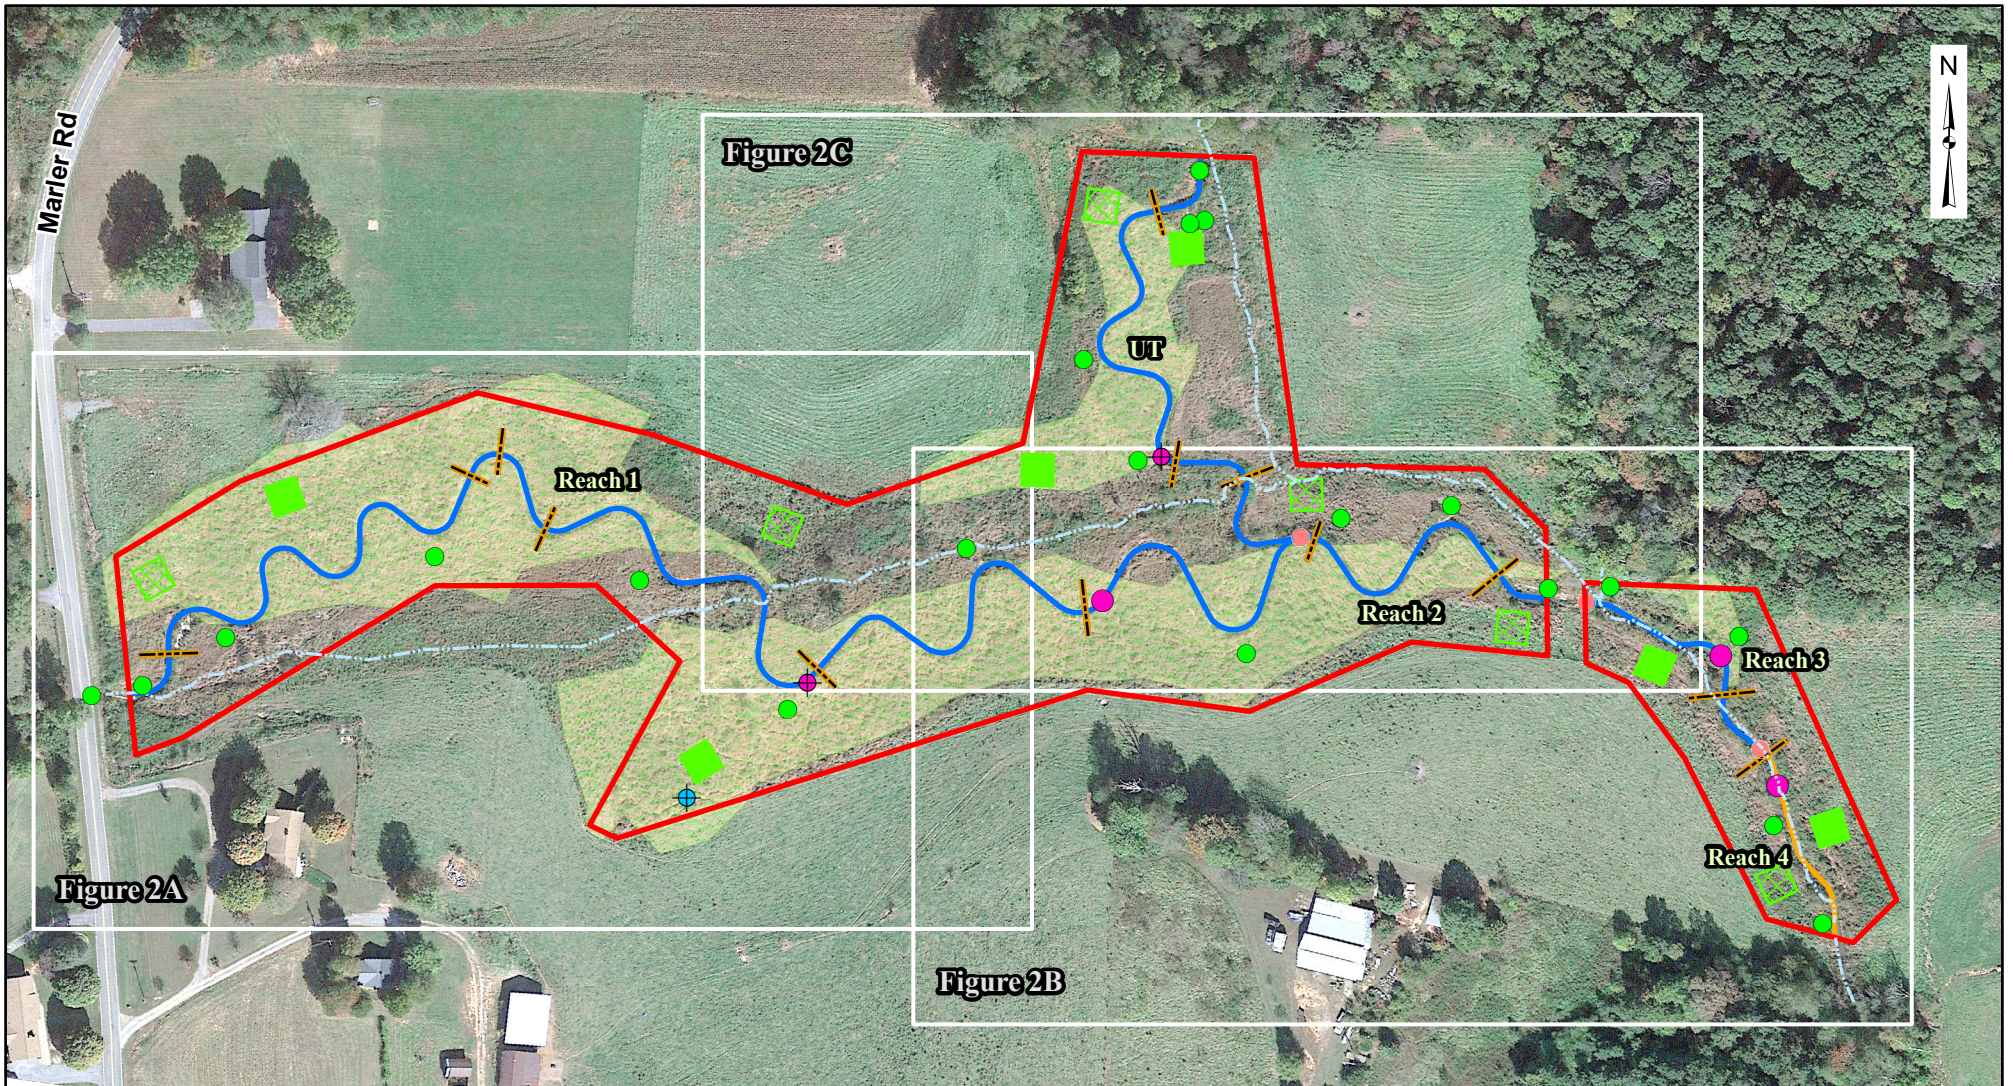
The three beaver dams that were found over the course of MY3 have not been rebuilt in MY4. The streambanks upstream of these dams have become revegetated and have remained stable. The Project will continue to be monitored for beaver activity throughout the rest of the monitoring periods to ensure no new dams are constructed.

Stream photo points and visual assessment indicate that all restored channels and in-stream structures are in good condition and performing as intended. No significant stream problem areas were observed. No channel manipulation, including vegetation or sediment removal, has been performed in this monitoring year.

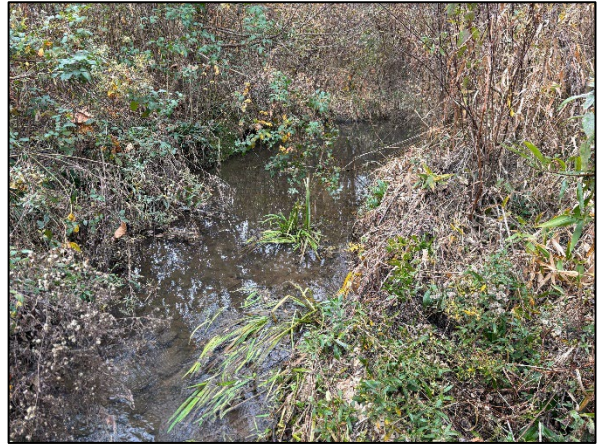
Representative Photo, Reach UT1
Facing Upstream (10/31/2023)

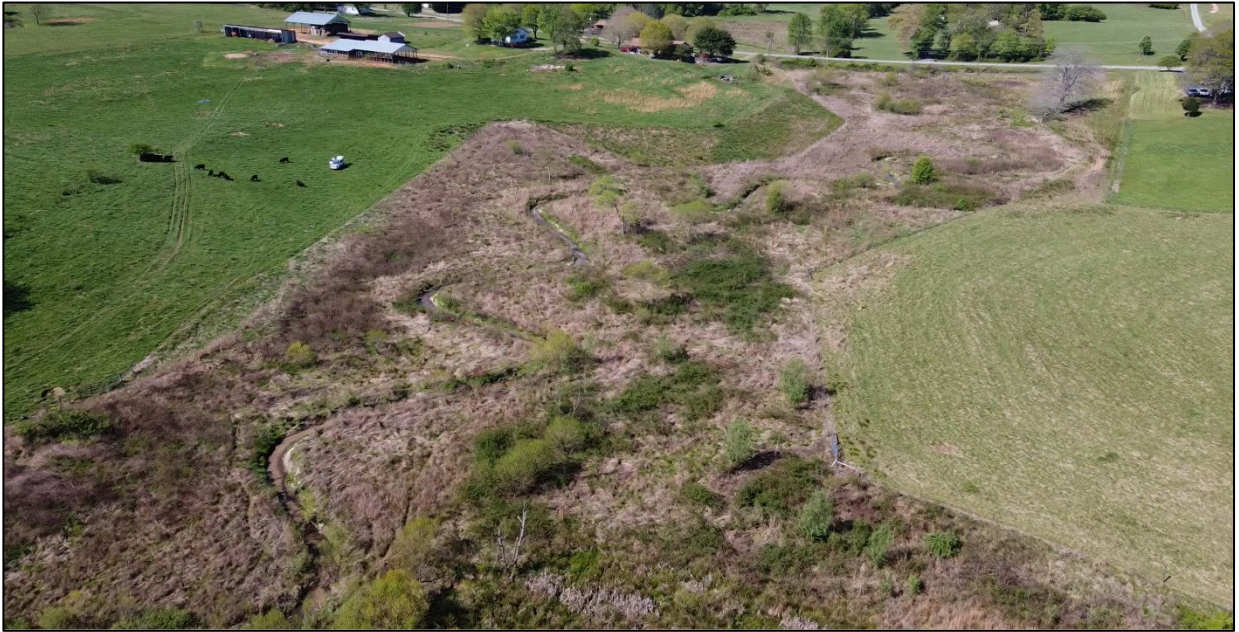
Site Overview
Facing East (4/14/2023)

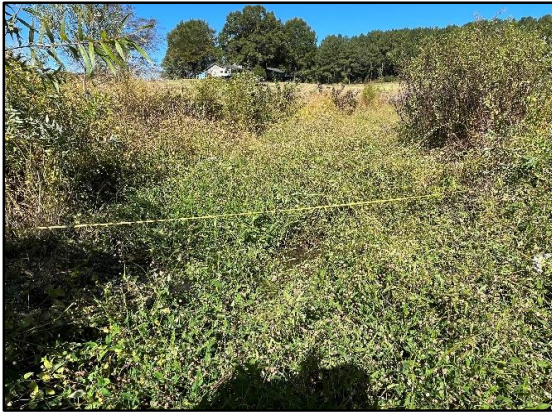
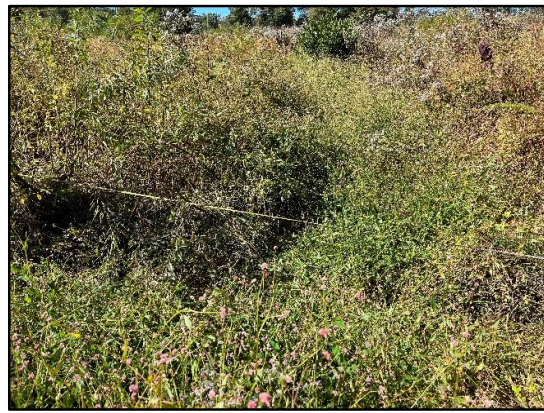
XS4 - Reach 1

XS4 looking upstream

XS4 looking downstream

2023 Notes: Minor pool aggregation reported in MY3(2022) was discussed. Cross Section 4 was noted as a concern. EPR believes that the pools will fluctuate but will eventually flush out. EPR noted that beaver have been a project issue in the past. The IRT asked about the fords and crossings on the site (photo point 19). EPR reported that cattle do not have continuous access to the project ford crossings and gates are kept closed when livestock are not crossing. RAP

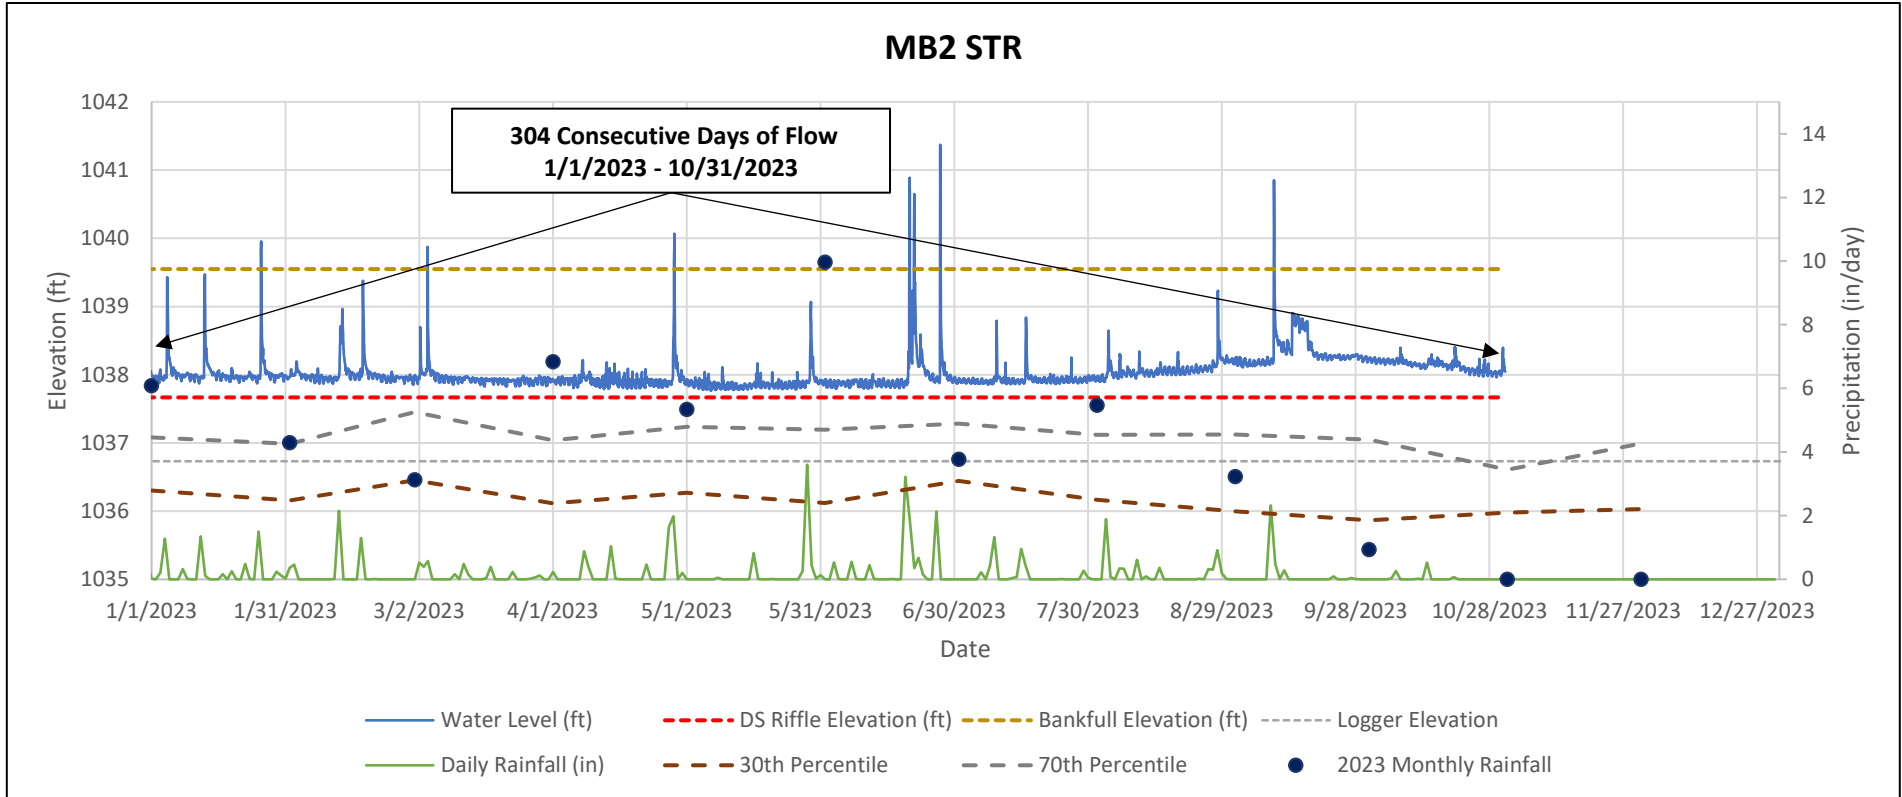
Meadow Brook Stream Restoration Project Year 4 (2023) Streamflow Data

Year 4 (2023) Streamflow Data	
Gauge ID	MB2 STR
Start Date	1/1/2023
End Date	10/31/2023
Flow Criteria (Days)	30
Recordings Per Day	24
Logger Elevation (ft)	1036.73
Controlling Grade Elevation (ft)	1037.67
Bankfull Elevation (ft)	1039.55
Most Consecutive Days of Flow	304
Total Days of Flow	304
Max High Water Level Above Bankfull (ft)	1.82
Bankfull Events	6
Meets Success Criteria	Yes

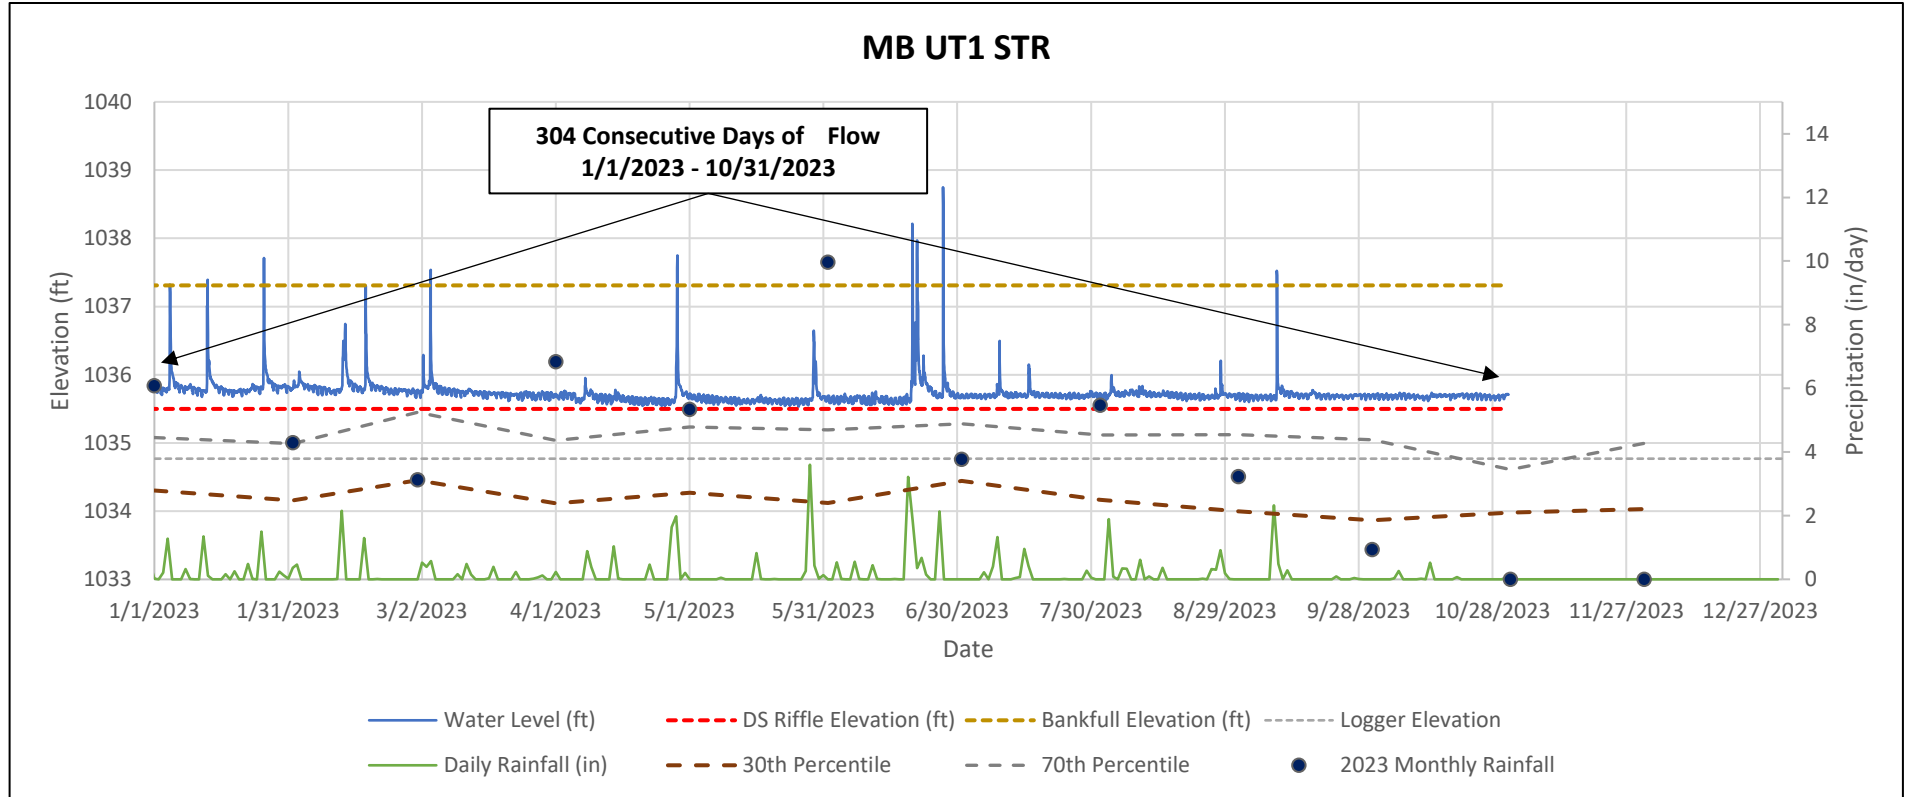
Meadow Brook Stream Restoration Project Year 4 (2023) Streamflow Data

Site Info	
Stream	Meadow Brook Stream Restoration Project
Reach	UT
Date Installed	7/16/2019
Serial Number	20234990
Reach Type	Perennial
