Meredell Farm Monitoring Report Year 3 of 5 (2010)

Randolph County, North Carolina

Project ID No. 247

Submitted November 2010

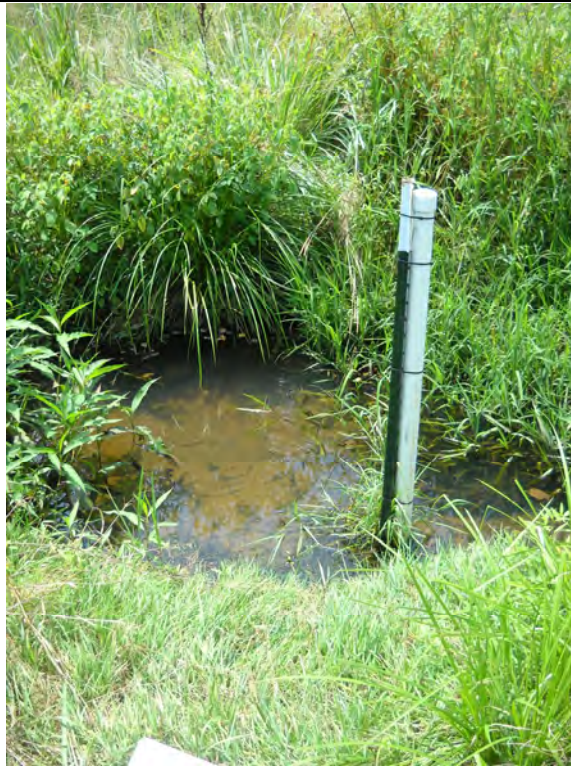
SP1: Crest Gage
Taken: 8-4-2010

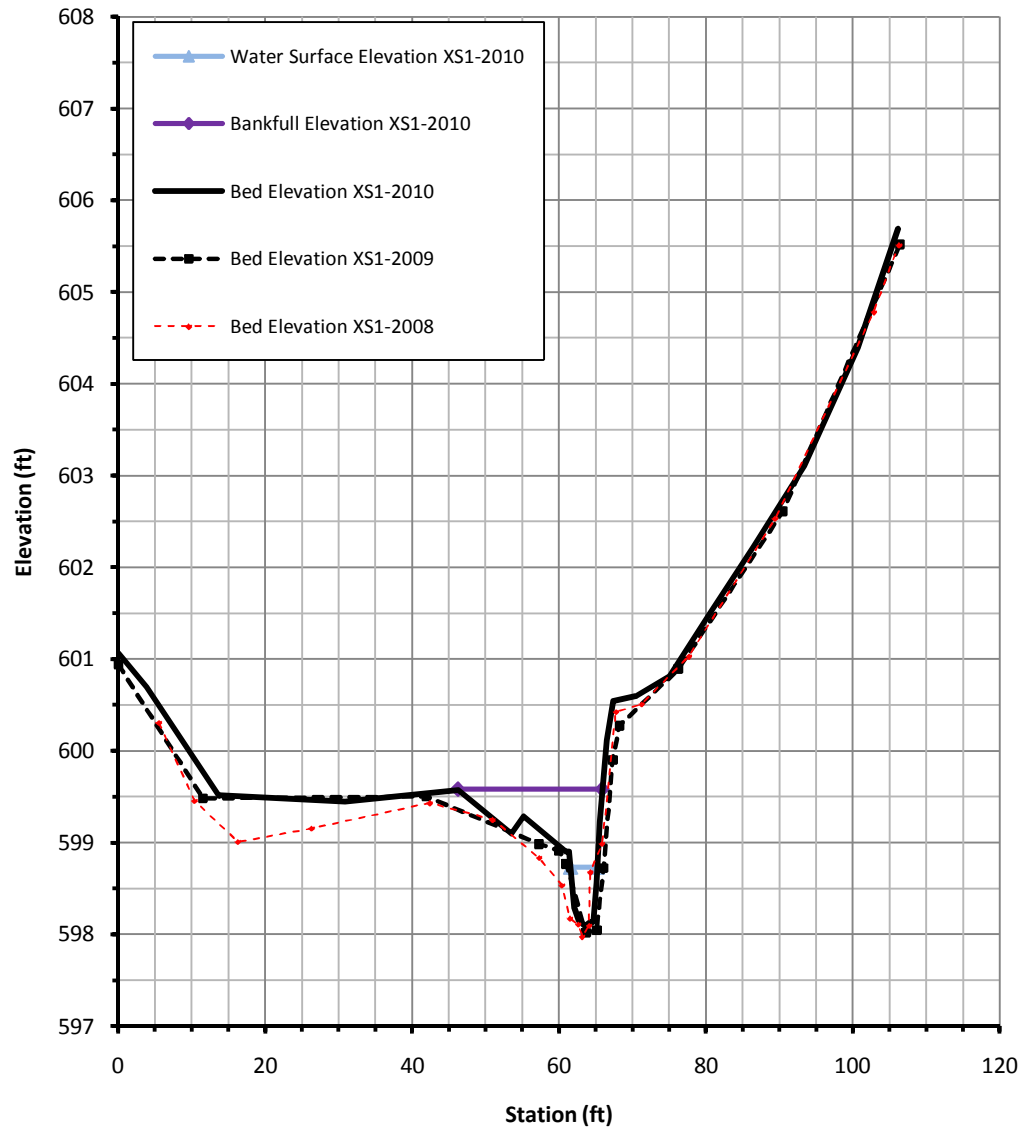
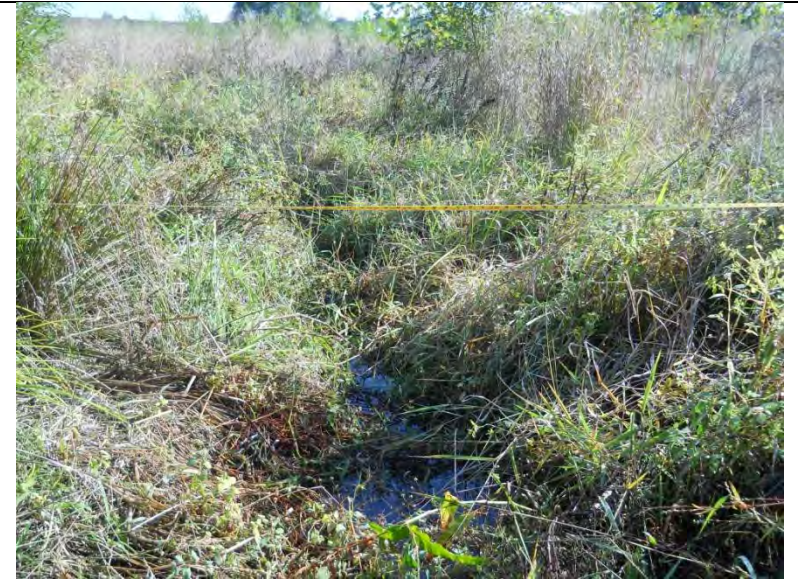
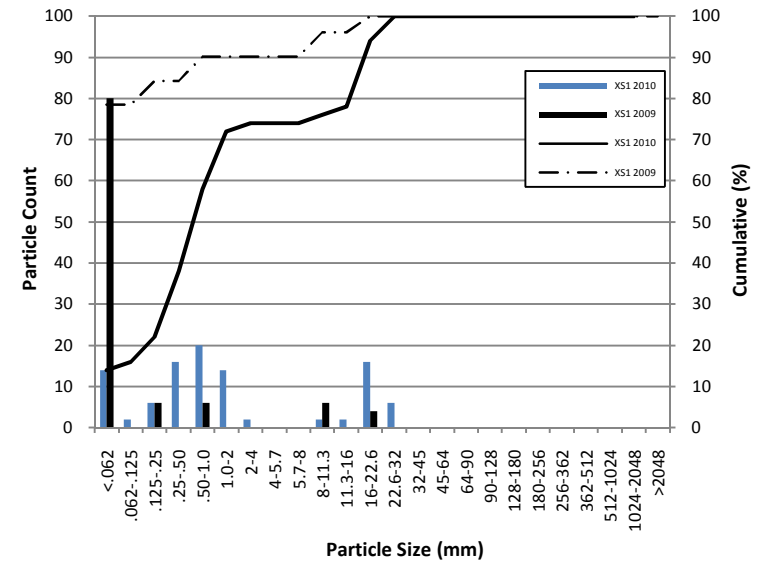
ID	YEAR	PHASE	FACET TYPE	Wbkf	Abkf	Dbkf
XS1	2008	CD	POOL	12.0	11.5	1.0
XS1	2008	MY1	POOL	10.9	4.5	0.5
XS1	2009	MY2	POOL	25.0	12.3	0.5
XS1	2010	MY3	POOL	19.6	10.9	0.6

ID	YEAR	PHASE	d50 (mm)	d84 (mm)
XS1	2009	MY2	<0.062	0.25
XS1	2010	MY3	0.8	18.5

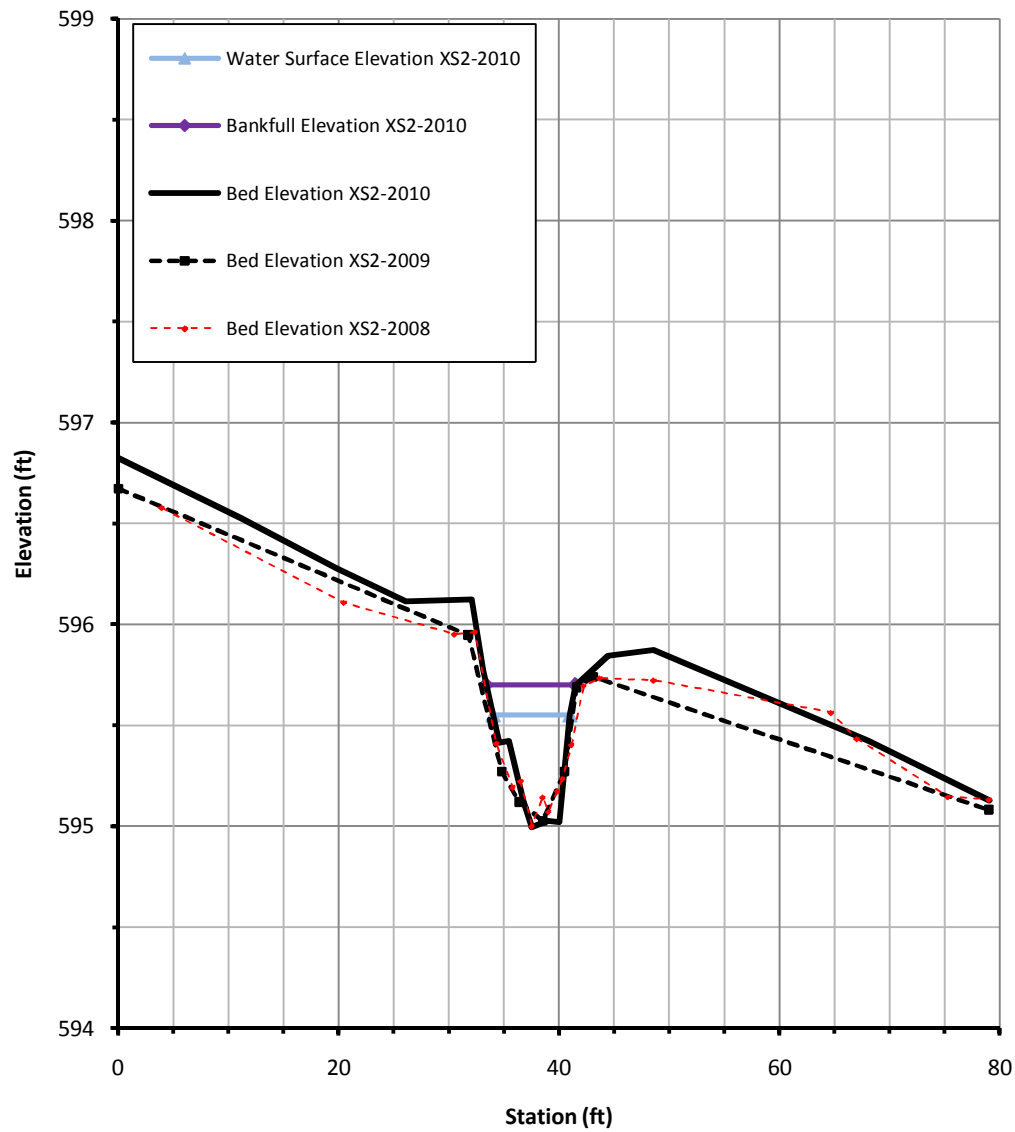
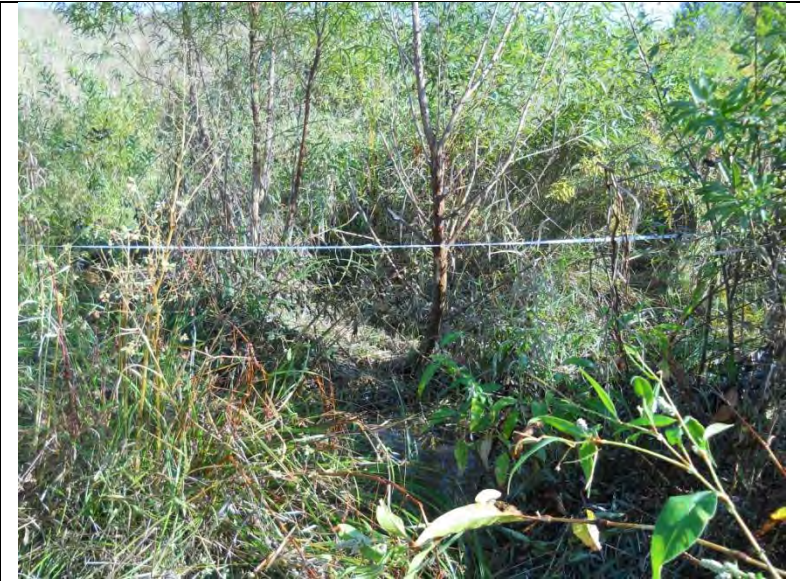
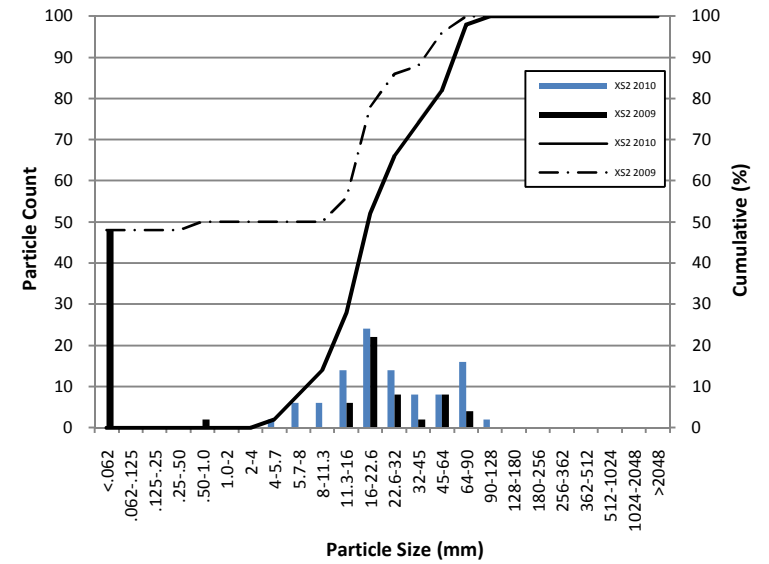
ID	YEAR	PHASE	FACET TYPE	Wbkf	Abkf	Dbkf
XS2	2008	CD	RIFFLE	7.3	4.5	0.6
XS2	2008	MY1	RIFFLE	8.9	3.8	0.4
XS2	2009	MY2	RIFFLE	8.7	3.8	0.4
XS2	2010	MY3	RIFFLE	8.1	3.6	0.5

ID	YEAR	PHASE	d50 (mm)	d84 (mm)
XS2	2009	MY2	8	22.6
XS2	2010	MY3	22.1	67.3

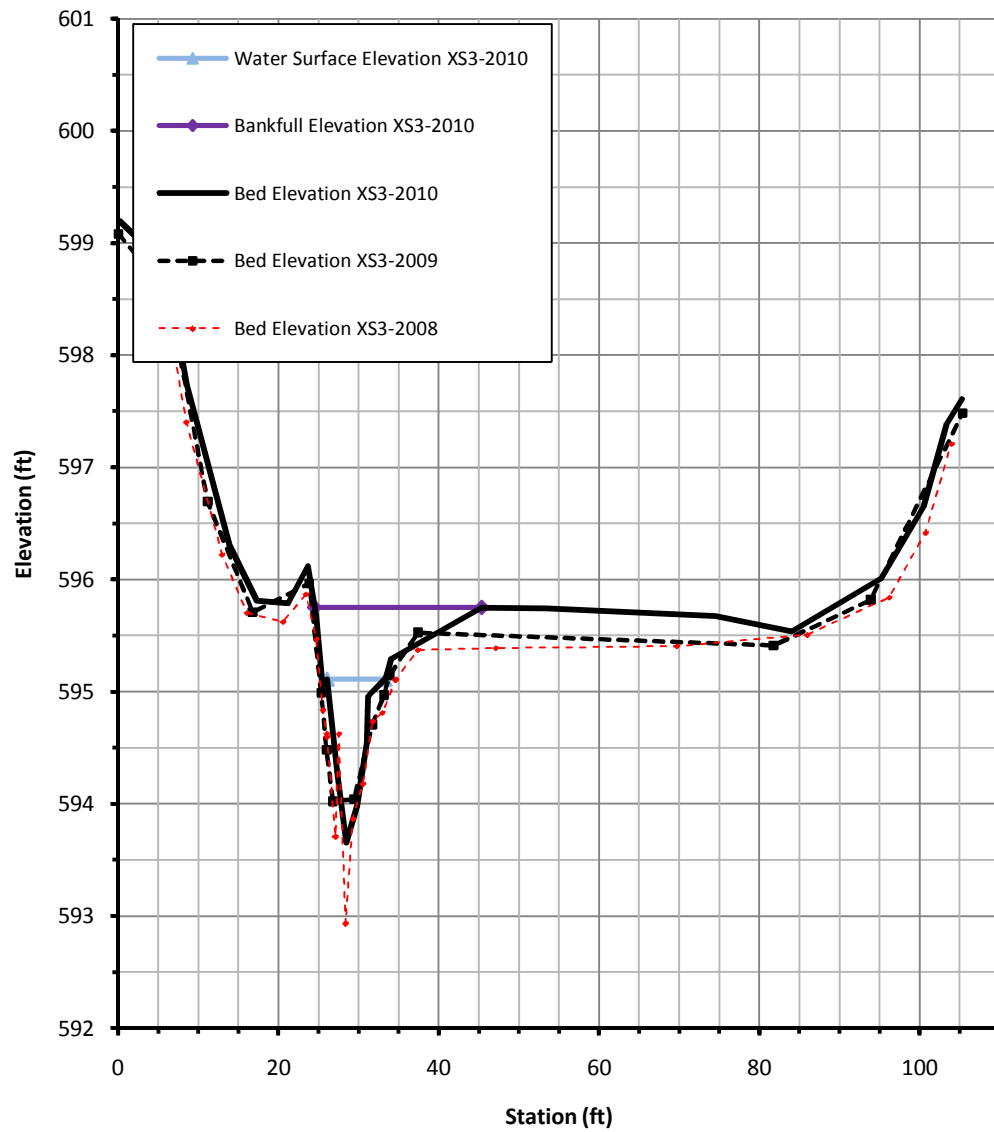
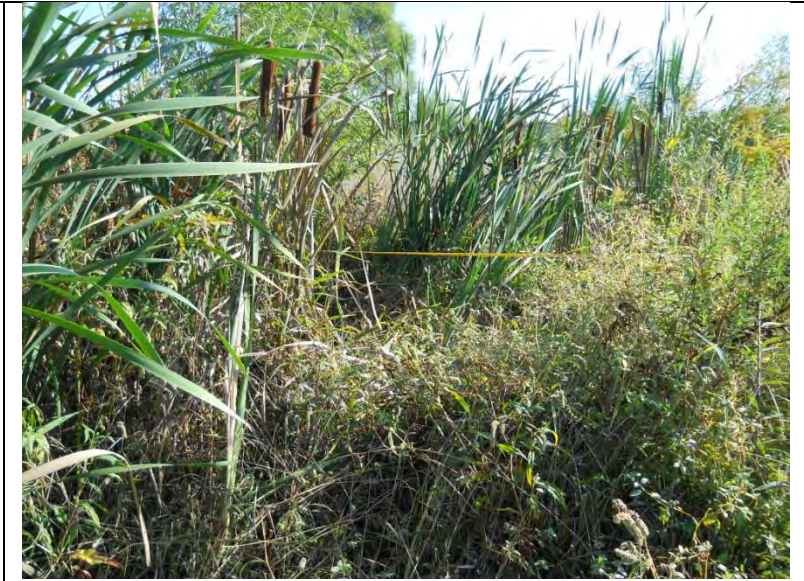
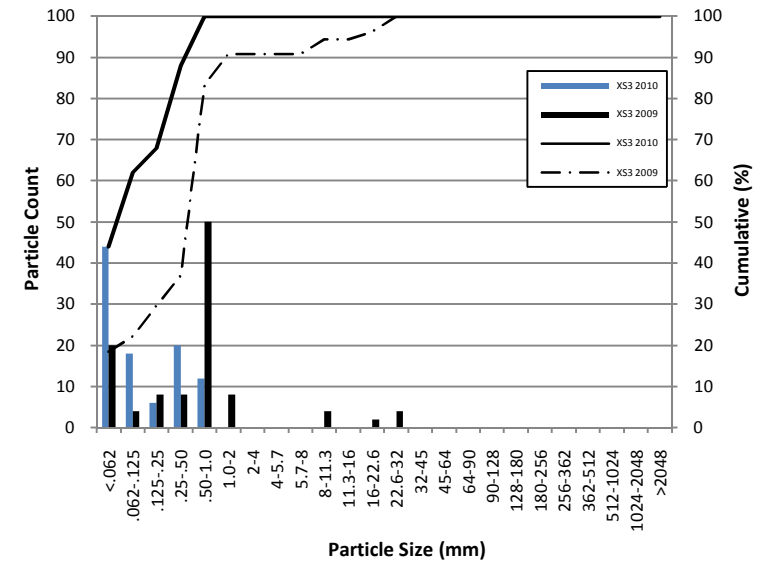
ID	YEAR	PHASE	FACET TYPE	Wbkf	Abkf	Dbkf
XS3	2008	CD	POOL	12.0	11.5	1.0
XS3	2008	MY1	POOL	12.4	10.1	0.8
XS3	2009	MY2	POOL	12.9	10.3	0.8
XS3	2010	MY3	POOL	20.8	13.1	0.6

ID	YEAR	PHASE	d50 (mm)	d84 (mm)
XS3	2009	MY2	0.5	1.0
XS3	2010	MY3	0.08	0.45

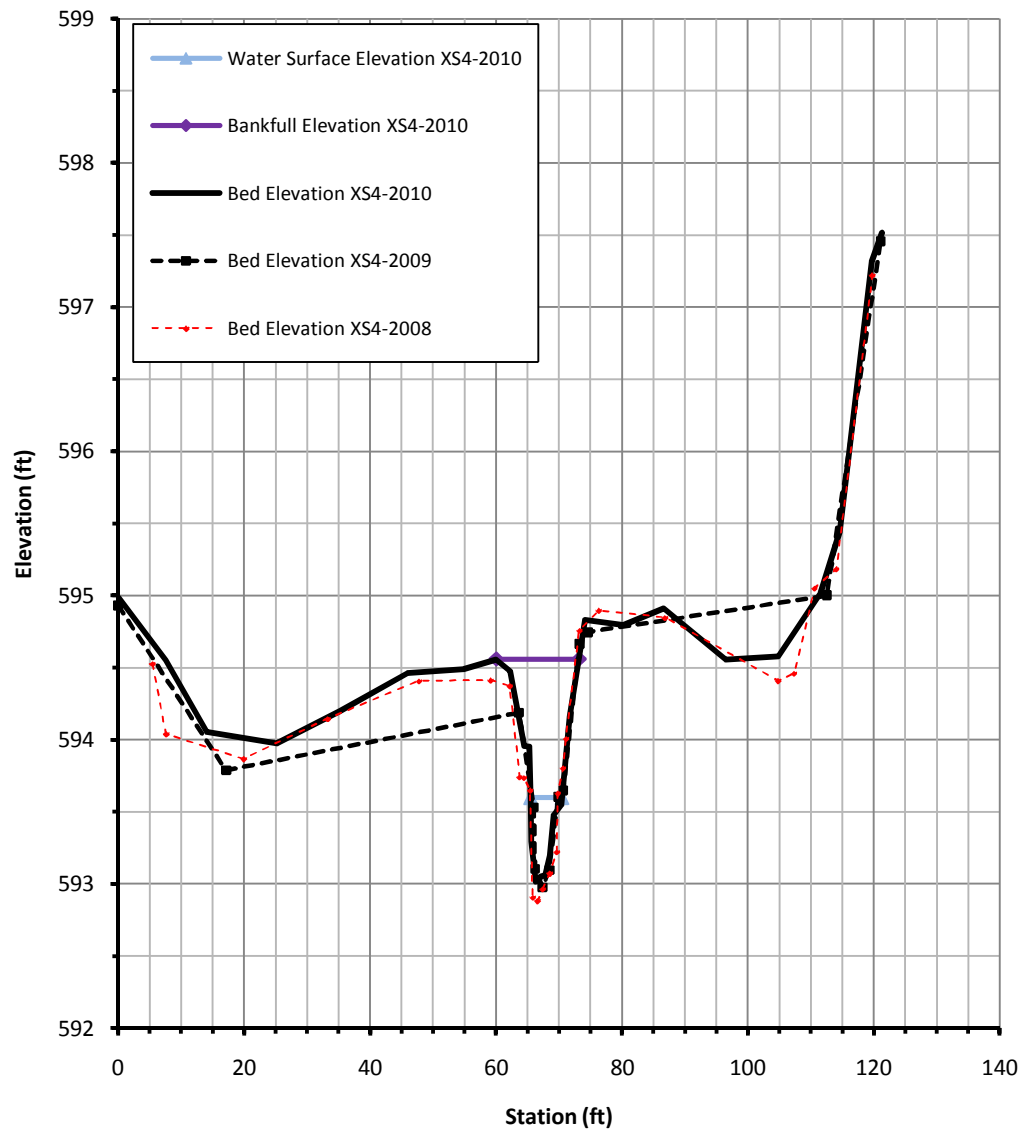
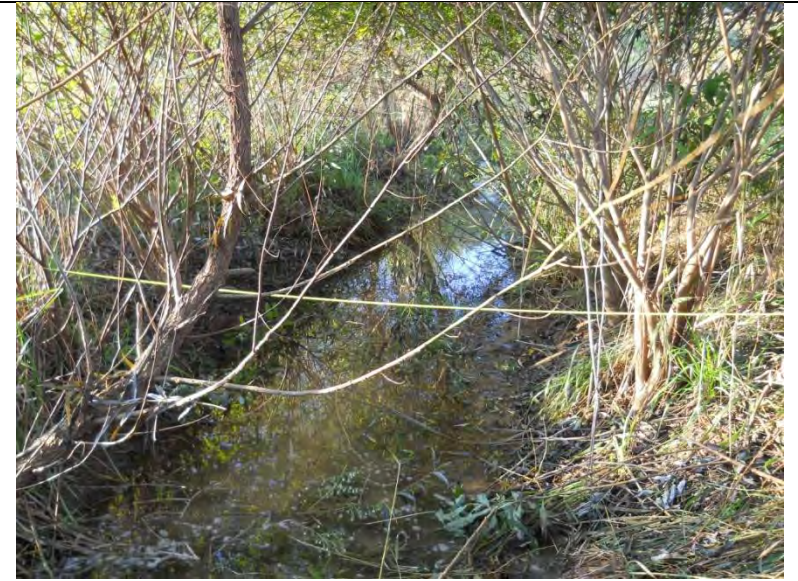
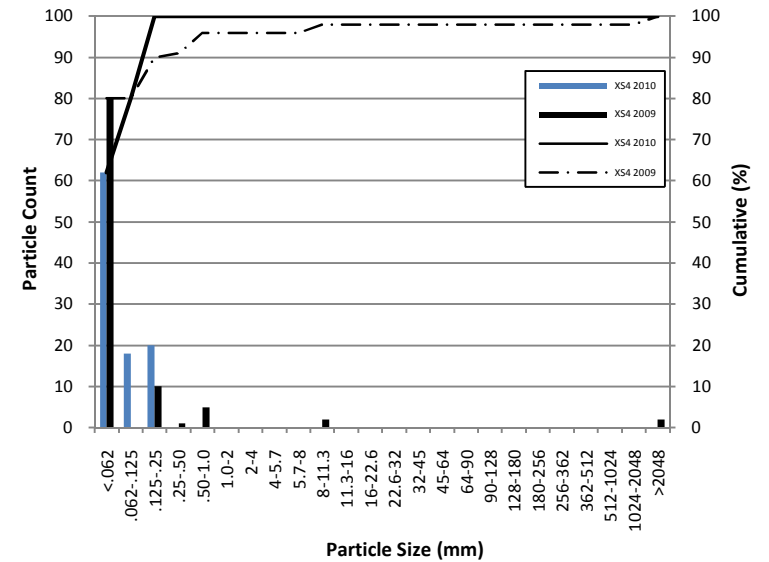
ID	YEAR	PHASE	FACET TYPE	Wbkf	Abkf	Dbkf
XS4	2008	CD	RIFFLE	7.3	4.5	0.6
XS4	2008	MY1	RIFFLE	10.0	8.2	0.8
XS4	2009	MY2	RIFFLE	8.4	5.2	0.6
XS4	2010	MY3	RIFFLE	13.1	9.2	0.7

ID	YEAR	PHASE	d50 (mm)	d84 (mm)
XS4	2009	MY2	<0.062	0.125
XS4	2010	MY3	<0.062	0.15

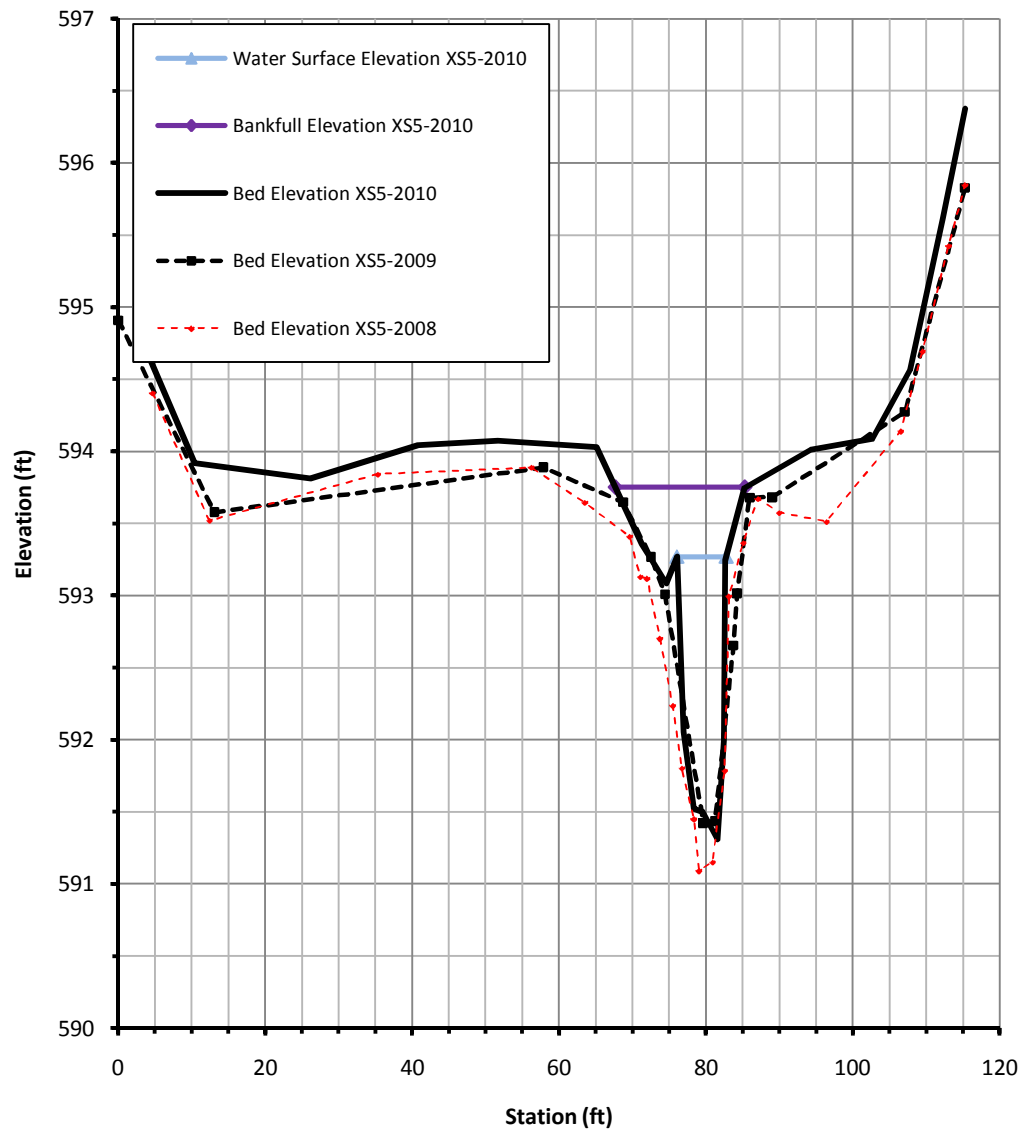
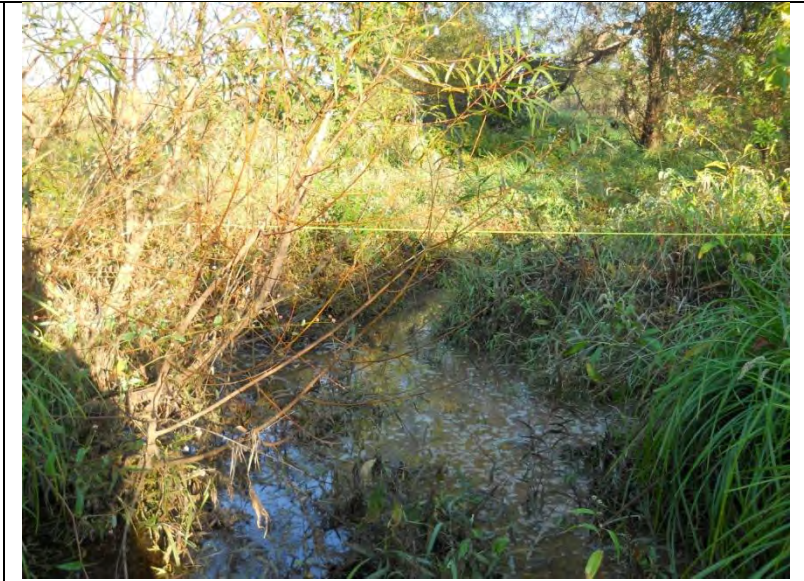
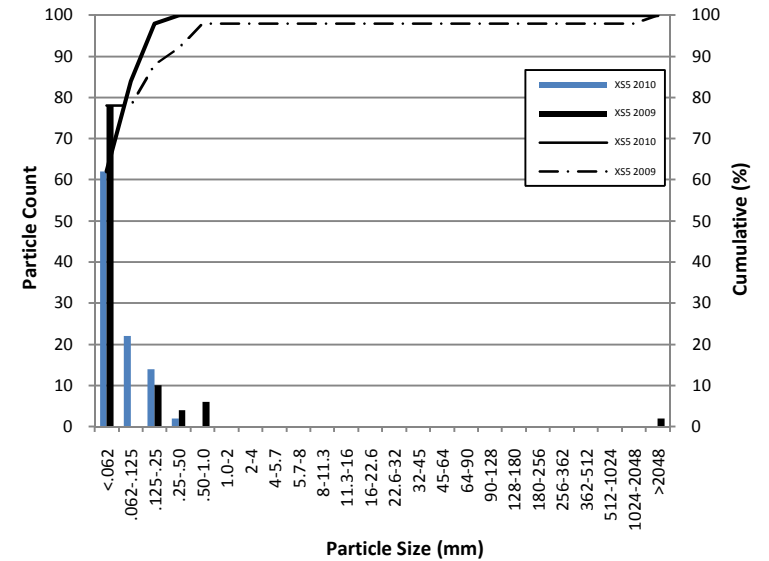
ID	YEAR	PHASE	FACET TYPE	Wbkf	Abkf	Dbkf
XS5	2008	CD	POOL	12.0	11.5	1.0
XS5	2008	MY1	POOL	23.4	21.9	0.9
XS5	2009	MY2	POOL	17.2	17.1	1.0
XS5	2010	MY3	POOL	17.5	17.0	1.0

ID	YEAR	PHASE	d50 (mm)	d84 (mm)
XS5	2009	MY2	<0.062	0.125
XS5	2010	MY3	<0.062	0.125
