Meredell Farm
Monitoring Report
FINAL
Year 4 of 5 (2011)

Randolph County, North Carolina

Project ID No. 247

Executive Summary

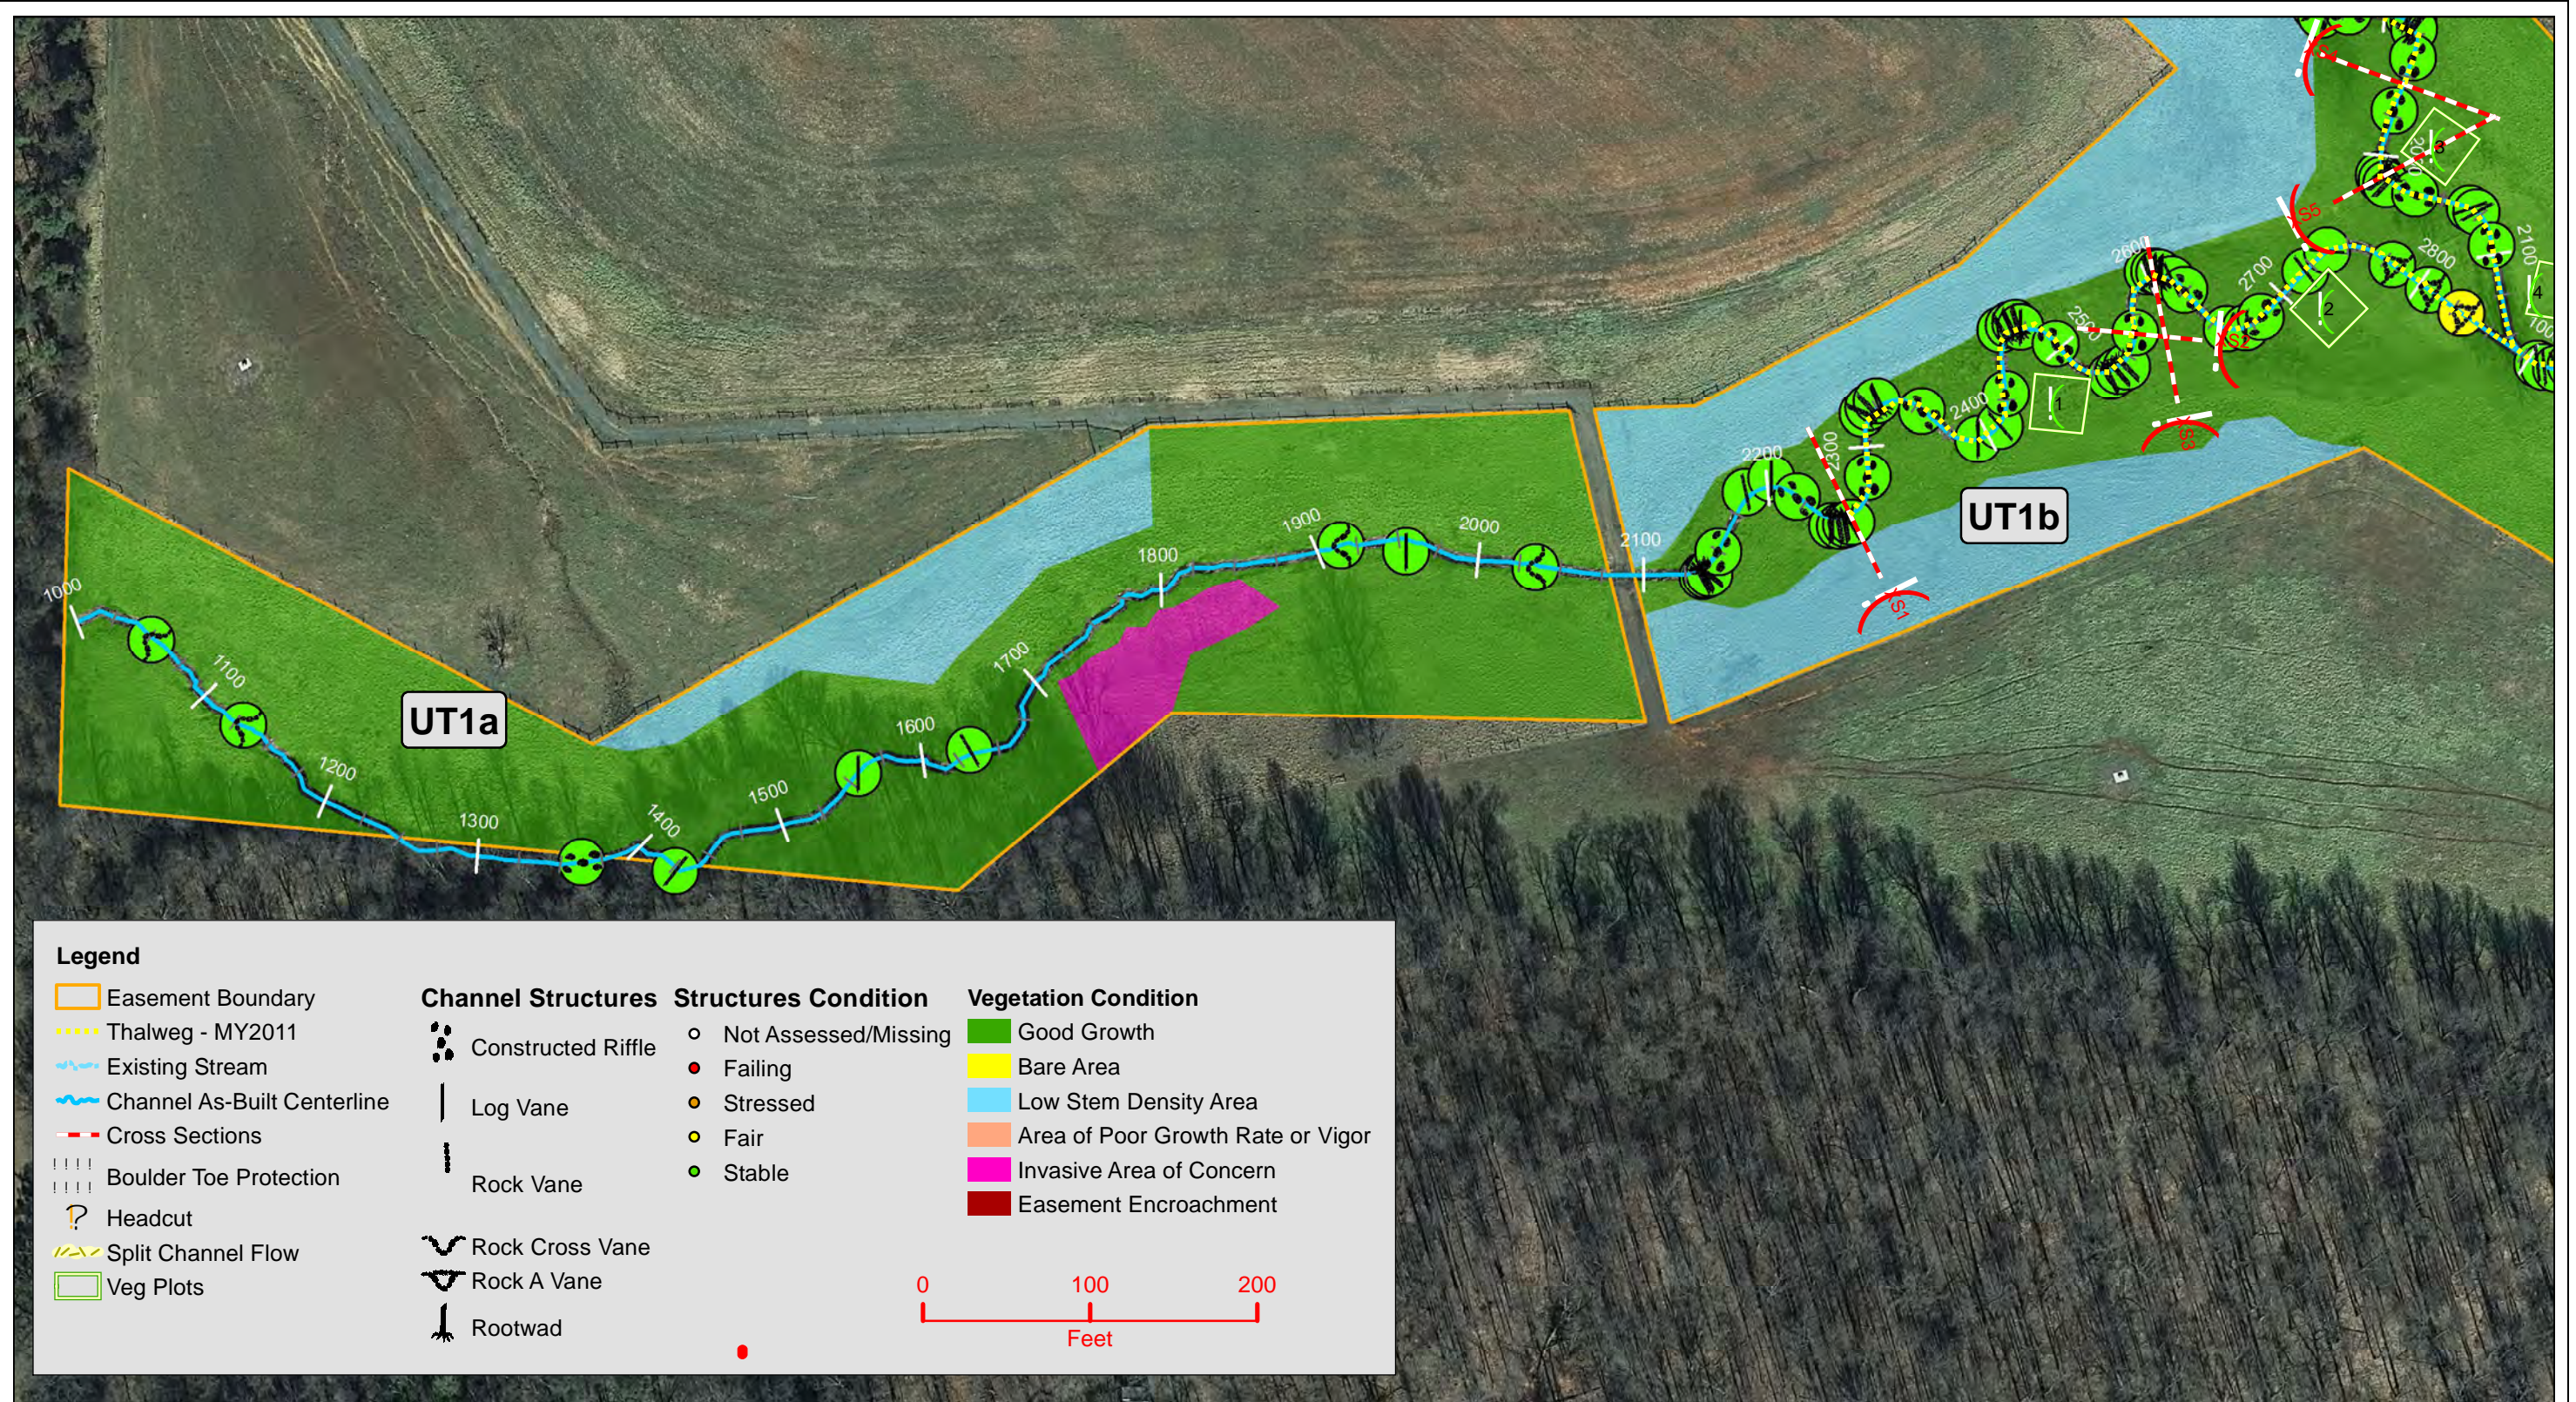
Title	Current Conditions Plan View UT1a and UT1b		
Prepared For: 	Project	Meredell Farm Stream Restoration Monitoring Year 4 – 2011 Randolph County, North Carolina	
	Date	1/3/12	Project Number 247
			Figure 2

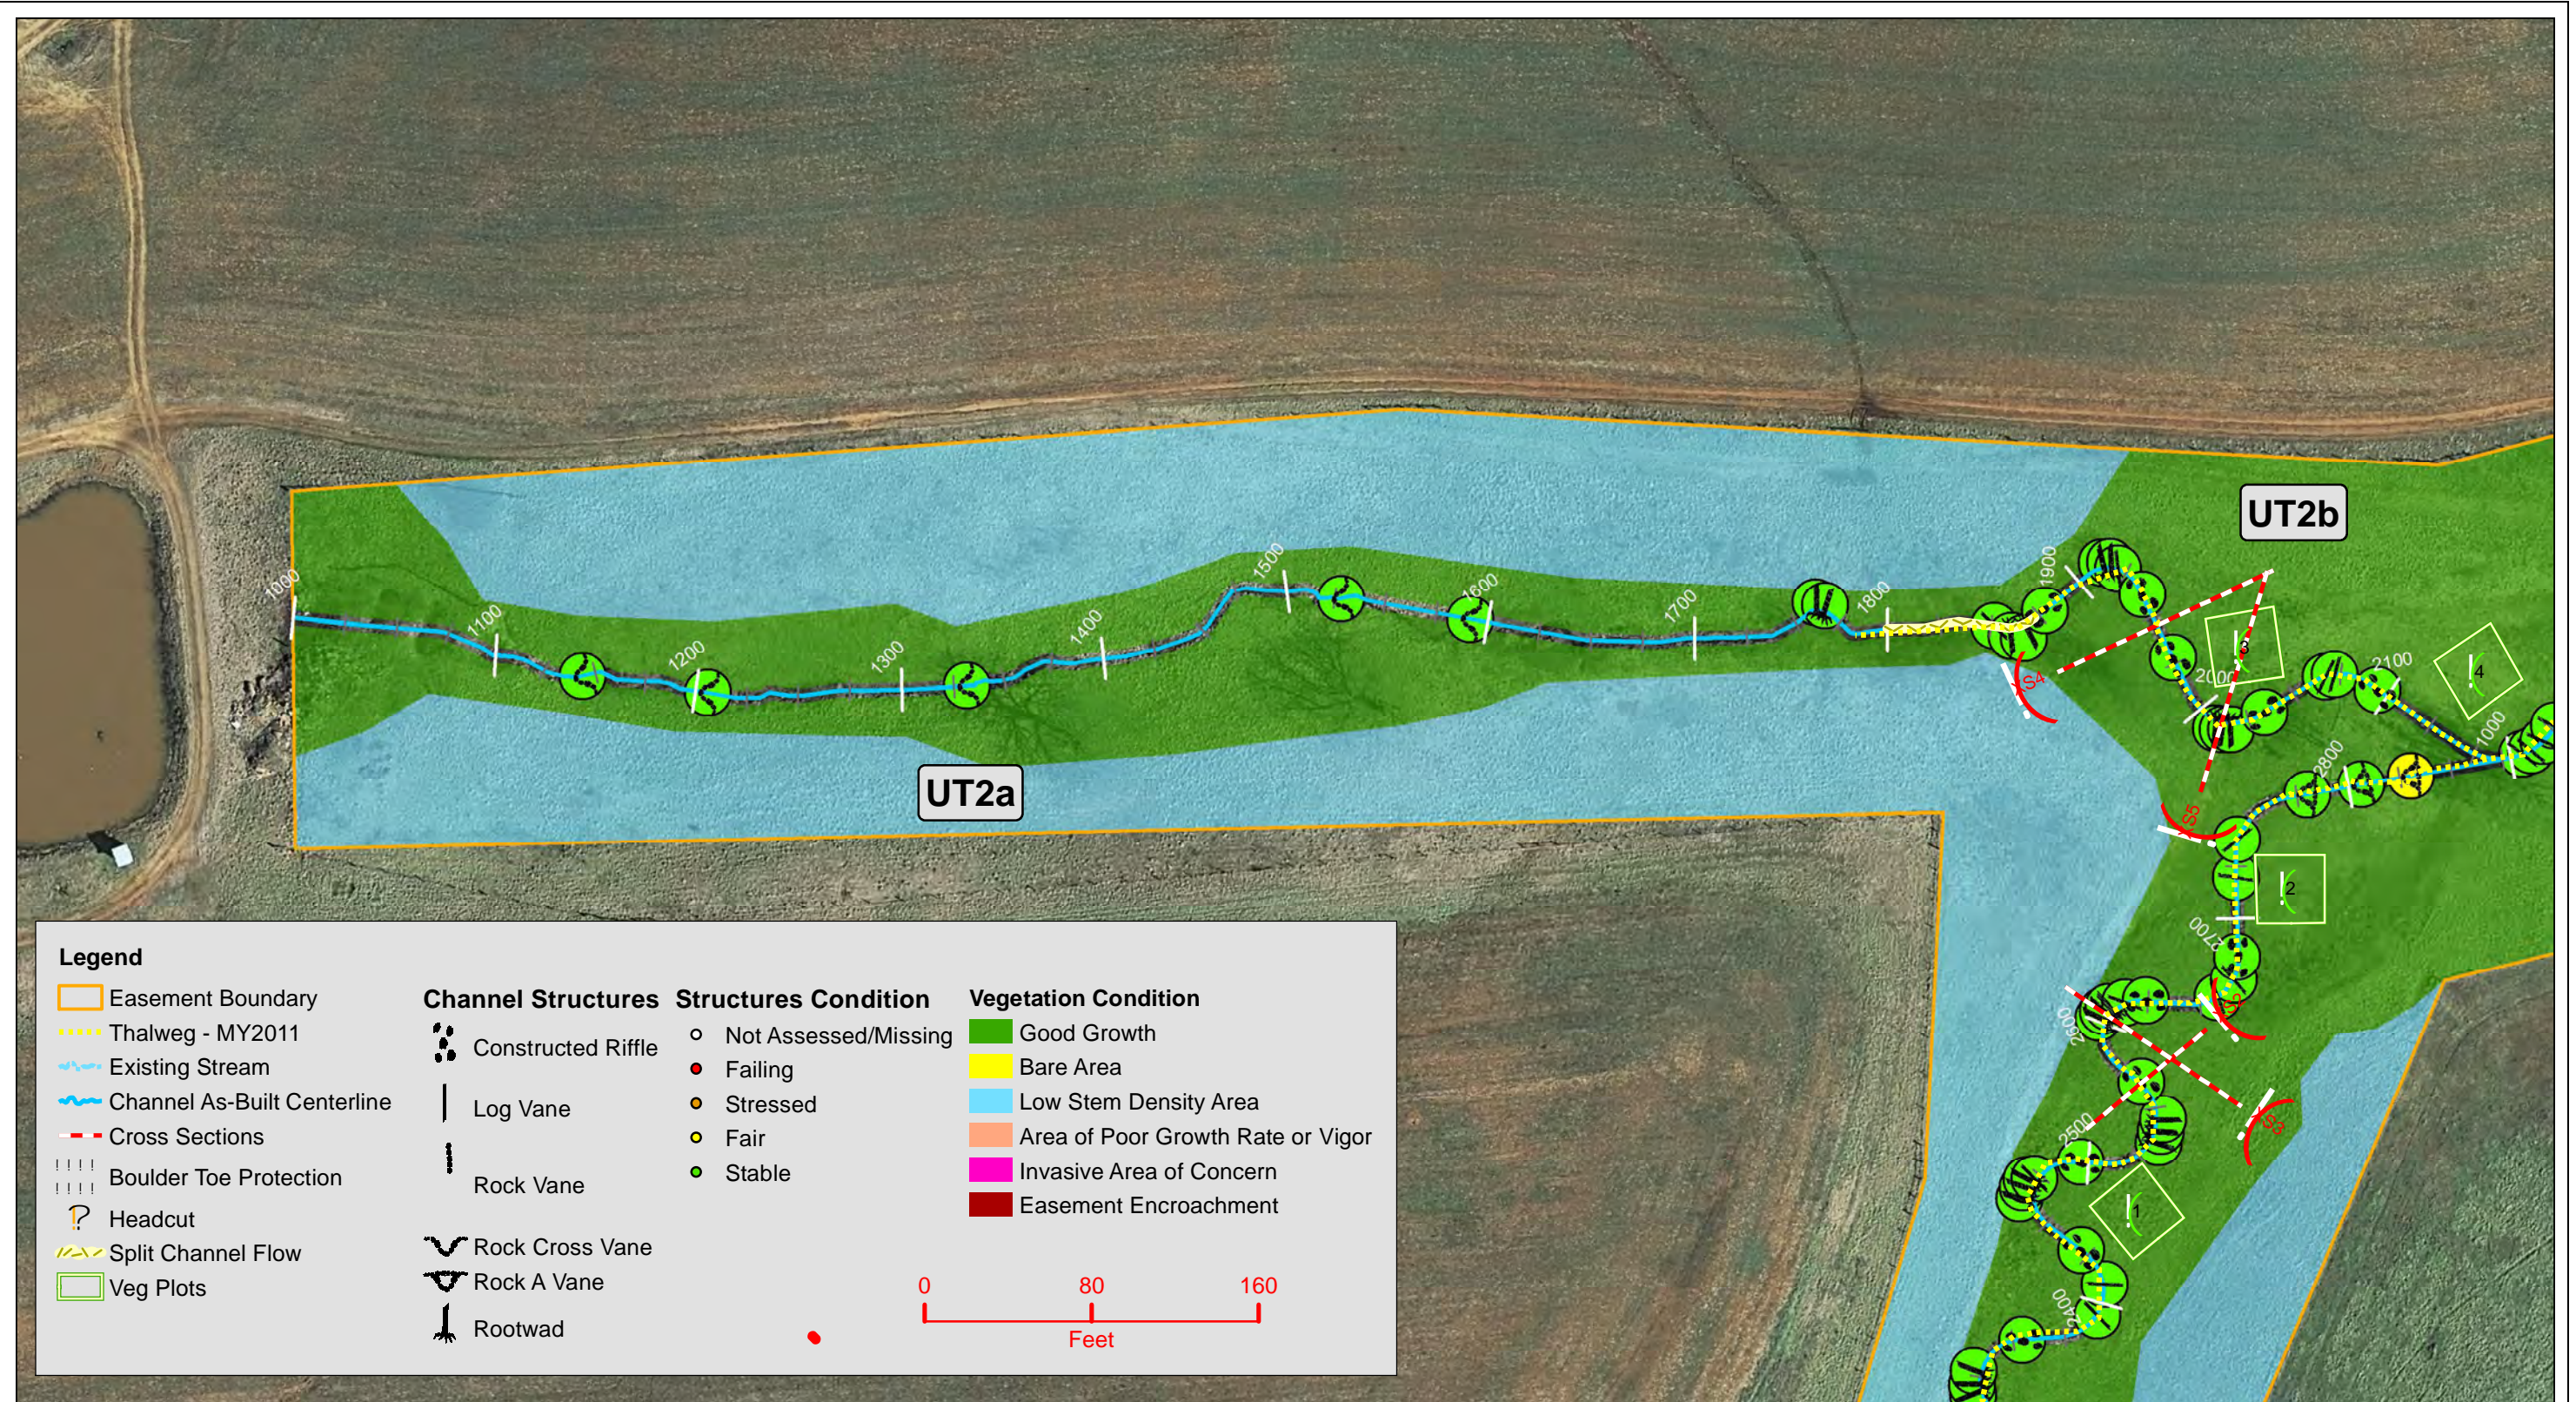
Title	Current Conditions Plan View UT2a and UT2b		
Prepared For:	Project	Date	Project Number
	Meredell Farm Stream Restoration Monitoring Year 4 – 2011 Randolph County, North Carolina	1/3/12	247
			Figure 3

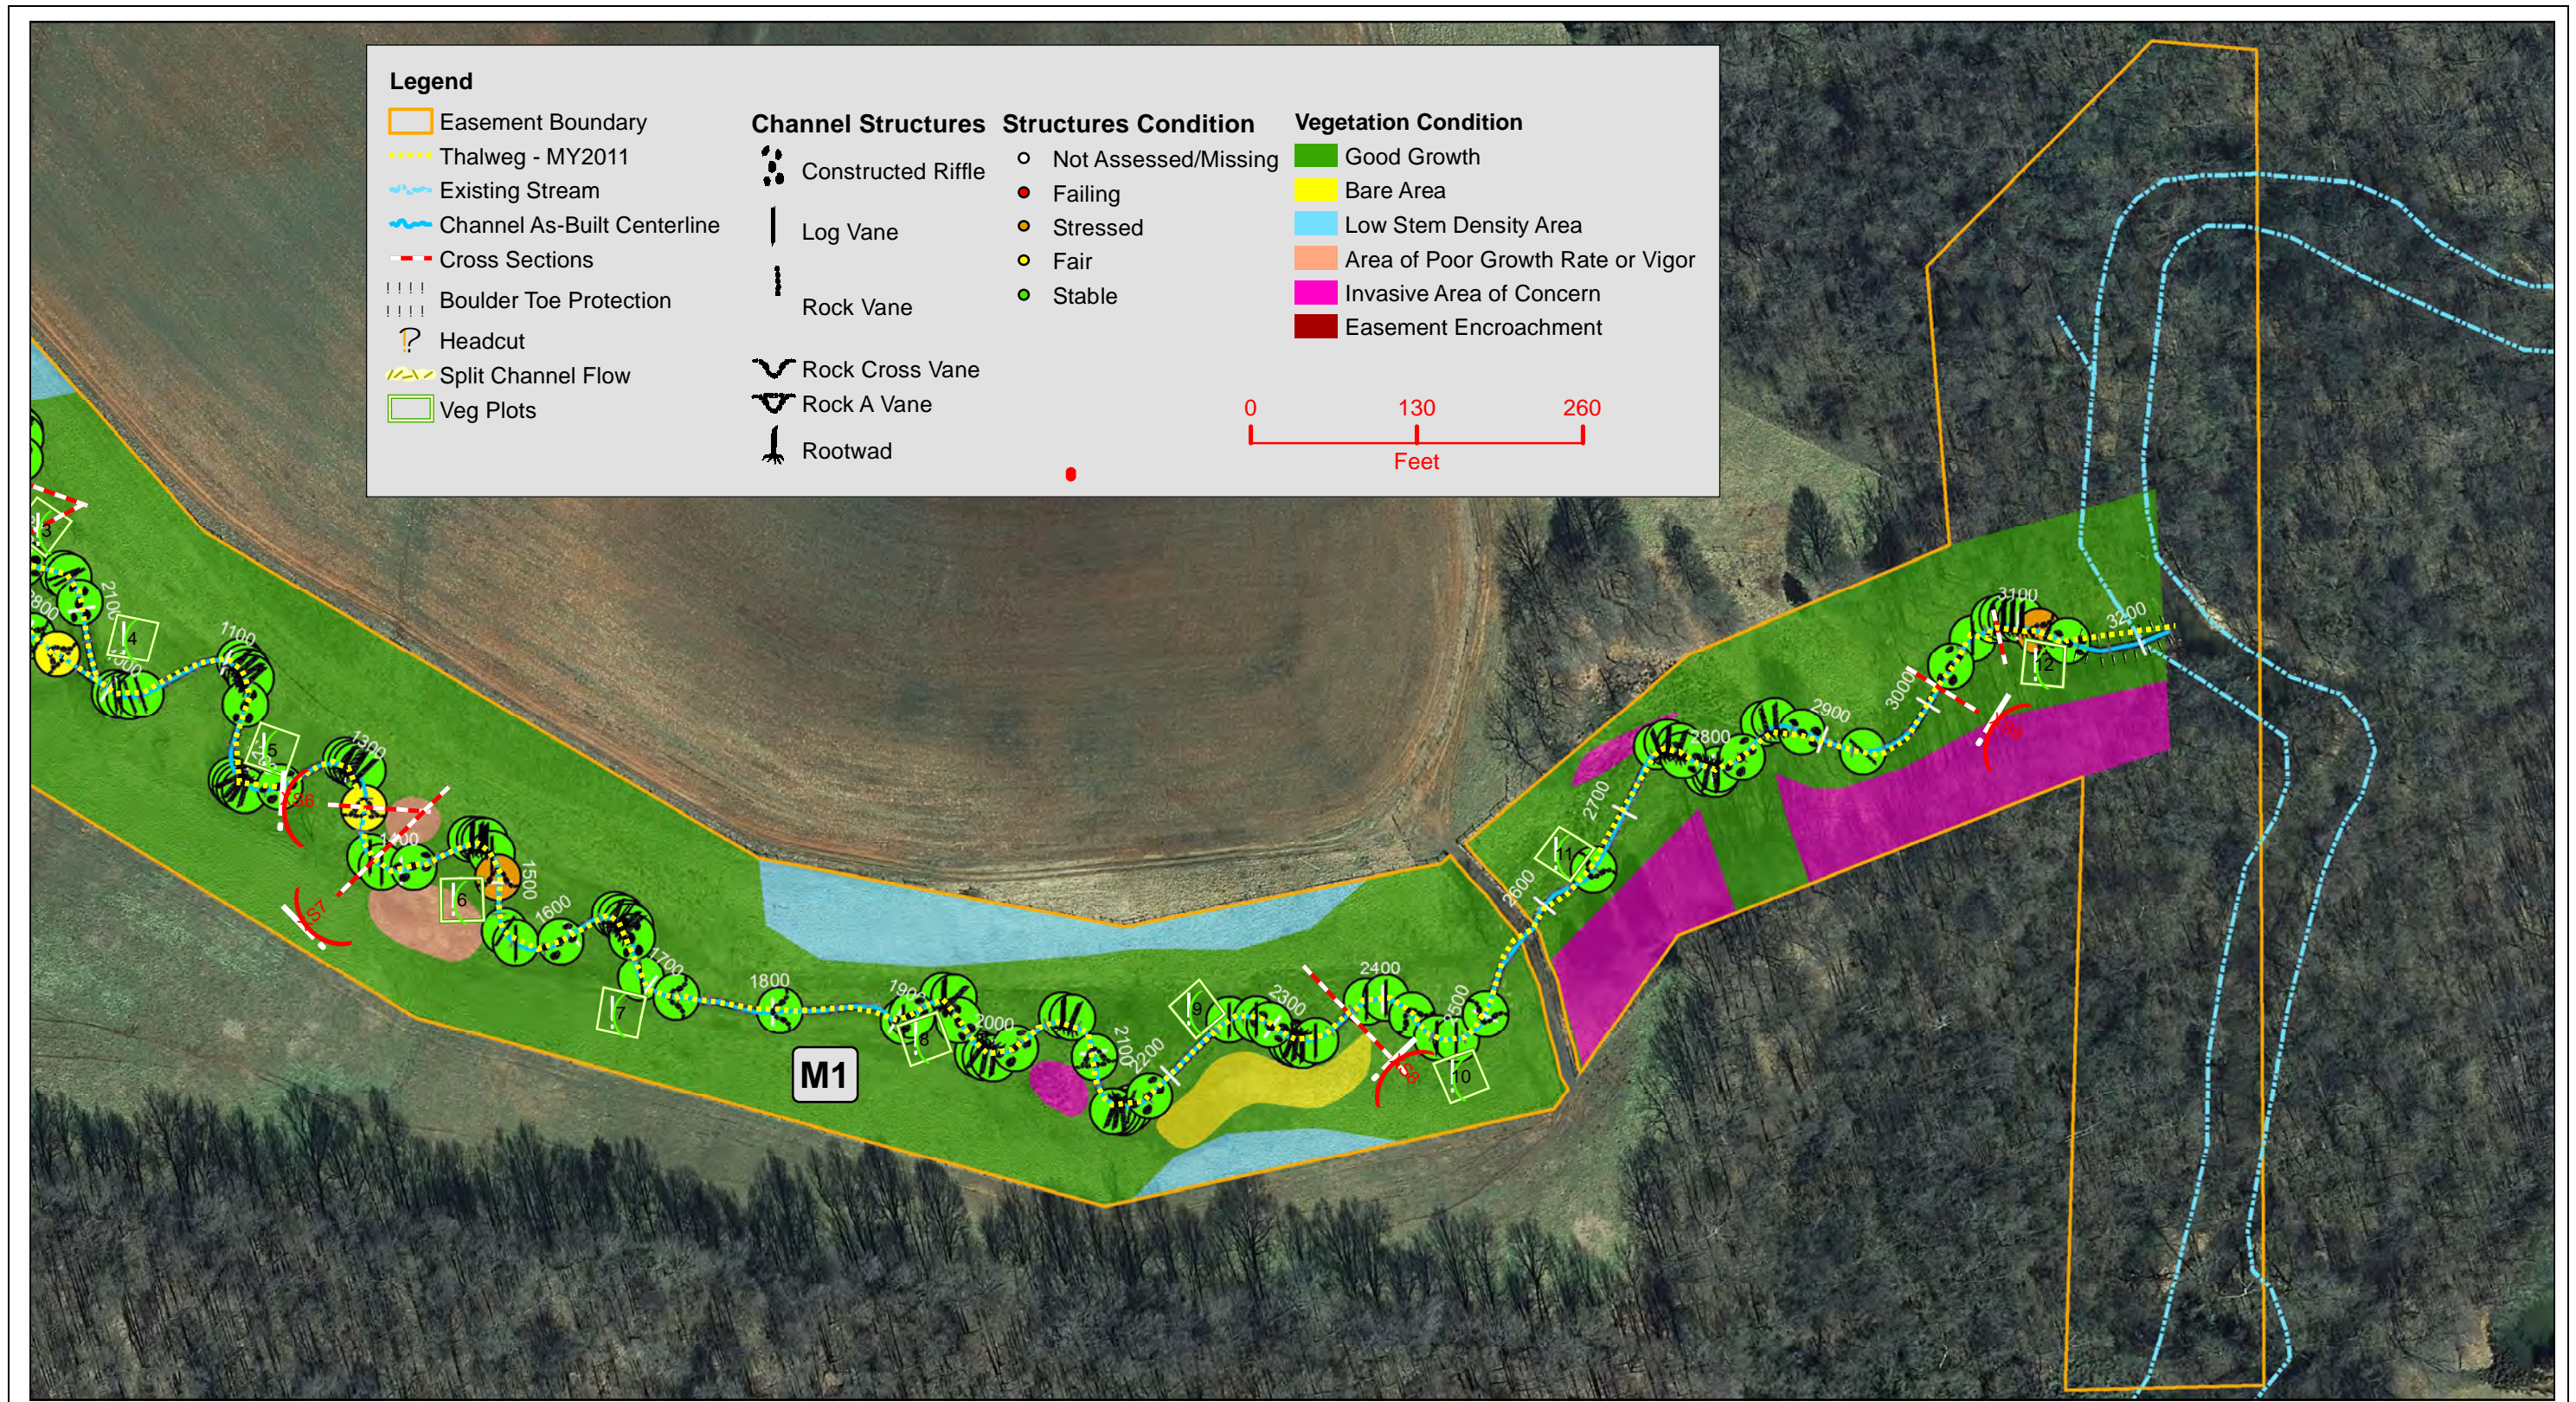
Title		Current Conditions Plan View M1 and SC1		
Prepared For:

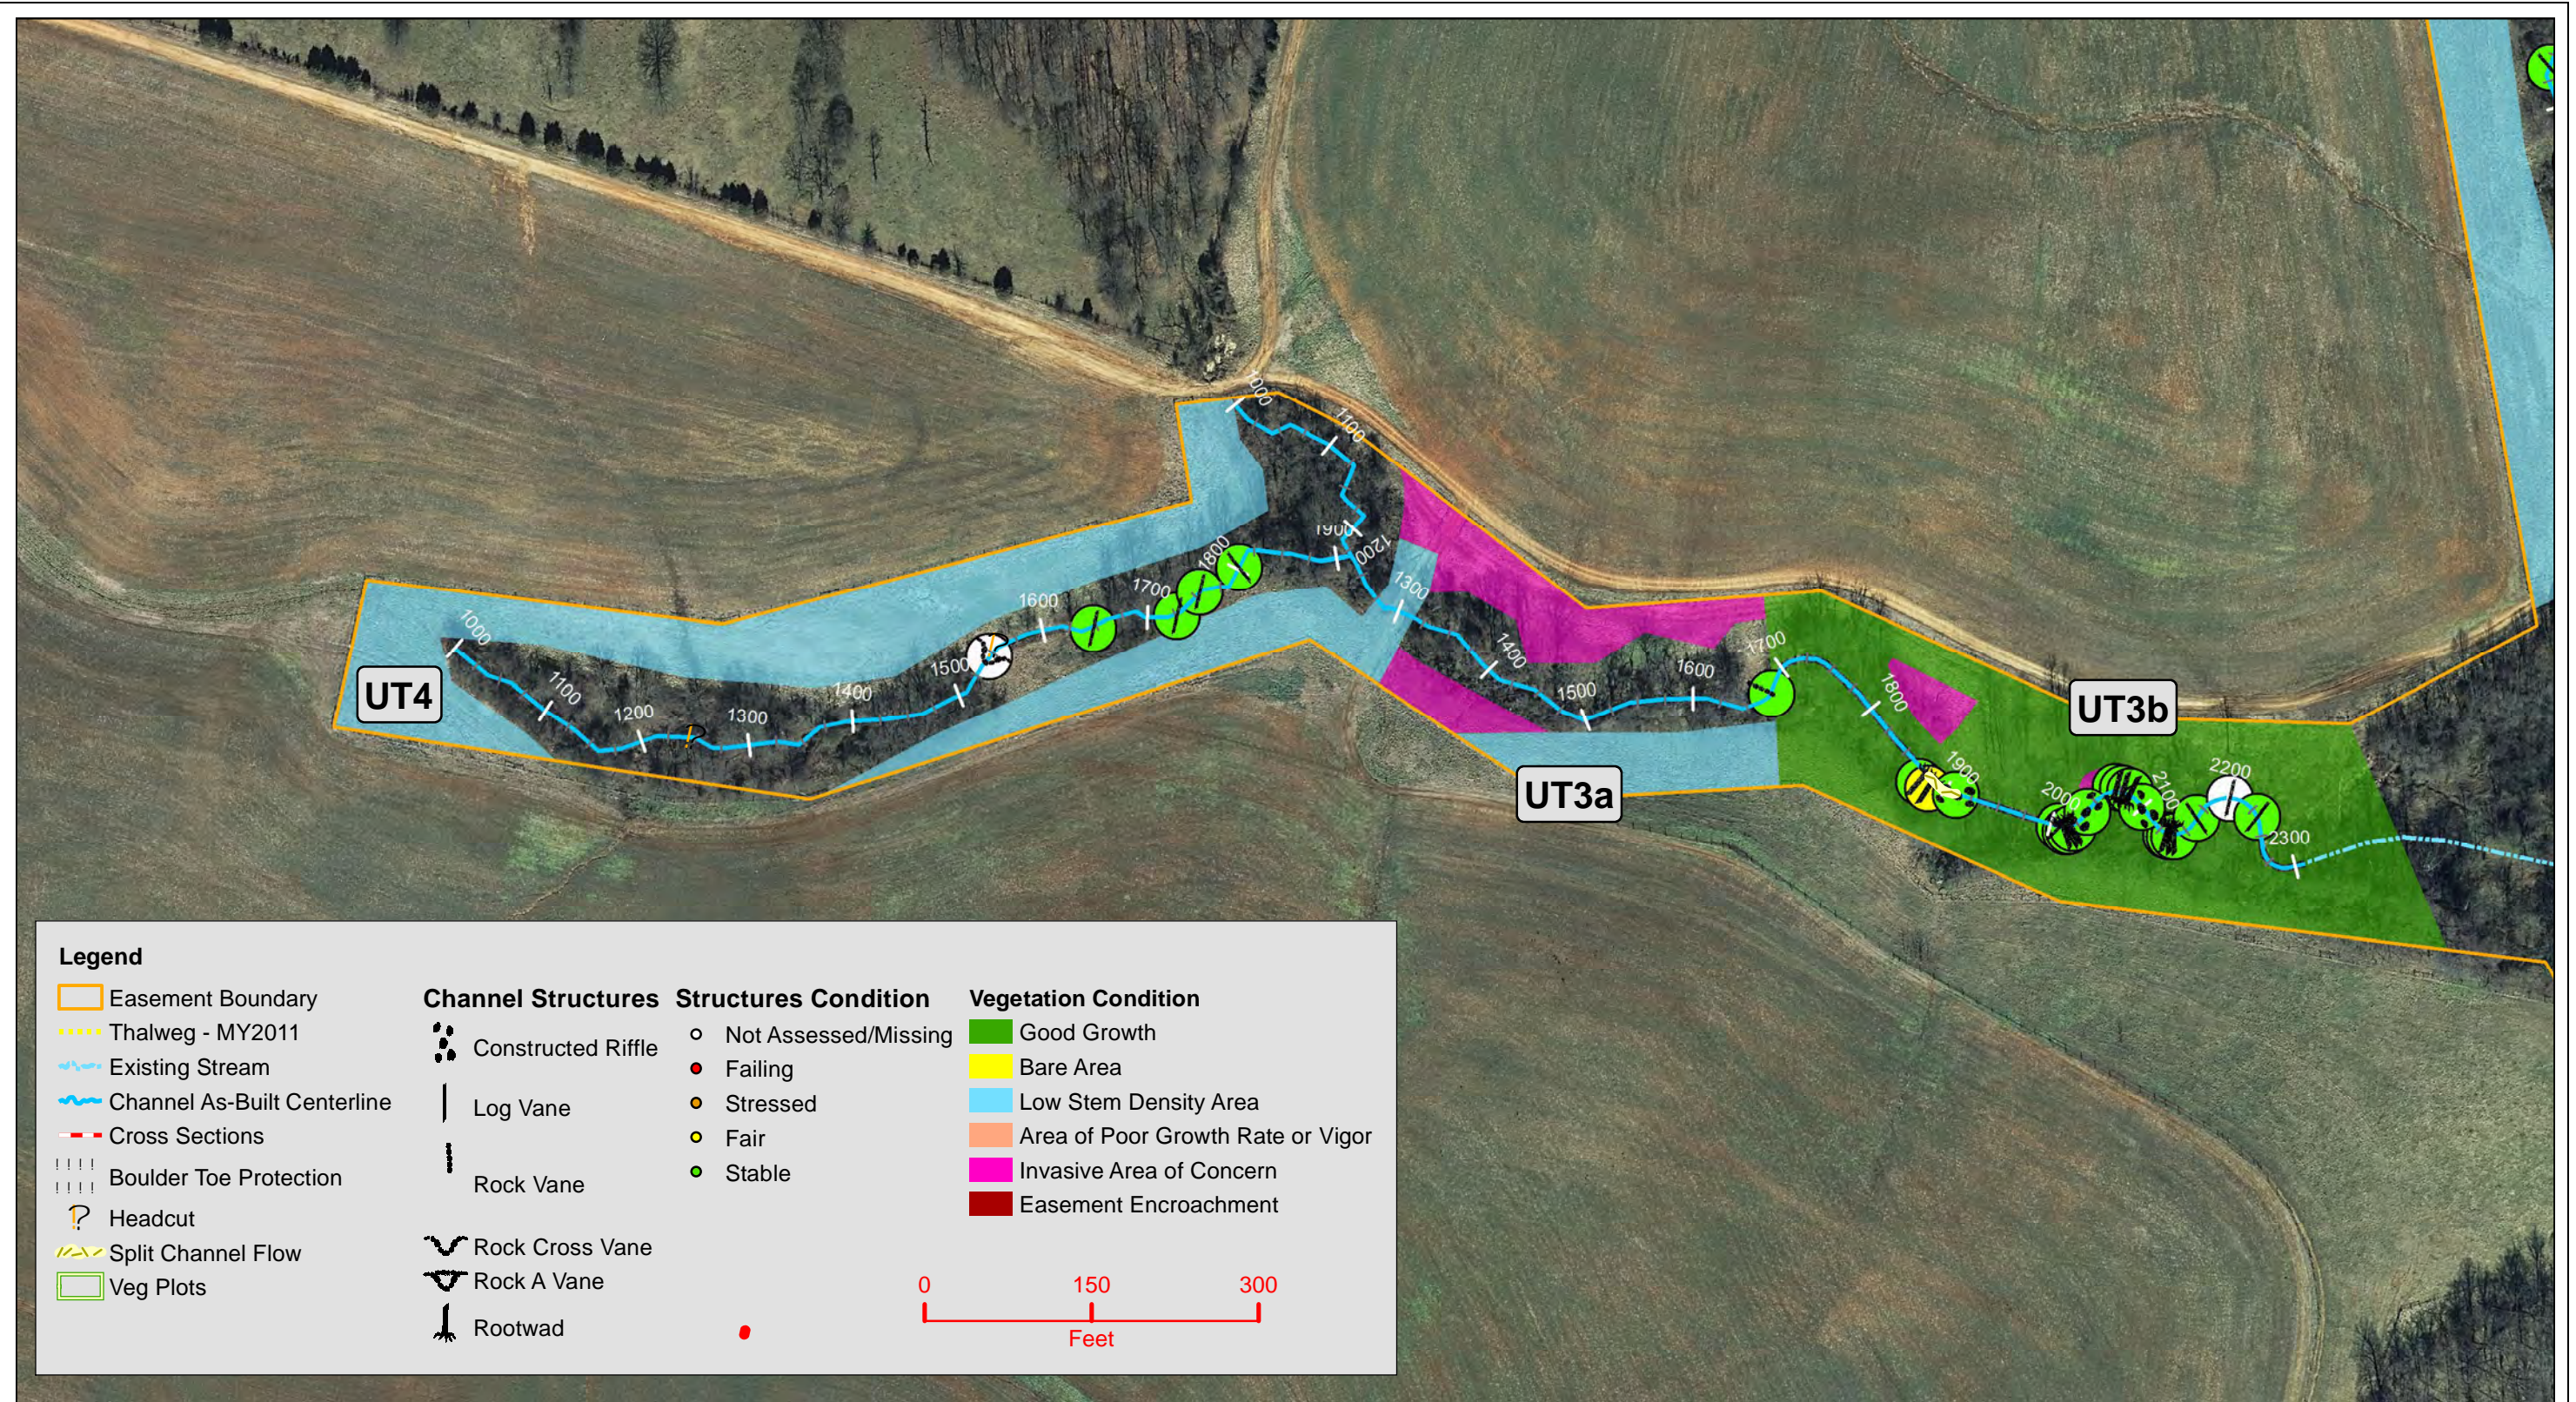
Title		Current Conditions Plan View UT3a, UT3b, and UT4		
Prepared For:

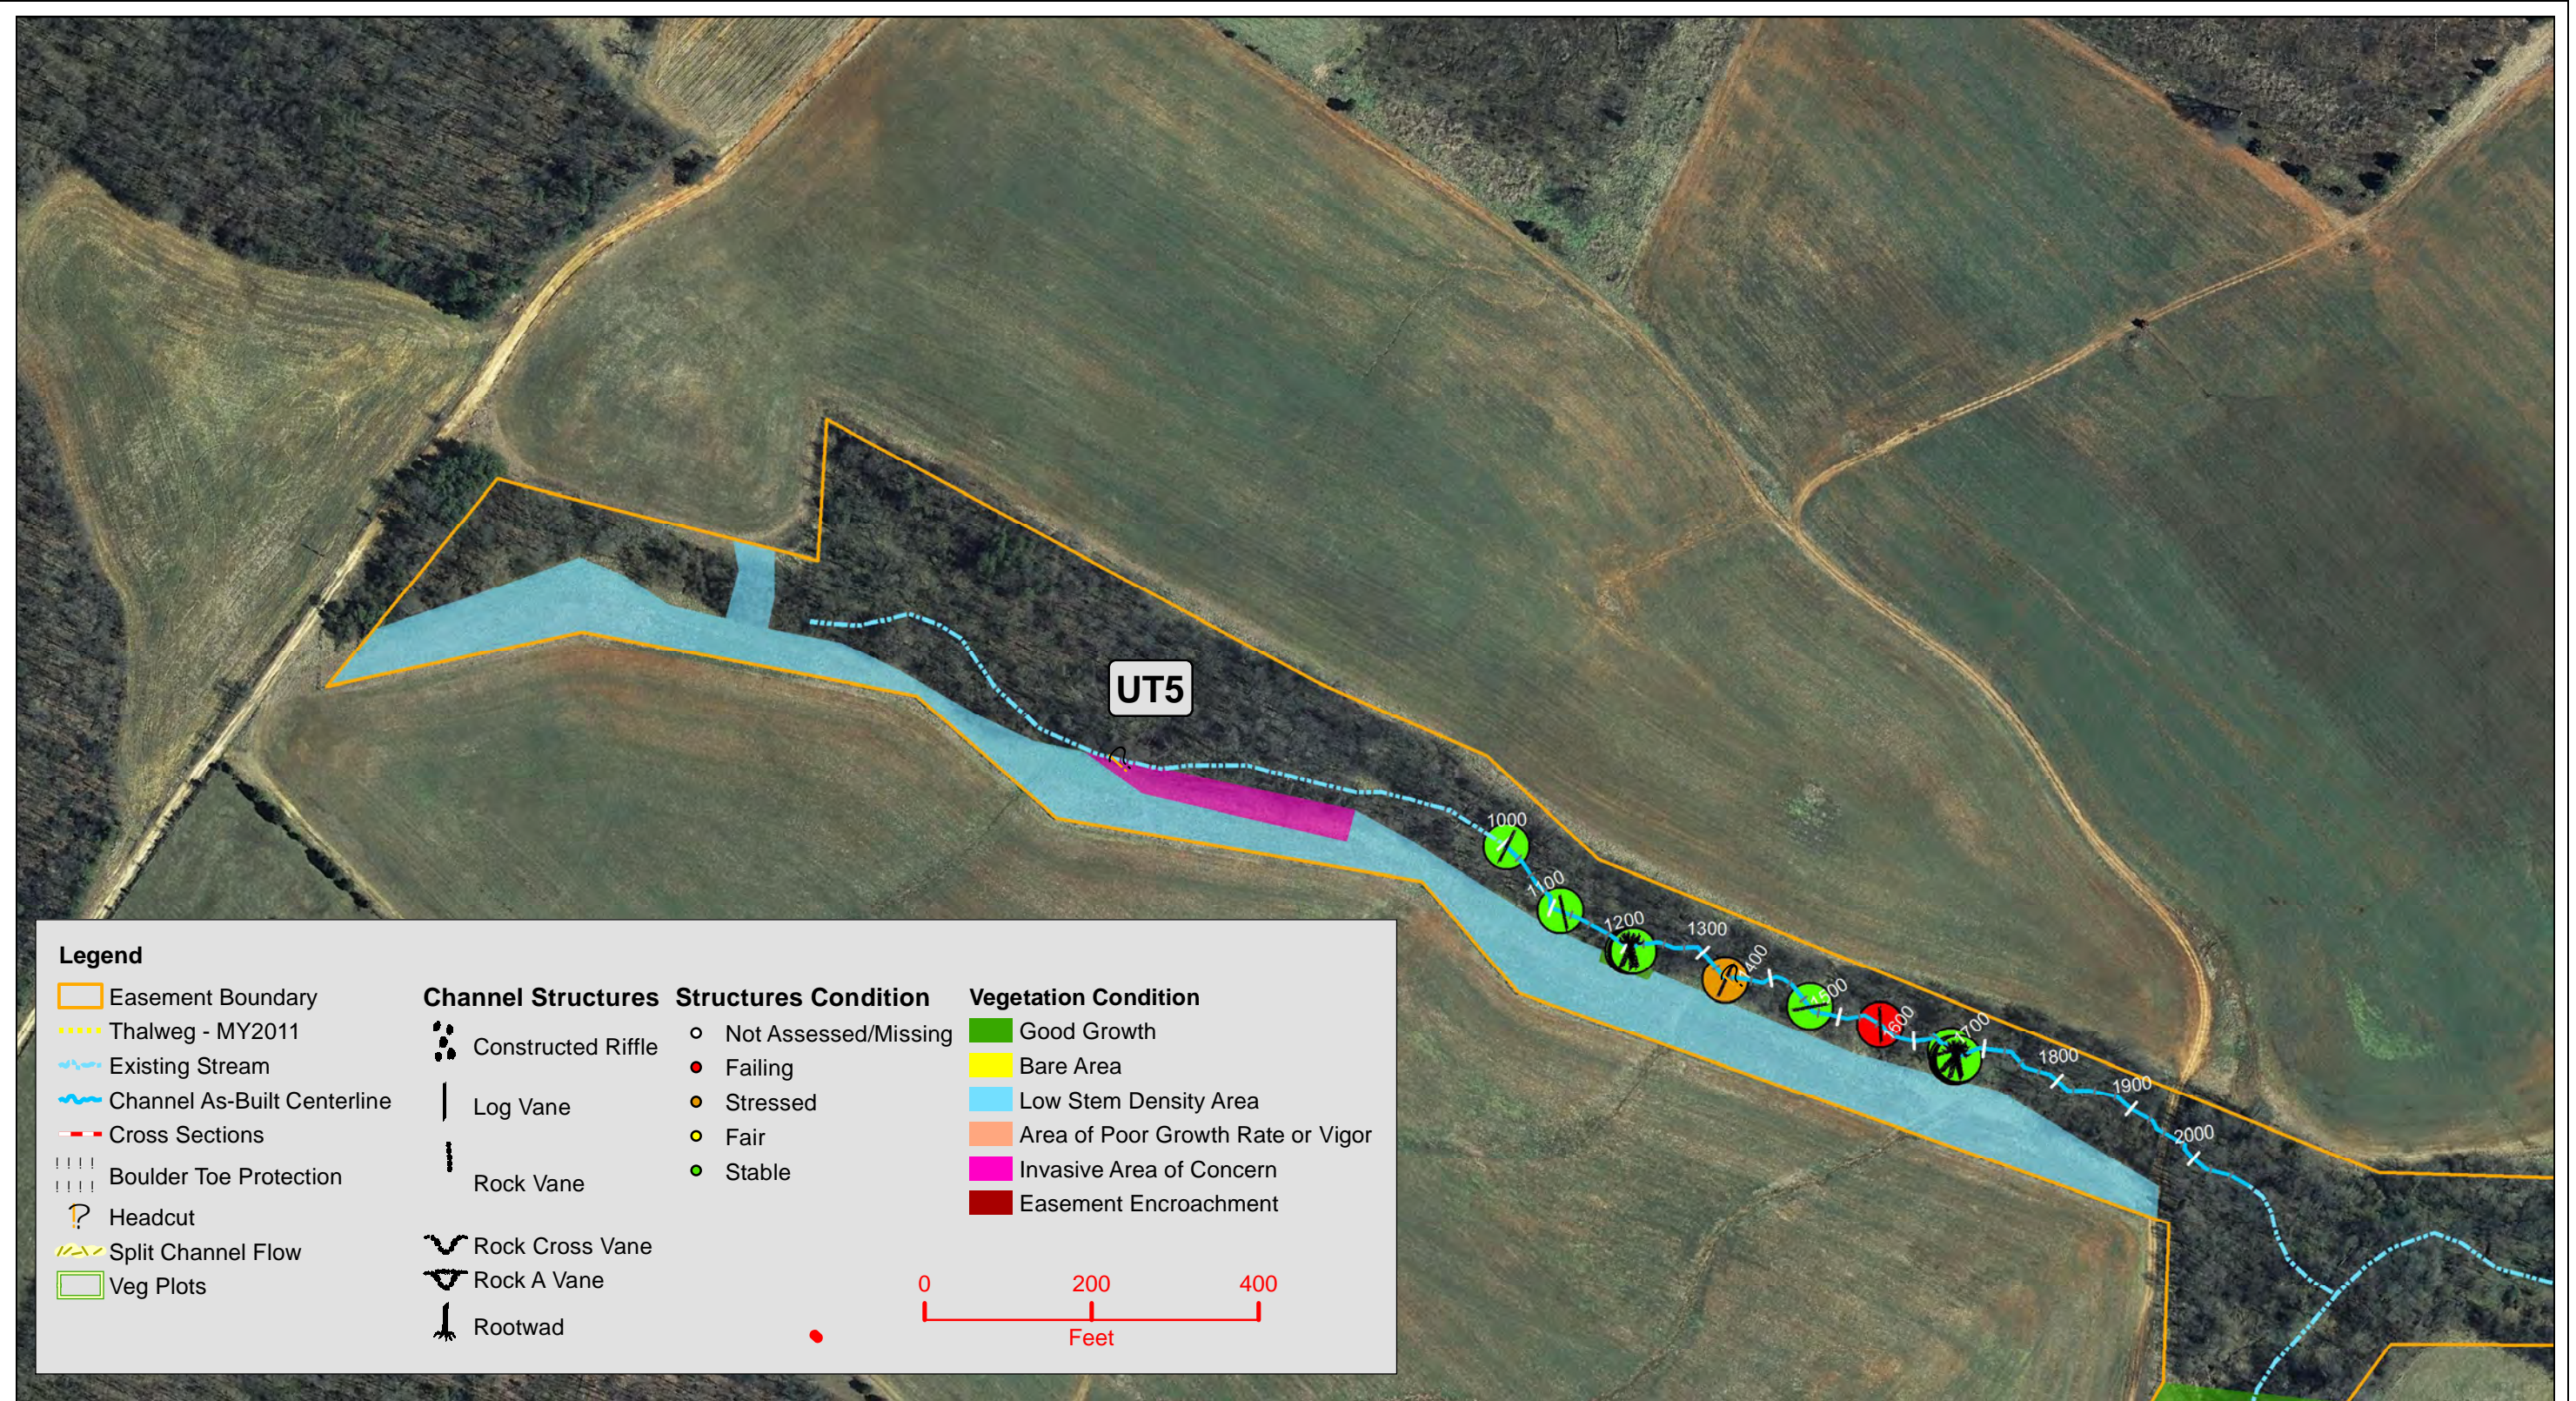
Title	Current Conditions Plan View UT5		
Prepared For:	Project	Meredell Farm Stream Restoration Monitoring Year 4 – 2011 Randolph County, North Carolina

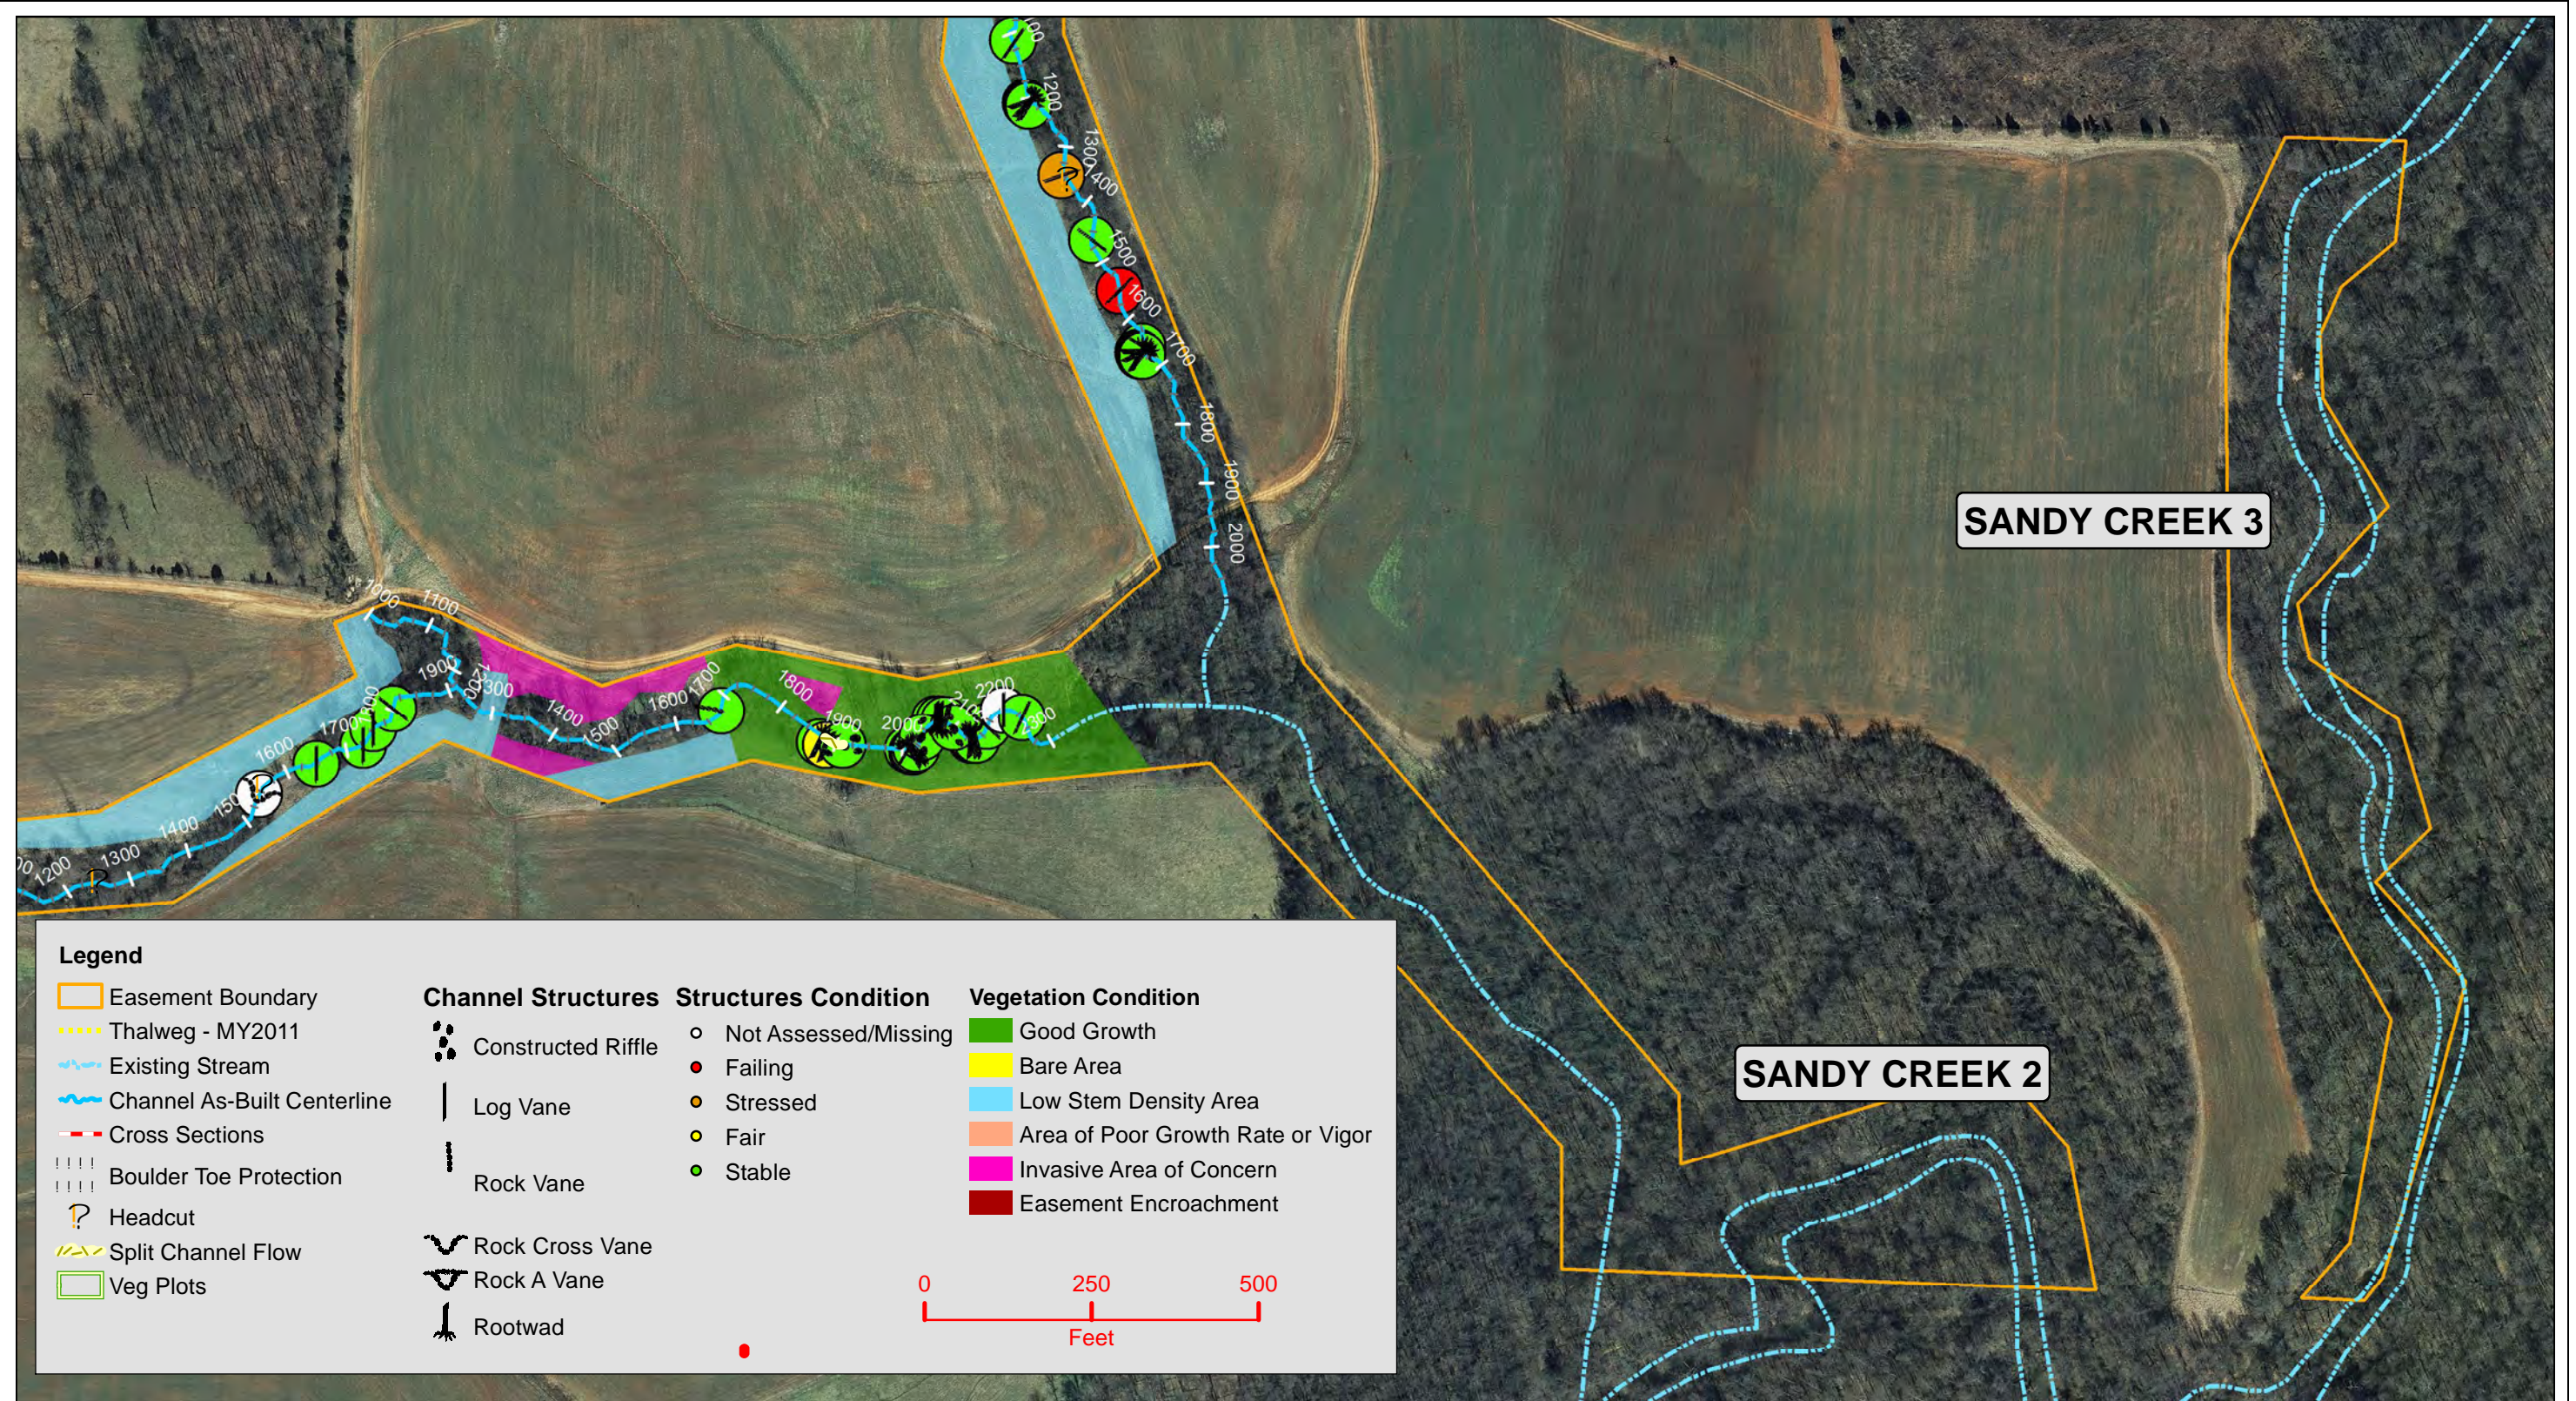
Title	Current Conditions Plan View SC2 and SC3		
Prepared For: 	Project	Meredell Farm Stream Restoration Monitoring Year 4 – 2011 Randolph County, North Carolina	
	Date	1/3/12	Project Number 247
			Figure 7
