Meredell Farm Monitoring Report

Year 5 of 5 (2012)

Randolph County, North Carolina

Project ID No. 247

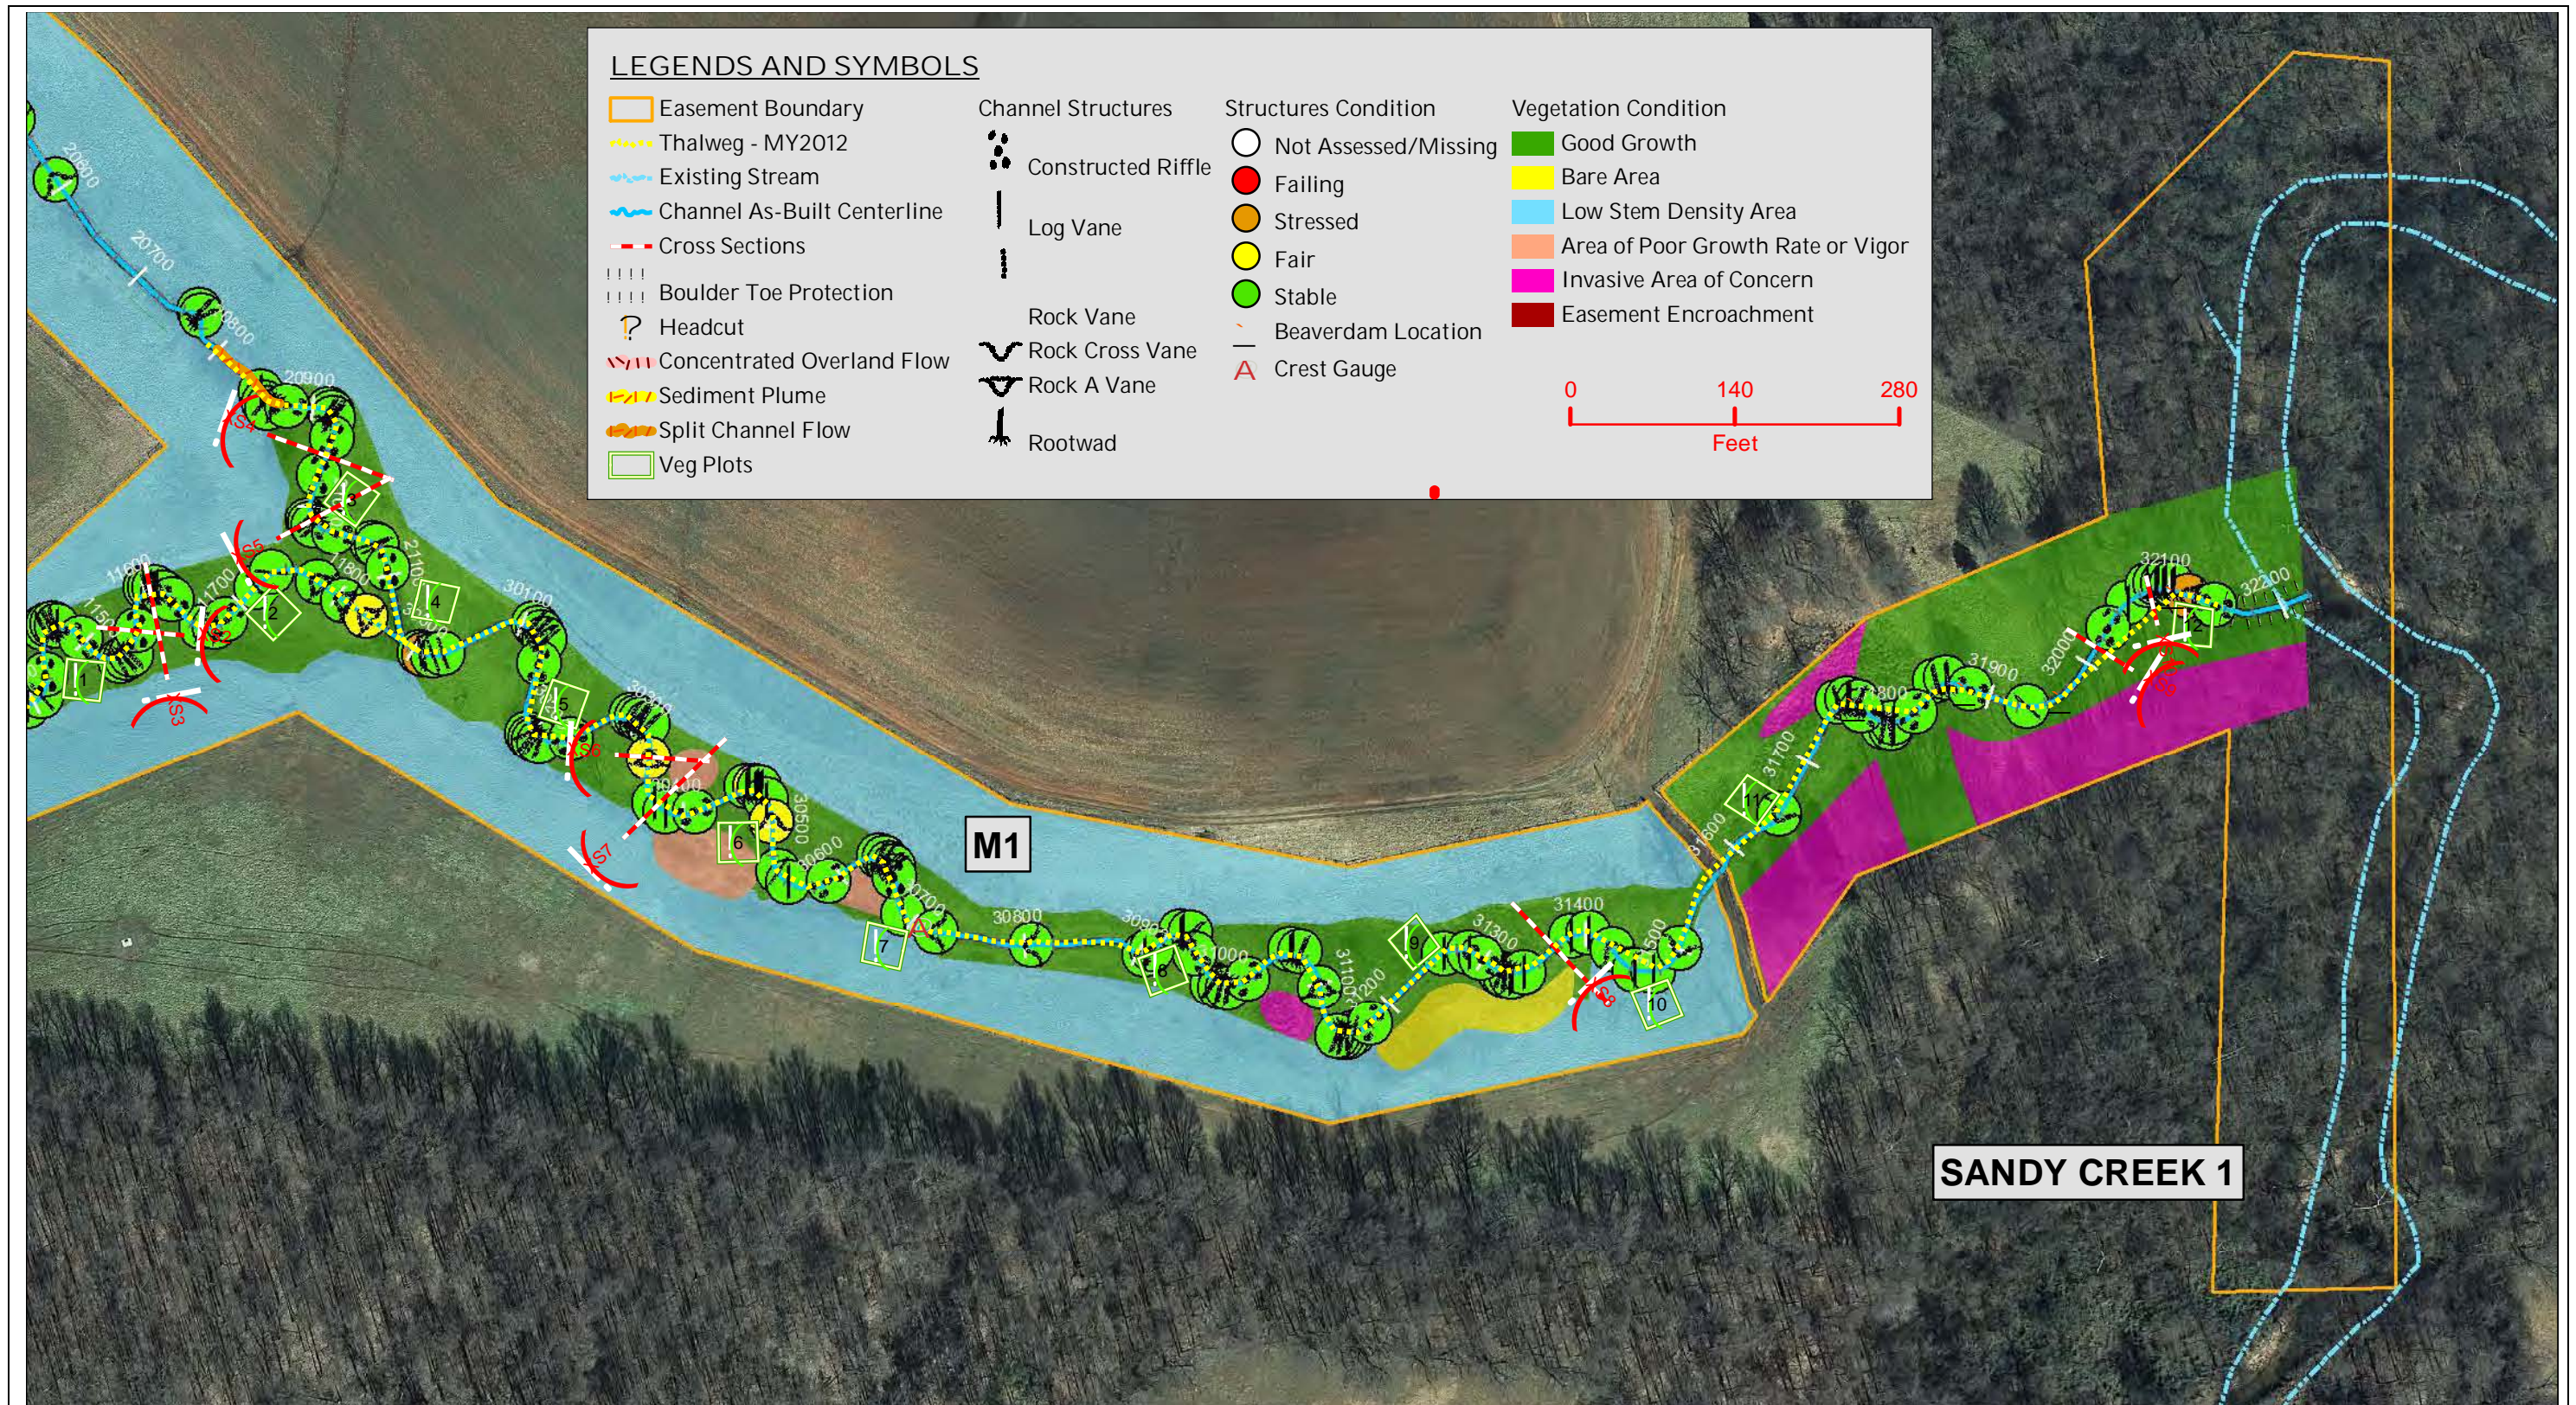
Title		Current Conditions Plan View M1 and SC1		
Prepared For:	Project	Meredell Farm Stream Restoration Monitoring Year 5 – 2012 Randolph County, North Carolina		
		Date	Project Number	Figure

- Three in-stream structures (UT1 and M1) had flow going between the header rocks, but no further instability was observed as a result of the conditions.

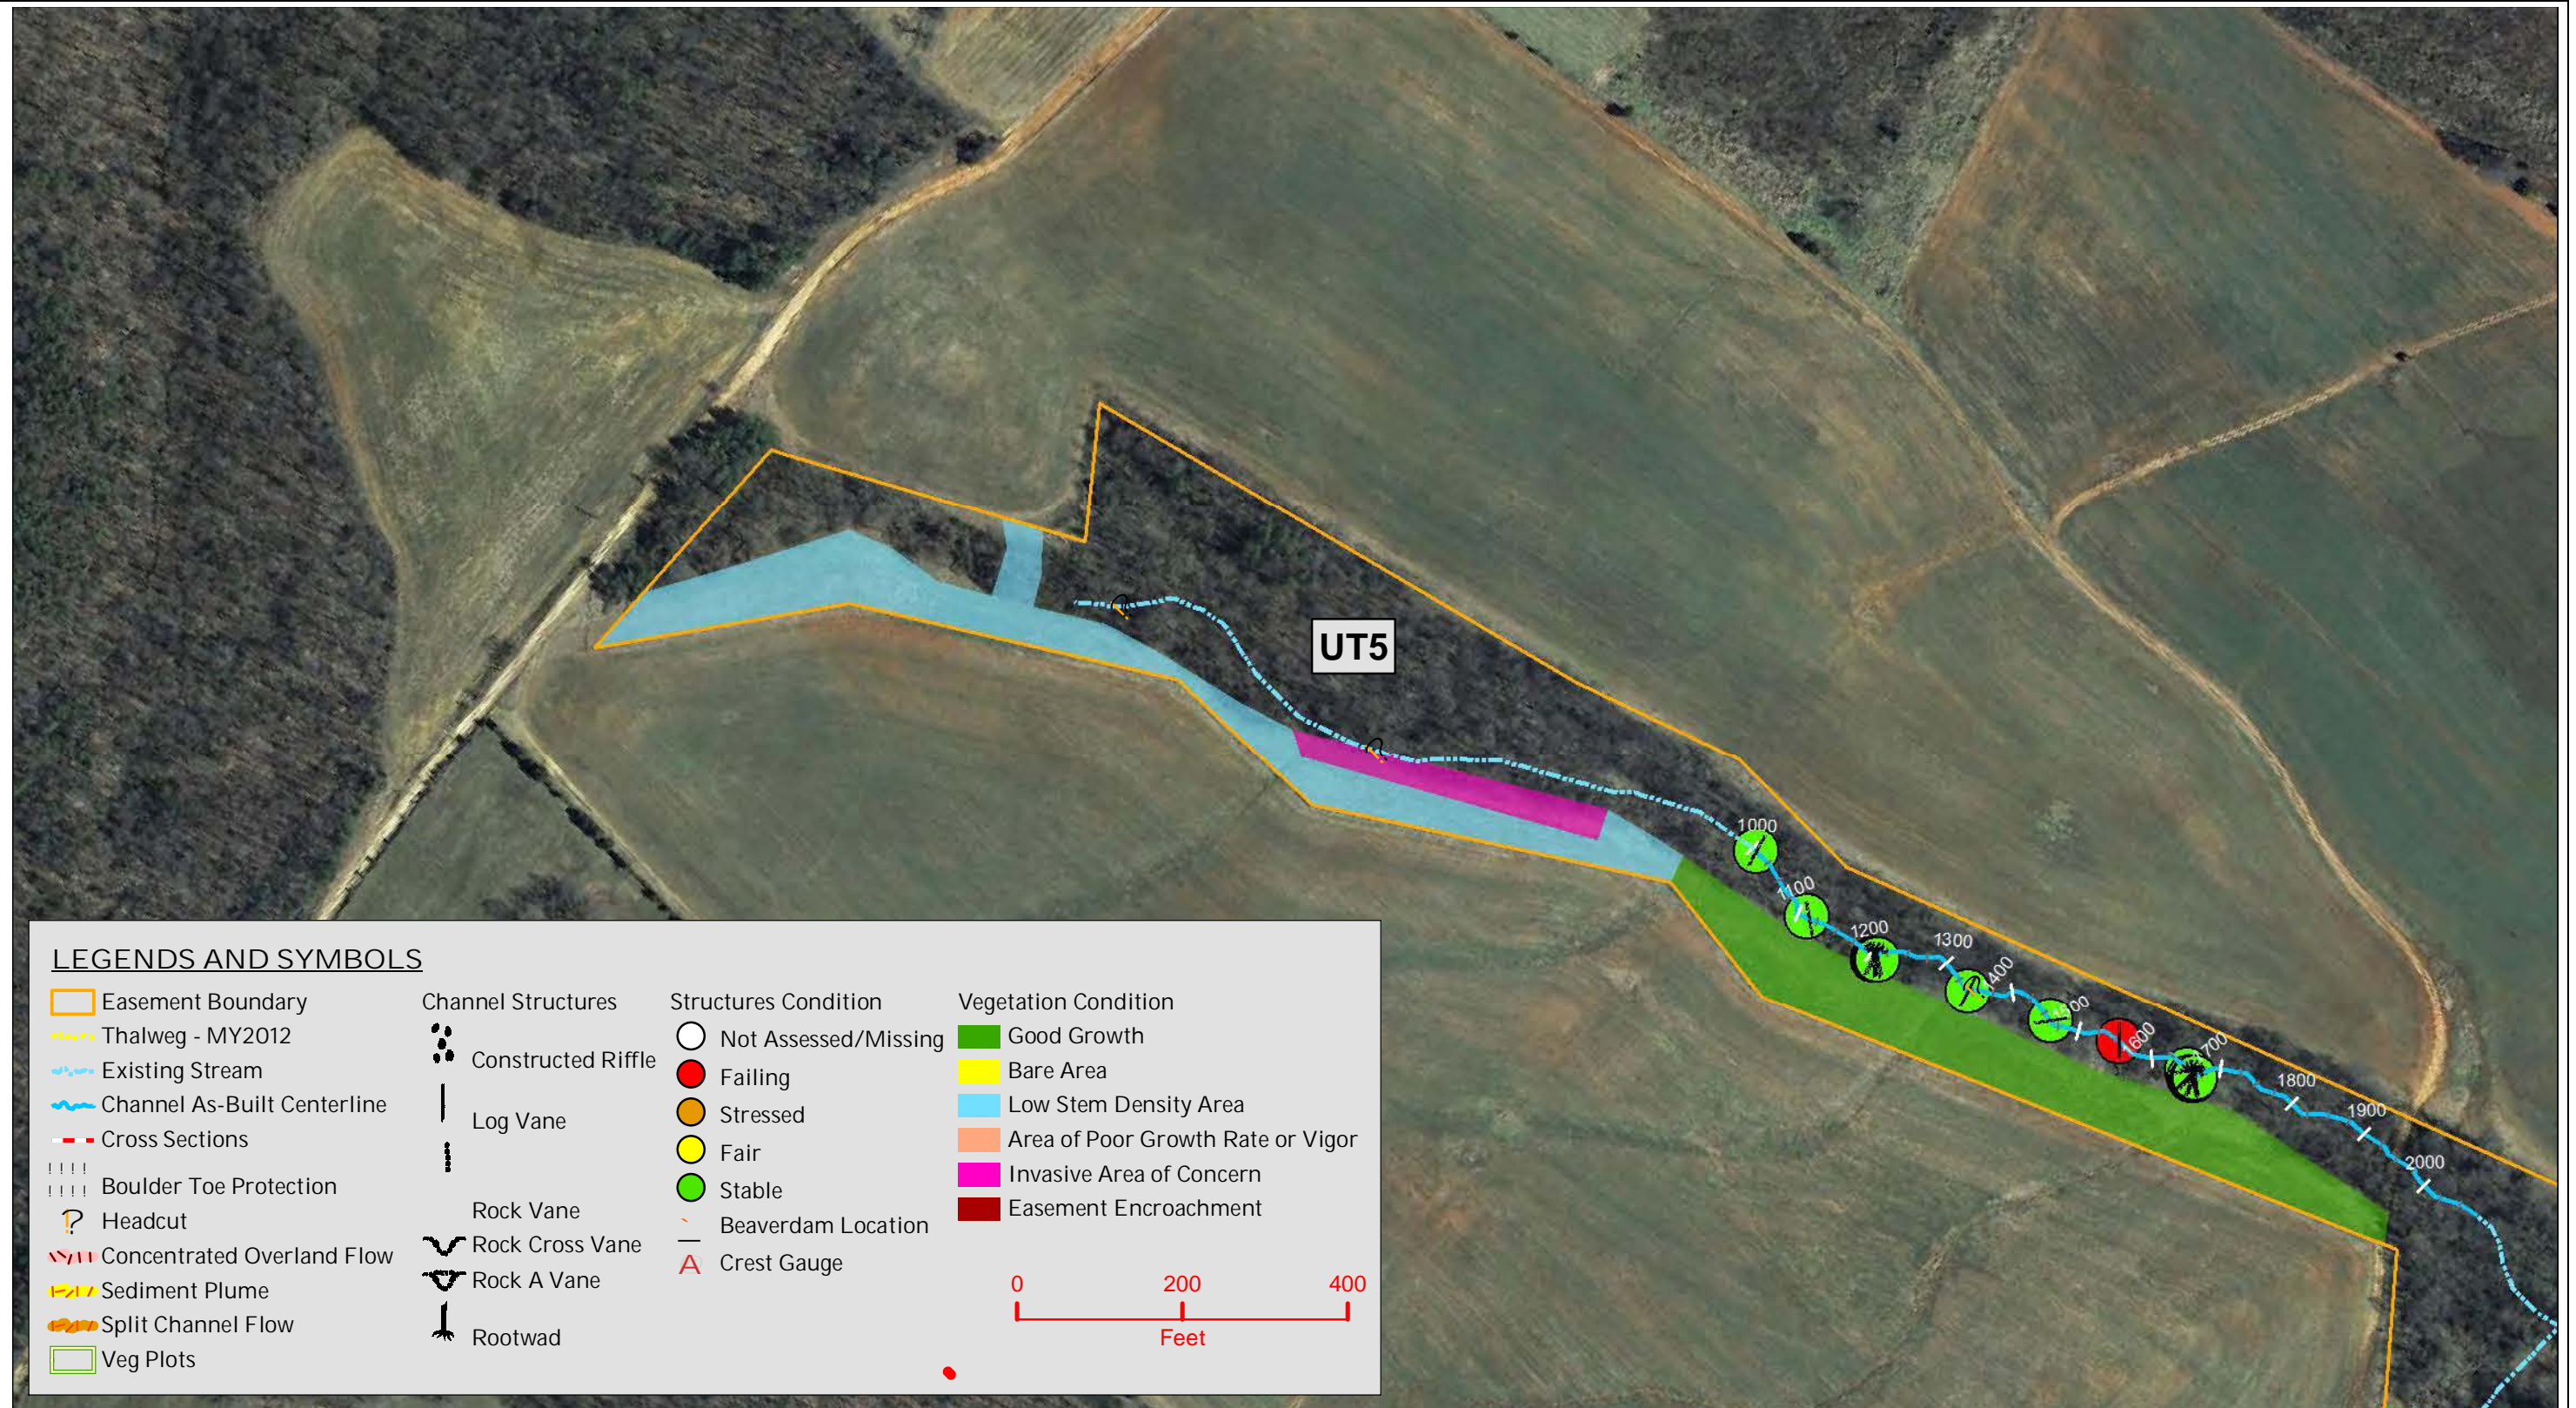
Title	Current Conditions Plan View UT5		
Prepared For: 	Project	Meredell Farm Stream Restoration Monitoring Year 5 – 2012 Randolph County, North Carolina	
	Date	11/15/12	Project Number 247
			Figure 6

- Two log structures on UT3b and UT5 were in fair condition or failing condition due to the lack of water in the channel, which is causing the structures to rot. The rotting structure has water flowing behind and under the structures.

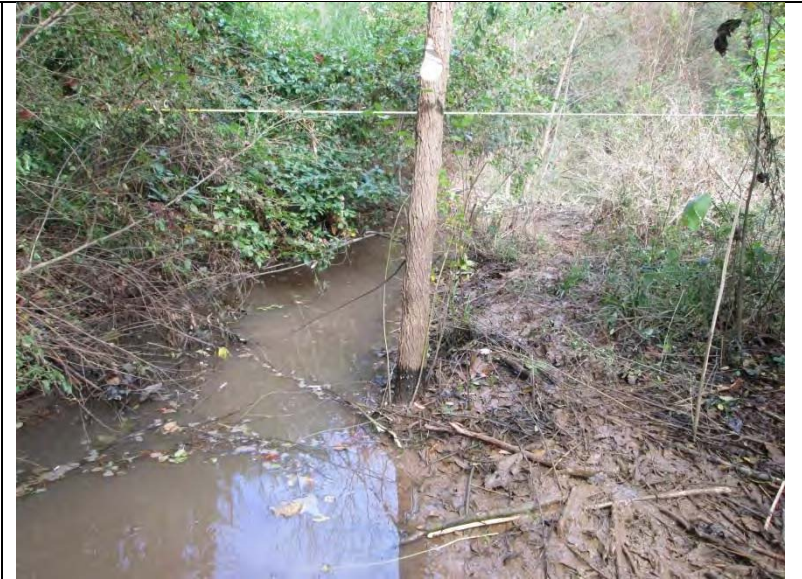
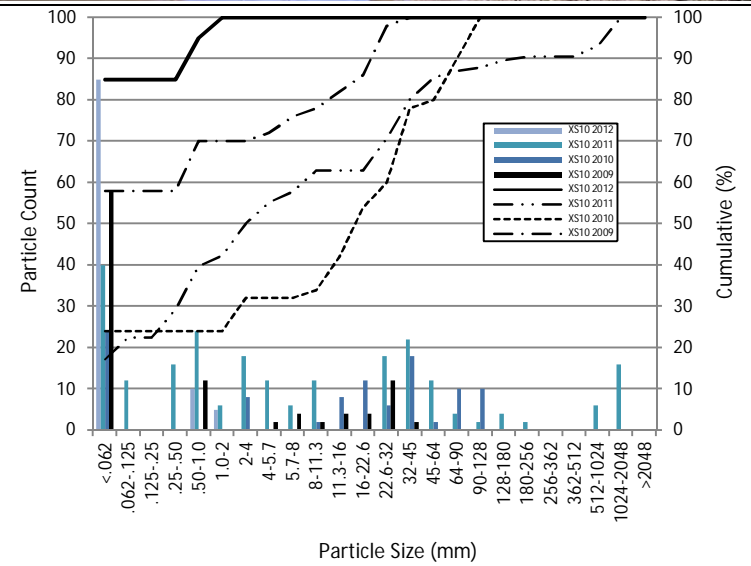
XS - 10 (STA 32+174.027)

ID	YEAR	PHASE	FACET TYPE	Wbkf	Abkf	Dbkf
XS10	2008	DESIGN	POOL	15.0	18.5	1.2
XS10	2008	MY1	POOL	11.9	12.7	1.1
XS10	2009	MY2	POOL	11.0	13.2	1.2
XS10	2010	MY3	POOL	9.9	14.2	1.4
XS10	2011	MY4	POOL	10.1	12.4	1.2
XS10	2012	MY5	POOL	13.6	16	1.18

ID	YEAR	PHASE	d50 (mm)	d84 (mm)
XS10	2009	MY2	<0.062	16
XS10	2010	MY3	20.4	74.4
XS10	2011	MY4	4.0	59.08
XS10	2012	MY5	0.04	0.06
