**MEREDELL FARM  
ANNUAL MONITORING REPORT  
YEAR 6 OF 7**

EEP Project #247  
Randolph County, North Carolina  
Completed Construction: 2008  
Submitted January 2014

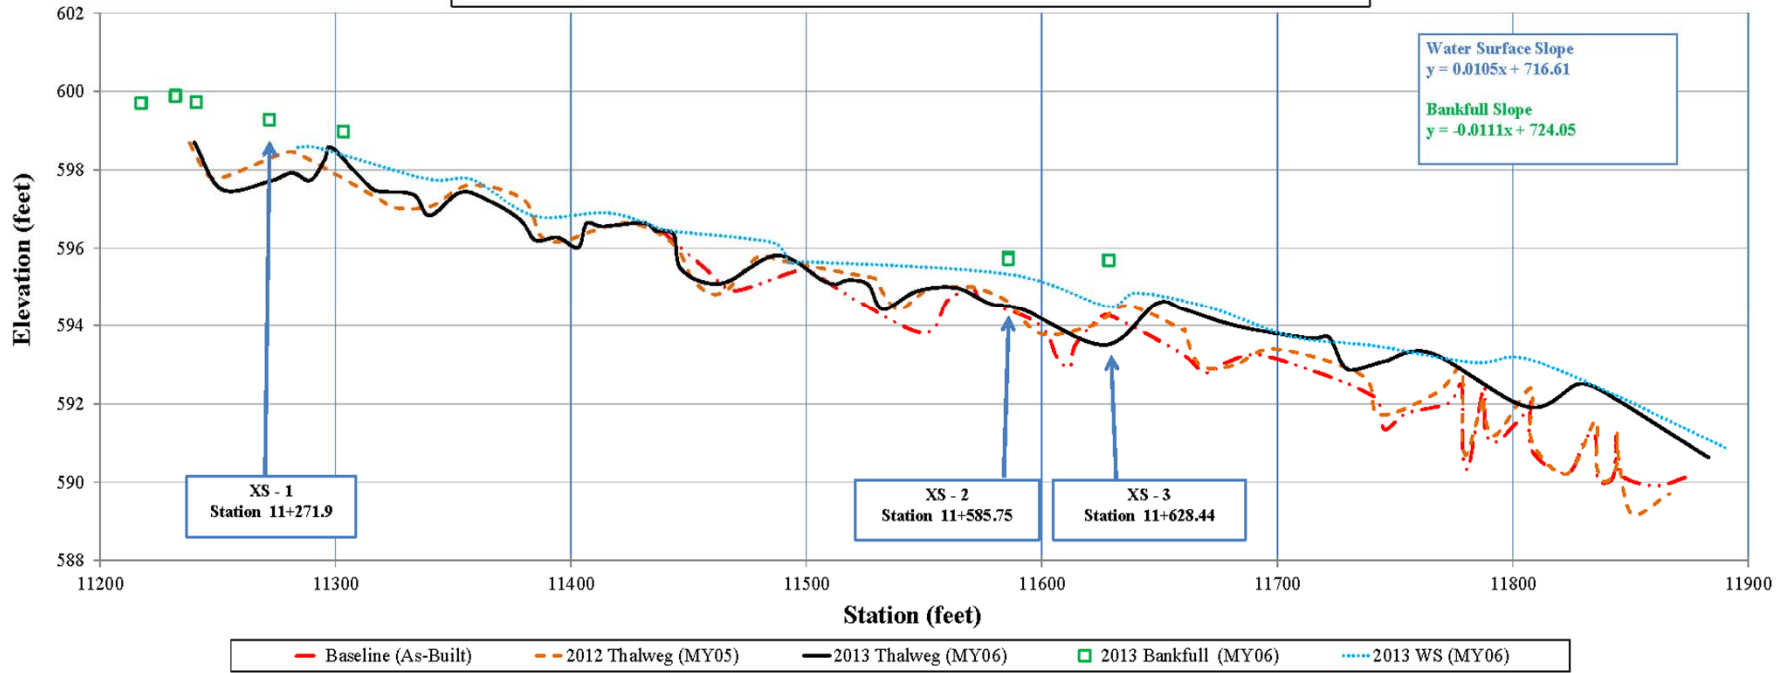
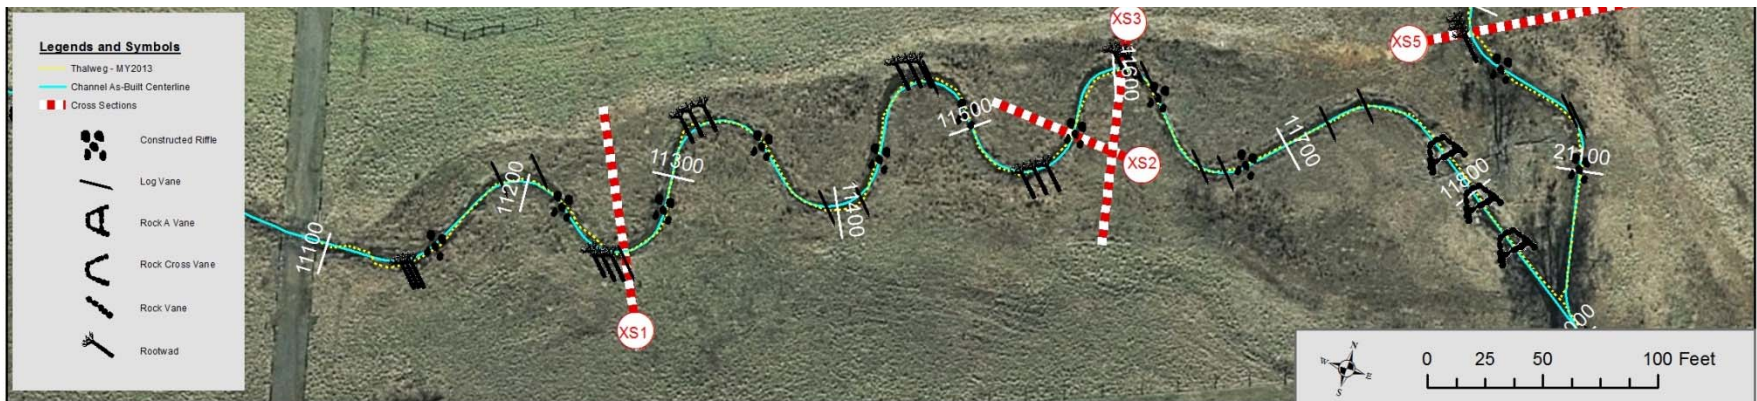
### MEREDELL UT1 STREAM THALWEG PROFILE 2013

NOTE: No areas of significant stream instability were observed during the field survey. Survey monuments were not present in the field. Due to this and differences in surveying methodologies between monitoring year 5 and monitoring year 6, the longitudinal profile data may differ in some areas.
