**MEREDELL FARM  
ANNUAL MONITORING REPORT  
YEAR 7 OF 7**

EEP Project #247  
Randolph County, North Carolina  
Completed Construction: 2008  
Submitted November 2014

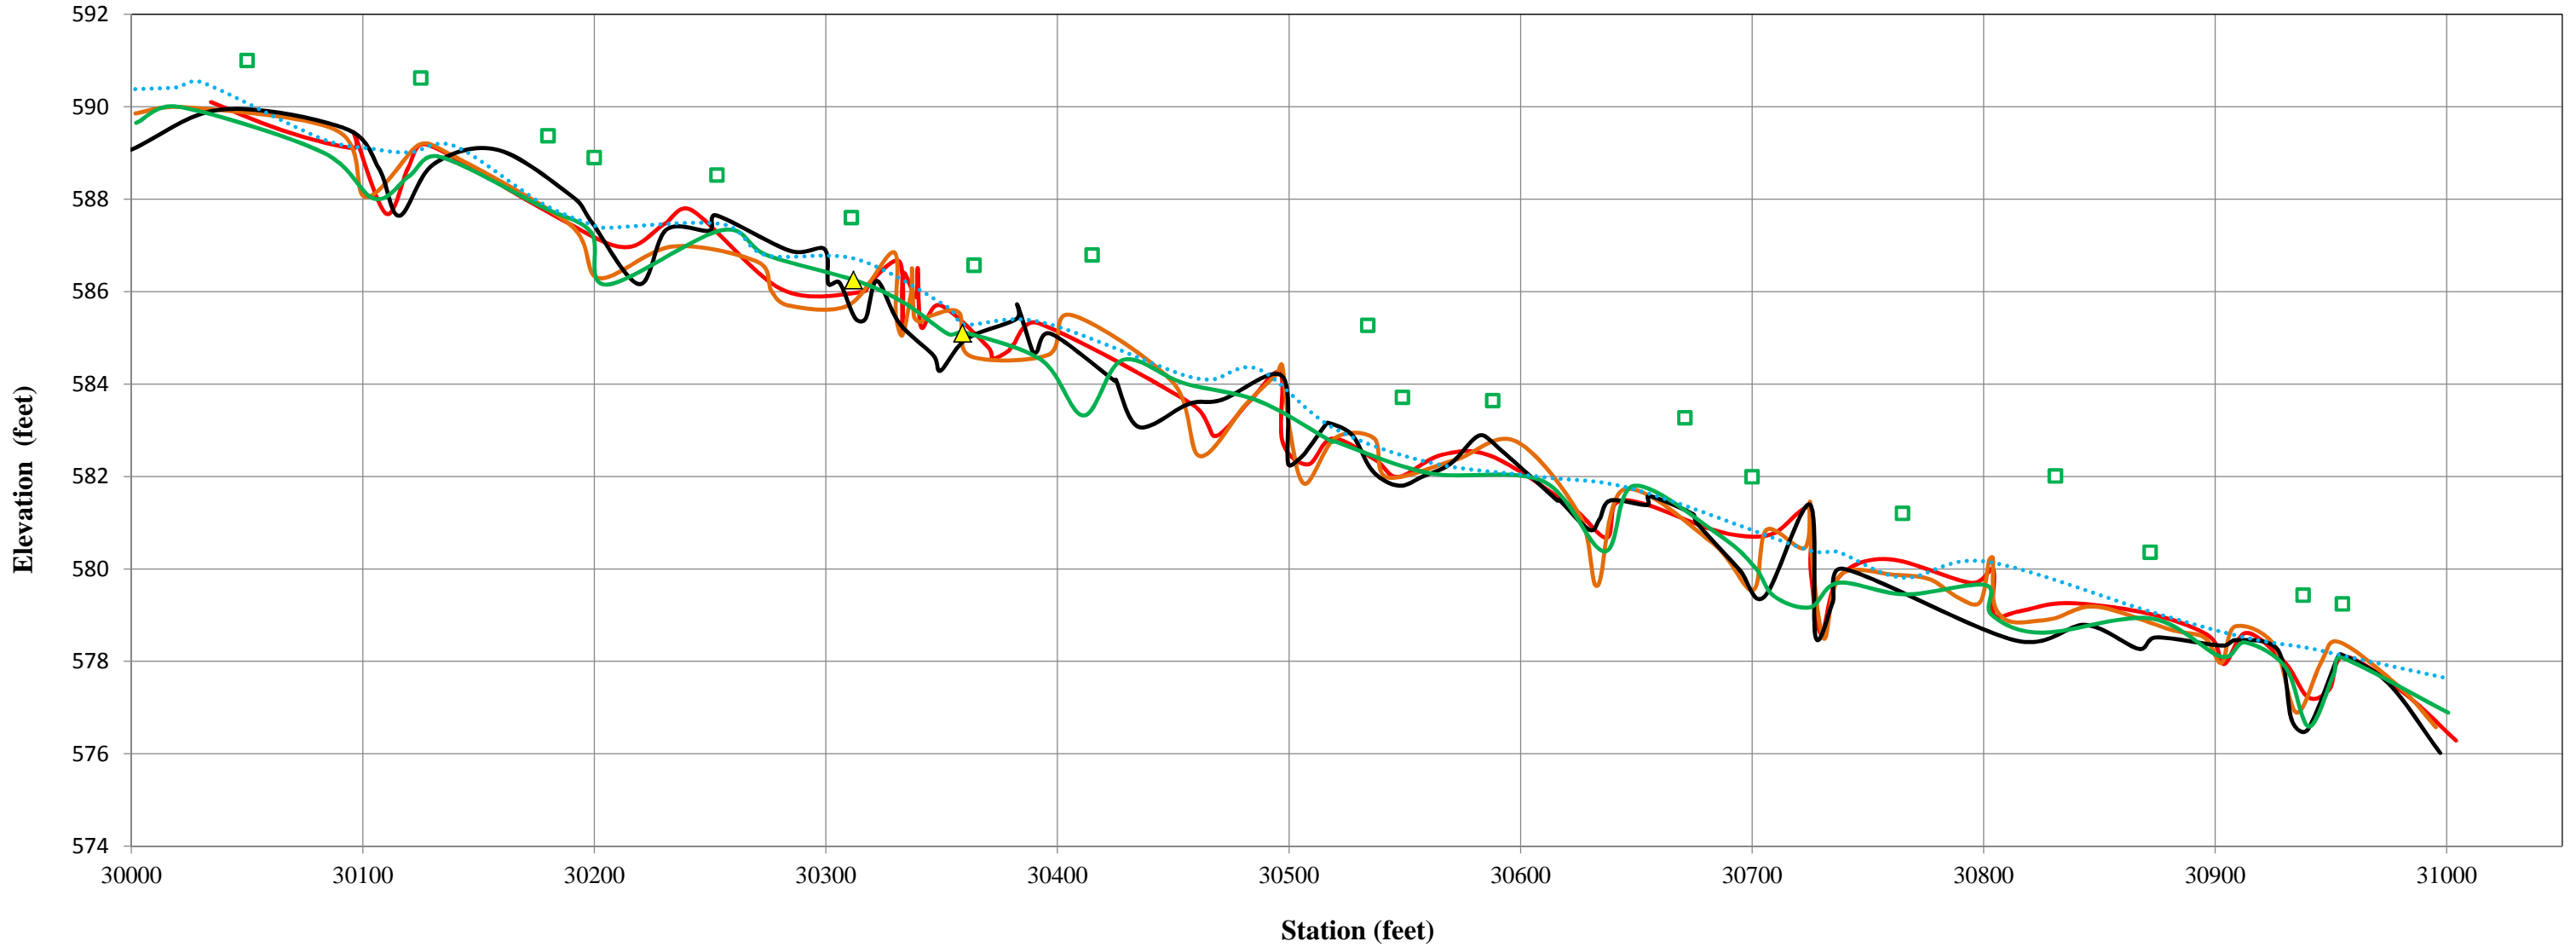
# MEREDELL M1 UPPPER STREAM THALWEG PROFILE 2014

Geomorphic monitoring included collection of 4 longitudinal profile segments. Channel profile stability assessment includes the entire restored length of the project. Survey monuments were not present in the field. Due to this and differences in surveying methodologies between monitoring year 5 and monitoring years 6 and 7, the longitudinal profile data may differ in some areas. It should also be noted that sections of reaches UT1 and M1 Lower indicate a one foot difference in thalweg elevations between MY06 and MY07. These areas were noted as stable during the field review. Therefore, it was concluded that these differences arose from difficulty obtaining accurate GPS signal under heavy canopy which resulted in greater distances between collected points along the thalweg. Refer to **Appendix D** contained herein for detailed results of the longitudinal profile data collection.
