# **Annual Monitoring Report**

Monitoring Year 2 of 5

Middle South Muddy Stream Restoration Site

NCDMS Project No.: 93875

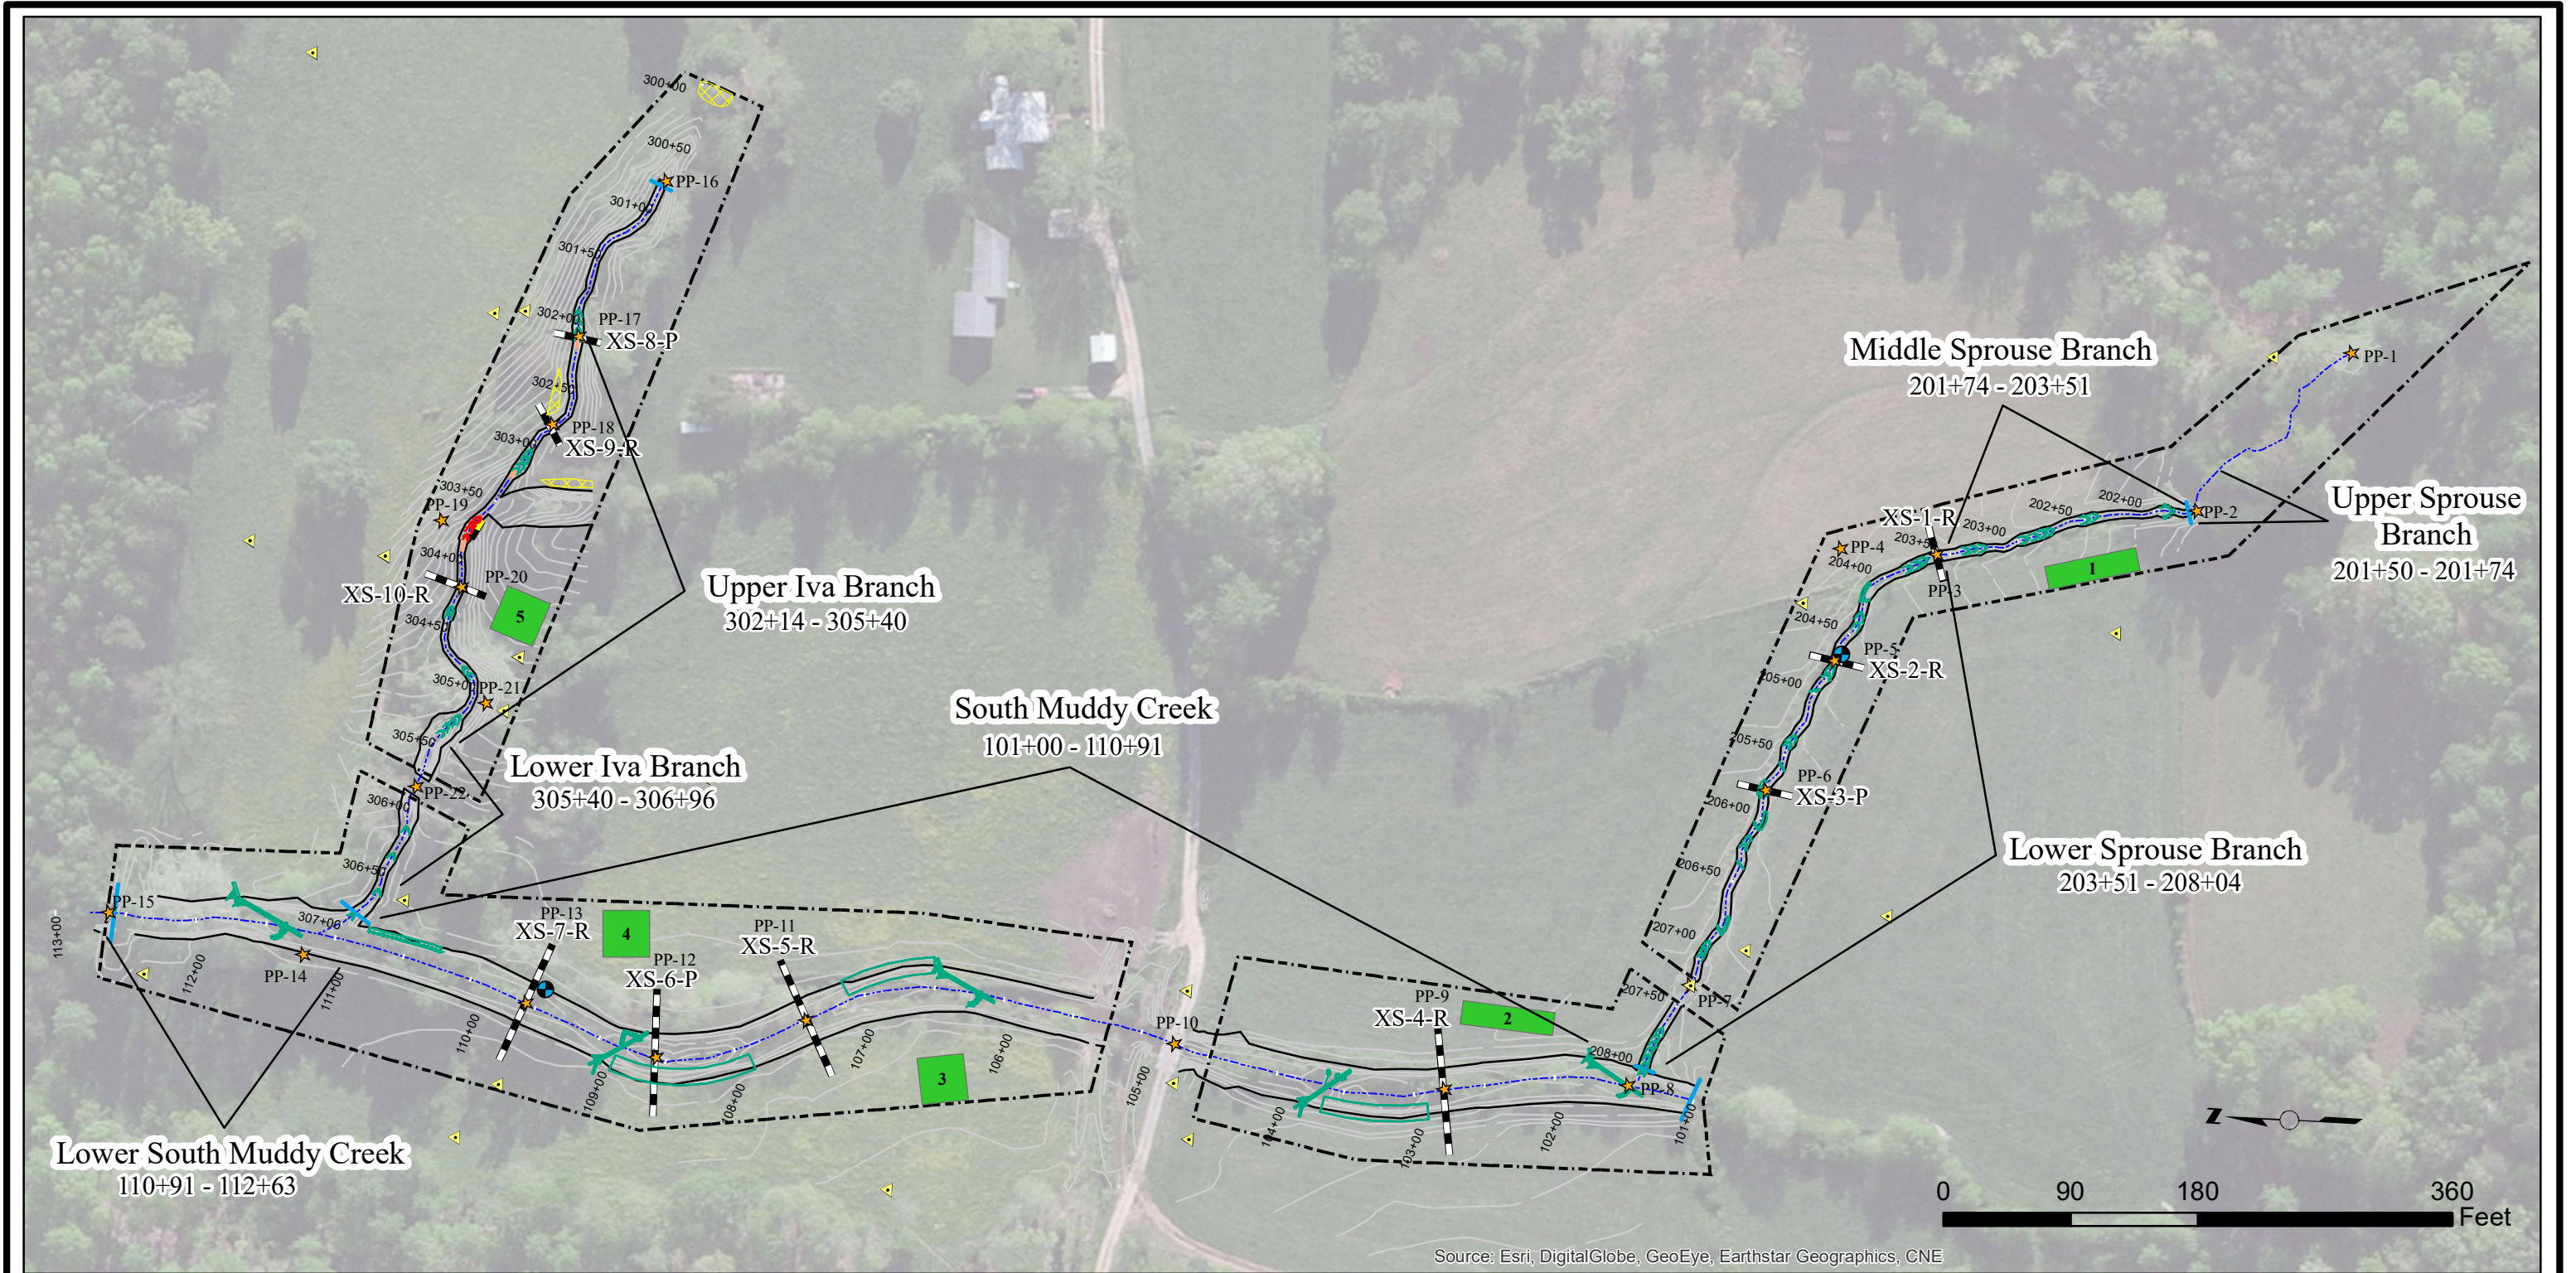
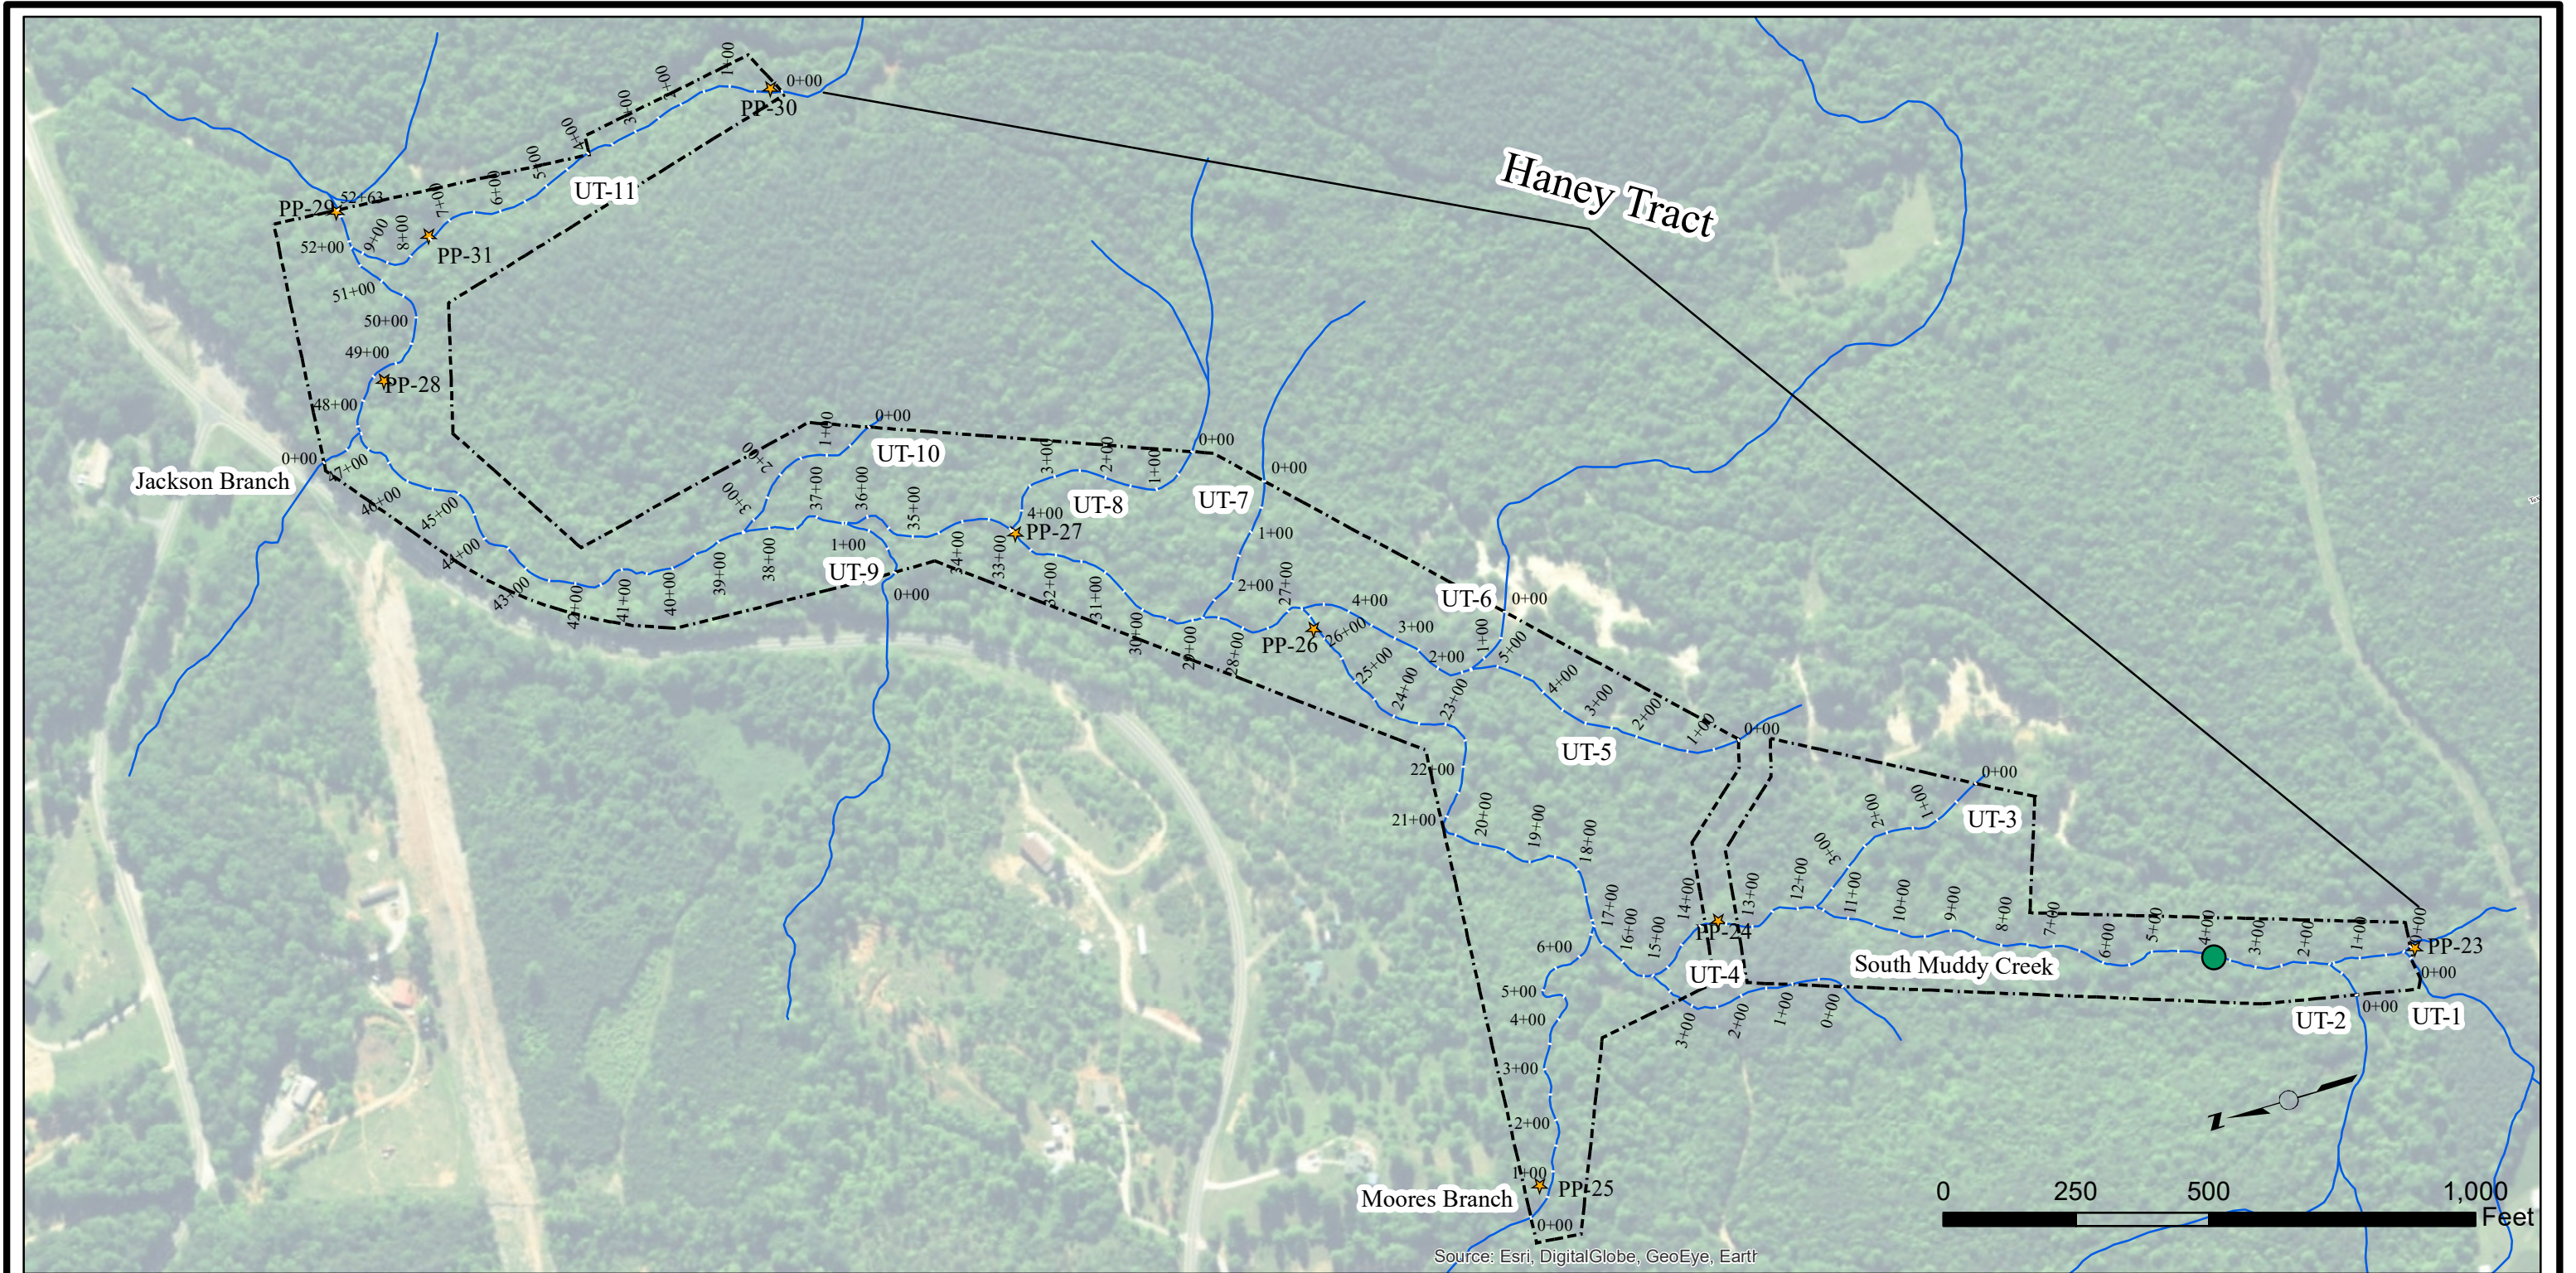
Figure 2. Integrated Current Condition Plan View

Visual assessment of the stream channel was performed to document signs of instability, such as eroding banks, structural instability, or excessive sedimentation. The structure on South Muddy Creek at STA 108+83 that was classified as being stressed, has stabilized between MY1 and MY2. The downstream head-of-riffle has also stabilized, lowering approximately 0.1ft between MY1 and MY2 (Table 5 and Figure 2). Deposition of fine sediment that occurred throughout the South Muddy Creek reach during MY1 also stabilized in MY2. While these large sediment blankets have not flushed out of the system, no large scale fine sediment influxes were noted during MY2. On Iva Branch, the boulder step structure at STA 303+67, has failed (Figure 2). Scour around the LDB of the arm of the top 3 boulder arches has undermined the structure. Material from the pools of the boulder steps has migrated downstream to fill in the riffle at STA 303+75 (Figure 2). While the upstream structures remain intact, the material from the boulder arches of the structures (STA 301+94 & 303+07) have also migrated into the downstream riffle causing aggradation at STA 302+25 and 303+25 (Figure 2). These area will be assessed during future site visits.

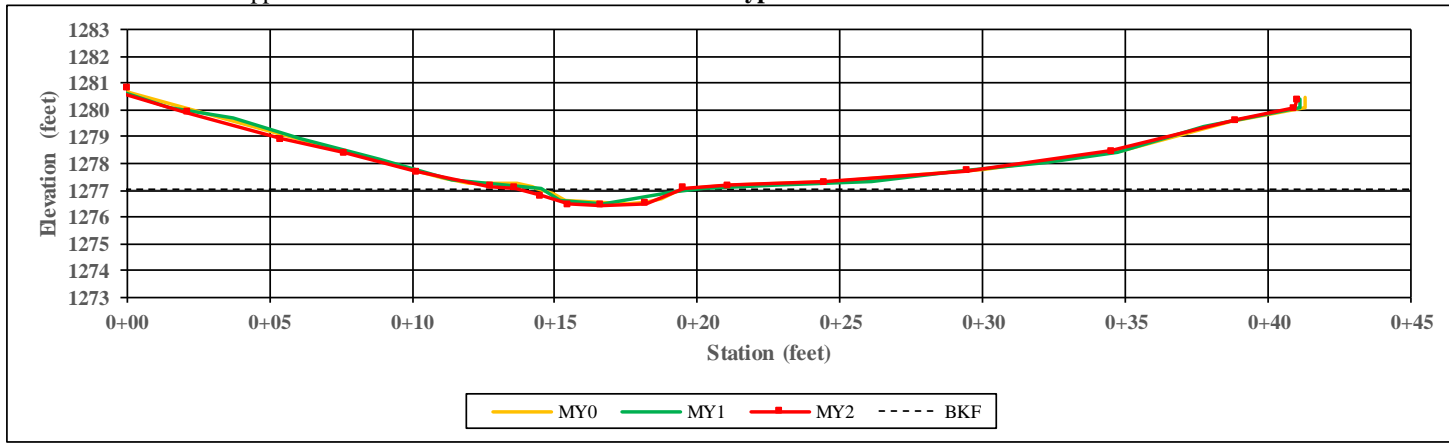
**XS Number:** 10  
**XS Type:** Riffle

CHANNEL DIMENSIONS SUMMARY	MY0	MY1	MY2	MY3	MY4	MY5	MY6	MY7
Bankfull Width (ft)	5.3	5.6	5.8	-	-	-	-	-
Floodprone Width (ft)	17.0	17.0	17.0	-	-	-	-	-
Bankfull Mean Depth (ft)	0.4	0.3	0.4	-	-	-	-	-
Bankfull Max Depth (ft)	0.6	0.6	0.6	-	-	-	-	-
Bankfull Cross-Sectional Area (ft <sup>2</sup> )	2.1	1.9	2.5	-	-	-	-	-
Width/Depth Ratio	13.3	16.7	13.3	-	-	-	-	-
Entrenchment Ratio	3.2	3.0	3.0	-	-	-	-	-
Bank Height Ratio	1.0	1.000	1.048	-	-	-	-	-

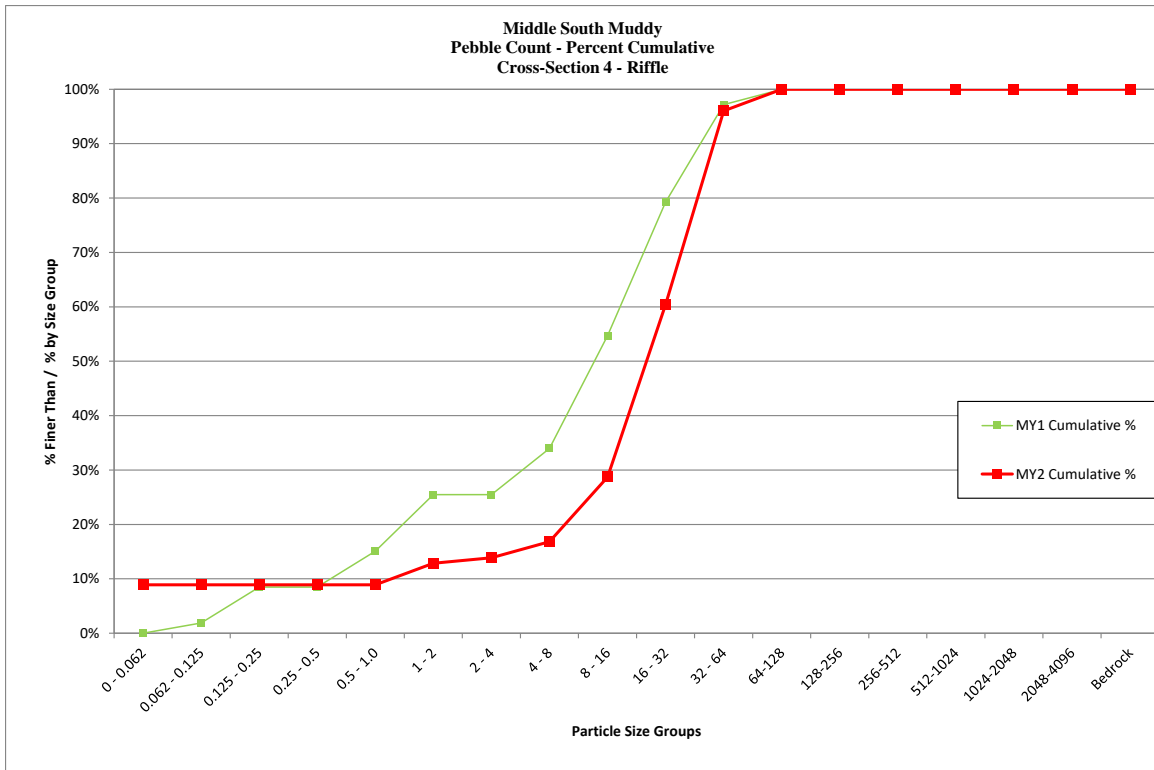
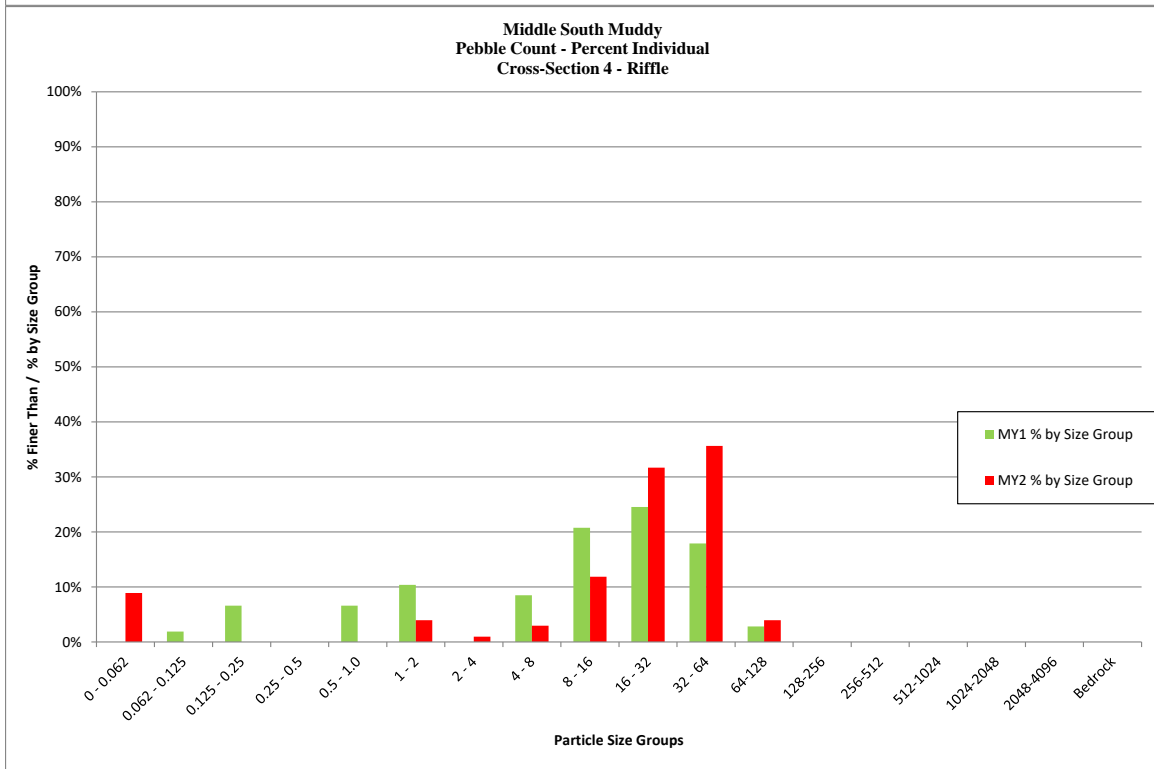
<b>Middle South Muddy</b>			
<b>Cross Section 4 - Riffle</b>			
<b>Monitoring Year - 2017; MY2</b>			
<b>Bed Surface Material Particle Size Class (mm)</b>	<b>Number</b>	<b>% Individual</b>	<b>% Cumulative</b>
0 - 0.062	9	8.9%	9%
0.062 - 0.125	0	0.0%	9%
0.125 - 0.25	0	0.0%	9%
0.25 - 0.5	0	0.0%	9%
0.5 - 1.0	0	0.0%	9%
1 - 2	4	4.0%	13%
2 - 4	1	1.0%	14%
4 - 8	3	3.0%	17%
8 - 16	12	11.9%	29%
16 - 32	32	31.7%	60%
32 - 64	36	35.6%	96%
64-128	4	4.0%	100%
128-256	0	0.0%	100%
256-512	0	0.0%	100%
512-1024	0	0.0%	100%
1024-2048	0	0.0%	100%
2048-4096	0	0.0%	100%
Bedrock	0	0.0%	100%
<b>Total</b>	<b>101</b>	<b>100%</b>	<b>100%</b>
		<b>Summary Data</b>	
		<b>D50</b>	<b>27</b>
		<b>D84</b>	<b>50</b>
		<b>D95</b>	<b>63</b>

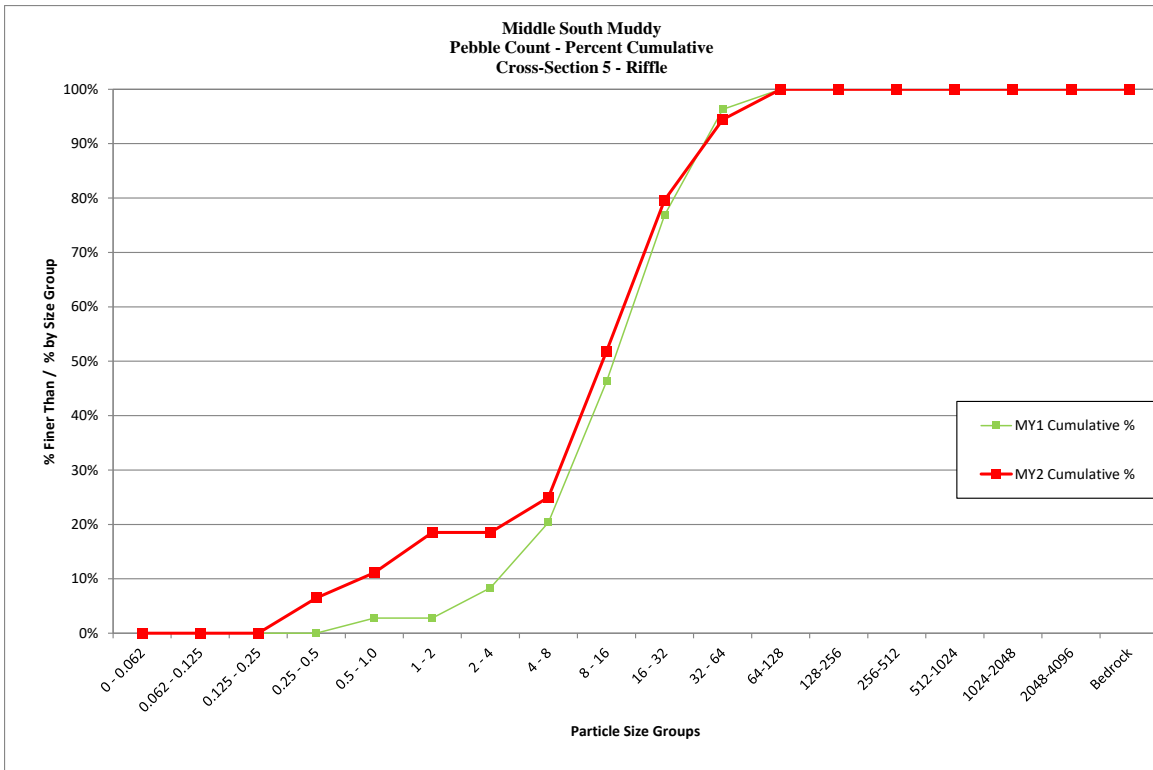
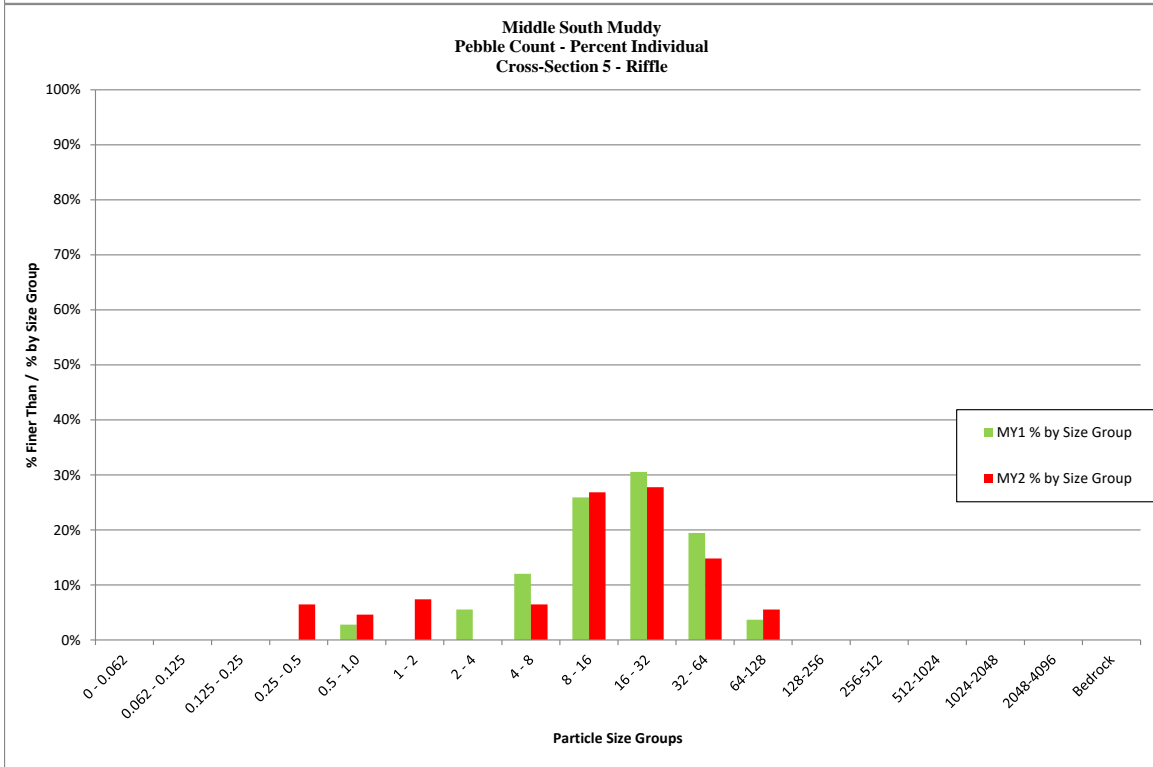
<b>Middle South Muddy</b>			
<b>Cross Section 5 - Riffle</b>			
<b>Monitoring Year - 2017; MY2</b>			
<b>Bed Surface Material Particle Size Class (mm)</b>	<b>Number</b>	<b>% Individual</b>	<b>% Cumulative</b>
0 - 0.062	0	0.0%	0%
0.062 - 0.125	0	0.0%	0%
0.125 - 0.25	0	0.0%	0%
0.25 - 0.5	7	6.5%	6%
0.5 - 1.0	5	4.6%	11%
1 - 2	8	7.4%	19%
2 - 4	0	0.0%	19%
4 - 8	7	6.5%	25%
8 - 16	29	26.9%	52%
16 - 32	30	27.8%	80%
32 - 64	16	14.8%	94%
64-128	6	5.6%	100%
128-256	0	0.0%	100%
256-512	0	0.0%	100%
512-1024	0	0.0%	100%
1024-2048	0	0.0%	100%
2048-4096	0	0.0%	100%
Bedrock	0	0.0%	100%
<b>Total</b>	<b>108</b>	<b>100%</b>	<b>100%</b>
		<b>Summary Data</b>	
		<b>D50</b>	<b>15</b>
		<b>D84</b>	<b>38</b>
		<b>D95</b>	<b>69</b>

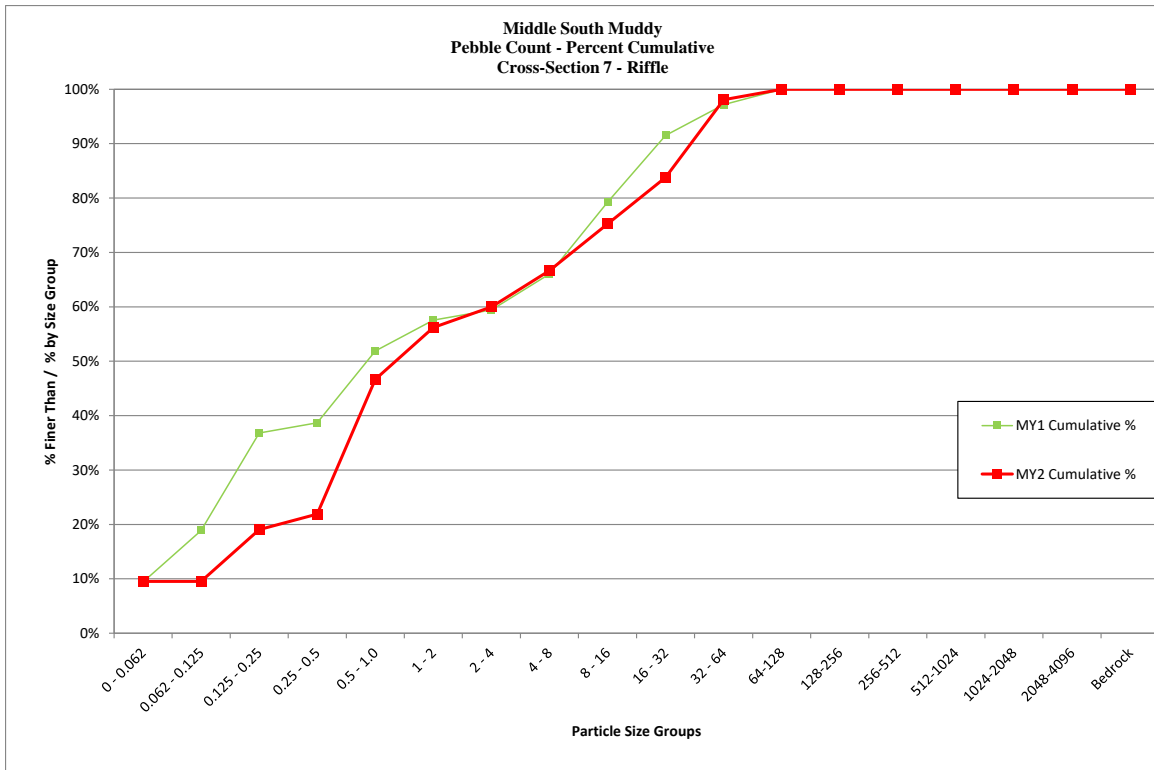
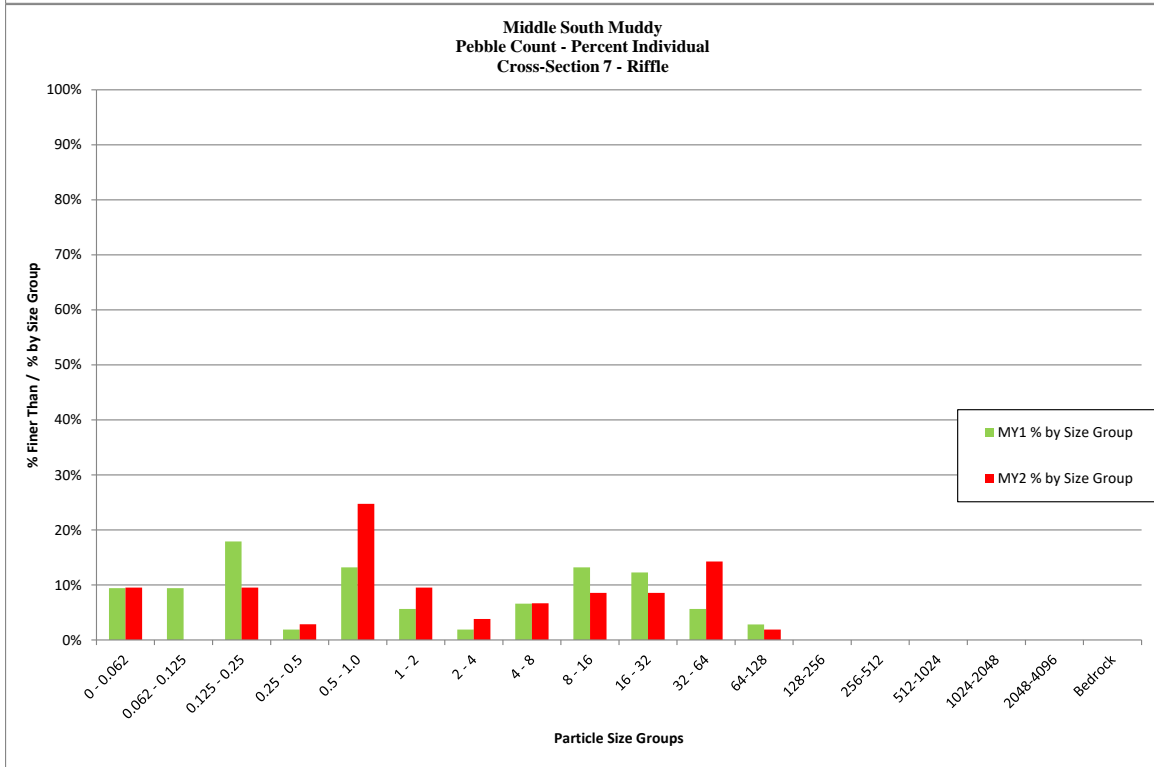
<b>Middle South Muddy</b>			
<b>Cross Section 7 - Riffle</b>			
<b>Monitoring Year - 2017; MY2</b>			
<b>Bed Surface Material Particle Size Class (mm)</b>	<b>Number</b>	<b>% Individual</b>	<b>% Cumulative</b>
0 - 0.062	10	9.5%	10%
0.062 - 0.125	0	0.0%	10%
0.125 - 0.25	10	9.5%	19%
0.25 - 0.5	3	2.9%	22%
0.5 - 1.0	26	24.8%	47%
1 - 2	10	9.5%	56%
2 - 4	4	3.8%	60%
4 - 8	7	6.7%	67%
8 - 16	9	8.6%	75%
16 - 32	9	8.6%	84%
32 - 64	15	14.3%	98%
64-128	2	1.9%	100%
128-256	0	0.0%	100%
256-512	0	0.0%	100%
512-1024	0	0.0%	100%
1024-2048	0	0.0%	100%
2048-4096	0	0.0%	100%
Bedrock	0	0.0%	100%
<b>Total</b>	<b>105</b>	<b>100%</b>	<b>100%</b>
		<b>Summary Data</b>	
		<b>D50</b>	<b>1.3</b>
		<b>D84</b>	<b>32</b>
		<b>D95</b>	<b>51</b>
