Annual Monitoring Report

Monitoring Year 4 of 5

Middle South Muddy Stream Restoration Site

McDowell County, North Carolina

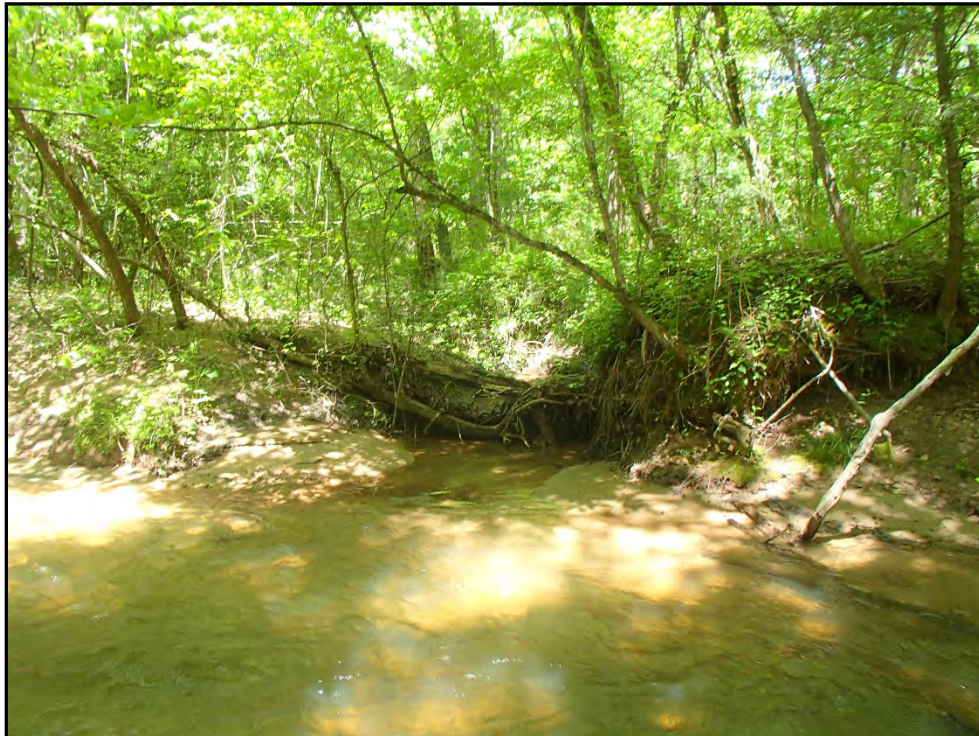
Haney Tract – Permanent Photo Station 28
Looking Downstream South Muddy Creek

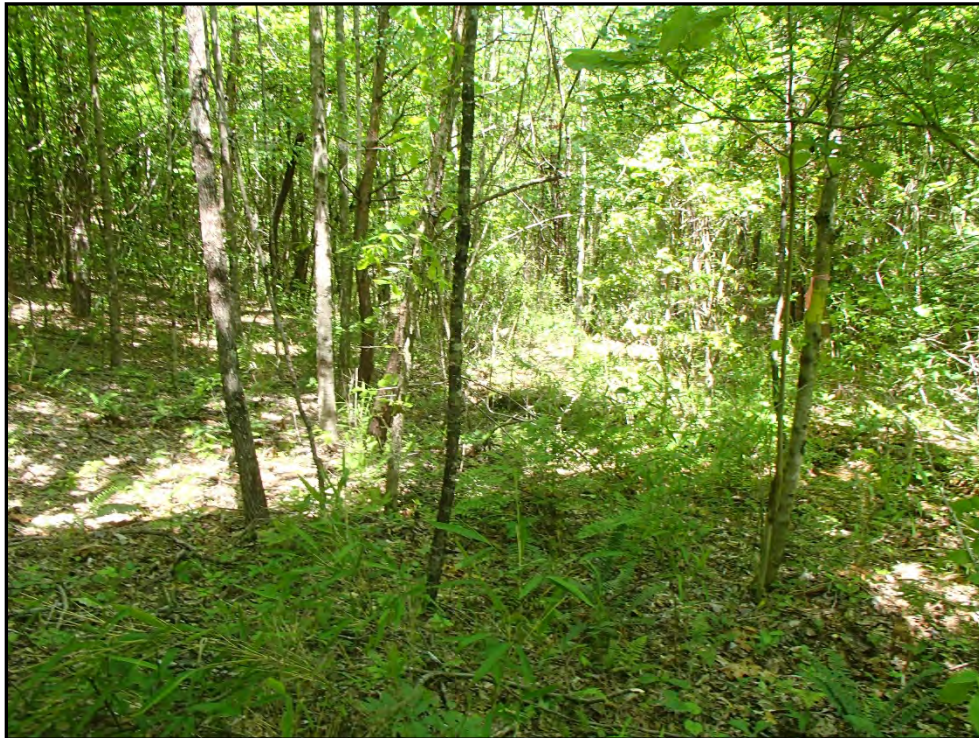
Haney Tract – Permanent Photo Station 29
Looking Upstream South Muddy Creek
