Annual Monitoring Report

Monitoring Year 5 of 5

Middle South Muddy Stream Restoration Site

NCDMS Project No.: 93875

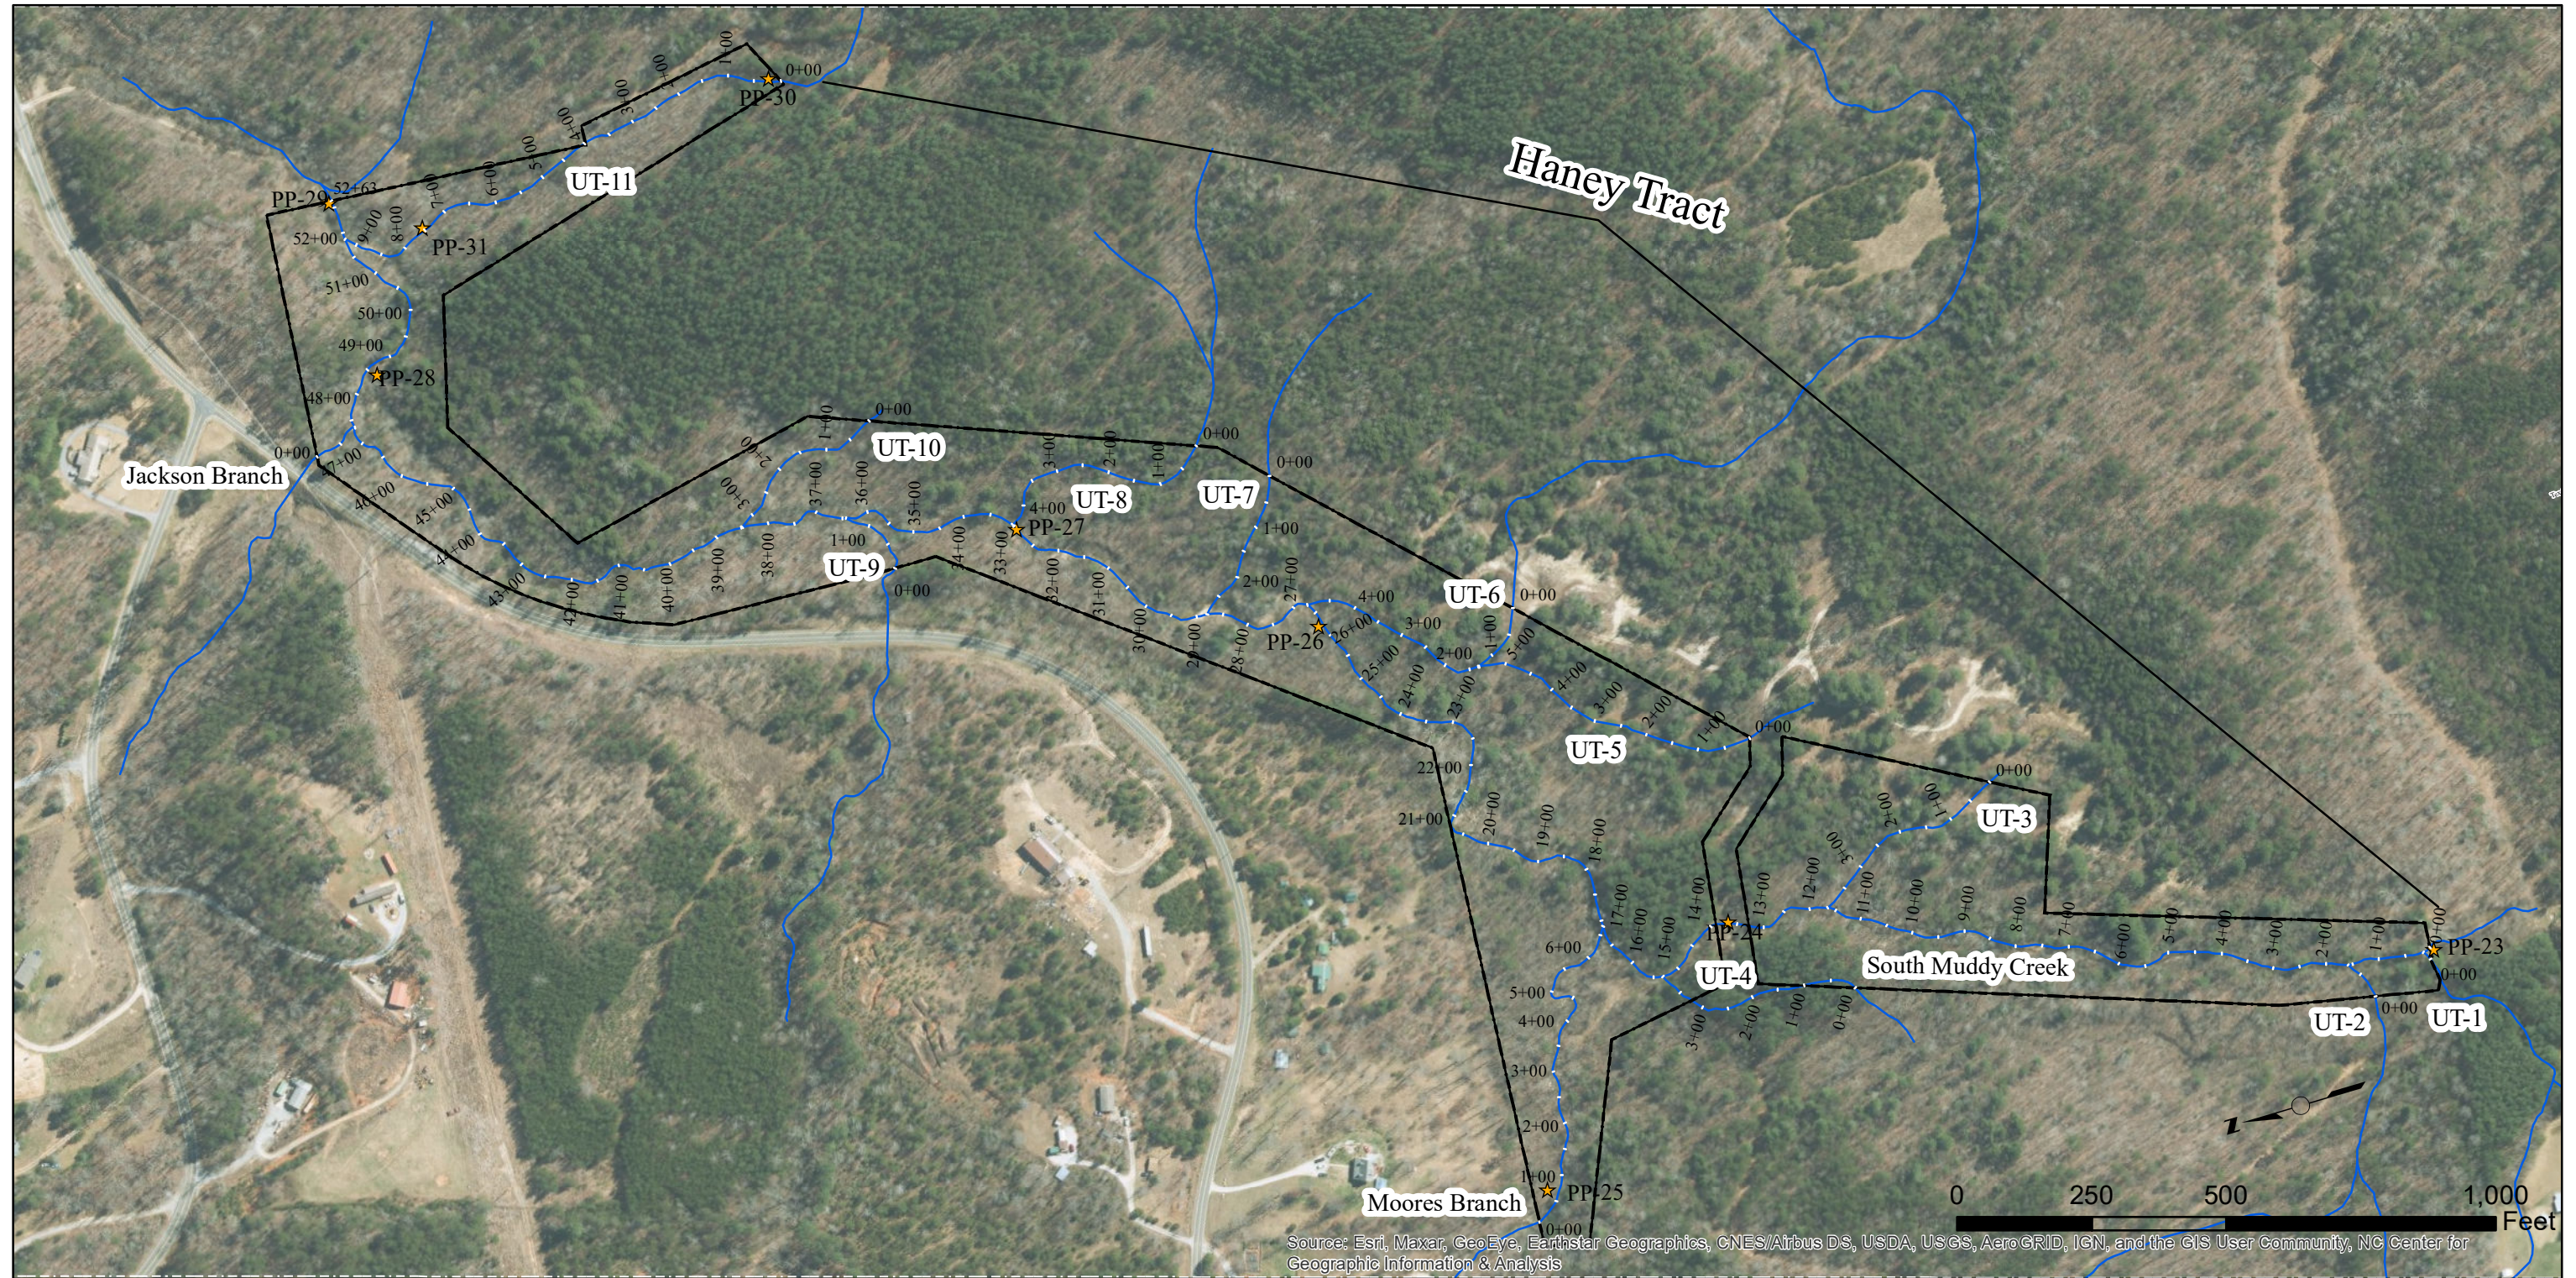
Figure 2. Integrated Current Condition Plan View

Visual assessment of the stream channel was performed to document signs of instability, such as eroding banks, structural instability, or excessive sedimentation. Sprouse Branch has remained stable throughout the project. Changes in pool depths and spacing were noted but have remained transient in nature. A persistent problem area was noted on South Muddy Creek since MY3 and is associated with the structure at STA 108+83. The exposure of the backer log and filter fabric which resulted in piping through the structure. The structure has remained stable into MY5, but increased stress on the right bank has resulted in scouring of the bankfull bench approximately 25 feet downstream (Table 5). Material from the failed structure on Iva Branch (Station 303+67) has cleared from the riffle at STA 303+75 and has migrated to Station 304+62 (Appendix D: Iva Branch Longitudinal Profile). Problem areas on Iva Branch noted in the MY3 and MY4 reports remain but have not worsened into MY5.
