# Annual Monitoring Report

Mill Dam Creek Restoration Site  
Yadkin River Basin - 03040101  
Monitoring Year 03  
DEQ Contract 6898  
DMS Project Number 97136  
DMS RFP No. 16-006706 (Date of Issue: October 21, 2015)

DWR #: 18-1349  
USACE Action ID: 2016-01335  
Yadkin County, North Carolina

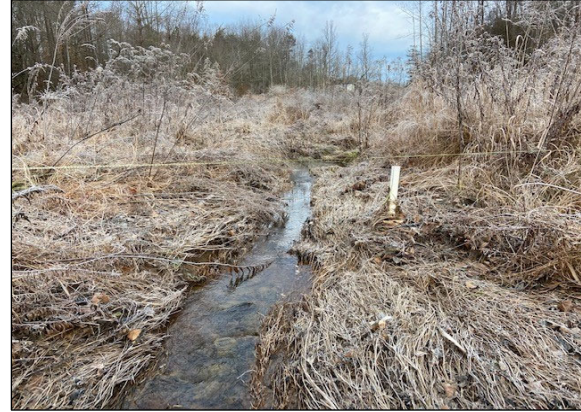
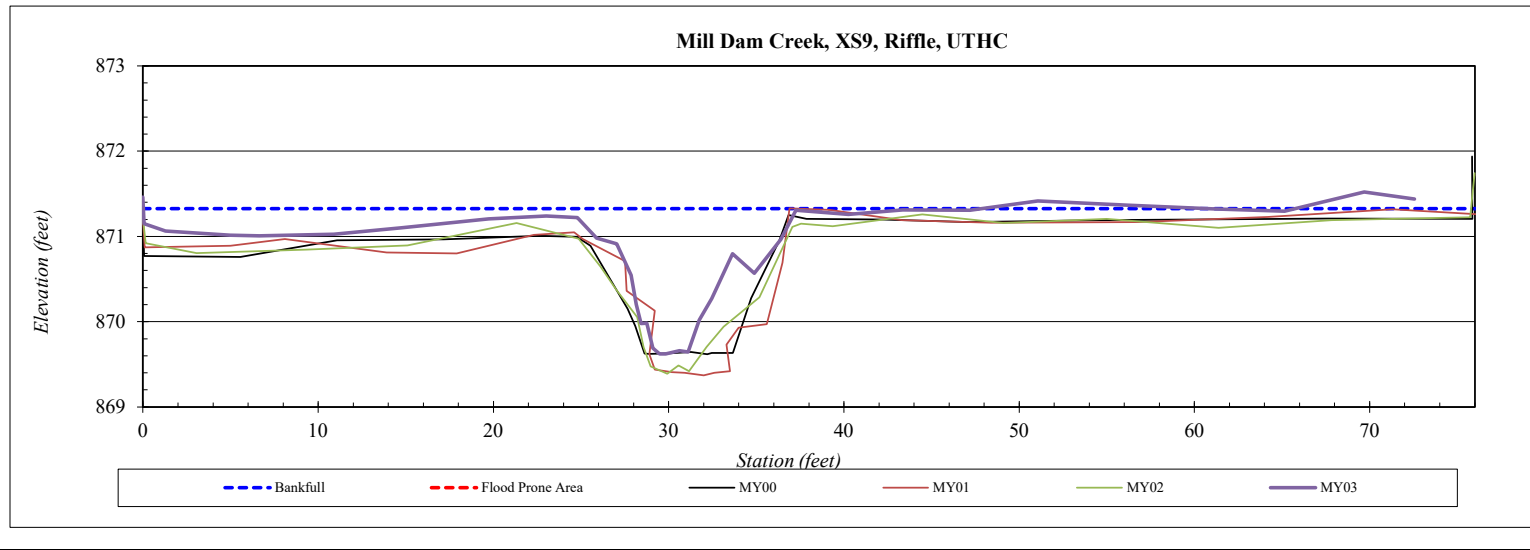
\*Cross-section located in an area that was repaired in MY1 (July 2021).

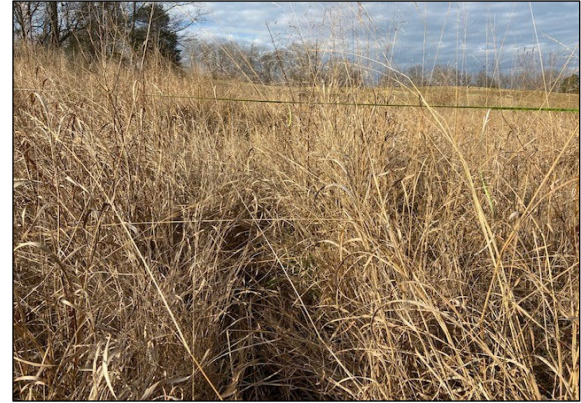
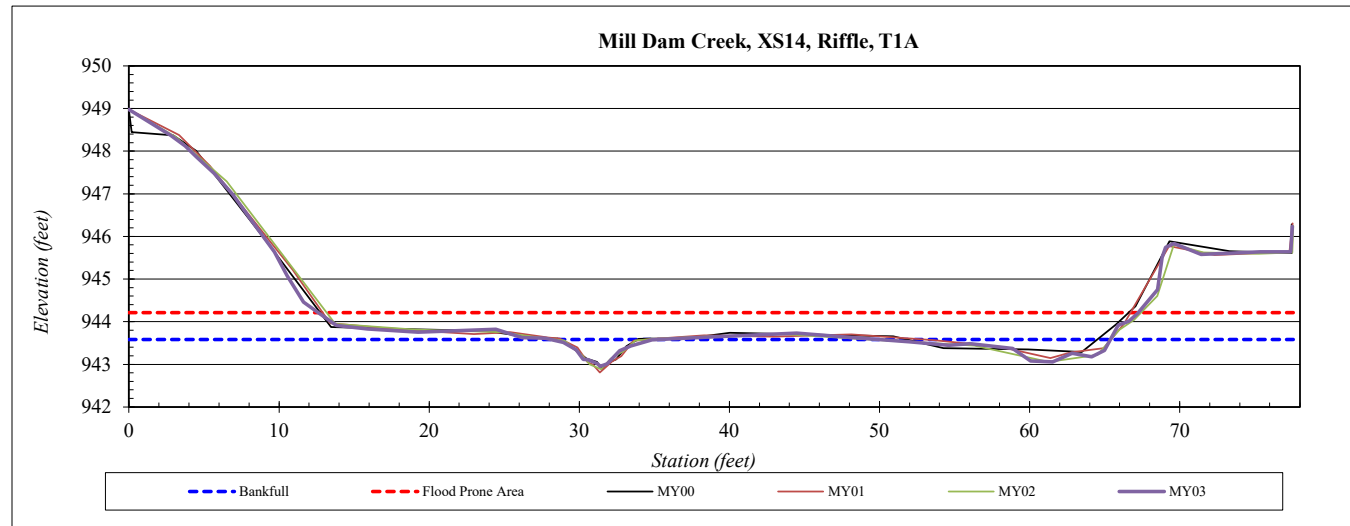
\*Cross-section located in an area that was repaired in MY1 (July 2021).

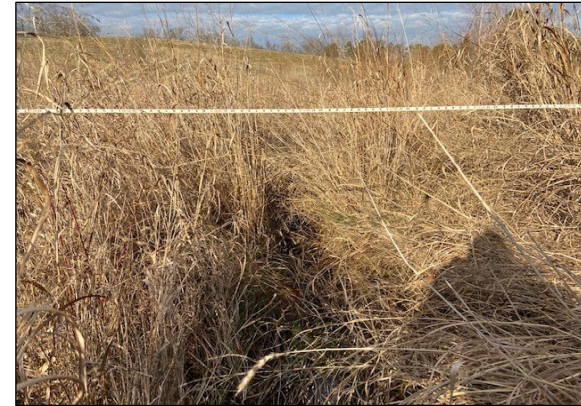
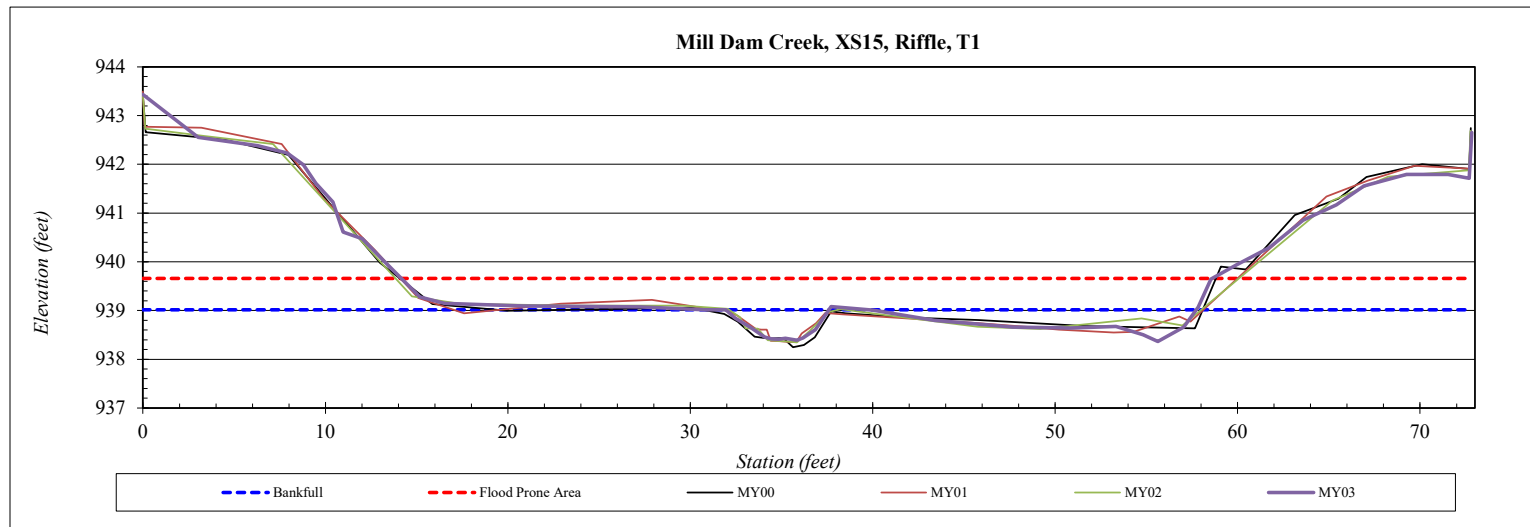
<b>River Basin:</b>	Yadkin River
<b>Site:</b>	Mill Dam Creek
<b>XS ID</b>	XS15
<b>Drainage Area (sq mi):</b>	0.07
<b>Date:</b>	1/11/2023
<b>Field Crew:</b>	KB, JS

SUMMARY DATA	
<b>Bankfull Elevation (ft) - Based on AB-Bankfull Area</b>	939.01
<b>Bankfull Cross-Sectional Area:</b>	2.3
<b>Total Cross-Sectional Area:</b>	1.9
<b>Bankfull Width:</b>	5.6
<b>Flood Prone Area Elevation:</b>	939.66
<b>Flood Prone Width:</b>	44.4
<b>Max Depth at Bankfull:</b>	0.6
<b>Mean Depth at Bankfull:</b>	0.4
<b>W / D Ratio:</b>	13.5
<b>Entrenchment Ratio:</b>	7.9
<b>Bank Height Ratio:</b>	1.0
<b>Thalweg Elevation:</b>	938.37

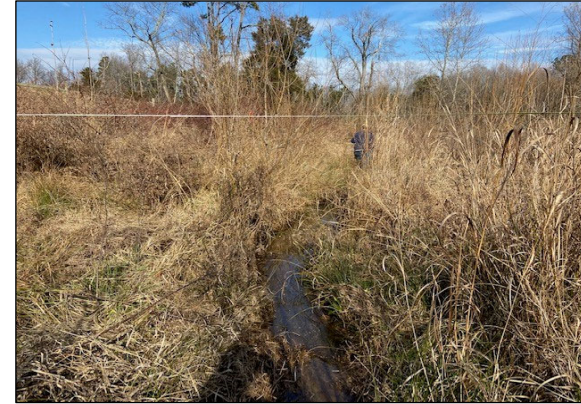
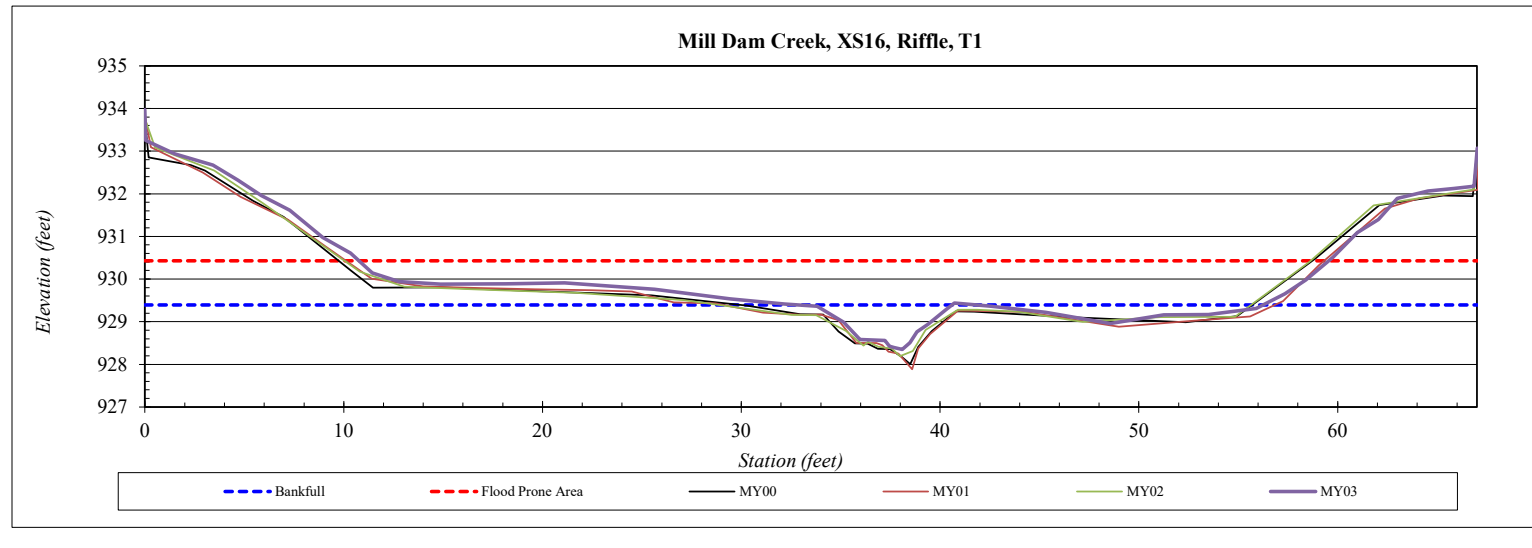
<b>River Basin:</b>	Yadkin River
<b>Site:</b>	Mill Dam Creek
<b>XS ID</b>	XS16
<b>Drainage Area (sq mi):</b>	0.07
<b>Date:</b>	1/11/2023
<b>Field Crew:</b>	KB, JS

SUMMARY DATA	
<b>Bankfull Elevation (ft) - Based on AB-Bankfull Area</b>	929.39
<b>Bankfull Cross-Sectional Area:</b>	3.9
<b>Total Cross-Sectional Area:</b>	2.5
<b>Bankfull Width:</b>	6.8
<b>Flood Prone Area Elevation:</b>	930.43
<b>Flood Prone Width:</b>	48.8
<b>Max Depth at Bankfull:</b>	1.0
<b>Mean Depth at Bankfull:</b>	0.6
<b>W / D Ratio:</b>	11.9
<b>Entrenchment Ratio:</b>	7.2
<b>Bank Height Ratio:</b>	0.9
<b>Thalweg Elevation:</b>	928.35

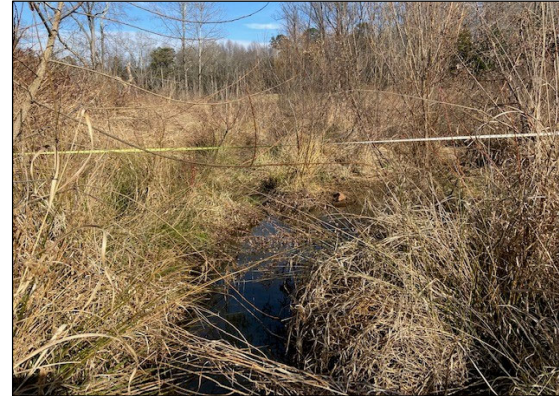
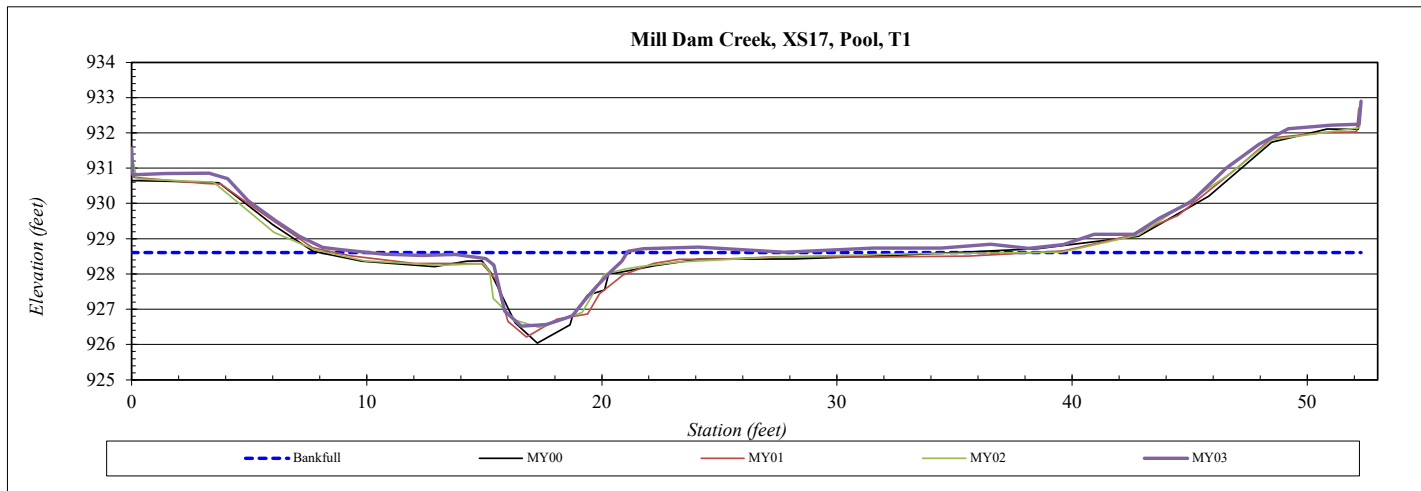
<b>River Basin:</b>	Yadkin River
<b>Site:</b>	Mill Dam Creek
<b>XS ID</b>	XS17
<b>Drainage Area (sq mi):</b>	0.07
<b>Date:</b>	1/11/2023
<b>Field Crew:</b>	KB, JS

SUMMARY DATA	
<b>Bankfull Elevation (ft) - Based on AB-Bankfull Area</b>	928.61
<b>Bankfull Cross-Sectional Area:</b>	8.3
<b>Total Cross-Sectional Area:</b>	6.9
<b>Bankfull Width:</b>	6.0
<b>Flood Prone Area Elevation:</b>	---
<b>Flood Prone Width:</b>	---
<b>Max Depth at Bankfull:</b>	2.1
<b>Mean Depth at Bankfull:</b>	1.4
<b>W / D Ratio:</b>	---
<b>Entrenchment Ratio:</b>	---
<b>Bank Height Ratio:</b>	---
<b>Thalweg Elevation:</b>	926.52

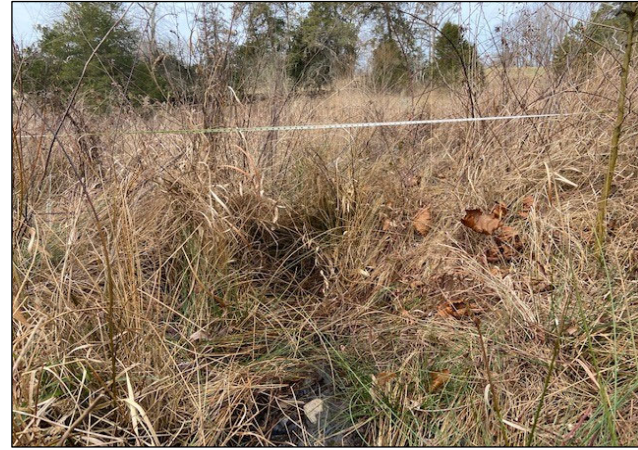
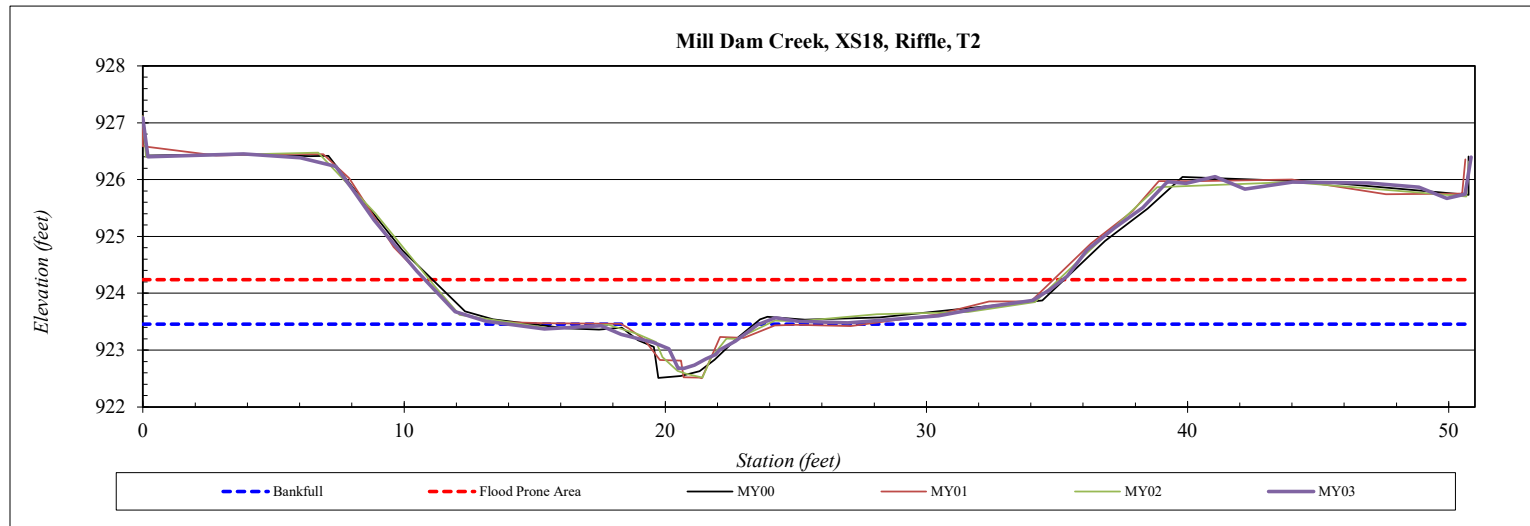
<b>River Basin:</b>	Yadkin River
<b>Site:</b>	Mill Dam Creek
<b>XS ID</b>	XS18
<b>Drainage Area (sq mi):</b>	0.02
<b>Date:</b>	1/11/2023
<b>Field Crew:</b>	KB, JS

SUMMARY DATA	
<b>Bankfull Elevation (ft) - Based on AB-Bankfull Area</b>	923.46
<b>Bankfull Cross-Sectional Area:</b>	2.3
<b>Total Cross-Sectional Area:</b>	1.7
<b>Bankfull Width:</b>	6.1
<b>Flood Prone Area Elevation:</b>	924.24
<b>Flood Prone Width:</b>	24.4
<b>Max Depth at Bankfull:</b>	0.8
<b>Mean Depth at Bankfull:</b>	0.4
<b>W / D Ratio:</b>	16.4
<b>Entrenchment Ratio:</b>	4.0
<b>Bank Height Ratio:</b>	1.0
<b>Thalweg Elevation:</b>	922.68

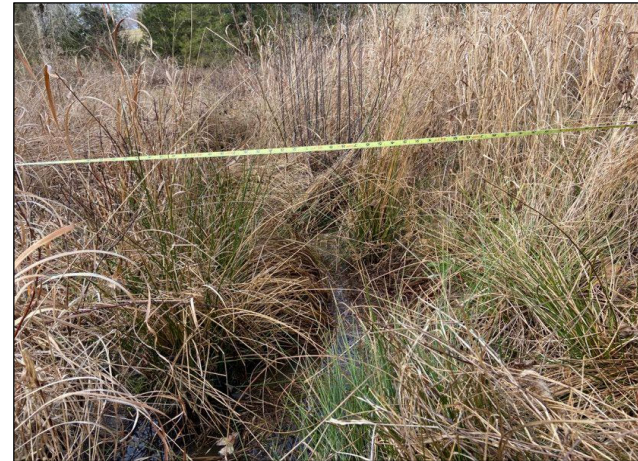
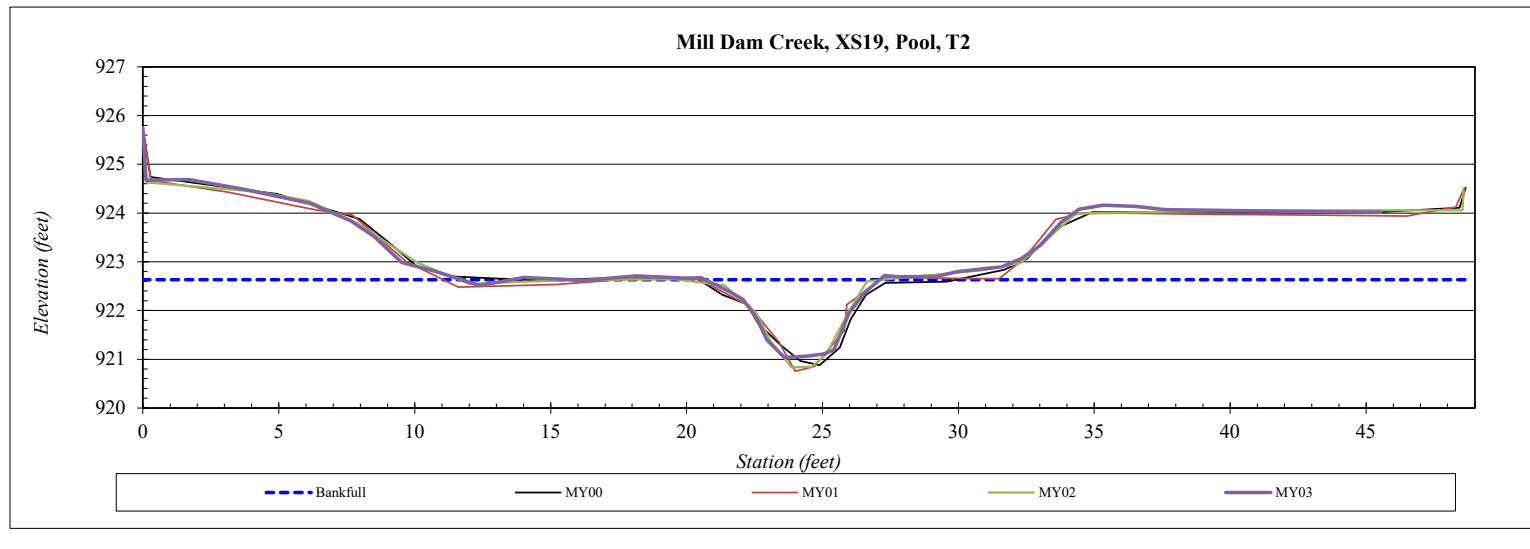
<b>River Basin:</b>	Yadkin River
<b>Site:</b>	Mill Dam Creek
<b>XS ID</b>	XS19
<b>Drainage Area (sq mi):</b>	0.02
<b>Date:</b>	1/11/2023
<b>Field Crew:</b>	KB, JS

SUMMARY DATA	
<b>Bankfull Elevation (ft) - Based on AB-Bankfull Area</b>	922.63
<b>Bankfull Cross-Sectional Area:</b>	5.6
<b>Total Cross-Sectional Area:</b>	5.2
<b>Bankfull Width:</b>	6.4
<b>Flood Prone Area Elevation:</b>	---
<b>Flood Prone Width:</b>	---
<b>Max Depth at Bankfull:</b>	1.6
<b>Mean Depth at Bankfull:</b>	0.9
<b>W / D Ratio:</b>	---
<b>Entrenchment Ratio:</b>	---
<b>Bank Height Ratio:</b>	---
<b>Thalweg Elevation:</b>	921.04

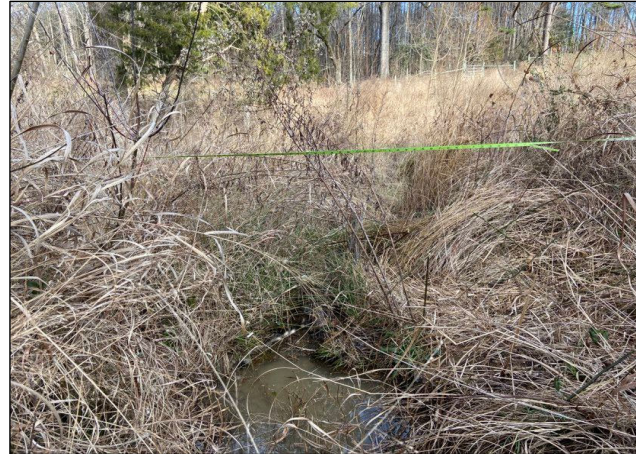
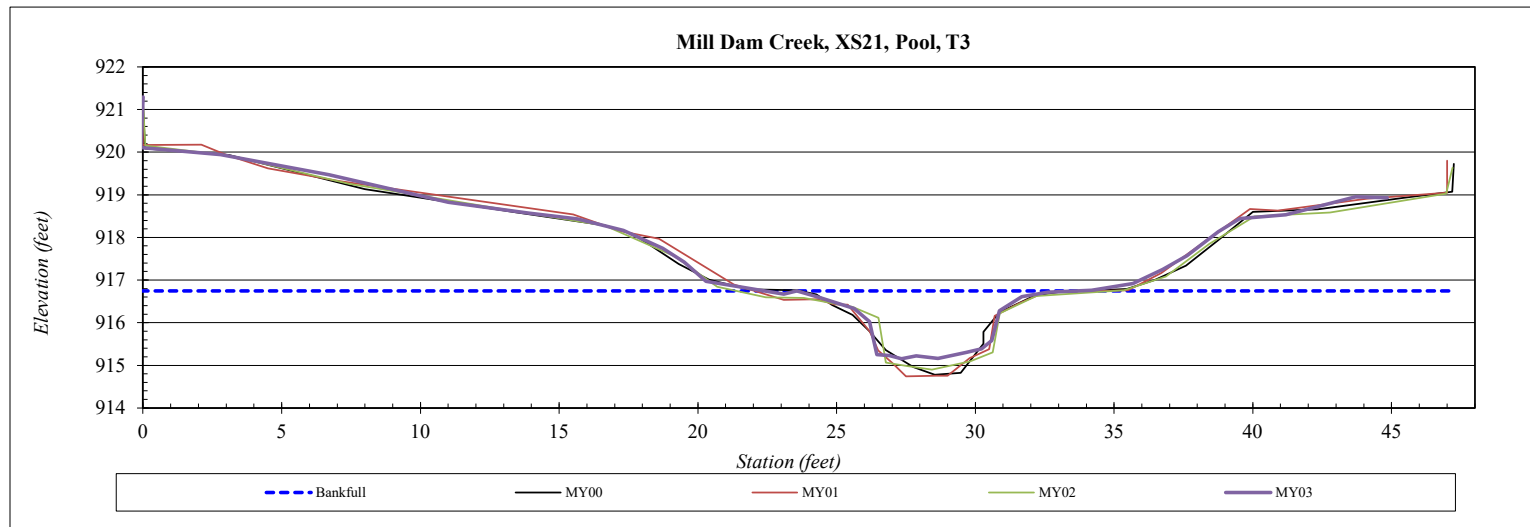
<b>River Basin:</b>	Yadkin River
<b>Site:</b>	Mill Dam Creek
<b>XS ID</b>	XS21
<b>Drainage Area (sq mi):</b>	0.01
<b>Date:</b>	1/10/2023
<b>Field Crew:</b>	KB, JS

SUMMARY DATA	
<b>Bankfull Elevation (ft) - Based on AB-Bankfull Area</b>	916.74
<b>Bankfull Cross-Sectional Area:</b>	7.7
<b>Total Cross-Sectional Area:</b>	6.8
<b>Bankfull Width:</b>	9.3
<b>Flood Prone Area Elevation:</b>	---
<b>Flood Prone Width:</b>	---
<b>Max Depth at Bankfull:</b>	1.6
<b>Mean Depth at Bankfull:</b>	0.8
<b>W / D Ratio:</b>	---
<b>Entrenchment Ratio:</b>	---
<b>Bank Height Ratio:</b>	---
<b>Thalweg Elevation:</b>	915.15

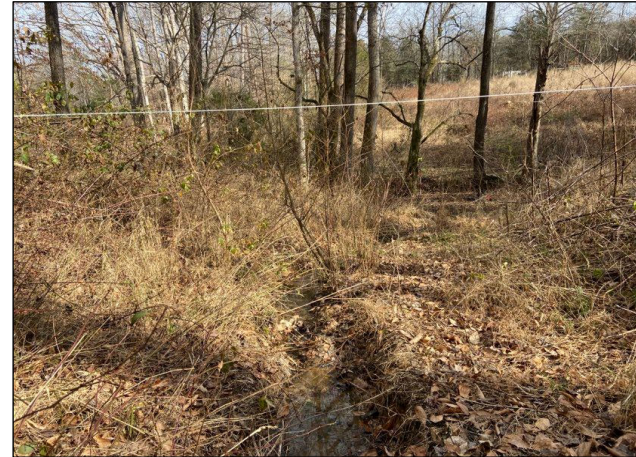
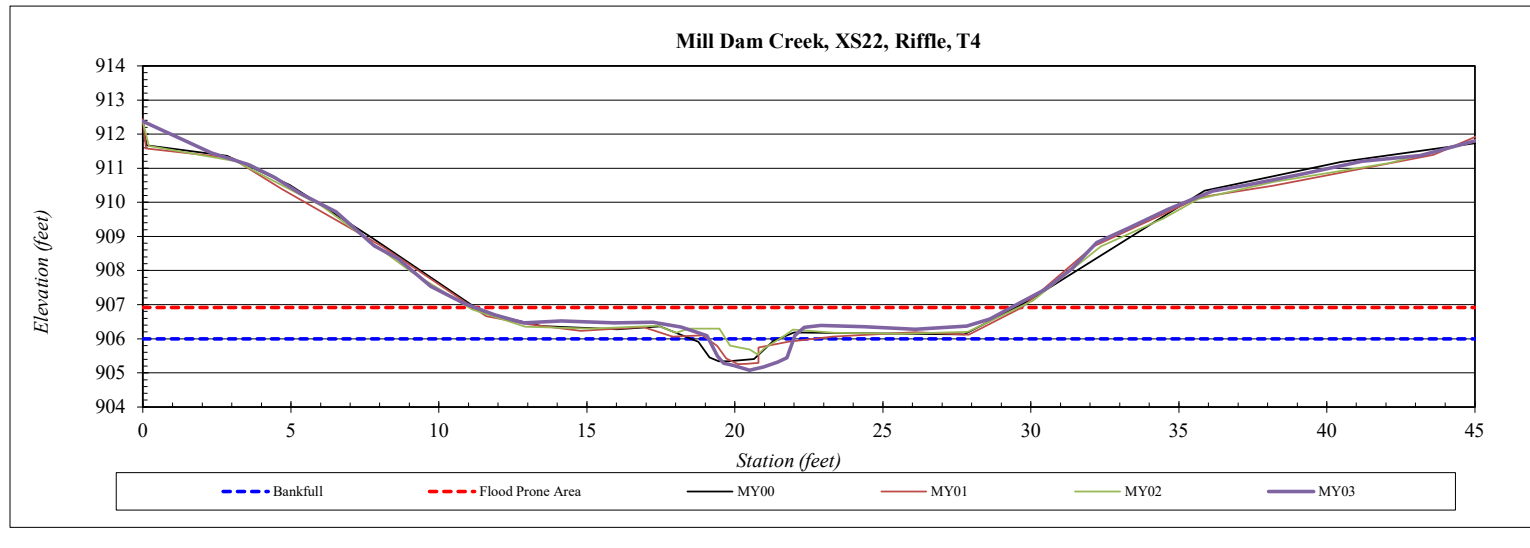
<b>River Basin:</b>	Yadkin River
<b>Site:</b>	Mill Dam Creek
<b>XS ID</b>	XS22
<b>Drainage Area (sq mi):</b>	0.01
<b>Date:</b>	1/10/2023
<b>Field Crew:</b>	KB, JS

SUMMARY DATA	
<b>Bankfull Elevation (ft) - Based on AB-Bankfull Area</b>	906.00
<b>Bankfull Cross-Sectional Area:</b>	1.9
<b>Total Cross-Sectional Area:</b>	2.5
<b>Bankfull Width:</b>	2.9
<b>Flood Prone Area Elevation:</b>	906.91
<b>Flood Prone Width:</b>	18.1
<b>Max Depth at Bankfull:</b>	0.9
<b>Mean Depth at Bankfull:</b>	0.7
<b>W / D Ratio:</b>	4.3
<b>Entrenchment Ratio:</b>	6.3
<b>Bank Height Ratio:</b>	1.1
<b>Thalweg Elevation:</b>	905.08

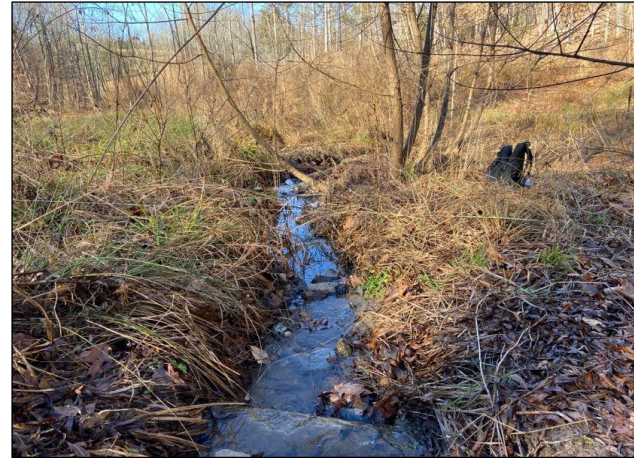
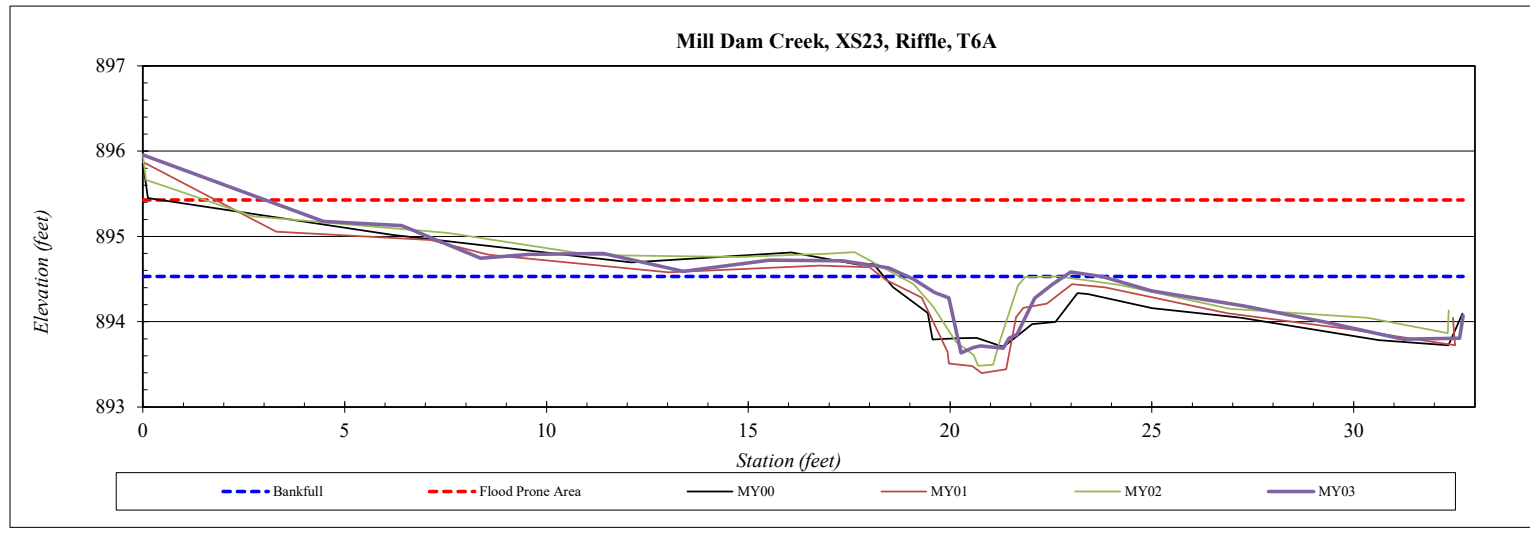
<b>River Basin:</b>	Yadkin River
<b>Site:</b>	Mill Dam Creek
<b>XS ID</b>	XS23
<b>Drainage Area (sq mi):</b>	0.01
<b>Date:</b>	1/10/2023
<b>Field Crew:</b>	KB, JS

SUMMARY DATA	
<b>Bankfull Elevation (ft) - Based on AB-Bankfull Area</b>	894.53
<b>Bankfull Cross-Sectional Area:</b>	1.7
<b>Total Cross-Sectional Area:</b>	1.1
<b>Bankfull Width:</b>	3.9
<b>Flood Prone Area Elevation:</b>	895.43
<b>Flood Prone Width:</b>	29.7
<b>Max Depth at Bankfull:</b>	0.9
<b>Mean Depth at Bankfull:</b>	0.4
<b>W / D Ratio:</b>	8.7
<b>Entrenchment Ratio:</b>	7.7
<b>Bank Height Ratio:</b>	1.1
<b>Thalweg Elevation:</b>	893.63

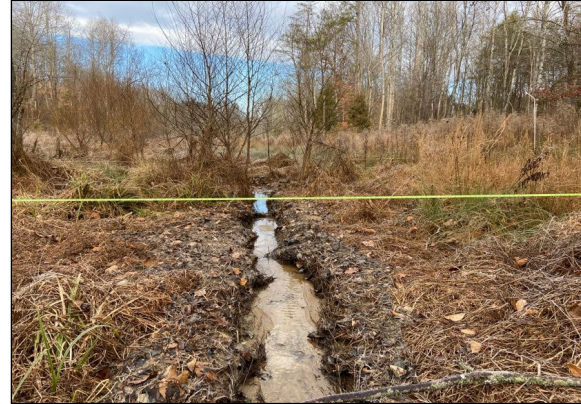
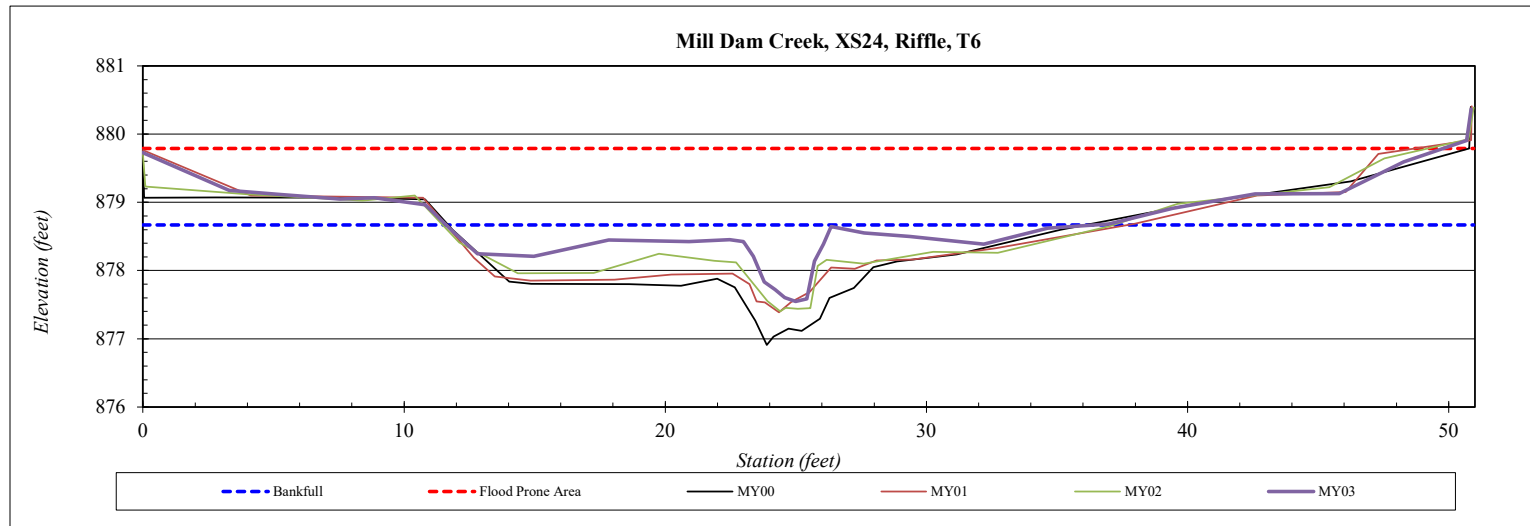
<b>River Basin:</b>	Yadkin River
<b>Site:</b>	Mill Dam Creek
<b>XS ID</b>	XS24
<b>Drainage Area (sq mi):</b>	0.07
<b>Date:</b>	1/10/2023
<b>Field Crew:</b>	KB, JS

SUMMARY DATA	
<b>Bankfull Elevation (ft) - Based on AB-Bankfull Area</b>	878.67
<b>Bankfull Cross-Sectional Area:</b>	2.6
<b>Total Cross-Sectional Area:</b>	0.4
<b>Bankfull Width:</b>	3.9
<b>Flood Prone Area Elevation:</b>	879.79
<b>Flood Prone Width:</b>	49.8
<b>Max Depth at Bankfull:</b>	1.1
<b>Mean Depth at Bankfull:</b>	0.7
<b>W / D Ratio:</b>	5.8
<b>Entrenchment Ratio:</b>	12.8
<b>Bank Height Ratio:</b>	0.8
<b>Thalweg Elevation:</b>	877.55

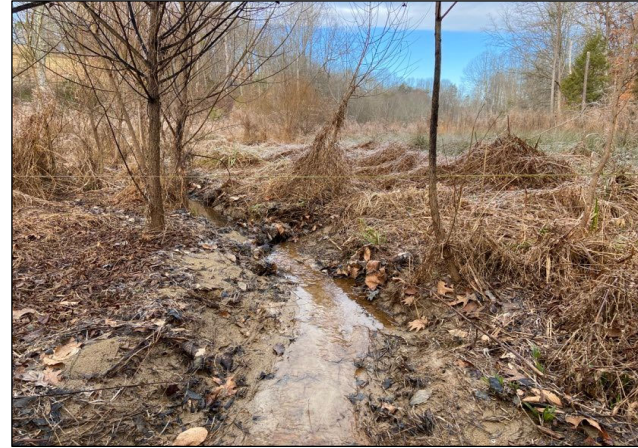
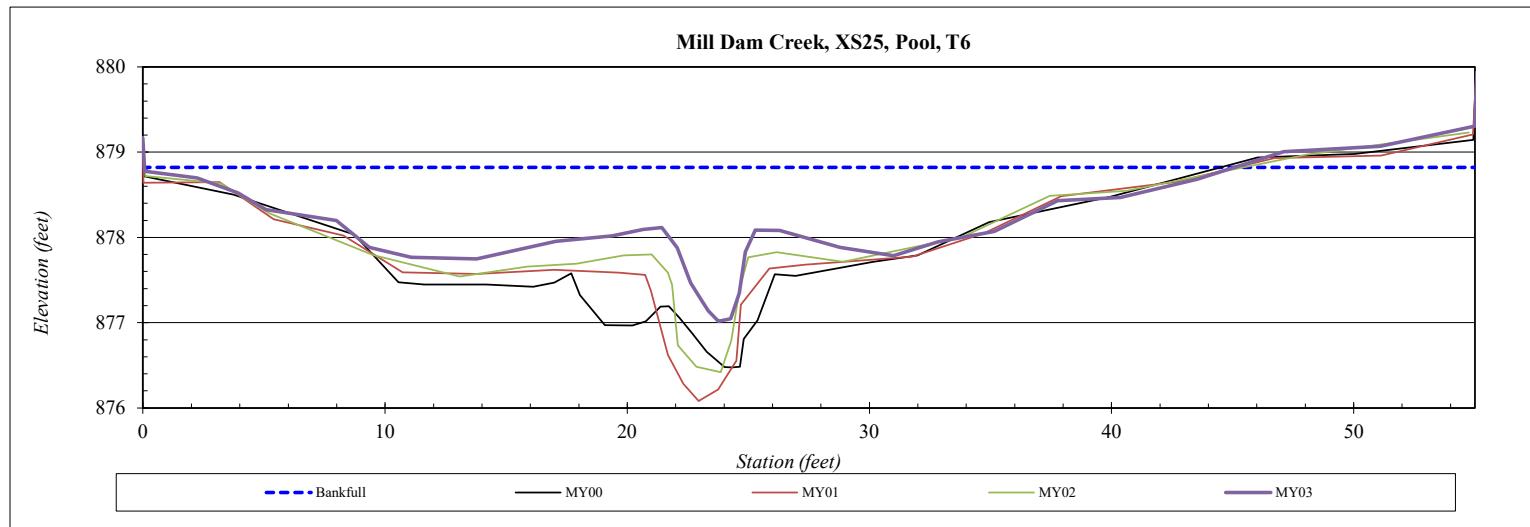
<b>River Basin:</b>	Yadkin River
<b>Site:</b>	Mill Dam Creek
<b>XS ID</b>	XS25
<b>Drainage Area (sq mi):</b>	0.07
<b>Date:</b>	1/10/2023
<b>Field Crew:</b>	KB, JS

SUMMARY DATA	
<b>Bankfull Elevation (ft) - Based on AB-Bankfull Area</b>	878.82
<b>Bankfull Cross-Sectional Area:</b>	5.1
<b>Total Cross-Sectional Area:</b>	0.8
<b>Bankfull Width:</b>	3.8
<b>Flood Prone Area Elevation:</b>	---
<b>Flood Prone Width:</b>	---
<b>Max Depth at Bankfull:</b>	1.8
<b>Mean Depth at Bankfull:</b>	1.3
<b>W / D Ratio:</b>	---
<b>Entrenchment Ratio:</b>	---
<b>Bank Height Ratio:</b>	---
<b>Thalweg Elevation:</b>	877.02

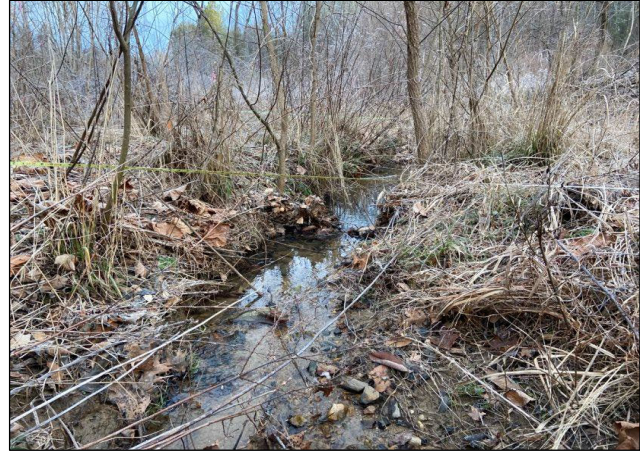
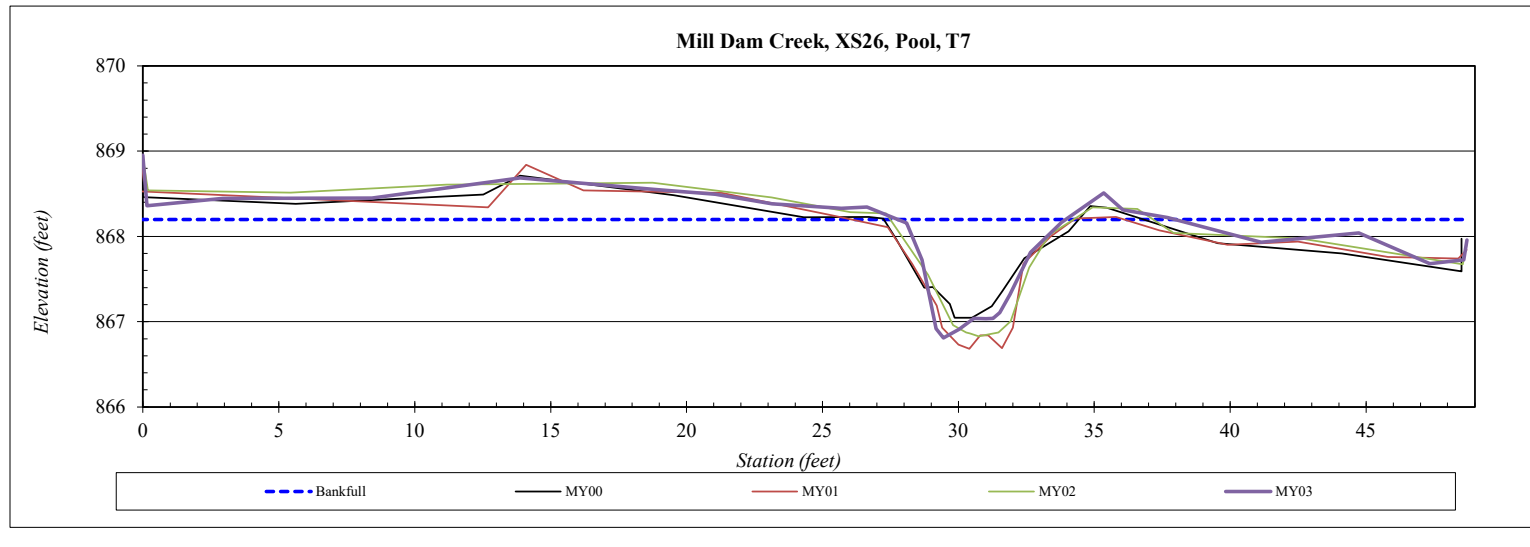
<b>River Basin:</b>	Yadkin River
<b>Site:</b>	Mill Dam Creek
<b>XS ID</b>	XS26
<b>Drainage Area (sq mi):</b>	0.07
<b>Date:</b>	1/10/2023
<b>Field Crew:</b>	KB, JS

SUMMARY DATA	
<b>Bankfull Elevation (ft) - Based on AB-Bankfull Area</b>	868.20
<b>Bankfull Cross-Sectional Area:</b>	4.6
<b>Total Cross-Sectional Area:</b>	4.7
<b>Bankfull Width:</b>	6.2
<b>Flood Prone Area Elevation:</b>	---
<b>Flood Prone Width:</b>	---
<b>Max Depth at Bankfull:</b>	1.4
<b>Mean Depth at Bankfull:</b>	0.7
<b>W / D Ratio:</b>	---
<b>Entrenchment Ratio:</b>	---
<b>Bank Height Ratio:</b>	---
<b>Thalweg Elevation:</b>	866.81

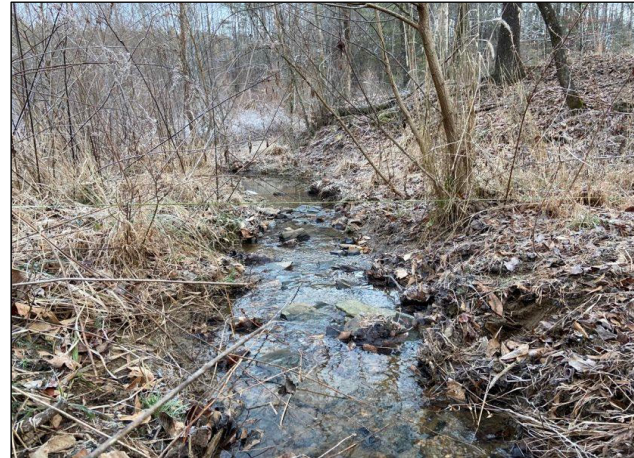
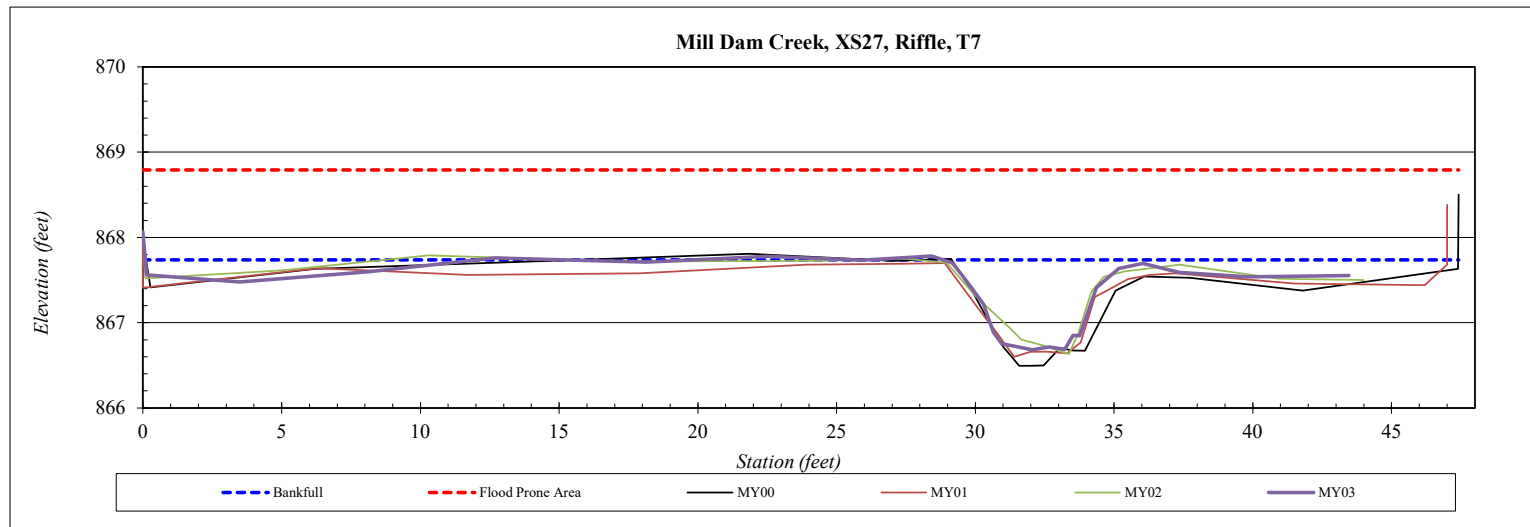
<b>River Basin:</b>	Yadkin River
<b>Site:</b>	Mill Dam Creek
<b>XS ID</b>	XS27
<b>Drainage Area (sq mi):</b>	0.07
<b>Date:</b>	1/10/2023
<b>Field Crew:</b>	KB, JS

SUMMARY DATA	
<b>Bankfull Elevation (ft) - Based on AB-Bankfull Area</b>	867.74
<b>Bankfull Cross-Sectional Area:</b>	4.3
<b>Total Cross-Sectional Area:</b>	3.1
<b>Bankfull Width:</b>	7.2
<b>Flood Prone Area Elevation:</b>	868.79
<b>Flood Prone Width:</b>	43.5
<b>Max Depth at Bankfull:</b>	1.1
<b>Mean Depth at Bankfull:</b>	0.6
<b>W / D Ratio:</b>	12.1
<b>Entrenchment Ratio:</b>	6.1
<b>Bank Height Ratio:</b>	1.0
<b>Thalweg Elevation:</b>	866.68

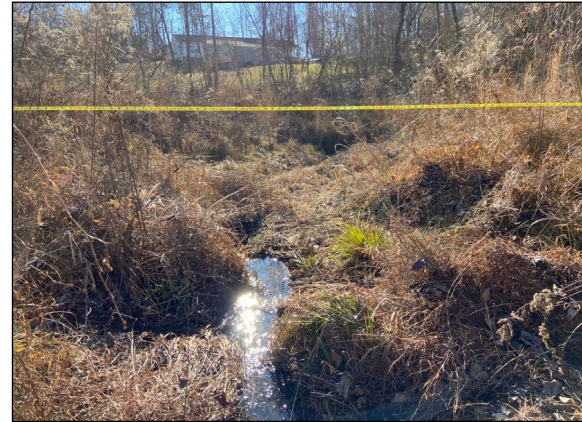
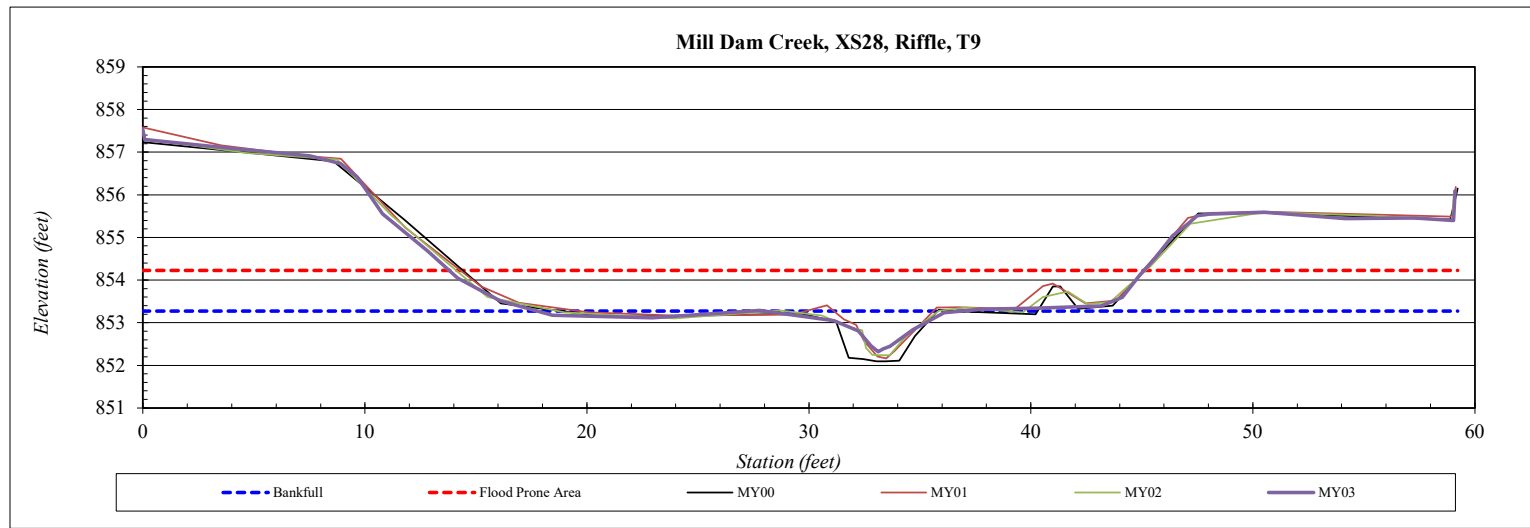
SUMMARY DATA	
<b>Bankfull Elevation (ft) - Based on AB-Bankfull Area</b>	853.27
<b>Bankfull Cross-Sectional Area:</b>	2.8
<b>Total Cross-Sectional Area:</b>	1.3
<b>Bankfull Width:</b>	8.1
<b>Flood Prone Area Elevation:</b>	854.22
<b>Flood Prone Width:</b>	31.3
<b>Max Depth at Bankfull:</b>	1.0
<b>Mean Depth at Bankfull:</b>	0.3
<b>W / D Ratio:</b>	23.1
<b>Entrenchment Ratio:</b>	3.9
<b>Bank Height Ratio:</b>	0.8
<b>Thalweg Elevation:</b>	852.32

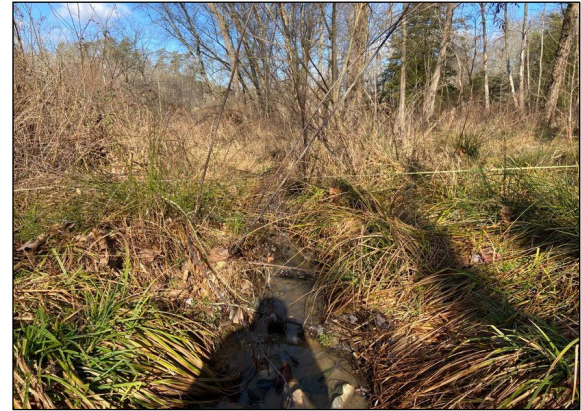
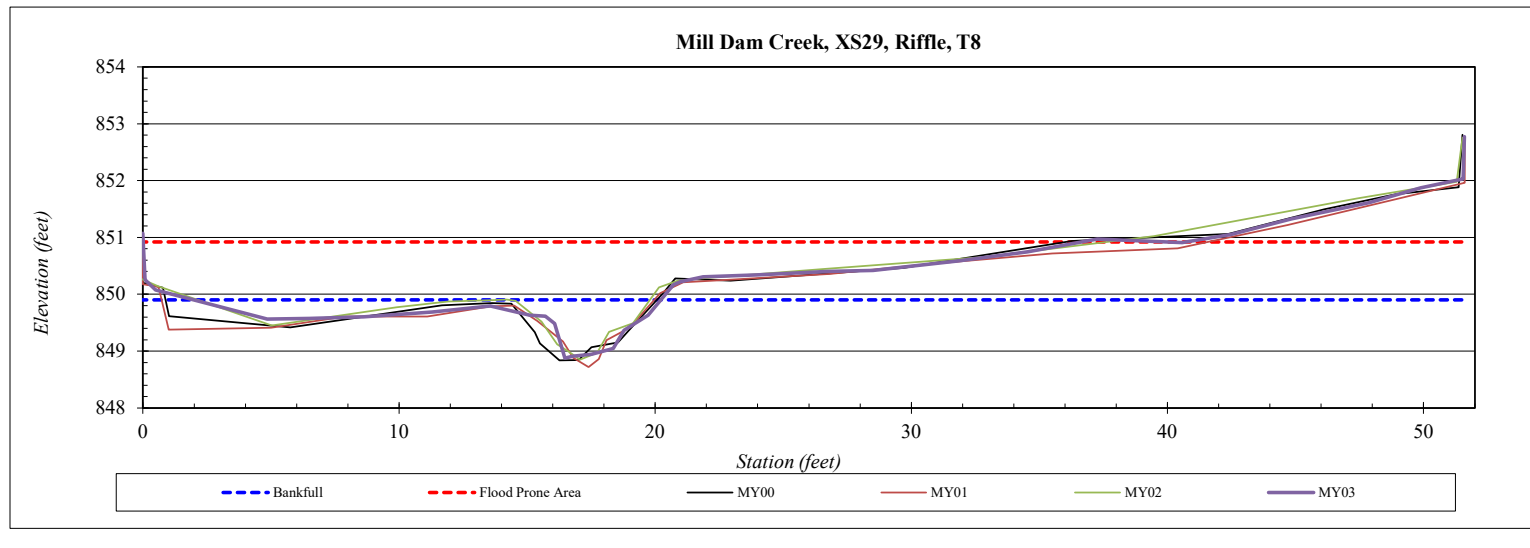
<b>River Basin:</b>	Yadkin River
<b>Site:</b>	Mill Dam Creek
<b>XS ID</b>	XS29
<b>Drainage Area (sq mi):</b>	0.03
<b>Date:</b>	1/9/2023
<b>Field Crew:</b>	KB, JS

SUMMARY DATA	
<b>Bankfull Elevation (ft) - Based on AB-Bankfull Area</b>	849.90
<b>Bankfull Cross-Sectional Area:</b>	3.4
<b>Total Cross-Sectional Area:</b>	2.9
<b>Bankfull Width:</b>	6.7
<b>Flood Prone Area Elevation:</b>	850.92
<b>Flood Prone Width:</b>	37.3
<b>Max Depth at Bankfull:</b>	1.0
<b>Mean Depth at Bankfull:</b>	0.5
<b>W / D Ratio:</b>	13.1
<b>Entrenchment Ratio:</b>	5.6
<b>Bank Height Ratio:</b>	0.9
<b>Thalweg Elevation:</b>	848.88

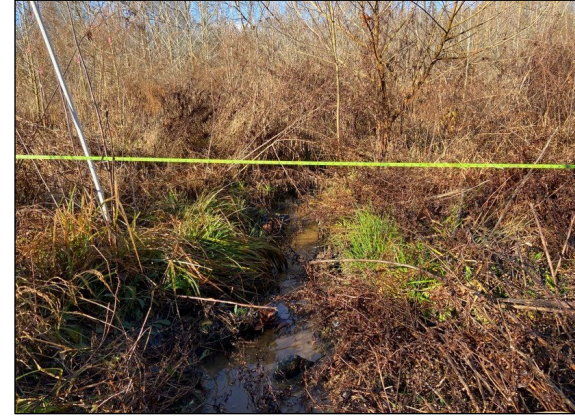
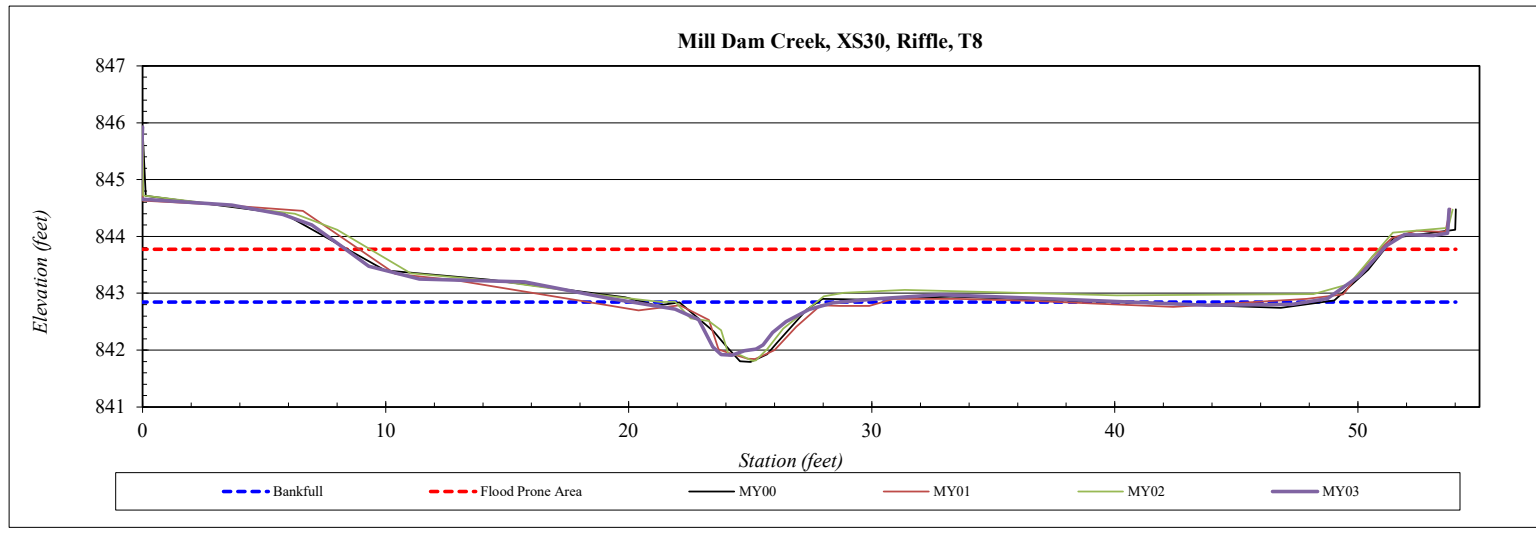
<b>River Basin:</b>	Yadkin River
<b>Site:</b>	Mill Dam Creek
<b>XS ID</b>	XS30
<b>Drainage Area (sq mi):</b>	0.03
<b>Date:</b>	1/9/2023
<b>Field Crew:</b>	KB, JS

SUMMARY DATA	
<b>Bankfull Elevation (ft) - Based on AB-Bankfull Area</b>	842.84
<b>Bankfull Cross-Sectional Area:</b>	3.2
<b>Total Cross-Sectional Area:</b>	3.2
<b>Bankfull Width:</b>	8.2
<b>Flood Prone Area Elevation:</b>	843.77
<b>Flood Prone Width:</b>	42.7
<b>Max Depth at Bankfull:</b>	0.9
<b>Mean Depth at Bankfull:</b>	0.4
<b>W / D Ratio:</b>	21.1
<b>Entrenchment Ratio:</b>	5.2
<b>Bank Height Ratio:</b>	0.9
<b>Thalweg Elevation:</b>	841.91

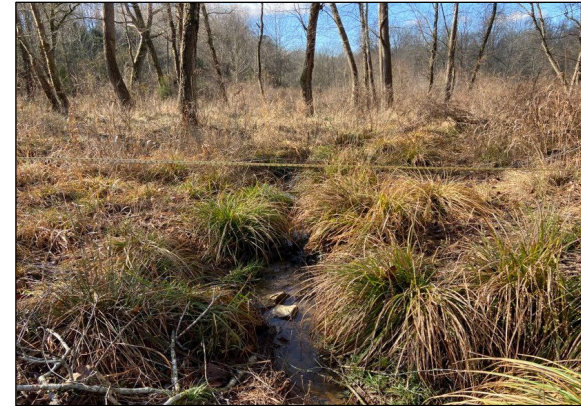
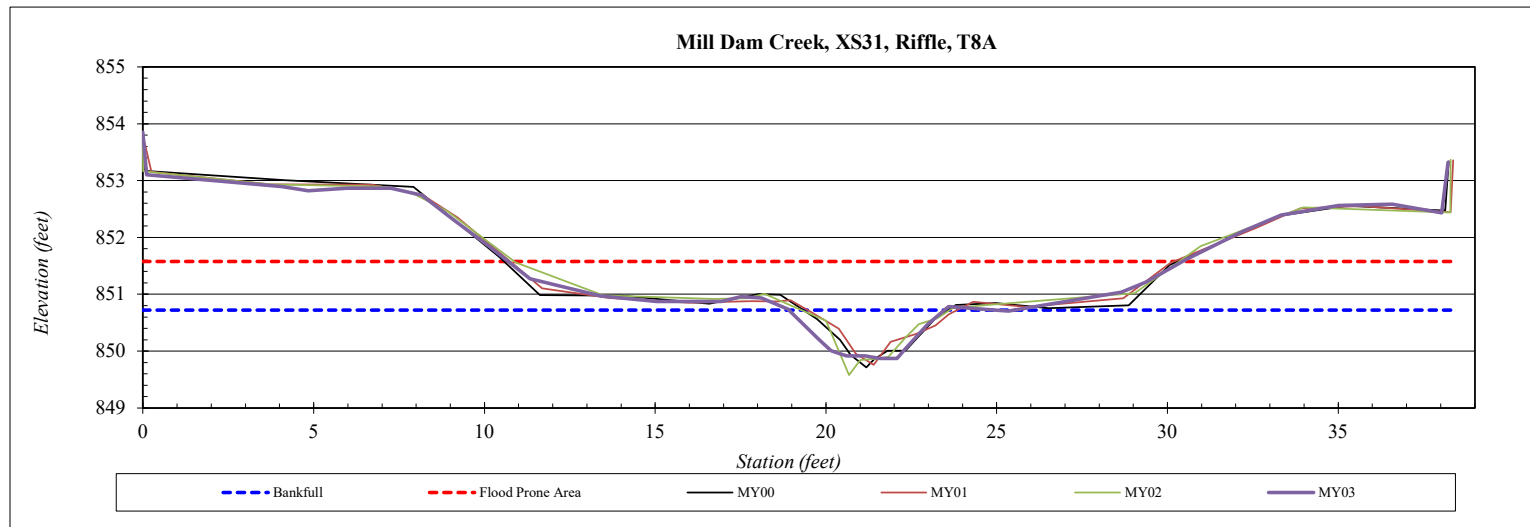
<b>River Basin:</b>	Yadkin River
<b>Site:</b>	Mill Dam Creek
<b>XS ID</b>	XS31
<b>Drainage Area (sq mi):</b>	0.01
<b>Date:</b>	1/9/2023
<b>Field Crew:</b>	KB, JS

SUMMARY DATA	
<b>Bankfull Elevation (ft) - Based on AB-Bankfull Area</b>	850.72
<b>Bankfull Cross-Sectional Area:</b>	2.6
<b>Total Cross-Sectional Area:</b>	3.0
<b>Bankfull Width:</b>	4.6
<b>Flood Prone Area Elevation:</b>	851.57
<b>Flood Prone Width:</b>	19.7
<b>Max Depth at Bankfull:</b>	0.9
<b>Mean Depth at Bankfull:</b>	0.6
<b>W / D Ratio:</b>	8.1
<b>Entrenchment Ratio:</b>	4.3
<b>Bank Height Ratio:</b>	1.1
<b>Thalweg Elevation:</b>	849.87
