# Annual Monitoring Report

Mill Dam Creek Restoration Site  
Yadkin River Basin - 03040101  
Monitoring Year 03  
DEQ Contract 6898  
DMS Project Number 97136  
DMS RFP No. 16-006706 (Date of Issue: October 21, 2015)

DWR #: 18-1349  
USACE Action ID: 2016-01335  
Yadkin County, North Carolina

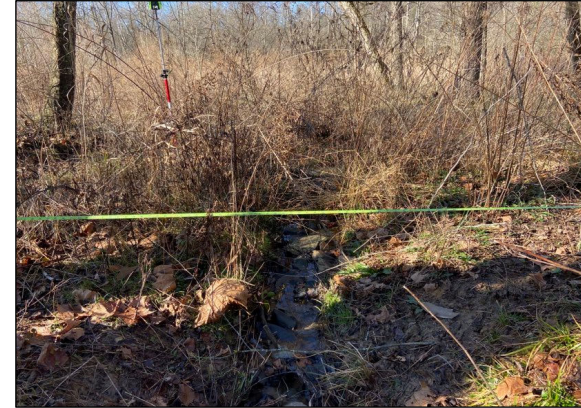
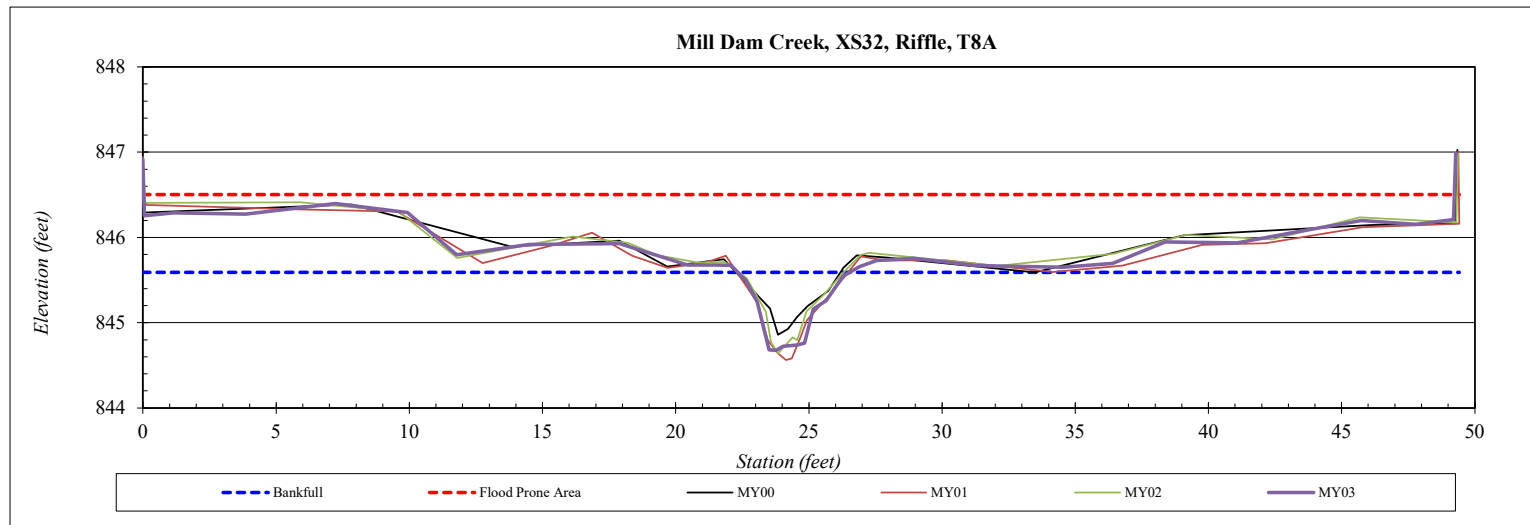
<b>River Basin:</b>	Yadkin River
<b>Site:</b>	Mill Dam Creek
<b>XS ID</b>	XS32
<b>Drainage Area (sq mi):</b>	0.01
<b>Date:</b>	1/9/2023
<b>Field Crew:</b>	KB, JS

SUMMARY DATA	
<b>Bankfull Elevation (ft) - Based on AB-Bankfull Area</b>	845.59
<b>Bankfull Cross-Sectional Area:</b>	2.1
<b>Total Cross-Sectional Area:</b>	3.5
<b>Bankfull Width:</b>	4.2
<b>Flood Prone Area Elevation:</b>	846.50
<b>Flood Prone Width:</b>	49.2
<b>Max Depth at Bankfull:</b>	0.9
<b>Mean Depth at Bankfull:</b>	0.5
<b>W / D Ratio:</b>	8.5
<b>Entrenchment Ratio:</b>	11.8
<b>Bank Height Ratio:</b>	1.1
<b>Thalweg Elevation:</b>	844.68
