# MILL BRANCH STREAM RESTORATION PROJECT

## MONITORING REPORT (YEAR 1 OF 5)

Columbus County, North Carolina  
SCO Project Number 020611301A  
EEP Project Number 0251

Status of Plan: Final  
Submission Date: August 2008

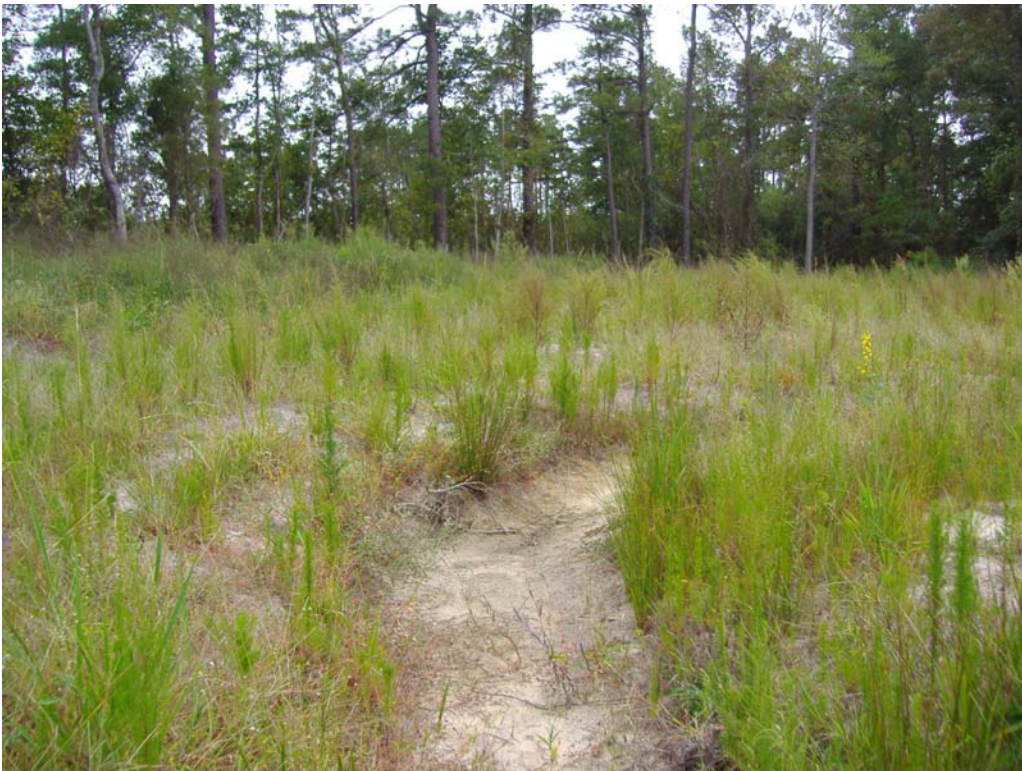
Photo Station 32. Pool Cross-section 8 – Downstream – Lower Reach

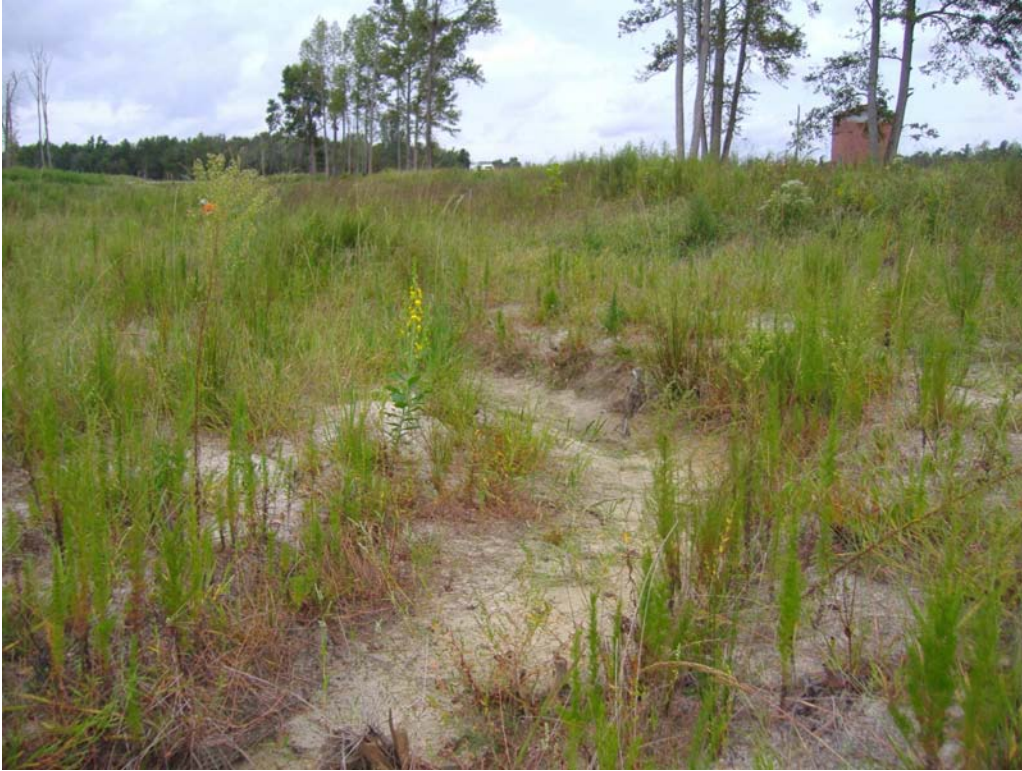
Photo Station 33. Pool Cross-section 8 – Upstream – Lower Reach
