Mill Branch Stream Restoration Project Columbus County North Carolina

**CU: 03040103
SCO# 020611301A
EEP Project No. 251**

2nd Year Monitoring Report January 22, 2009

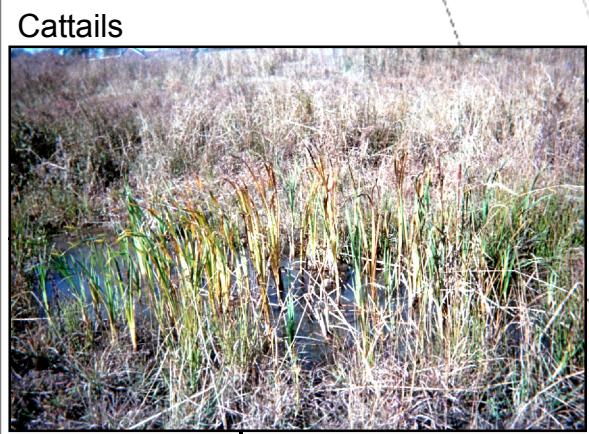
Exhibit Table B.1 Stream Problem Areas				
Mill Branch Stream Restoration Site EEP Project No. 251				
Feature Issue	Reach	Station Number	Suspected Cause	Photo Number
Aggradation	Western	10+00 to 13+50	N/A	*
	Upper	10+00 to 12+50	N/A	*
Cattails	All	Throughout	Dry Conditions	VPA 2
Bare Ground	Middle Reach	20+30	Dry Conditions	VPA 1

Cattails

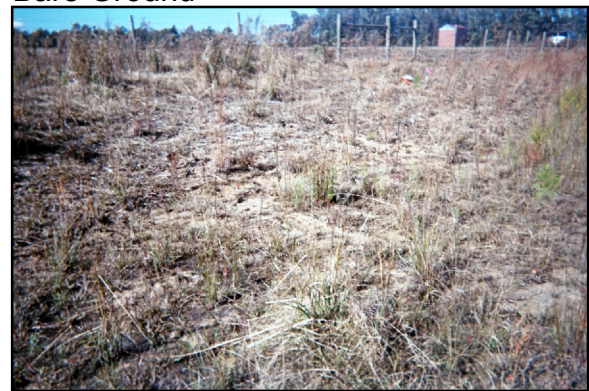
Bare Ground
