# **Mill Branch Stream Restoration Project Columbus County North Carolina**

**EEP Project No. 251  
CU: 03040206  
SCO# 020611301A**

**Year 4 of 5 Monitoring Report  
Data Collection: June through October 2010  
Submission Date: March 31, 2011**

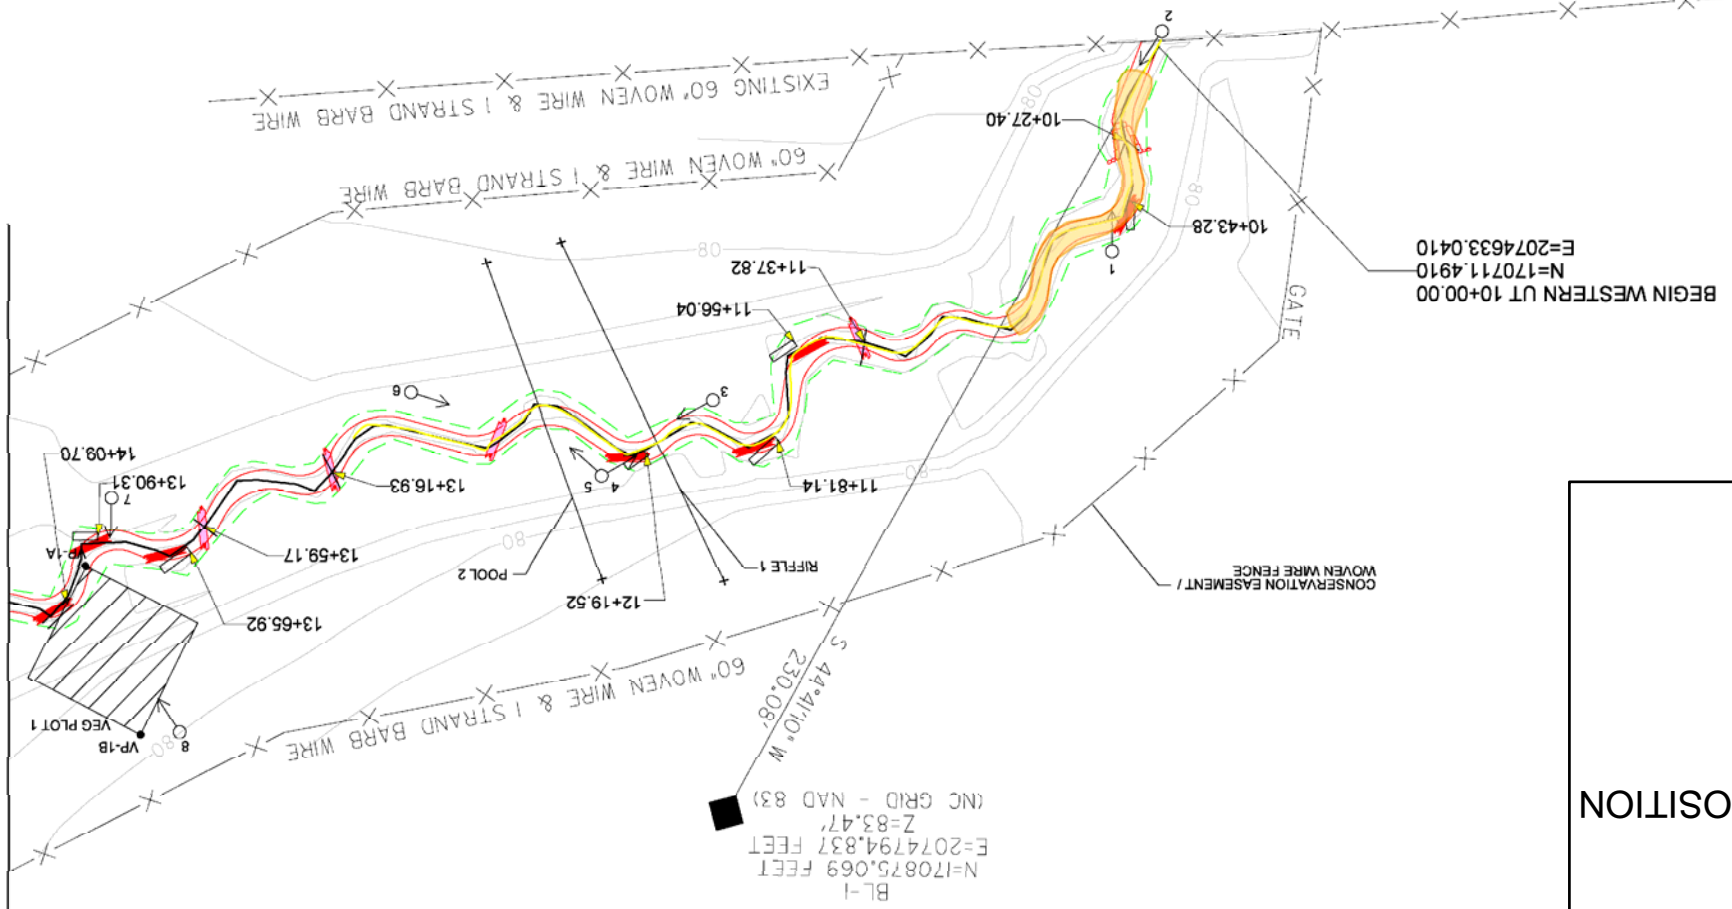
<b>FIGURE 2b</b>	
Mill Branch Stream Restoration Site	
PROJECT NO.	SCO# 02-06113-01A
SHEET NO.	2

### Problem Areas

RILL EROSION
	BARE GROUND
	CATTAILS
	SEDIMENT DEPOSITION

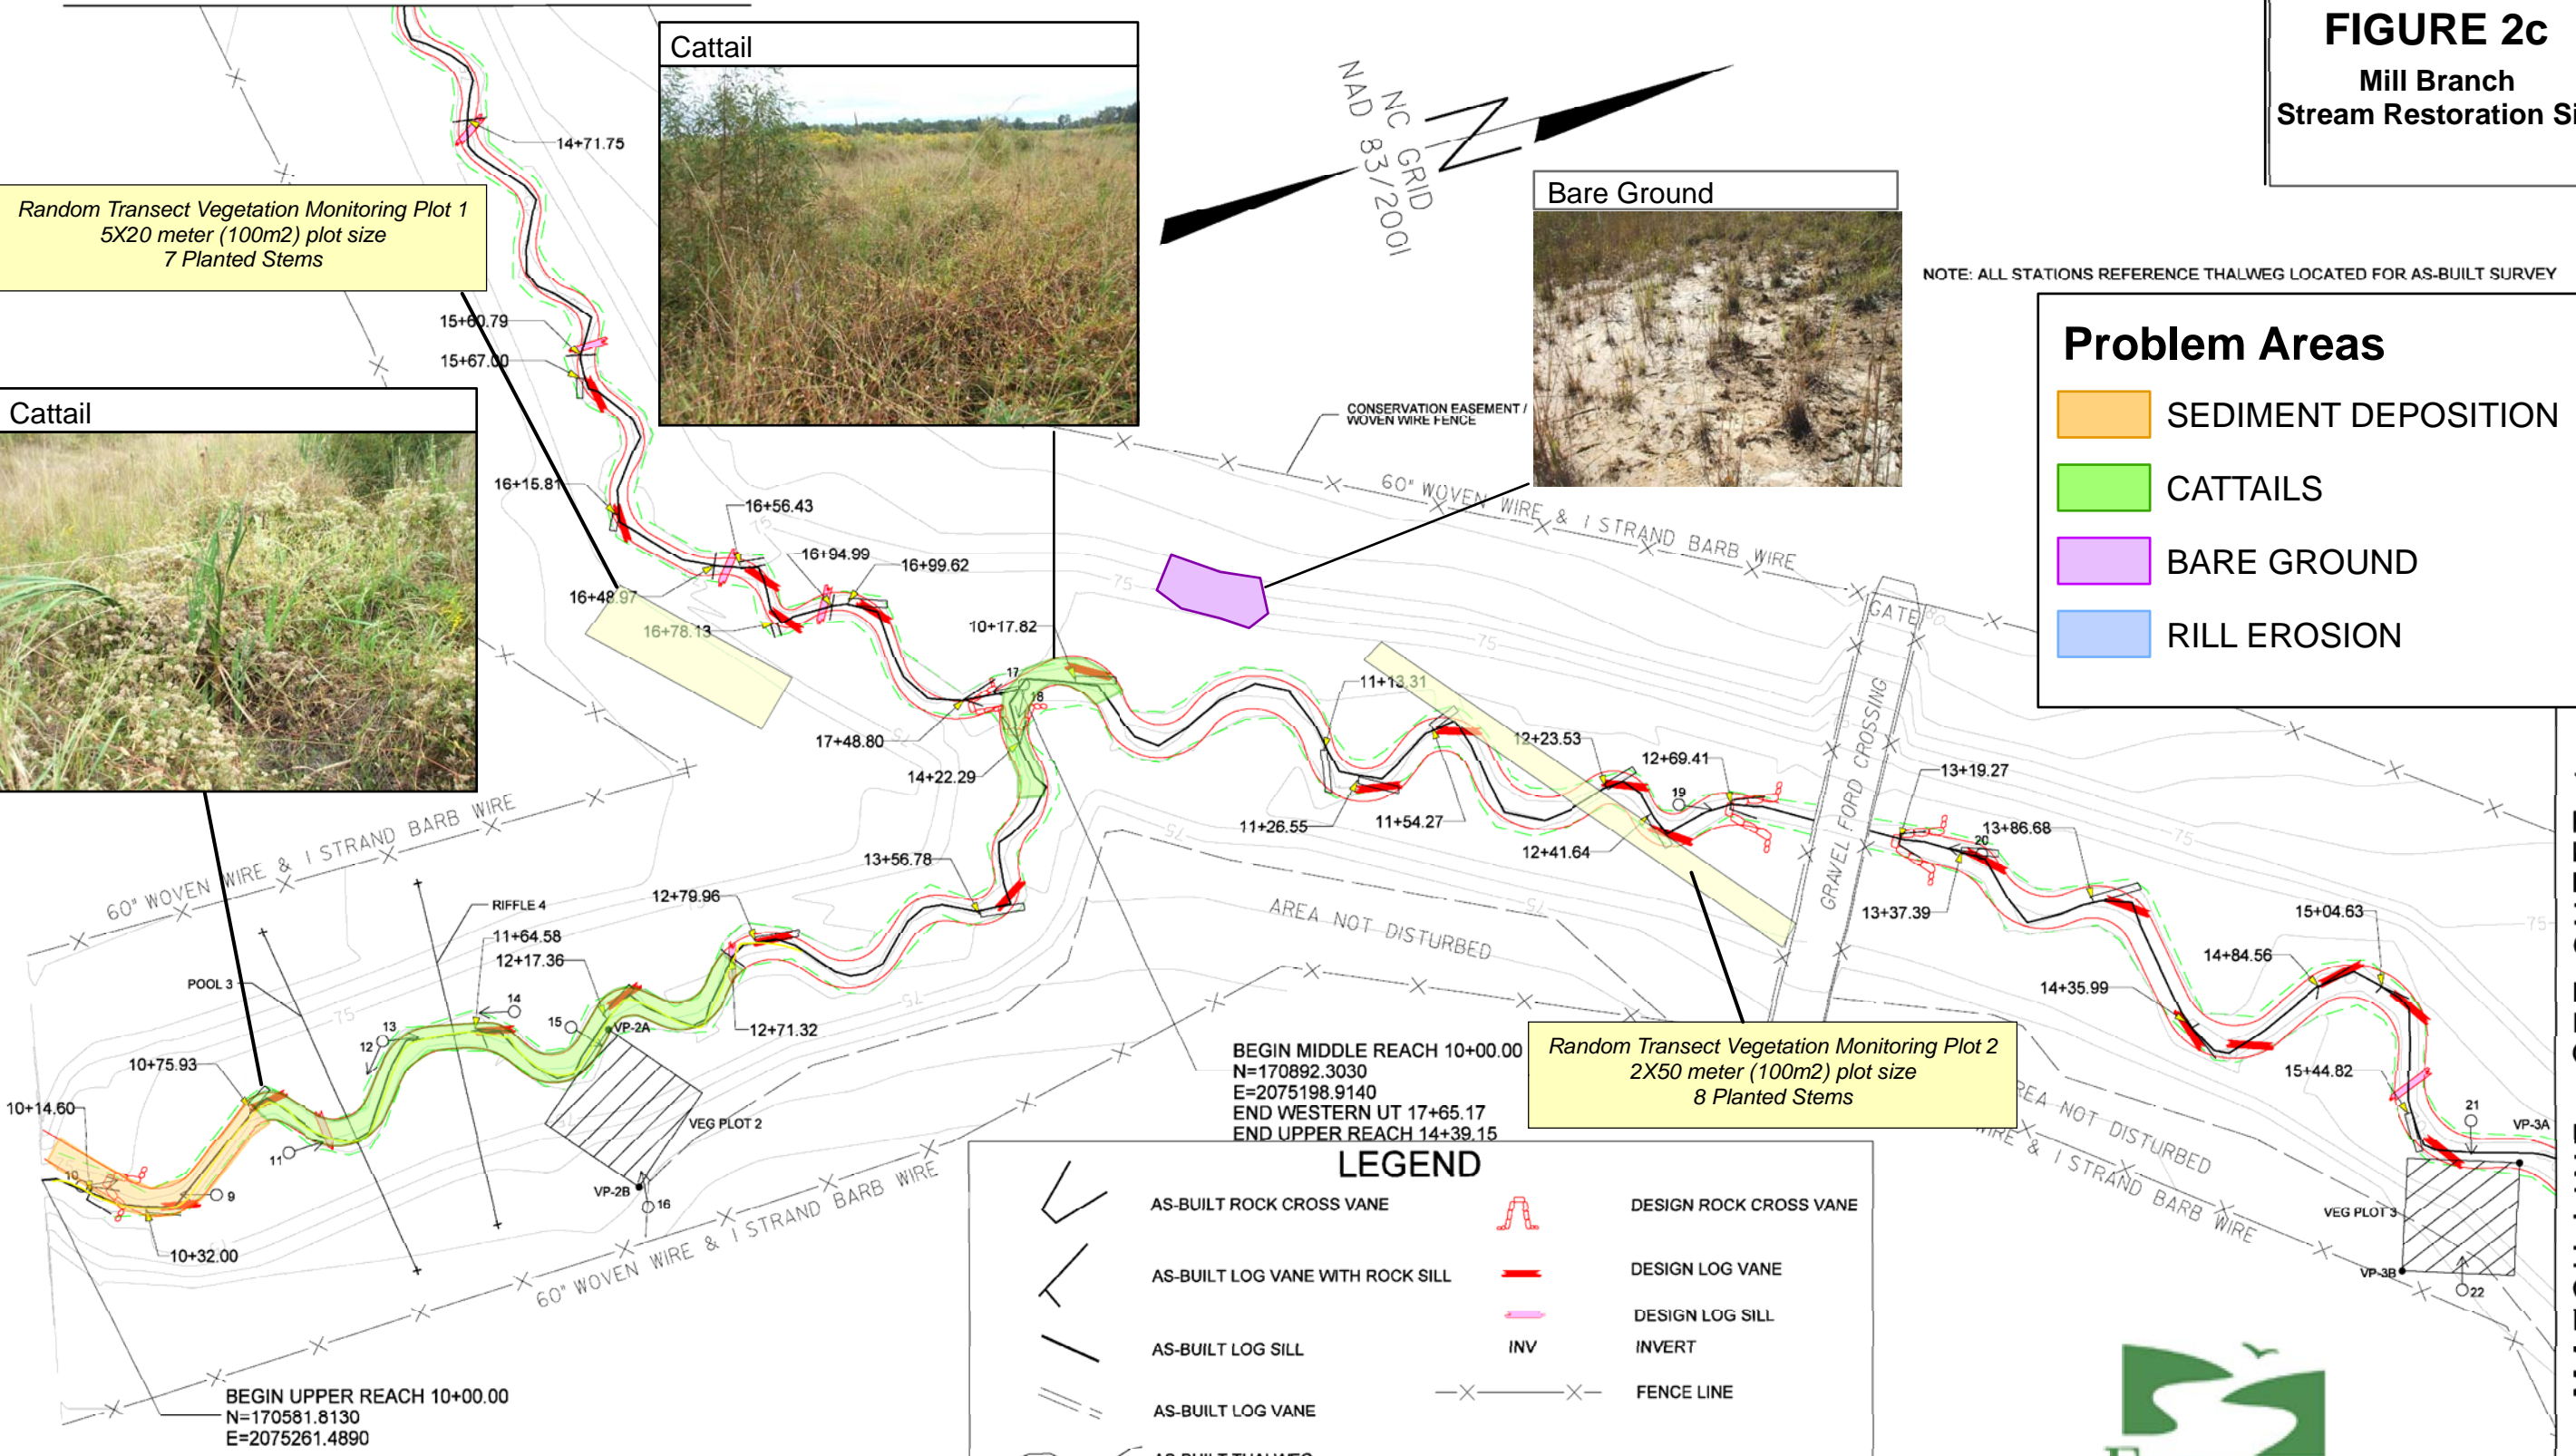
**FIGURE 2c**  
Mill Branch  
Stream Restoration Site

**Problem Areas**

- SEDIMENT DEPOSITION
- CATTAILS
- BARE GROUND
- RILL EROSION

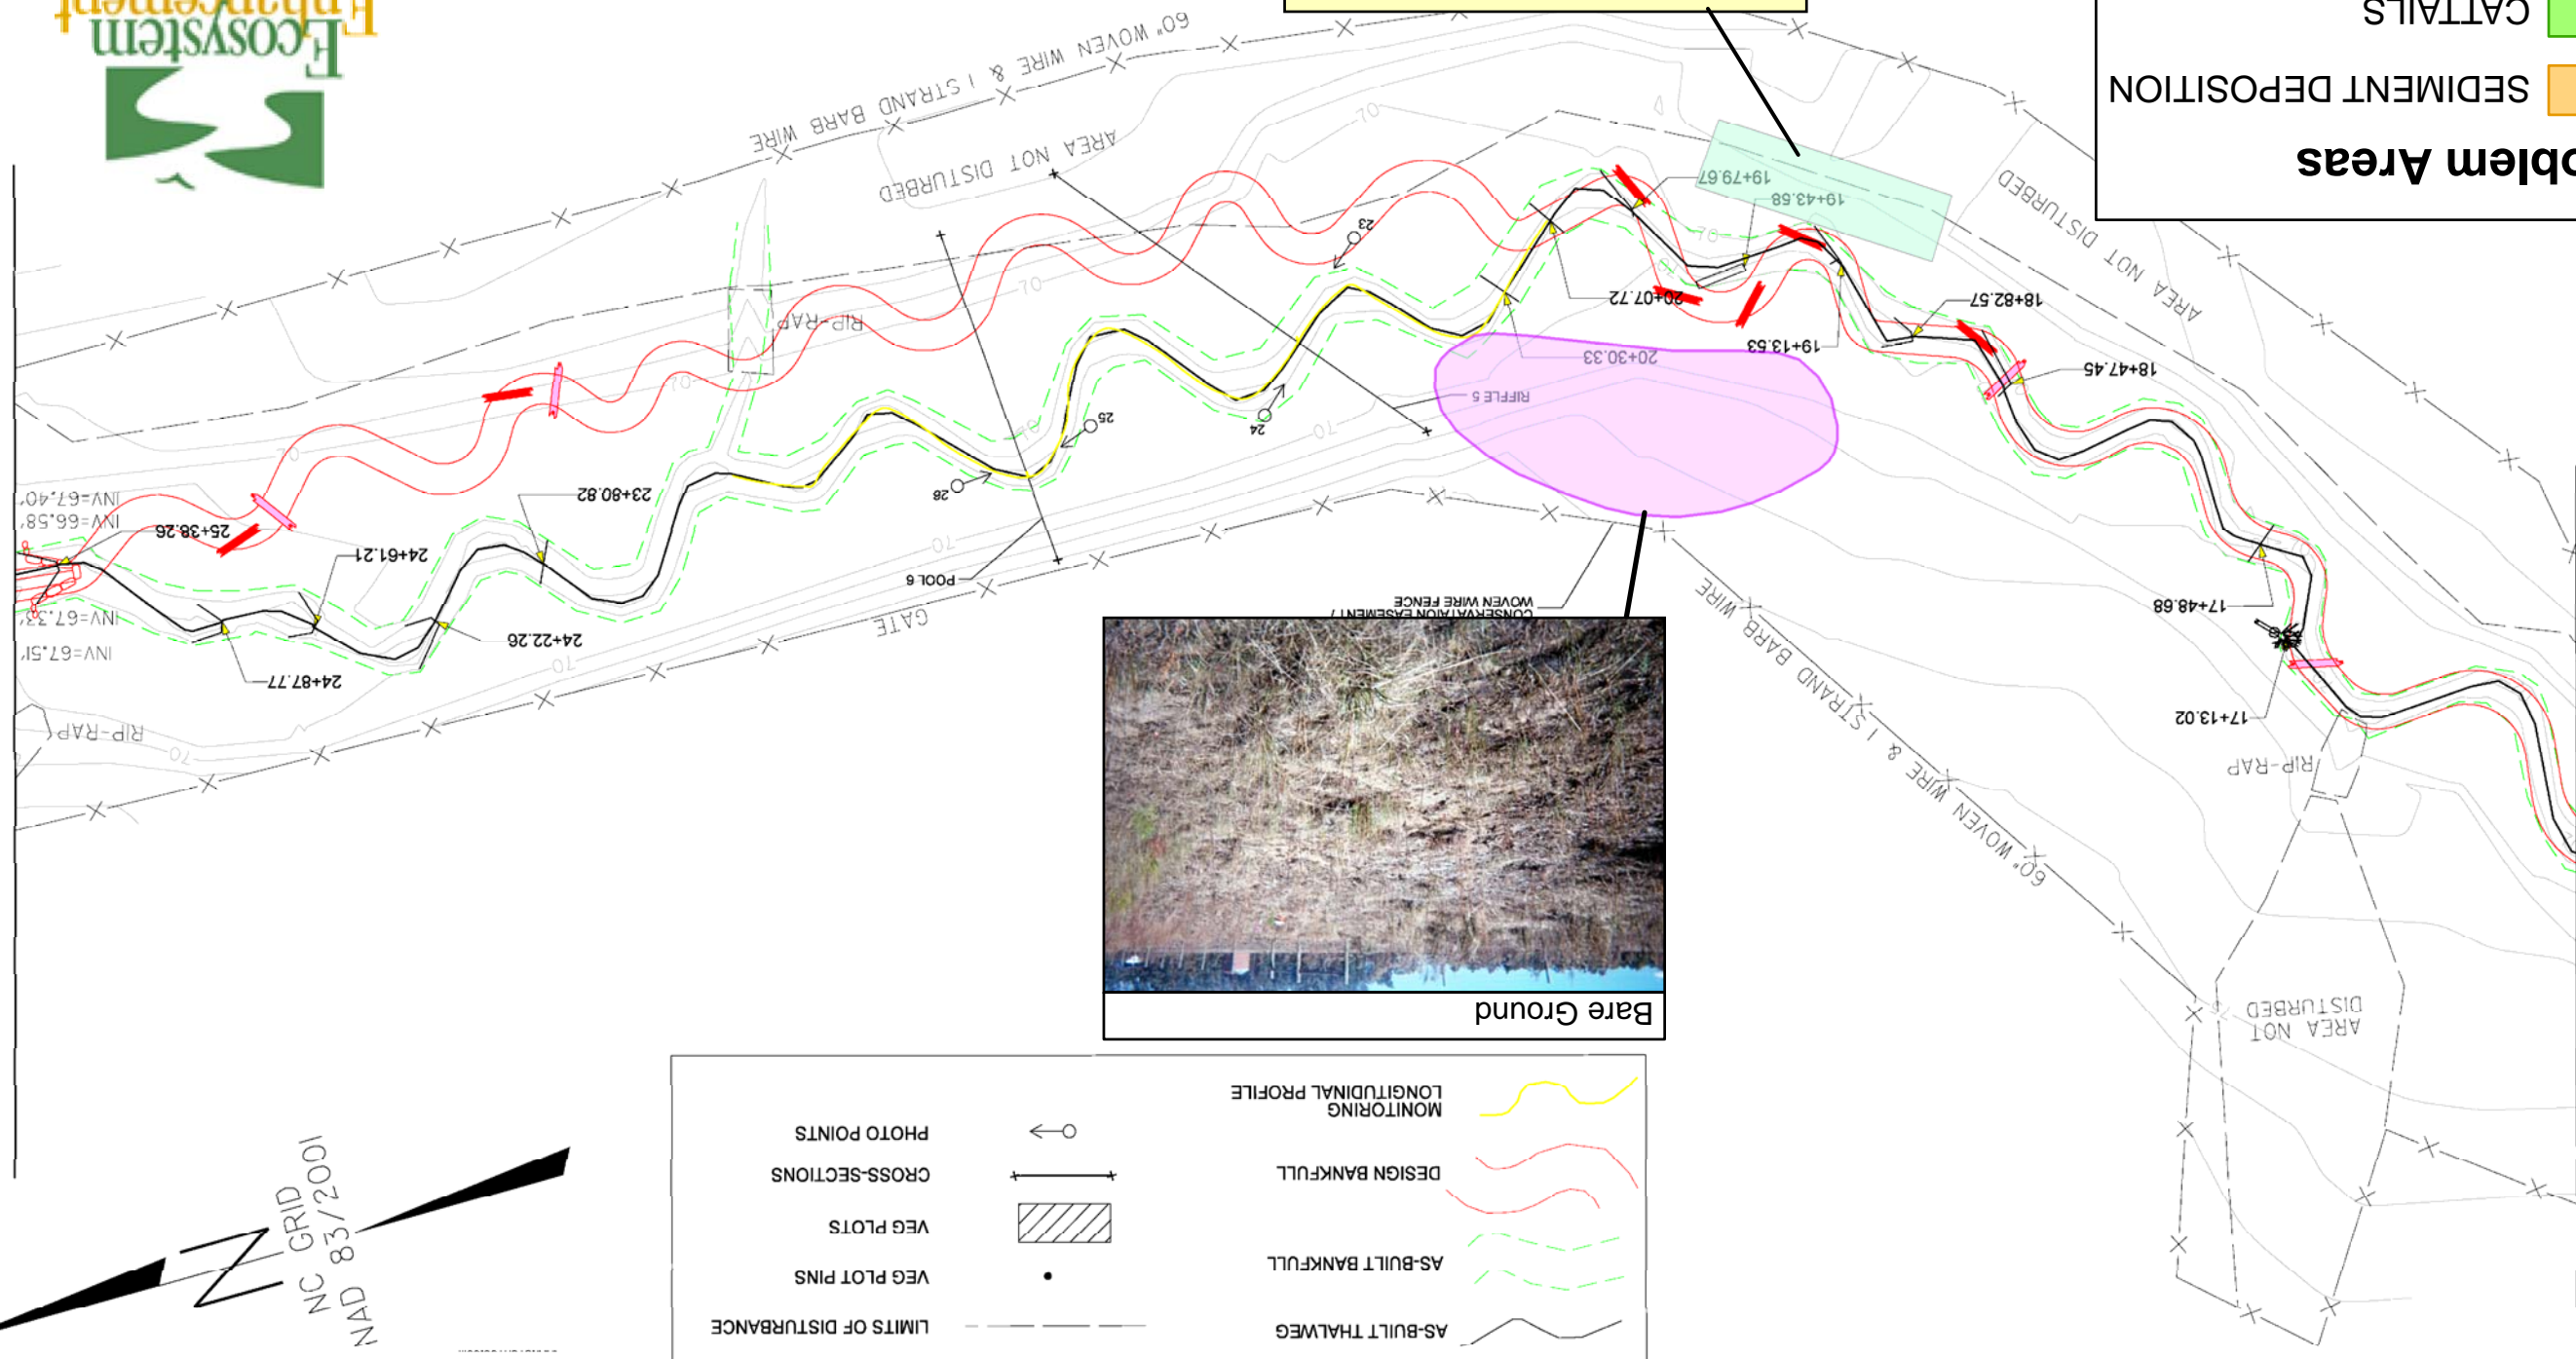
**FIGURE 2e**  
Mill Branch  
Stream Restoration Site

### Problem Areas

- SEDIMENT DEPOSITION
- CATTAILS
- BARE GROUND
- RILL EROSION
