Mill Branch Stream Restoration Project Columbus County North Carolina

EEP Project No. 251

**Year 5 of 5 Monitoring Report
Data Collection: June through October 2011
Submission Date: February 17, 2012**

Rummel, Klepper & Kahl, LLP
900 Ridgefield Drive
Suite 350
Raleigh, NC 27609

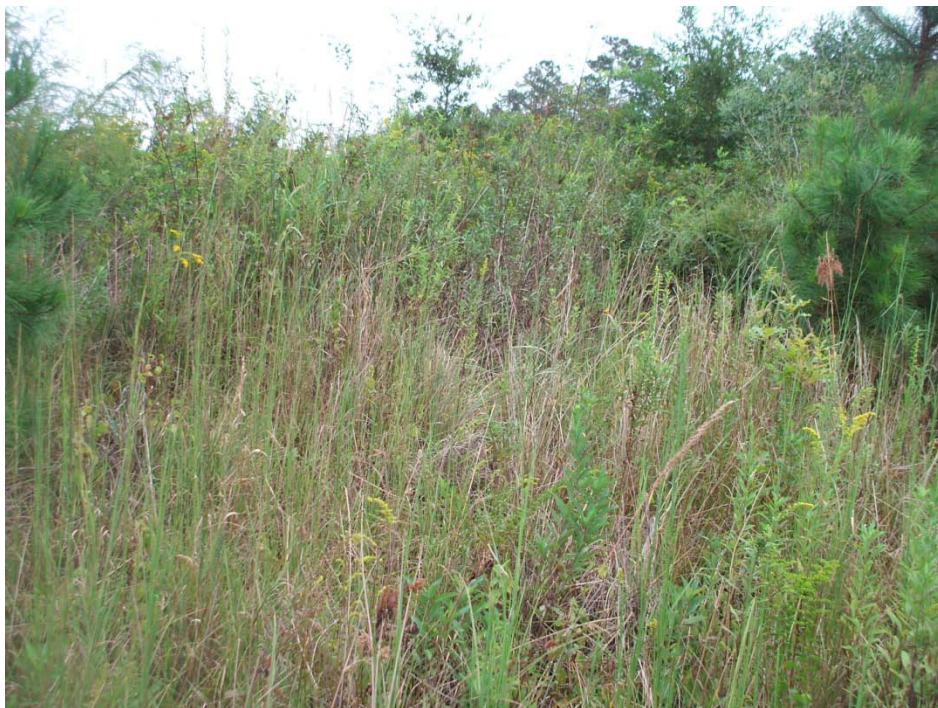
Vegetation Plot 2

Table 7. Vegetation Plot Criteria Attainment			
Mill Branch Stream Restoration Project EEP No: 251			
Tract	Vegetation Plot ID	Vegetation Survival Threshold Met?	Tract Mean
Western	VP1	Y	100%
Upper	VP2	N	0%
Middle	VP3	N	0%
Lower	VP4	Y	100%
