FINAL
ANNUAL MONITORING REPORT
YEAR 3 (2014)
MILL CREEK STREAM/WETLAND RESTORATION SITE
RANDOLPH COUNTY, NORTH CAROLINA
(EEP Project No. 253, Contract No. 004803)
Construction Completed March 2011

Prepared by:
Axiom Environmental, Inc.
218 Snow Avenue
Raleigh, North Carolina 27603

October 2014

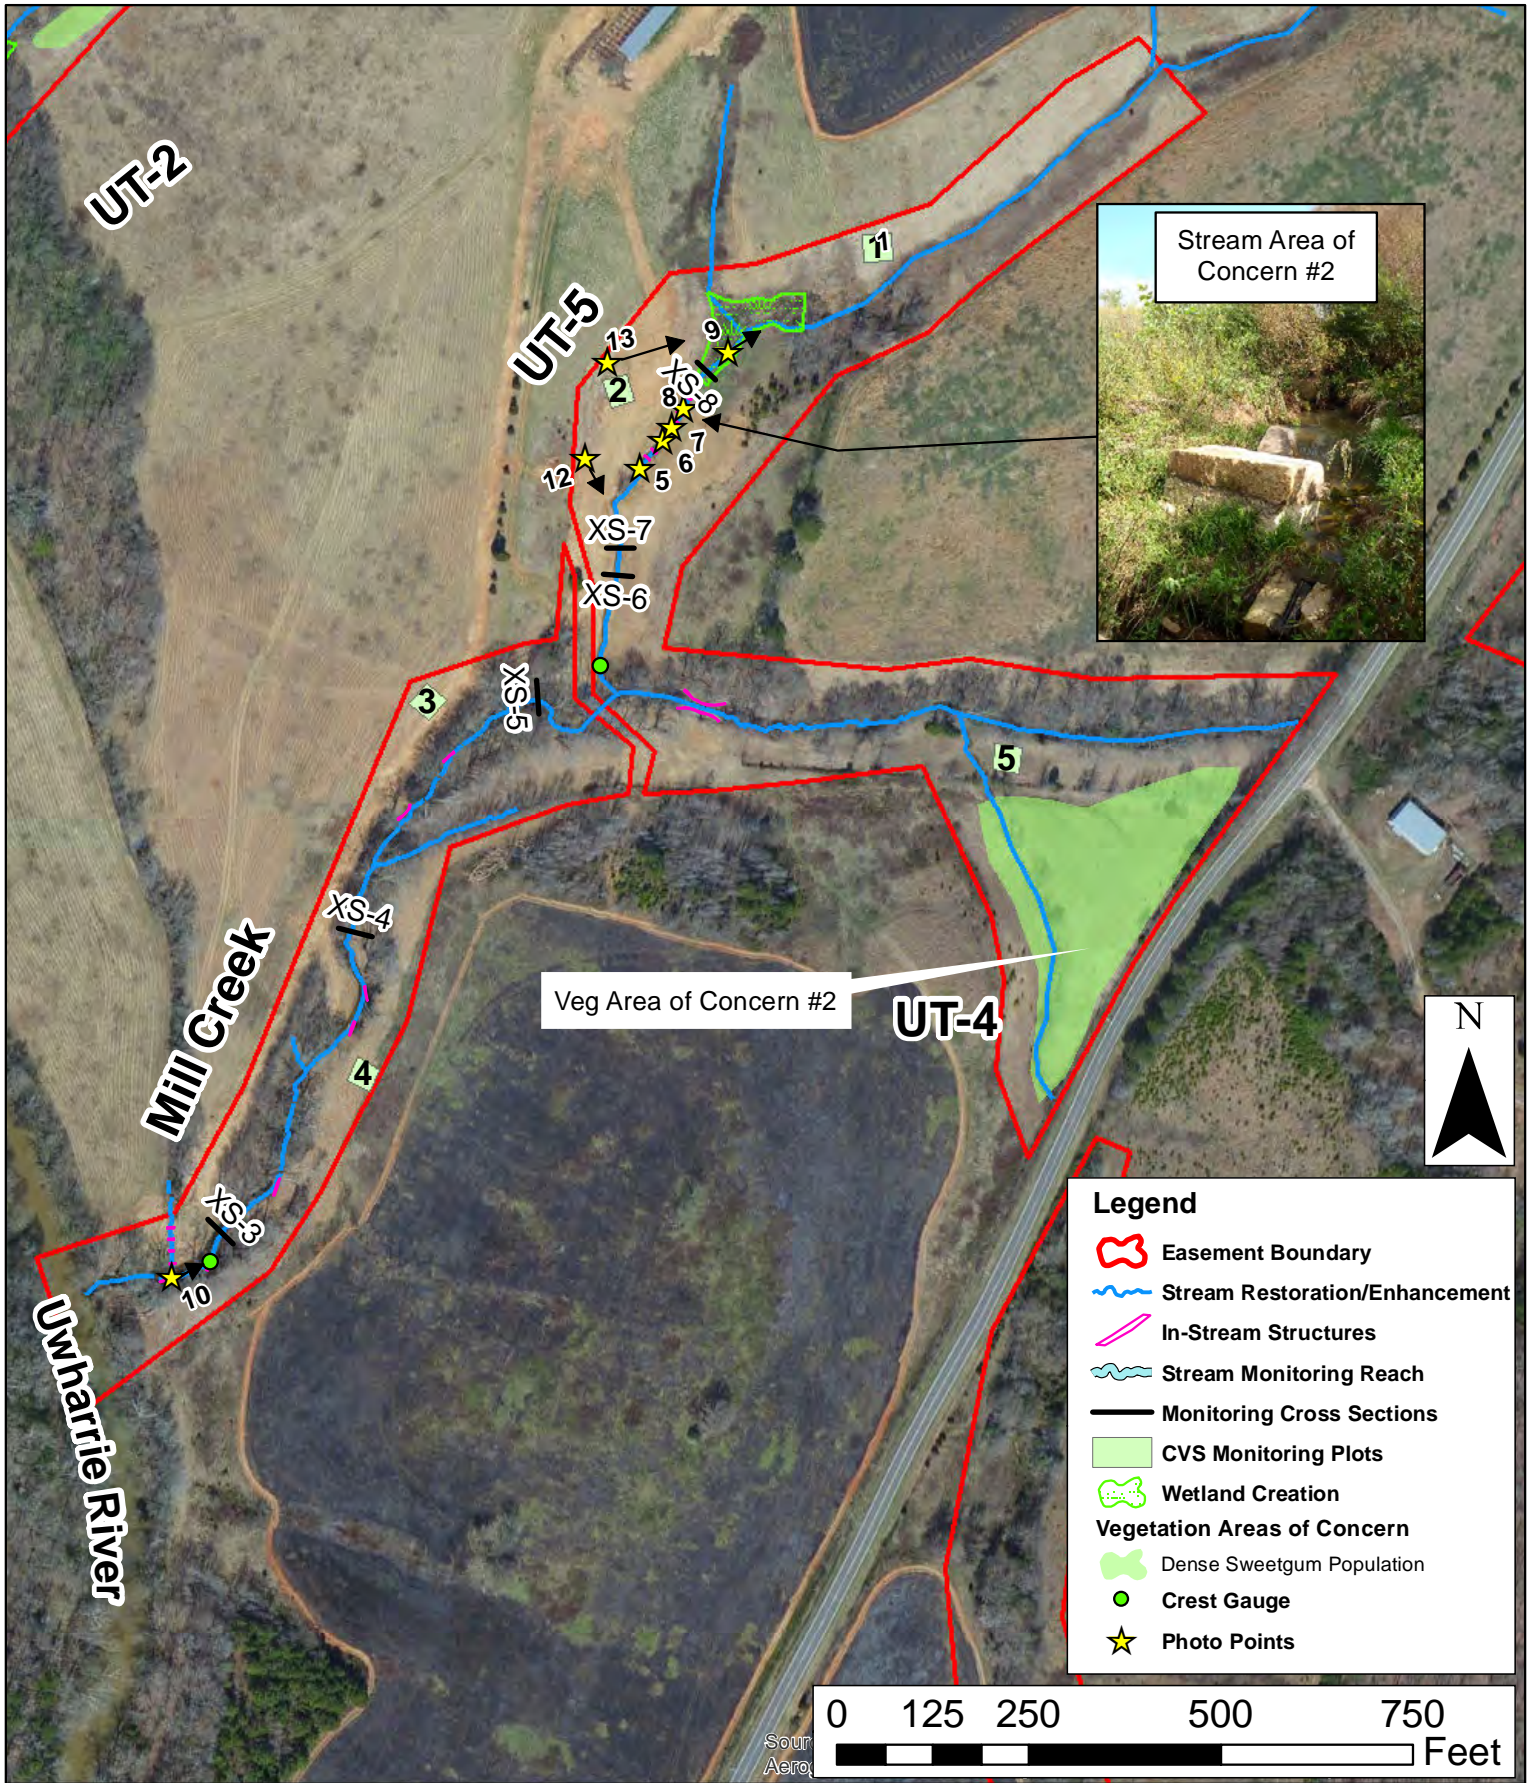
FIGURE
2A

Visual assessment and geomorphic surveys completed for the Site indicate that project reaches were performing within established success criteria ranges as shown below. No significant bank erosion was recorded, and geomorphic measurements are within the range of the design parameters. Two areas of concern were observed along stream monitoring reaches within the sites. The table below describes the issues and each area is identified on Figures 2A and 2B (Appendix B).

Map Identifier	Feature/Issue
Stream Area of Concern #1	Cross vane at bottom of Mill Creek has been compromised due to high flows of the Uwharrie River. Structure is intact but adjacent banks have been eroded causing water to flow around arms and pipe underneath headers
Stream Area of Concern #2	Sixth upstream cross vane in series of drop structures has failed completely, upstream and downstream structures are intact and functioning. Failure likely due to localized heavy rain event between June and September 2014.
