FINAL
ANNUAL MONITORING REPORT
YEAR 4 (2015)
MILL CREEK STREAM/WETLAND RESTORATION SITE
RANDOLPH COUNTY, NORTH CAROLINA
(DMS Project No. 253, Contract No. 004803)
Construction Completed March 2011

December 2015

Prepared by:
Axiom Environmental, Inc.
218 Snow Avenue
Raleigh, North Carolina 27603

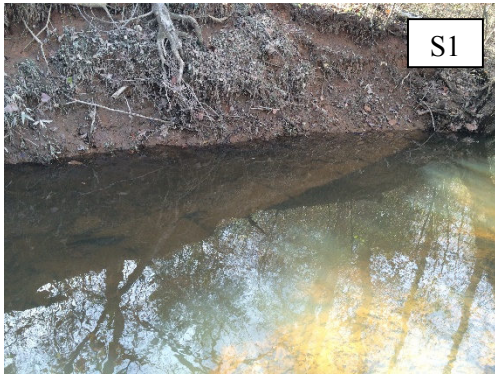
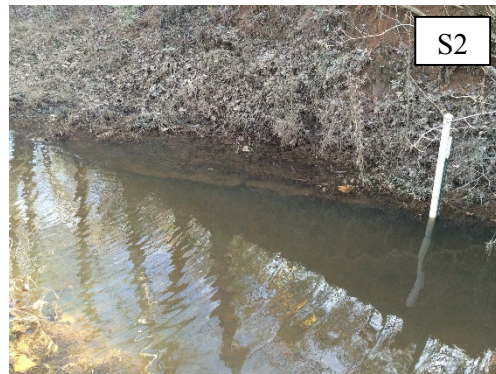
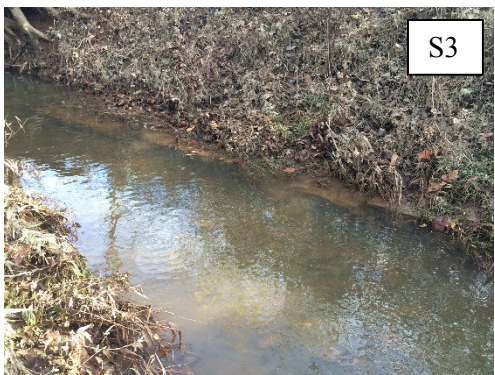
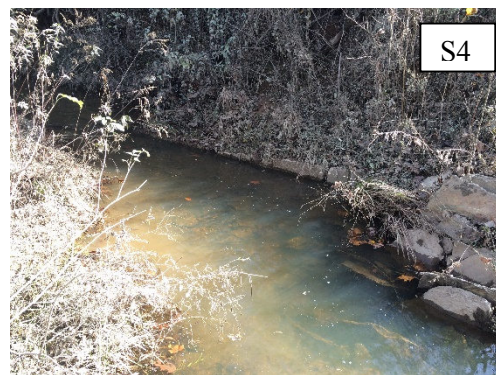
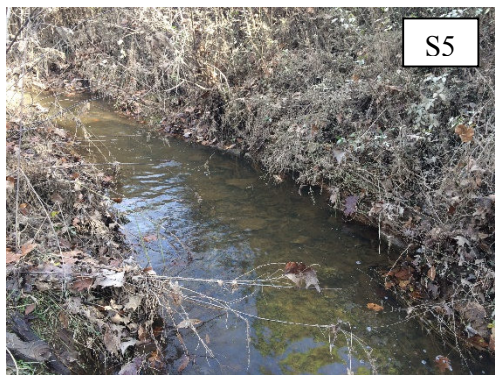
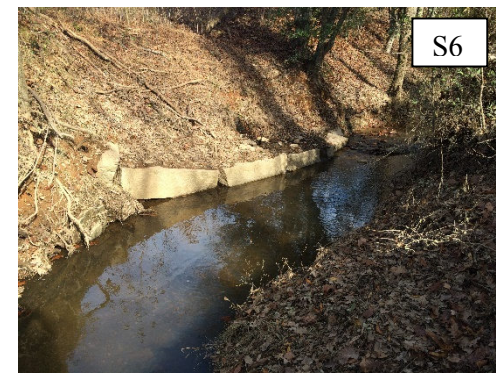
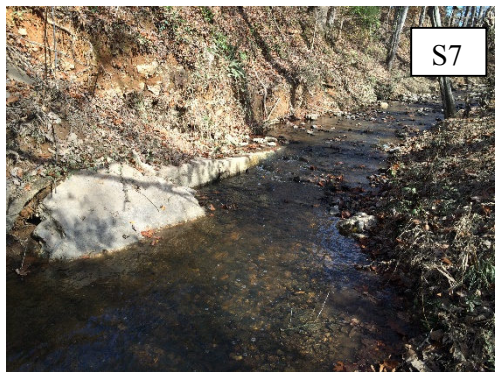
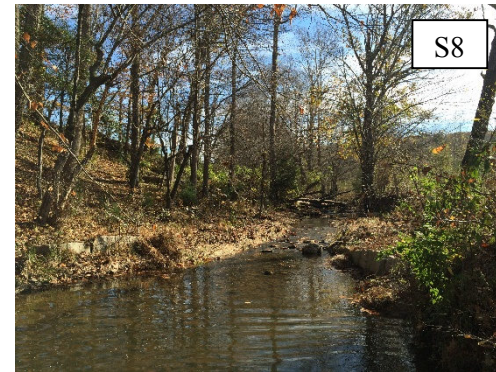
**Mill Creek
Main Tributary Structure Photographs
Taken November 2015**

Map Identifier	Feature/Issue
Stream Area of Concern #1	Cross vane at bottom of UT-2 has been compromised due to high flows of the Uwharrie River. Structure is intact but adjacent banks have been eroded causing water to flow around arms and pipe underneath headers
Stream Area of Concern #2	Sixth upstream cross vane in series of drop structures has failed completely, upstream and downstream structures are intact and functioning. Failure likely due to localized heavy rain event between June and September 2014.
