**MILLER ET AL. MITIGATION SITE ON MEAT CAMP CREEK,
WATAUGA COUNTY**

Year 5 Monitoring Report
Period Covered: December 22, 2006 – December 1, 2007

Prepared for the
North Carolina Ecosystem Enhancement Program

North Carolina Wildlife Resources Commission
Watershed Enhancement Group
Raleigh

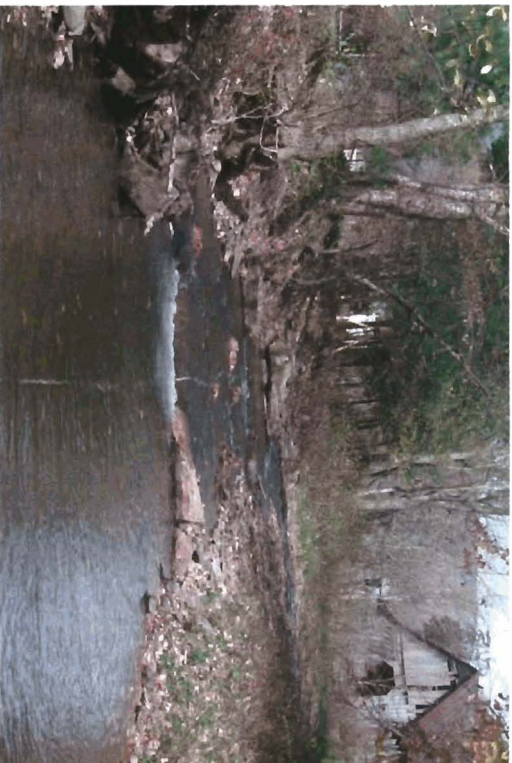
Appendix 2: Pre and Post Photographs of September 8, 13, 27, 2004 hurricane damage between station 4+15 and station 4+97 at the Miller et al. mitigation site on Meat Camp Creek, New River drainage, Watauga County. This site was repaired on November 19, 2004. All photographs are looking upstream. Notice the disappearance of the point bar adjacent to the large brown boulder.

As-built photo before the storm damage, April 2003.
