PHASES I & II MONITORING YEAR 0 BASELINE REPORT

MILLSTONE CREEK MITIGATION SITE

Randolph County, NC
Cape Fear River Basin
HUC 03030003

DMS Project No. # 204
NCDEQ Contract No. 6741
USACE Action ID No. 2018-01788
DWR Project No. 16-1200

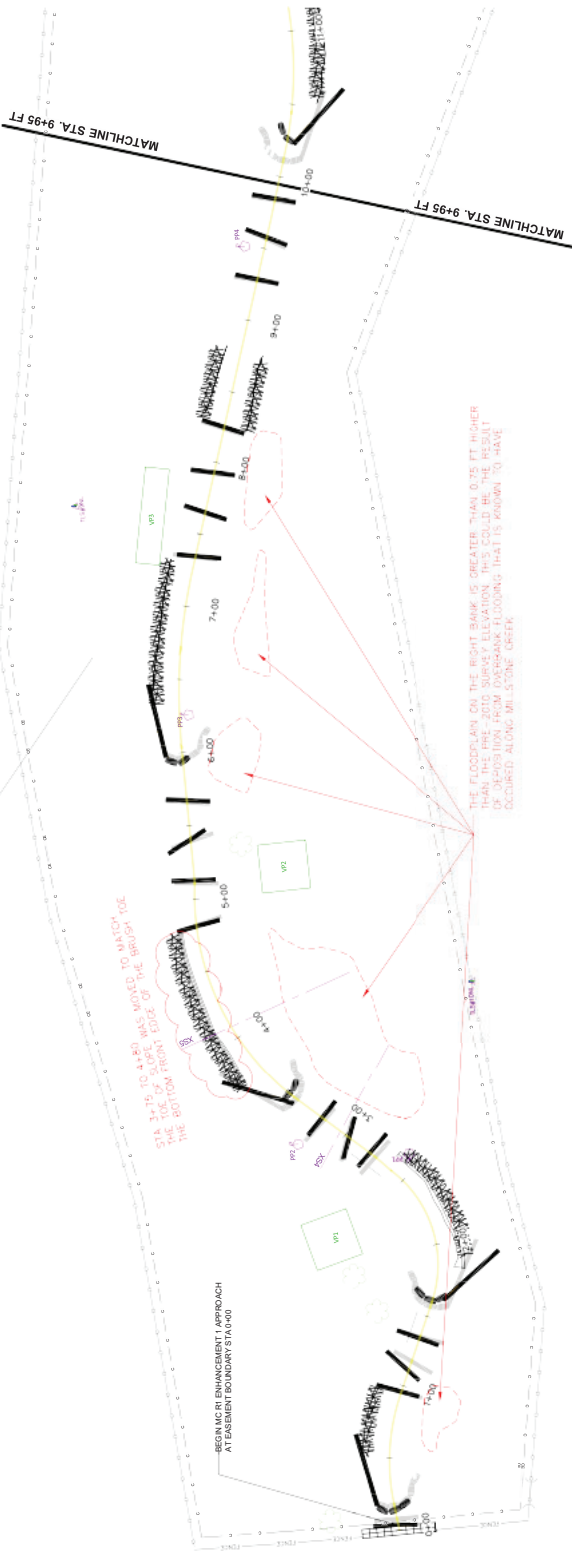
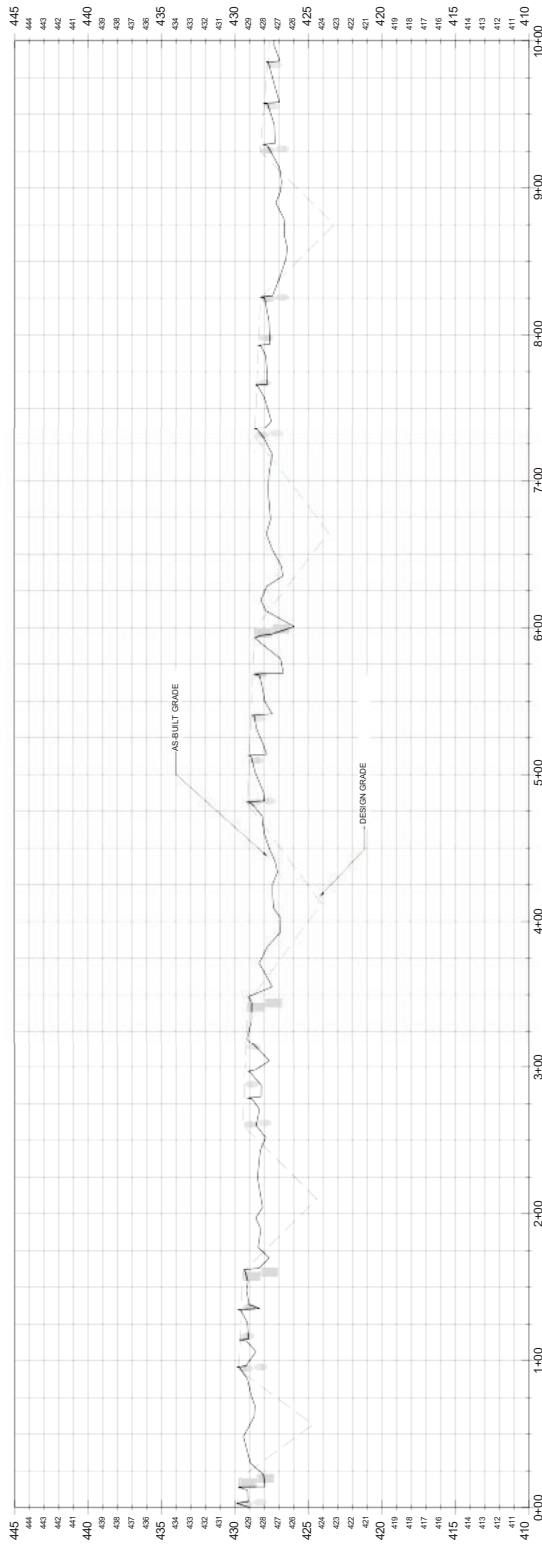
MC: PLAN - PROFILE
 4.3
 MILLSTONE CREEK
 NC DMS MITIGATION SITE
 RANDOLPH COUNTY, NC
 PHASE 1

- NOTES:
1. DEVIATIONS FROM THE DESIGN WILL BE SHOWN IN RED.
 2. ALL J-HOOKS WERE LOCATED AND ORIENTED ACCORDING TO THE DESIGN DETAIL NOT THE PLAN VIEW.
 3. ALL POOL DEPTHS WERE MODIFIED TO BE TWO (2) FT BELOW THE UPRISING FOR THE PRESENCE OF RUNNING SAND.
