**Moccasin Creek Buffer & Wetland
Restoration, Enhancement &
Preservation
Wake and Franklin Counties
North Carolina**

1st Year Monitoring Report

December 26, 2006

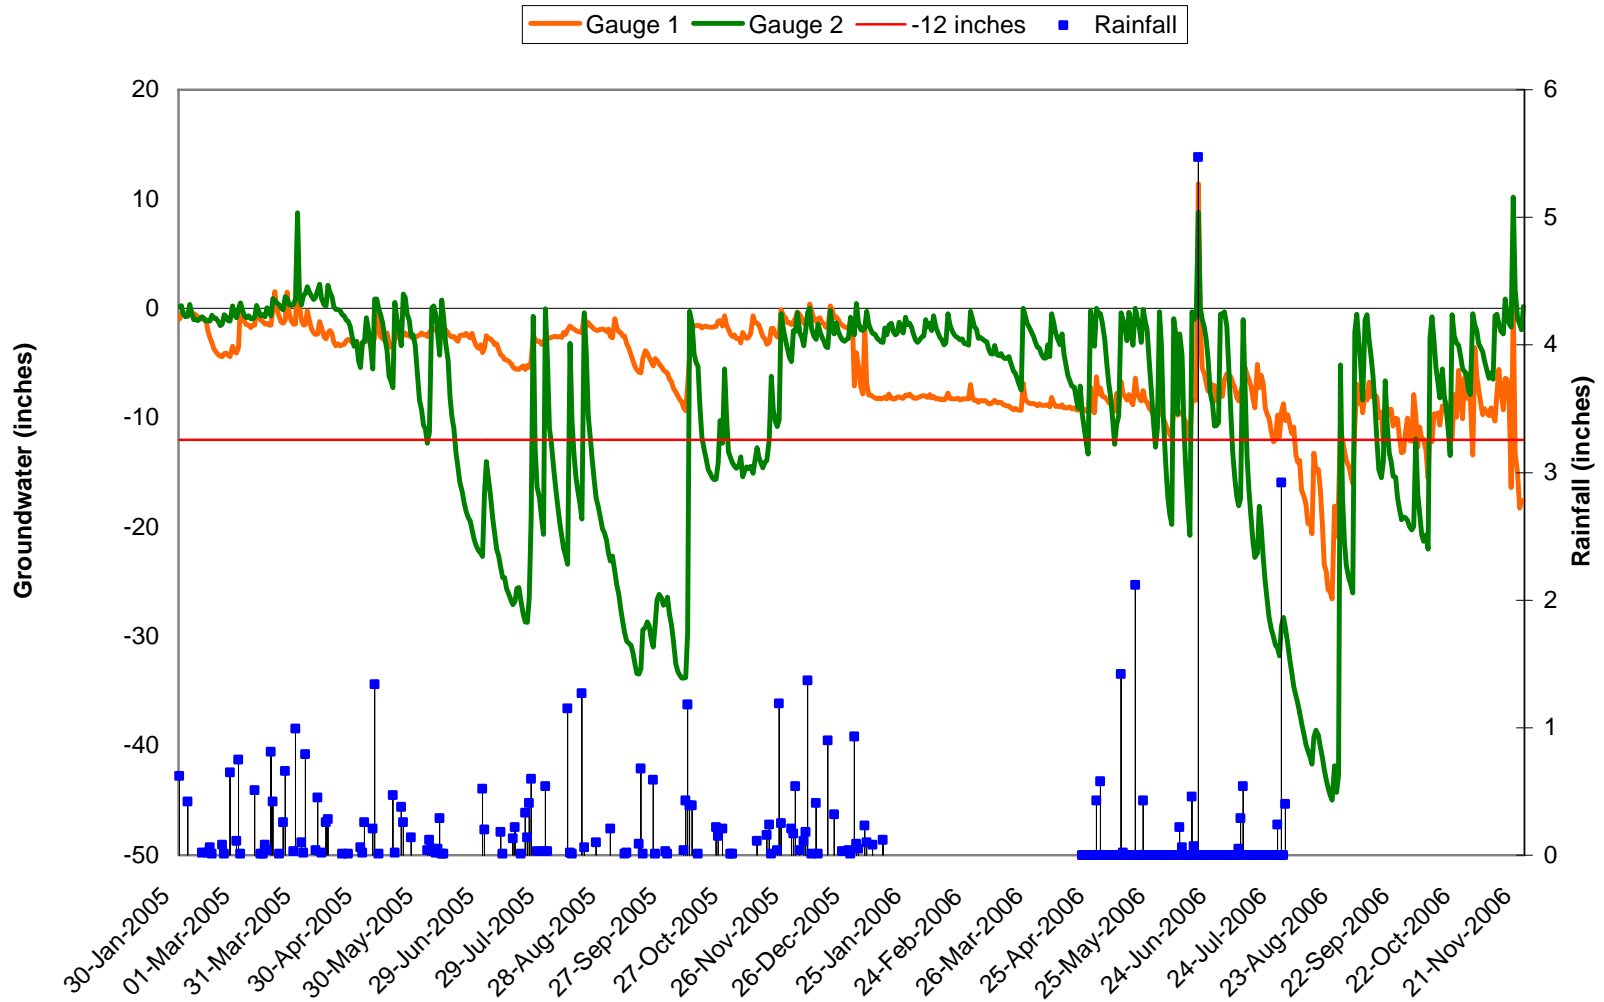
Figure 2: Rainfall vs. Ground water Level Gauges 1 and 2

The initial monitoring of Groundwater Gauge 1, 2, and 3 commenced on January 30, 2005. The growing season is considered to be 213 days (April 5-November 3). Gauge locations are depicted in Figure 2 and rainfall amounts along with groundwater gauge data can be seen in Figure 3. Analysis of Groundwater Gauges 1 and 2 in the intermittently exposed and semi permanently flooded regions shows that in 2005, groundwater levels were less than 12 inches below the soil surface or more than 12.5 % of the growing season (27 consecutive days). Gauge 1 had groundwater levels less than 12 inches for 538 consecutive days, and Gauge 2 had levels less than 12 inches for 58 consecutive days. Comparison of rainfall data and groundwater level trends indicates that the groundwater levels do fluctuate in correspondence with rainfall events.

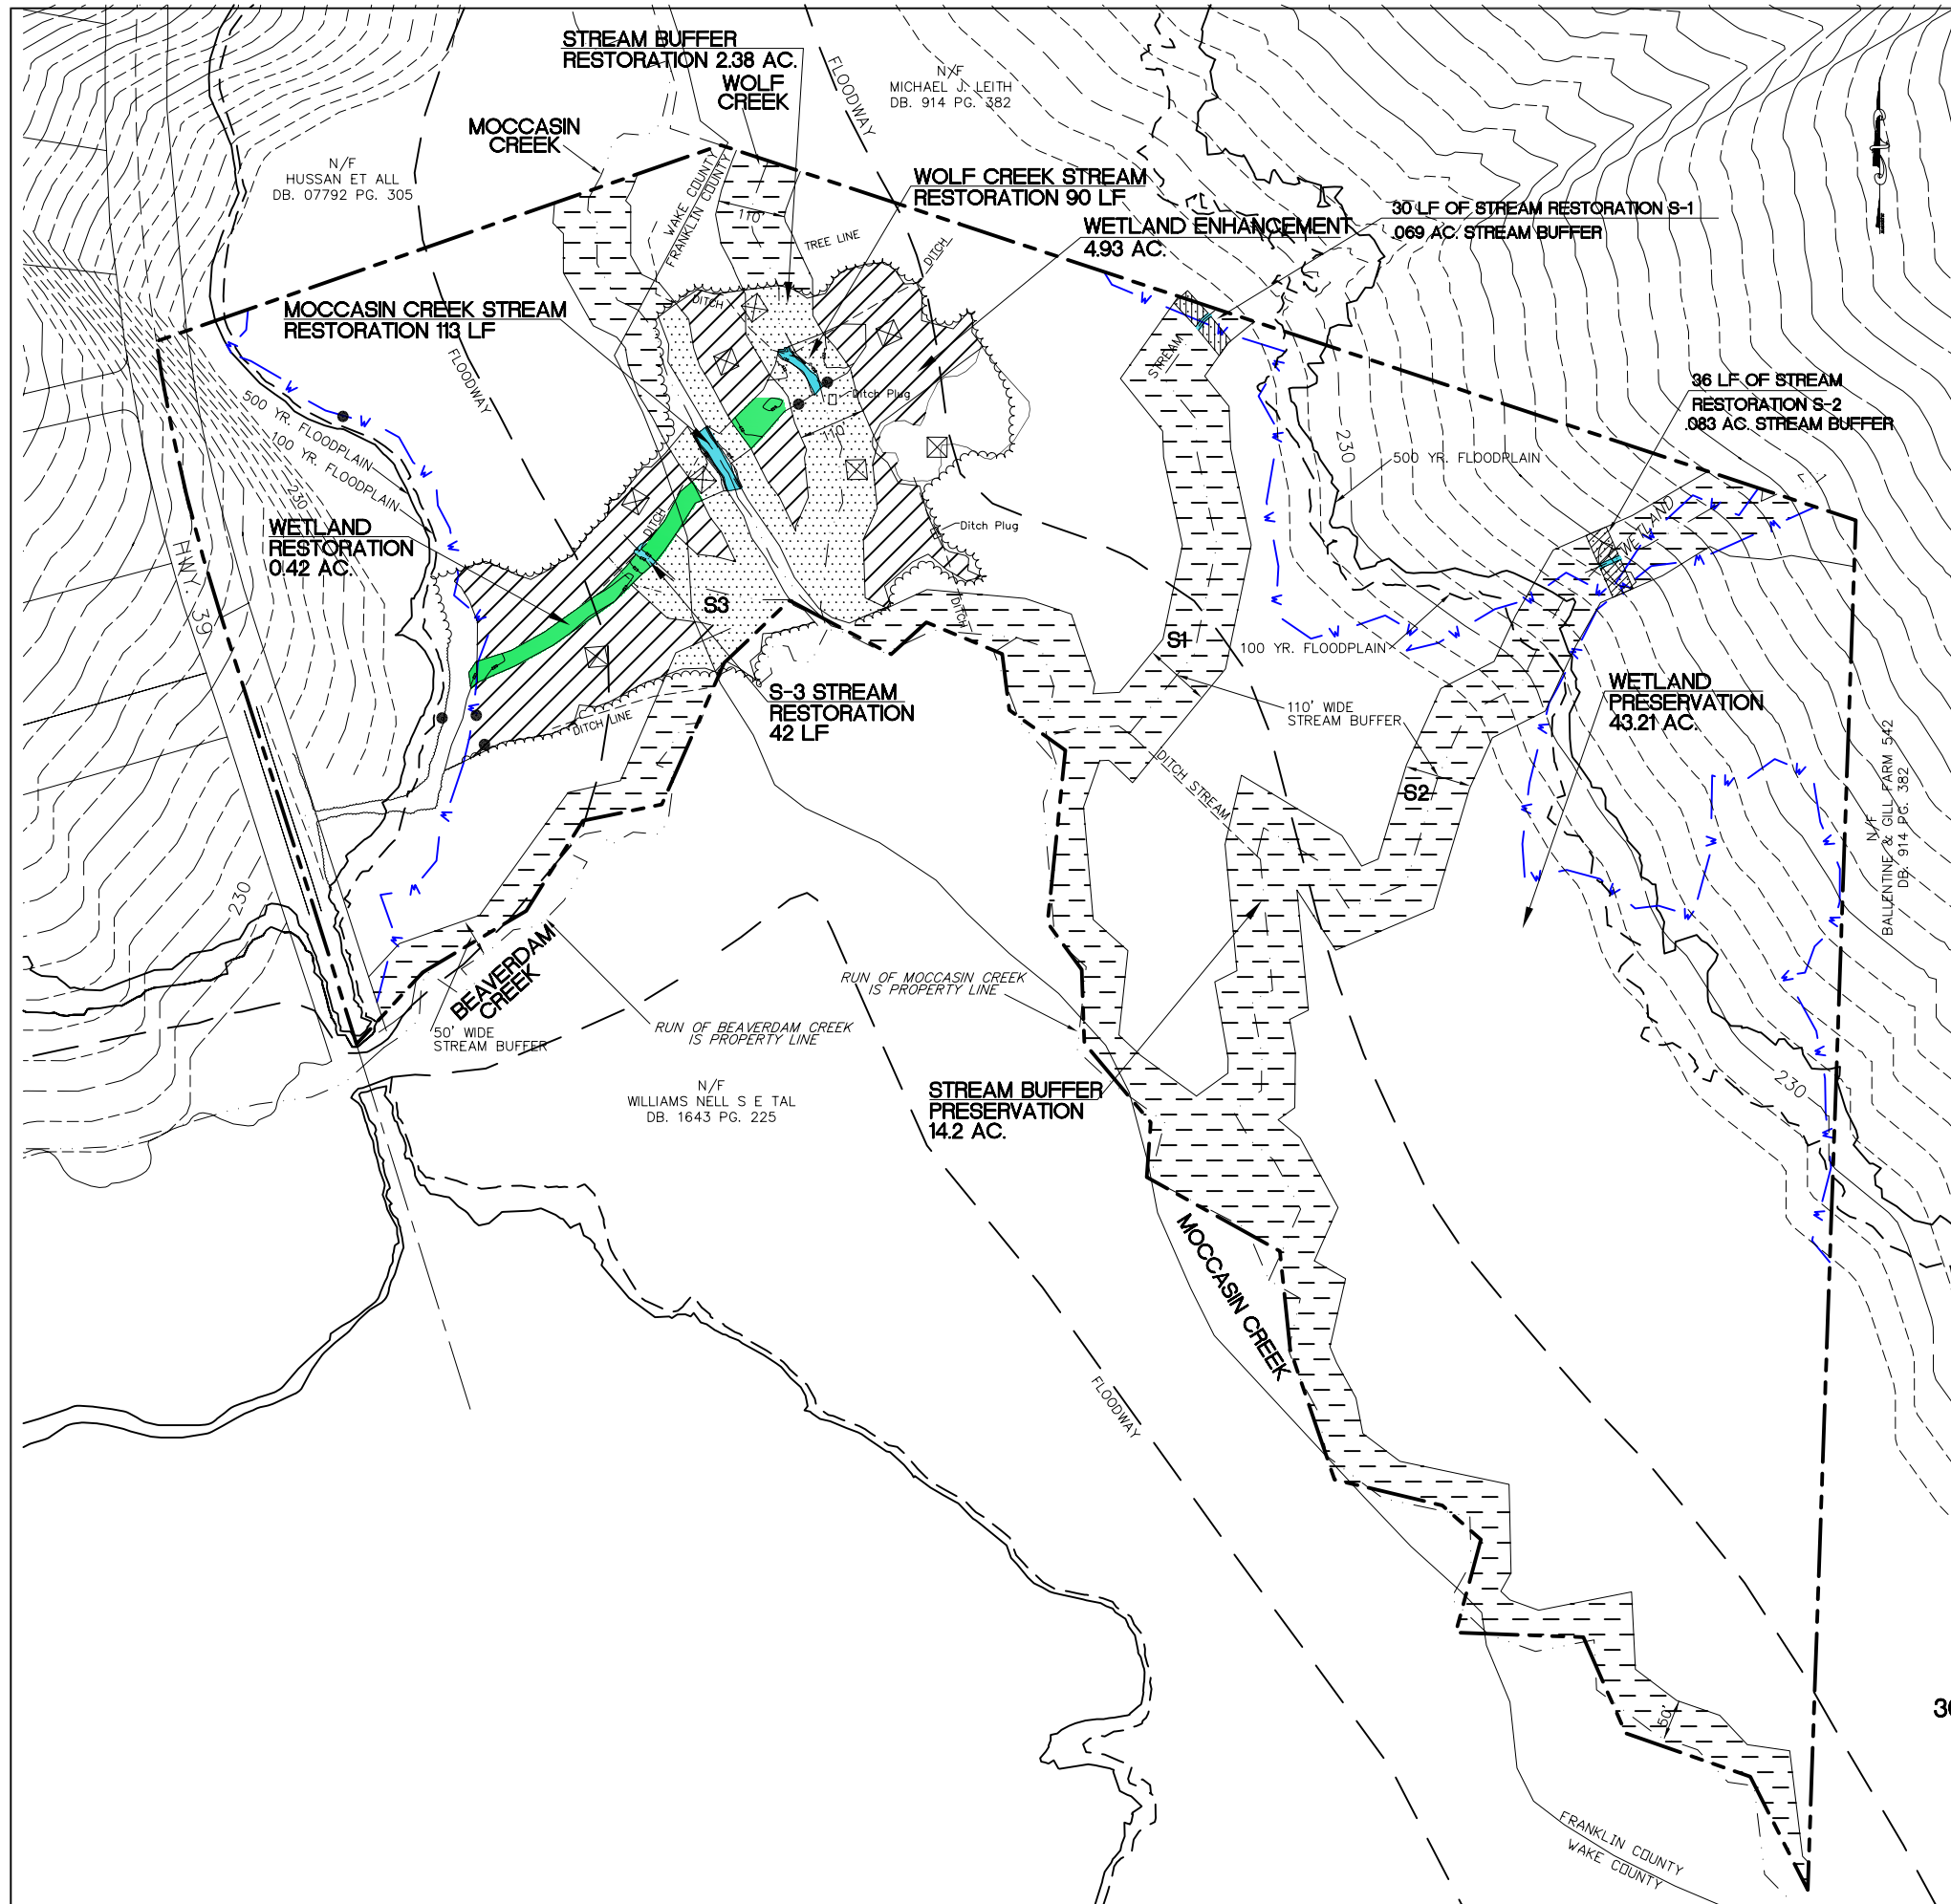
MOCCASIN CREEK
 AS-BUILT OVERALL SITE
 PROBLEM AREA PLAN

PROBLEM AREA IDENTIFICATION	
AREA	DESCRIPTION
1	Juncus dominated - plant larger trees
2	Patches of Polygonum pennsylvanicum and Polygonum sagittatum and other native plant species are out-competing trees - plant larger trees.
3	Patches of Rubus sp.-out and treat with herbicides
4	Patches of Polygonum sagittatum out-competing trees - plant larger trees.
[X]	Beaver Dam - remove
