Year 2 Monitoring Report

MOCKINGBIRD SITE

NCDMS Project # 100021 (Contract # 7185)
USACE Action ID: SAW-2017-01505
DWR Project #20171040

February 2023

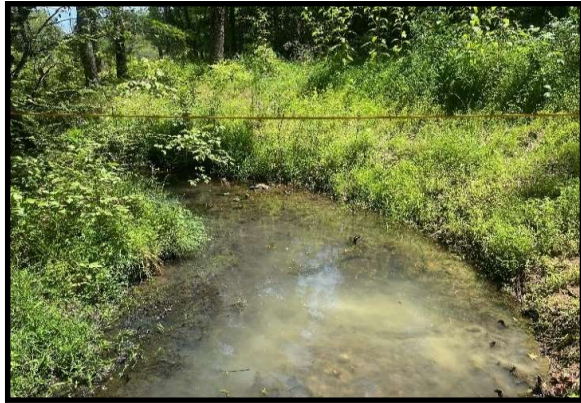
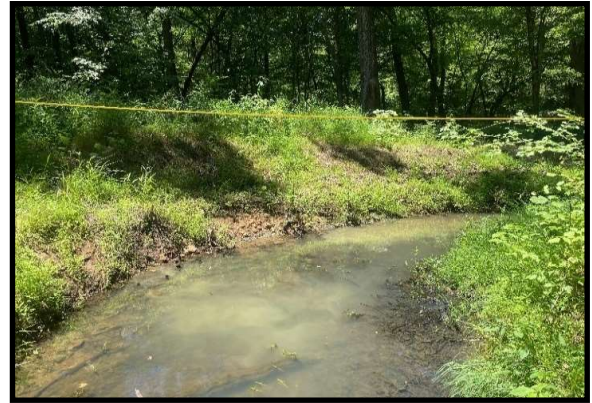
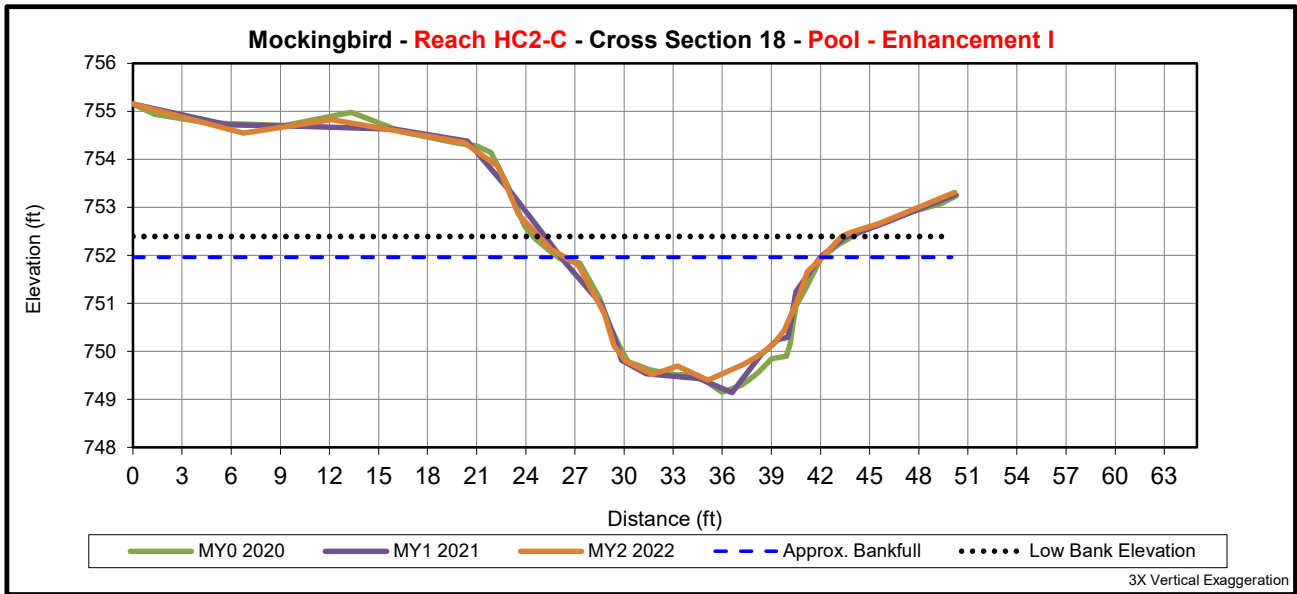
Cross Section 18 (Pool)						
	MY0	MY1	MY2	MY3	MY5	MY7	MY+
Bankfull Elevation (ft) - Based on AB-XSA¹	751.83	751.9	752.0				
Bankfull Width (ft) ¹	-	-	-				
Floodprone Width (ft) ¹	-	-	-				
Bankfull Max Depth (ft) ²	2.7	2.8	1.9				
Low Bank Elevation (ft)	751.83	752.0	752.4				
Bankfull Cross Sectional Area (ft ²) ²	26.8	28.3	34.3				
Bankfull Entrenchment Ratio ¹	-	-	-				
Bankfull Bank Height Ratio ¹	-	-	-

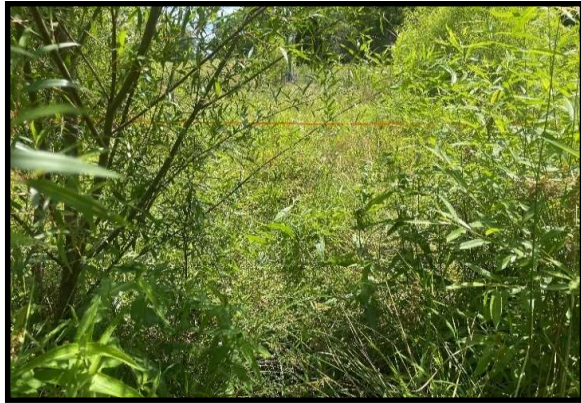
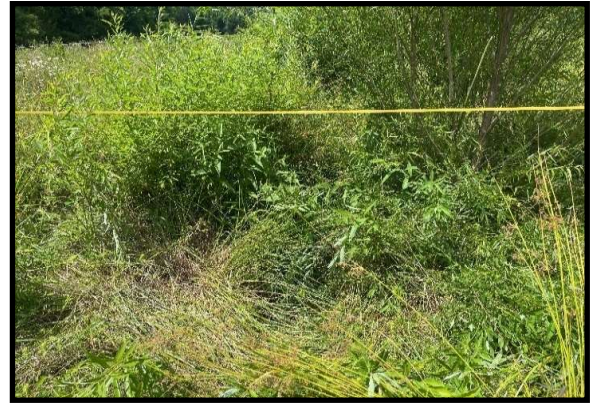
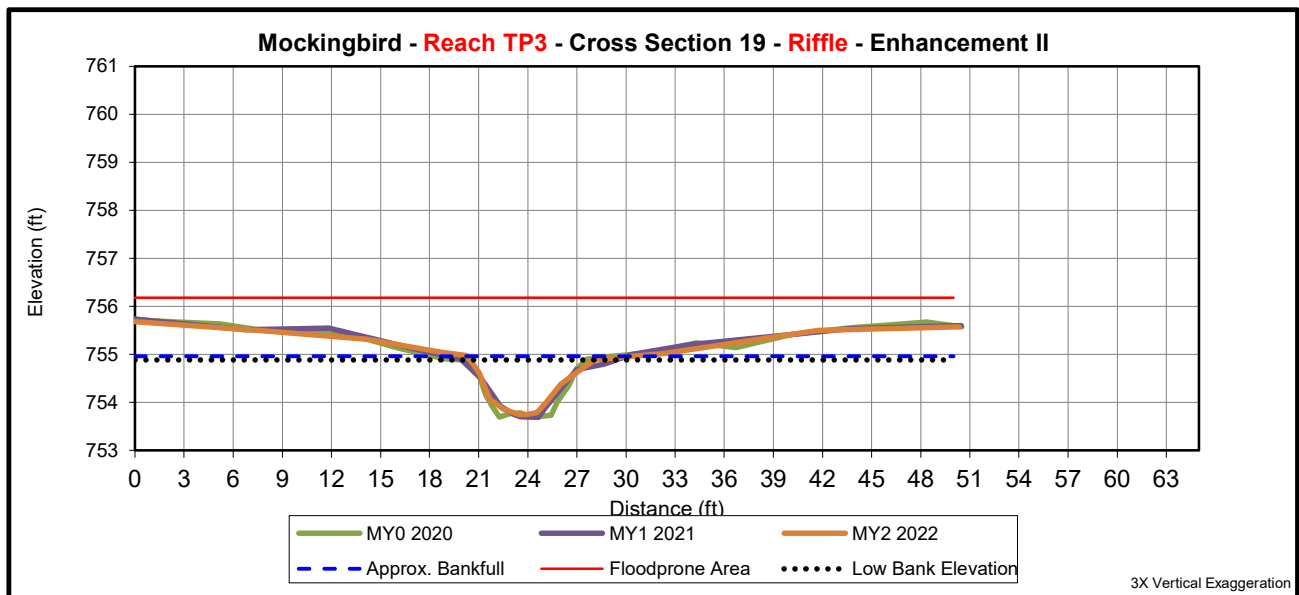
Cross Section 19 (Riffle)						
	MY0	MY1	MY2	MY3	MY5	MY7	MY+
Bankfull Elevation (ft) - Based on AB-XSA¹	754.87	754.9	755.0				
Bankfull Width (ft) ¹	7.1	9.7	10.2				
Floodprone Width (ft) ¹	>50.5	>50.5	>50.4				
Bankfull Max Depth (ft) ²	1.2	1.1	1.1				
Low Bank Elevation (ft)	754.87	754.8	754.9				
Bankfull Cross Sectional Area (ft ²) ²	5.8	4.8	5.2				
Bankfull Entrenchment Ratio ¹	>7.1	>5.2	>4.9				
Bankfull Bank Height Ratio ¹	1.0	0.9	0.9

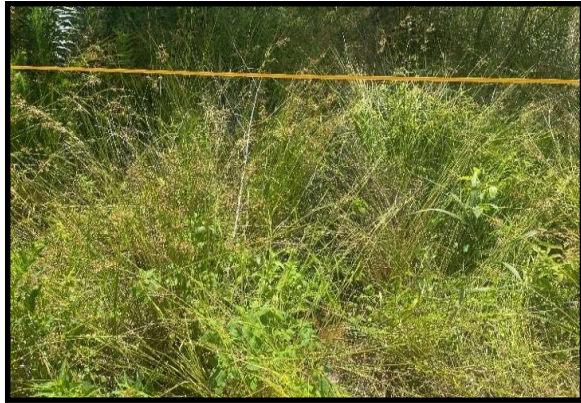
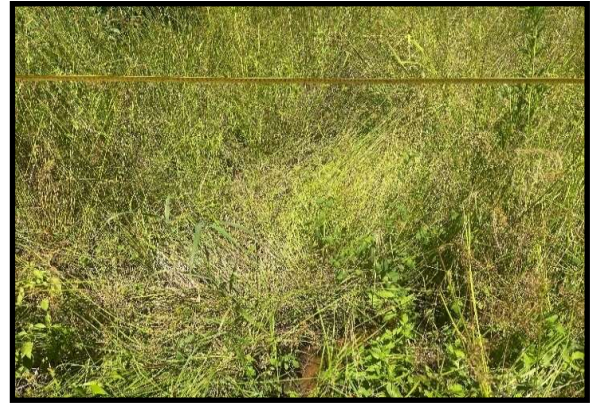
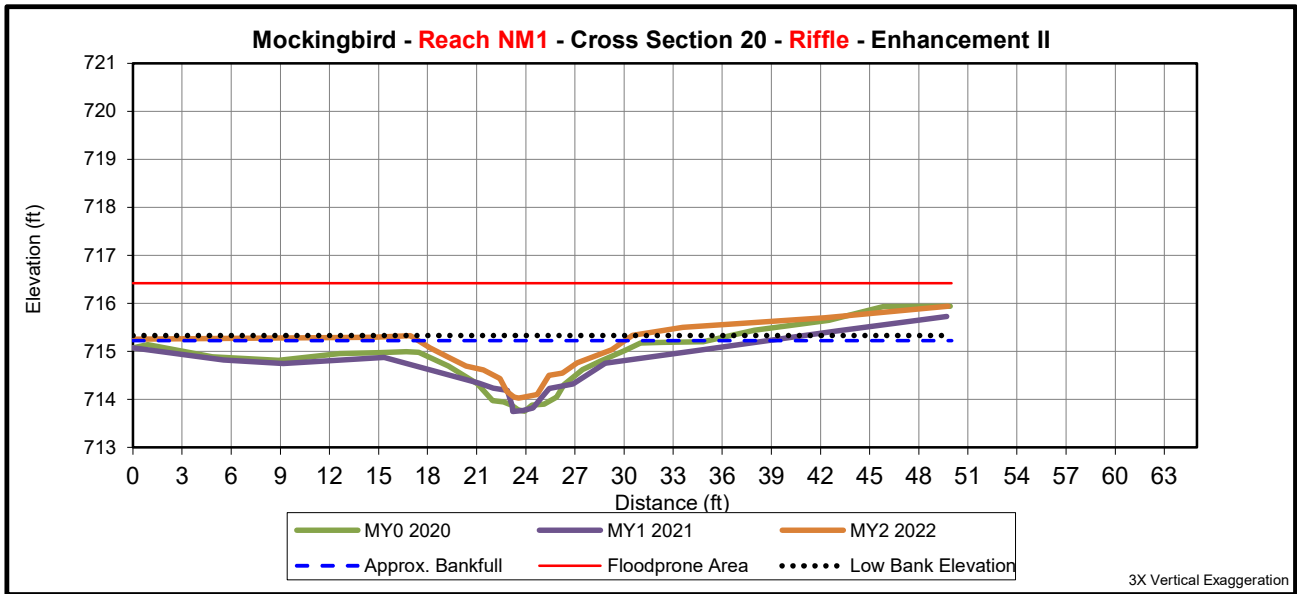
Cross Section 20 (Riffle)						
	MY0	MY1	MY2	MY3	MY5	MY7	MY+
Bankfull Elevation (ft) - Based on AB-XSA¹	714.99	714.9	715.2				
Bankfull Width (ft) ¹	12.4	16.9	12.6				
Floodprone Width (ft) ¹	>49.9	>49.7	>49.8				
Bankfull Max Depth (ft) ²	1.2	1.0	1.3				
Low Bank Elevation (ft)	714.99	714.8	715.3				
Bankfull Cross Sectional Area (ft ²) ²	7.5	5.1	8.5				
Bankfull Entrenchment Ratio ¹	>4.0	>2.9	>3.9				
Bankfull Bank Height Ratio ¹	1.0	0.9	1.1

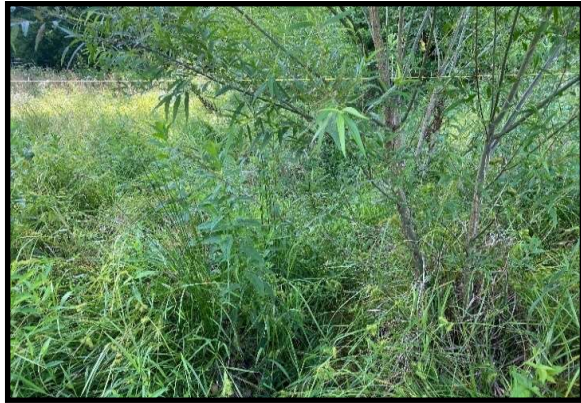
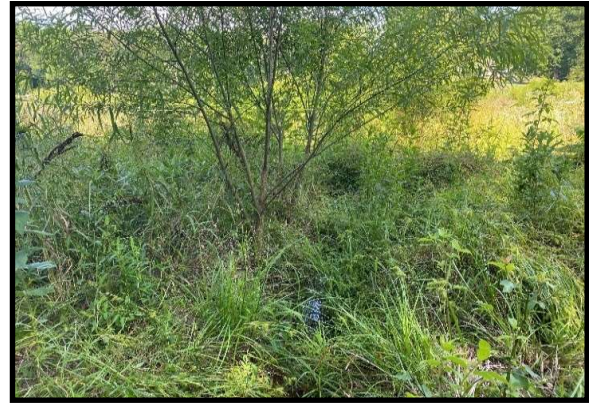
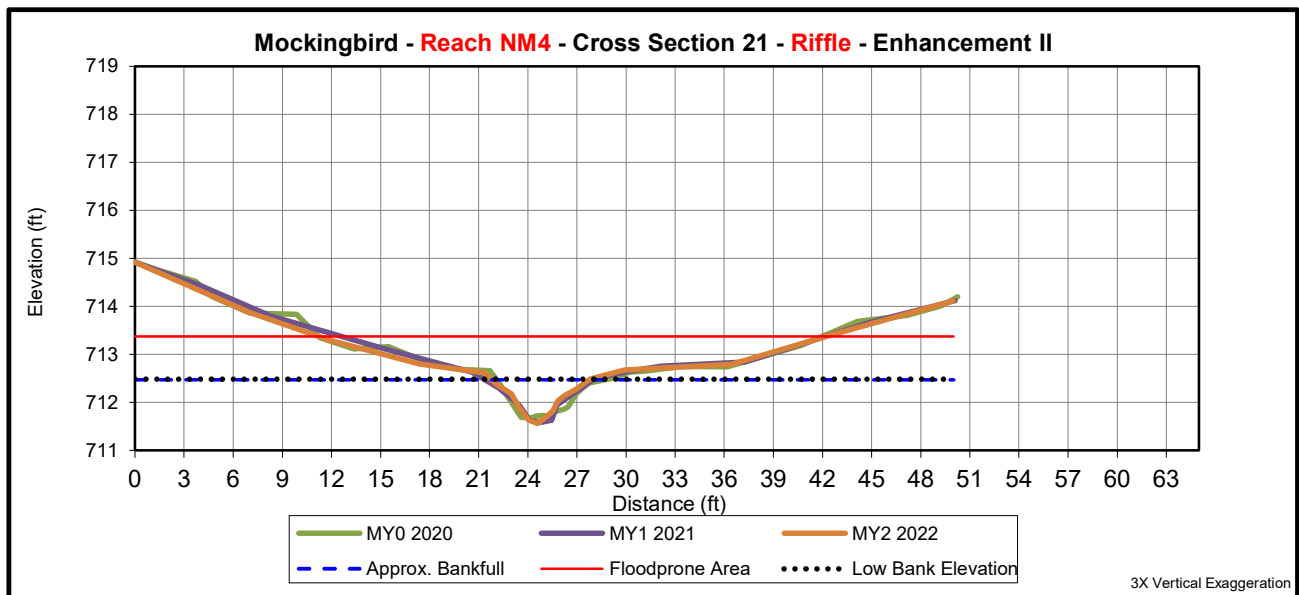
Cross Section 21 (Riffle)						
	MY0	MY1	MY2	MY3	MY5	MY7	MY+
Bankfull Elevation (ft) - Based on AB-XSA¹	712.40	712.4	712.5				
Bankfull Width (ft) ¹	5.5	6.1	6.0				
Floodprone Width (ft) ¹	24.7	6.1	31.0				
Bankfull Max Depth (ft) ²	0.7	1.1	0.9				
Low Bank Elevation (ft)	712.40	712.6	712.5				
Bankfull Cross Sectional Area (ft ²) ²	2.6	4.2	2.7				
Bankfull Entrenchment Ratio ¹	4.5	4.5	5.2				
Bankfull Bank Height Ratio ¹	1.0	1.3	1.0
