Year 3 Monitoring Report

MOCKINGBIRD SITE

NCDMS Project # 100021 (Contract # 7185)

January 2024

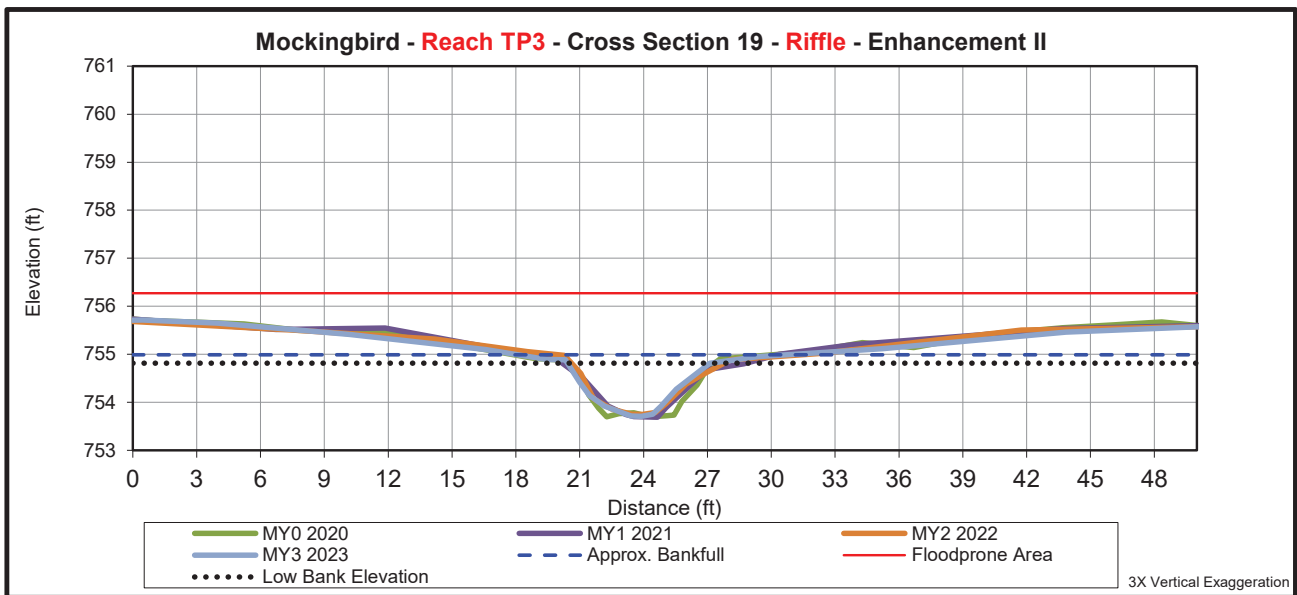
Cross Section 19 (Riffle)						
	MY0	MY1	MY2	MY3	MY5	MY7	MY+
Bankfull Elevation (ft) - Based on AB-XSA¹	754.87	754.9	755.0	755.0			
Bankfull Width (ft) ¹	7.1	9.7	10.2	6.8			
Floodprone Width (ft) ¹	>50.5	>50.5	>50.4	>50.3			
Bankfull Max Depth (ft) ²	1.2	1.1	1.1	1.1			
Low Bank Elevation (ft)	754.87	754.8	754.9	754.8			
Bankfull Cross Sectional Area (ft ²) ²	5.8	4.8	5.2	4.6			
Bankfull Entrenchment Ratio ¹	>7.1	>5.2	>4.9	>7.4			
Bankfull Bank Height Ratio ¹	1.0	0.9	0.9	0.9

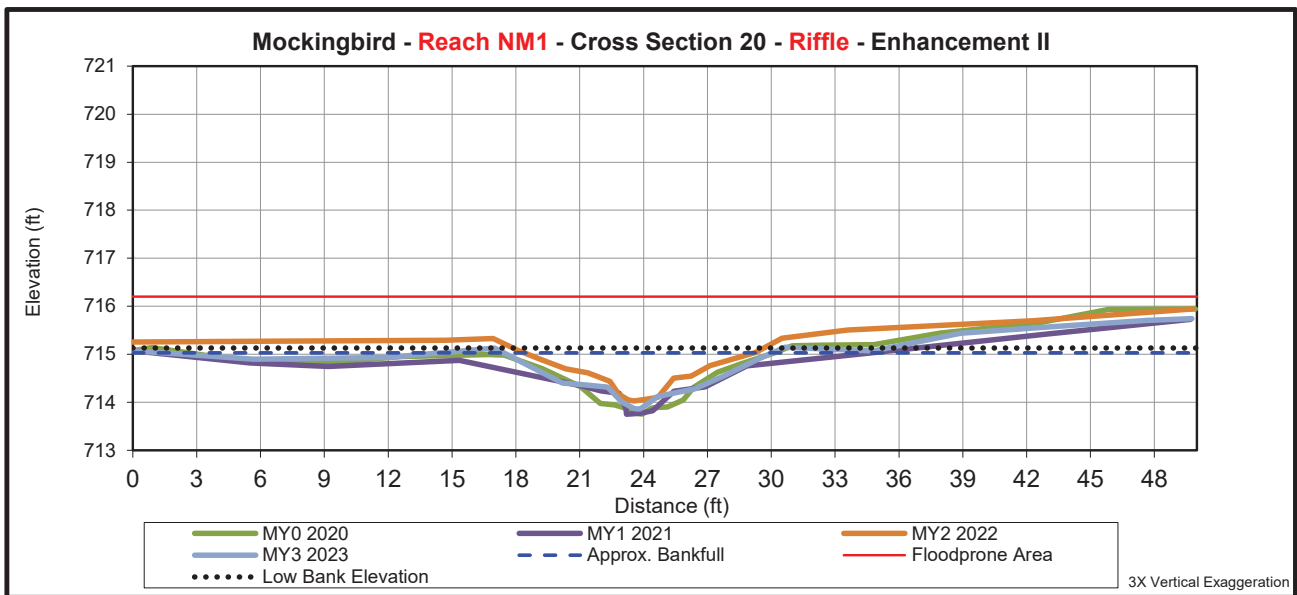
Cross Section 20 (Riffle)						
	MY0	MY1	MY2	MY3	MY5	MY7	MY+
Bankfull Elevation (ft) - Based on AB-XSA¹	714.99	714.9	715.2	715.0			
Bankfull Width (ft) ¹	12.4	16.9	12.6	12.6			
Floodprone Width (ft) ¹	>49.9	>49.7	>49.8	>49.8			
Bankfull Max Depth (ft) ²	1.2	1.0	1.3	1.3			
Low Bank Elevation (ft)	714.99	714.8	715.3	715.1			
Bankfull Cross Sectional Area (ft ²) ²	7.5	5.1	8.5	8.8			
Bankfull Entrenchment Ratio ¹	>4.0	>2.9	>3.9	>4.0			
Bankfull Bank Height Ratio ¹	1.0	0.9	1.1	1.1

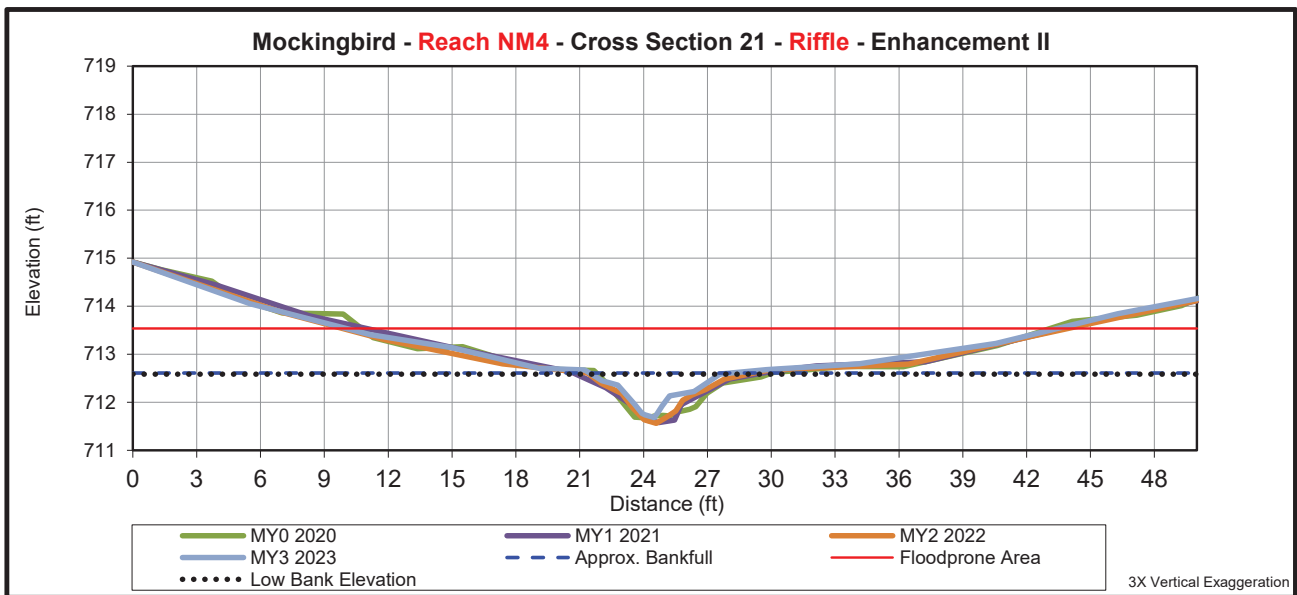
Cross Section 21 (Riffle)						
	MY0	MY1	MY2	MY3	MY5	MY7	MY+
Bankfull Elevation (ft) - Based on AB-XSA¹	712.40	712.4	712.5	712.6			
Bankfull Width (ft) ¹	5.5	6.1	6.0	6.1			
Floodprone Width (ft) ¹	24.7	6.1	31.0	33.4			
Bankfull Max Depth (ft) ²	0.7	1.1	0.9	0.9			
Low Bank Elevation (ft)	712.40	712.6	712.5	712.6			
Bankfull Cross Sectional Area (ft ²) ²	2.6	4.2	2.7	2.4			
Bankfull Entrenchment Ratio ¹	4.5	4.5	5.2	5.4			
Bankfull Bank Height Ratio ¹	1.0	1.3	1.0	1.0

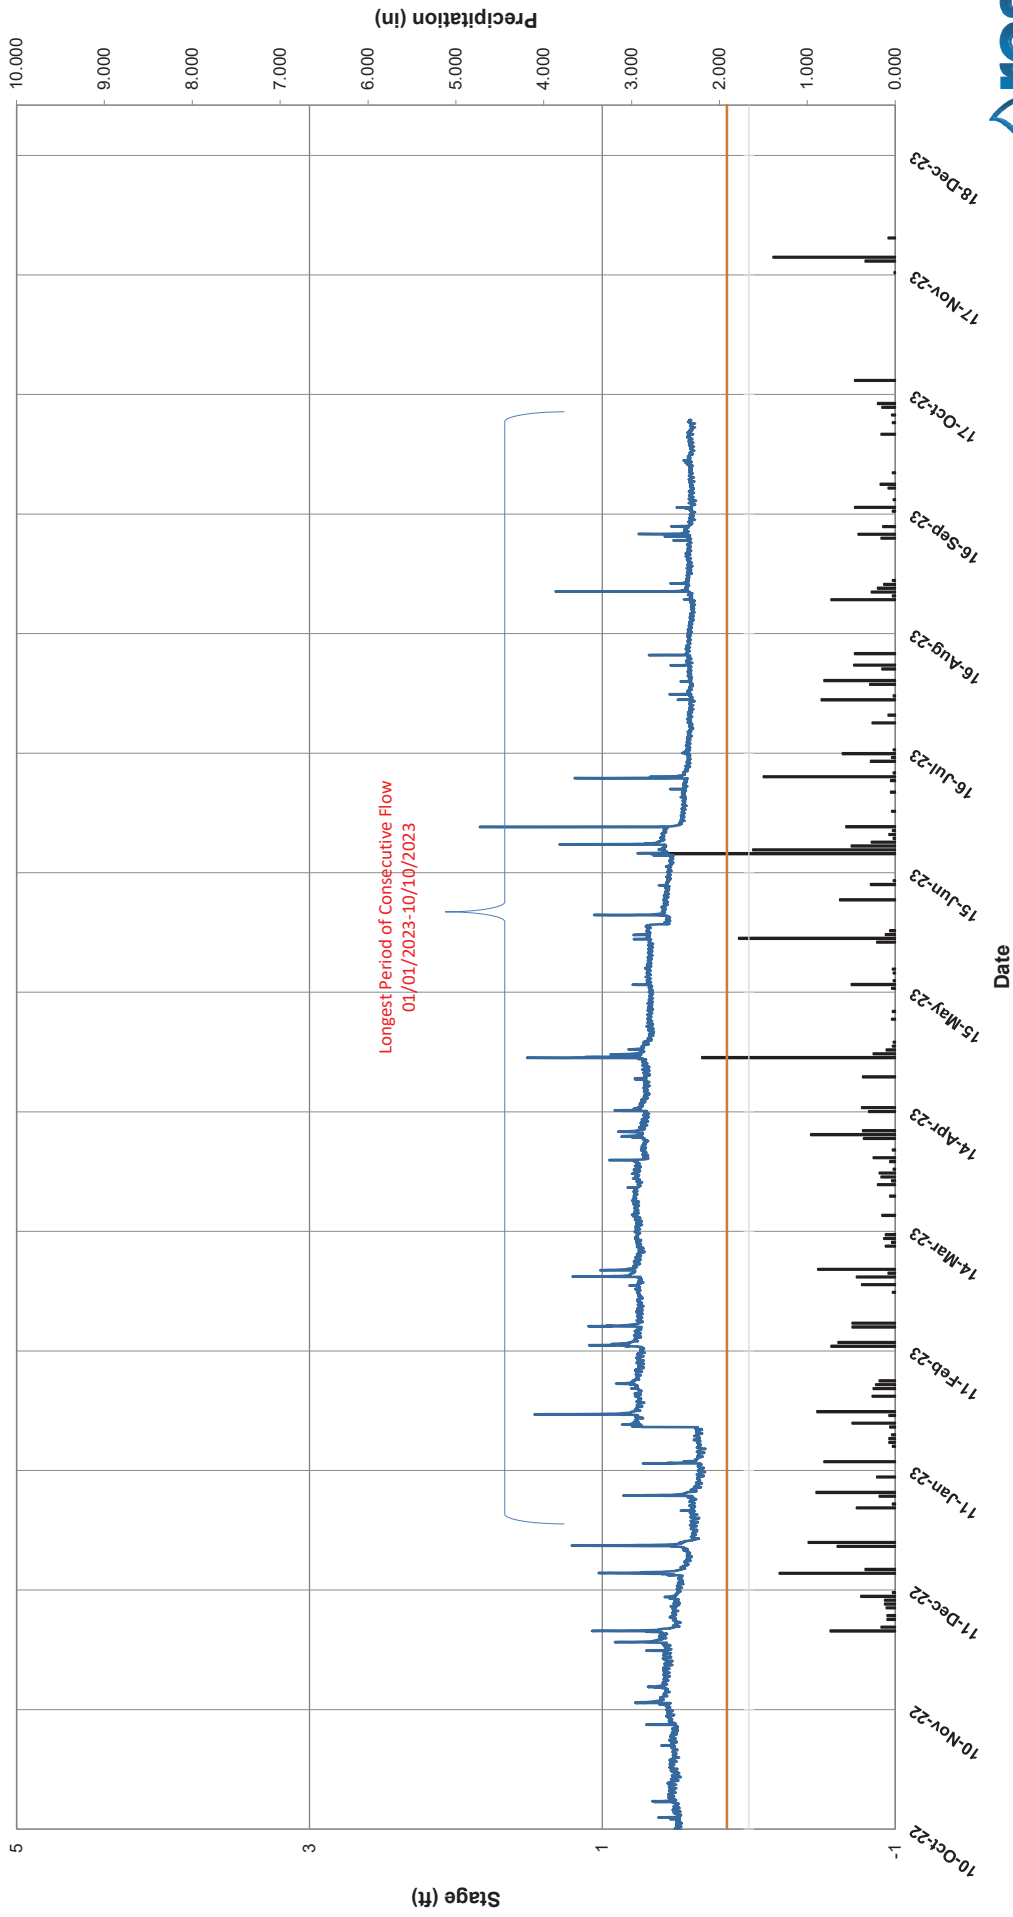
2023 Mockingbird NM4 Flow Gauge Graph

282 Consecutive Days of Hydrology
01/01/2023 - 10/10/2023
