**Modlin Property Wetland Mitigation Project
Martin County, NC**

**2010 Annual Monitoring Report
Year 4**

**NCEEP Project Number D050241
Roanoke River Basin**

Date: October, 2010

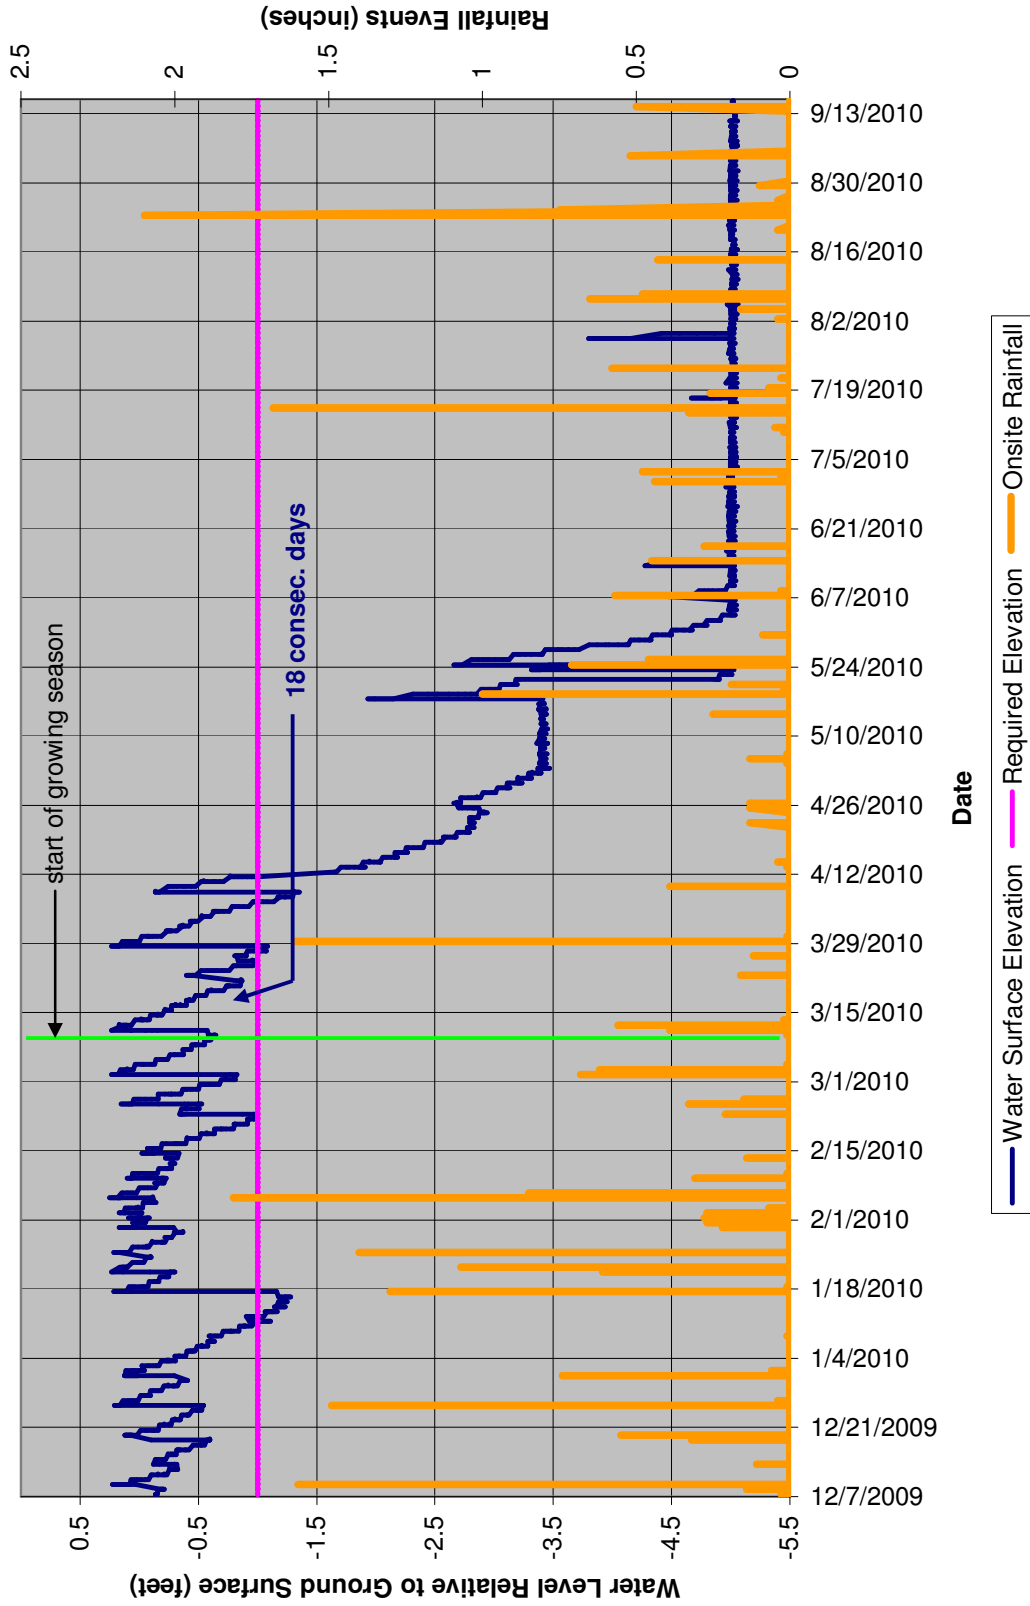
Modlin Monitoring Gauge #1A (2342650)

Table C-1															
Longest Consecutive Successful Hydrologic Period in Days and Success at 5% and 8% of Growing Season															
Gauge	Year 1			Year 2			Year 3			Current Year			Year 5		
	Days	5%	8%	Days	5%	8%	Days	5%	8%	Days	5%	8%	Days	5%	8%
1	4	N	N	6	N	N	9	N	N	4	N	N			
1A	N/A	---	---	N/A	---	---	12	N	N	18	Y	N			
2	7	N	N	97	Y	Y	52	Y	Y	41	Y	Y			
3	1	N	N	15	Y	N	48	Y	Y	27	Y	Y			
4	4	N	N	16	Y	N	25	Y	Y	12	N	N			
5	2	N	N	61	Y	Y	59	Y	Y	31	Y	Y			
6	2	N	N	18	Y	Y	48	Y	Y	35	Y	Y			
7(Ref)	N/A	N		37	Y	Y	61	Y	Y	39	Y	Y
