Year 2 Monitoring Report

MONKEY WALL PROJECT

NCDMS Project #100069 (Contract #7536)
USACE Action ID: 2018-01162
DWR Project #20181029

Mitchell County, North Carolina
French Broad River Basin
HUC 06010108

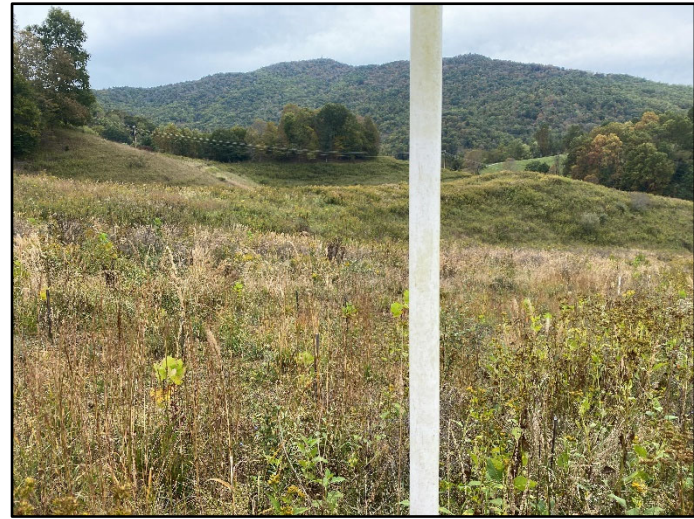
Minor monitoring device location changes were made during as-built installation; however, the quantities remained as proposed in the Final Mitigation Plan. Vegetation Plot 10 was moved downslope due to slippery, steep conditions during installation; vegetation plot 8 was also moved slightly downslope, due to extremely steep conditions, but is still very much on the slope. The original installation of two fixed vegetation plots, 6 and 7, interfered with the relocated powerline easement and were therefore shifted outside of the right-of-way on May 3, 2022. There were no changes made to the planting plan between Final Mitigation Plan and planting. However, in response to IRT comments on the Draft Mitigation Plan, understory species were added to the proposed planting plan.

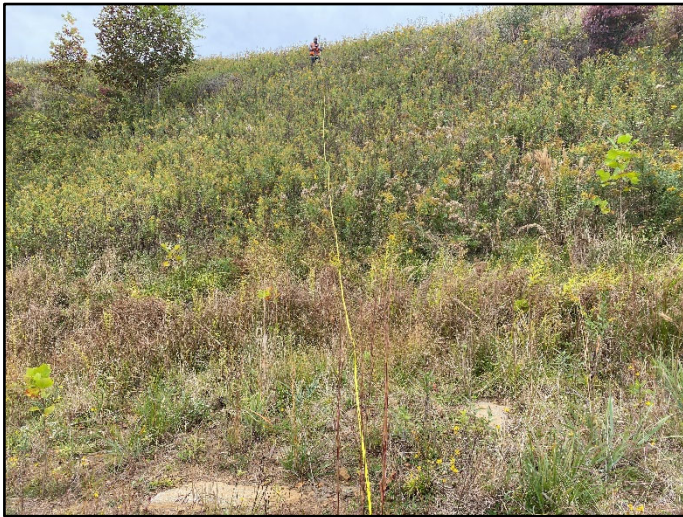
Random Vegetation Plot 2

the vicinity of MY1 random plot one (RVP1) to determine whether needed supplemental planting was warranted. With the higher detection rate of trees beginning to outgrow herbaceous cover of RVP2, RES is not currently scheduling supplemental planting in this area, however will continue to monitor vegetative succession and implement additional plantings when found beneficial. Planted stem densities ranged from 405 to 688 planted stems per acre with an average of 483 planted stems per acre across all plots. A total of 12 species were documented within the plots. Volunteer species were not noted during MY2 but are expected to establish in upcoming years. The average stem height in the plots was 1.9 feet.

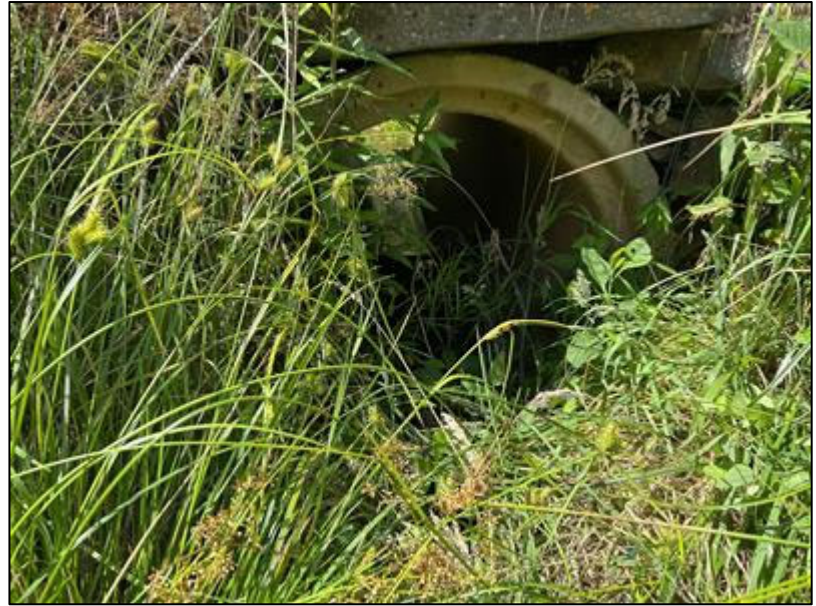
Culvert Looking Downstream

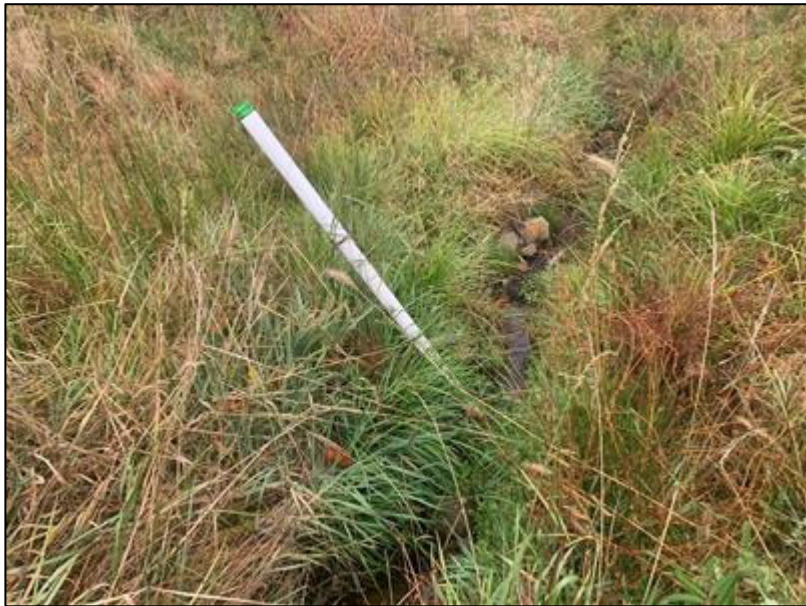
Stage Recorder G1C (Below Confluence)

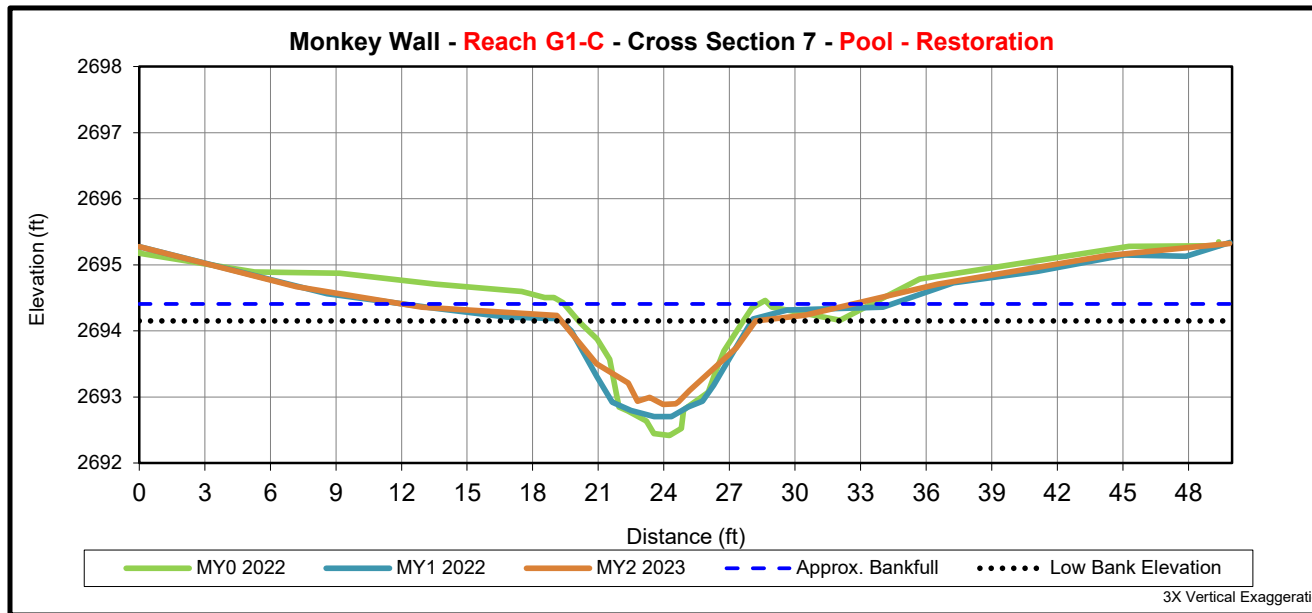
Cross Section 7 (Pool)						
	MY0	MY1	MY2	MY3	MY5	MY7	MY+
Bankfull Elevation (ft) - Based on AB-XSA¹	2694.3	2694.2	2694.4				
Bankfull Width (ft) ¹	-	-	-				
Floodprone Width (ft) ¹	-	-	-				
Bankfull Max Depth (ft) ²	1.9	1.5	1.3				
Low Bank Elevation (ft)	2694.3	2694.2	2694.2				
Bankfull Cross Sectional Area (ft ²) ²	9.1	8.6	6.7				
Bankfull Entrenchment Ratio ¹	-	-	-				
Bankfull Bank Height Ratio ¹	-	-	-

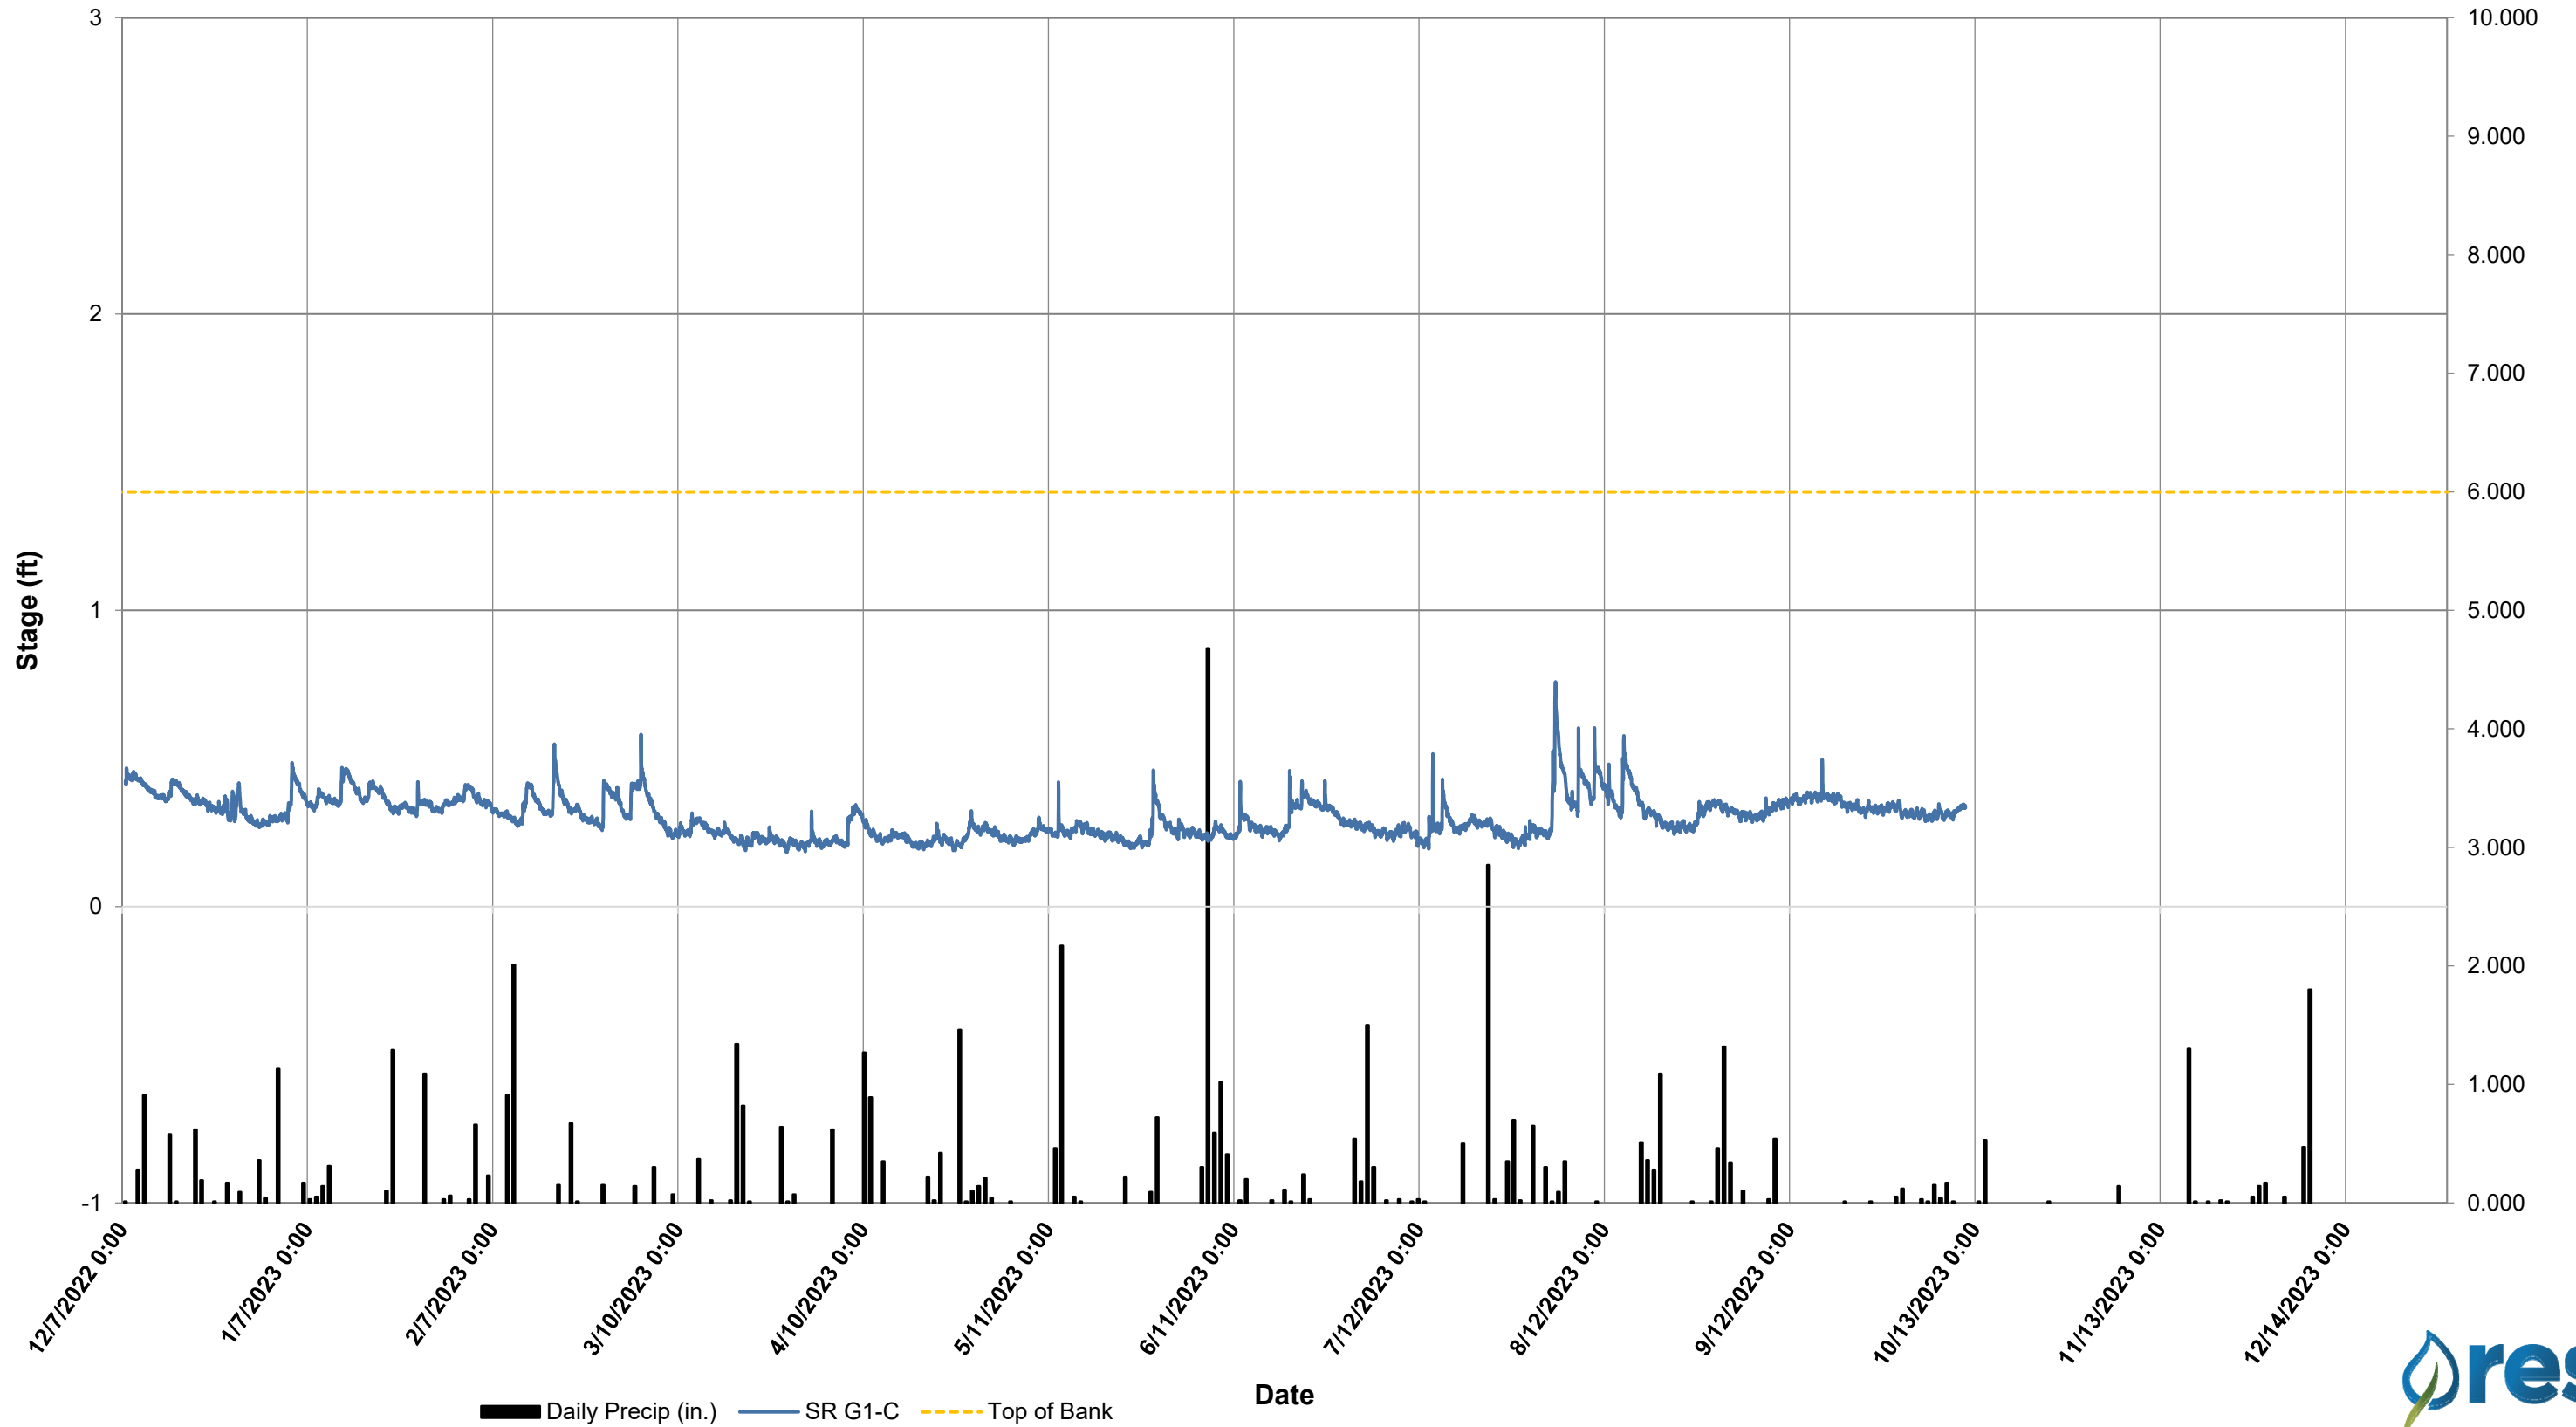
2023 Monkey Wall G1 Stage Recorder Graph

MY2; however the stage recorder on G1 did not experience any out of bank events. Reaches G1 and G2, above the confluence, have slopes between 12-14%. Overbank events at these slopes are far more likely to cause significant erosion due to increased flow velocities. With this in mind, these reaches were not designed to reach bankfull stage as often as below the confluence (8% slope). This is particularly true in the early stages of the Project where channel roughness is lower and floodplain vegetation/stability has not fully developed. RES has installed an additional stage recorder below the confluence to support evidence of out of bank events, however, does not have enough data to present yet. The flow gauge on G1-C recorded one event, which lasted 278 days. The flow gauge on G2 recorded 2 events, lasting three days. We believe this level of flow tracking is due to the subsurface flow path and will be investigated and remedied. Stream hydrology data is included in **Appendix E**. Gauge locations can be found on **Figure 2** and photos are in **Appendix B**.
