MONITORING YEAR 4

ANNUAL REPORT

MOORES FORK STREAM MITIGATION PROJECT

DMS Project Number 94709

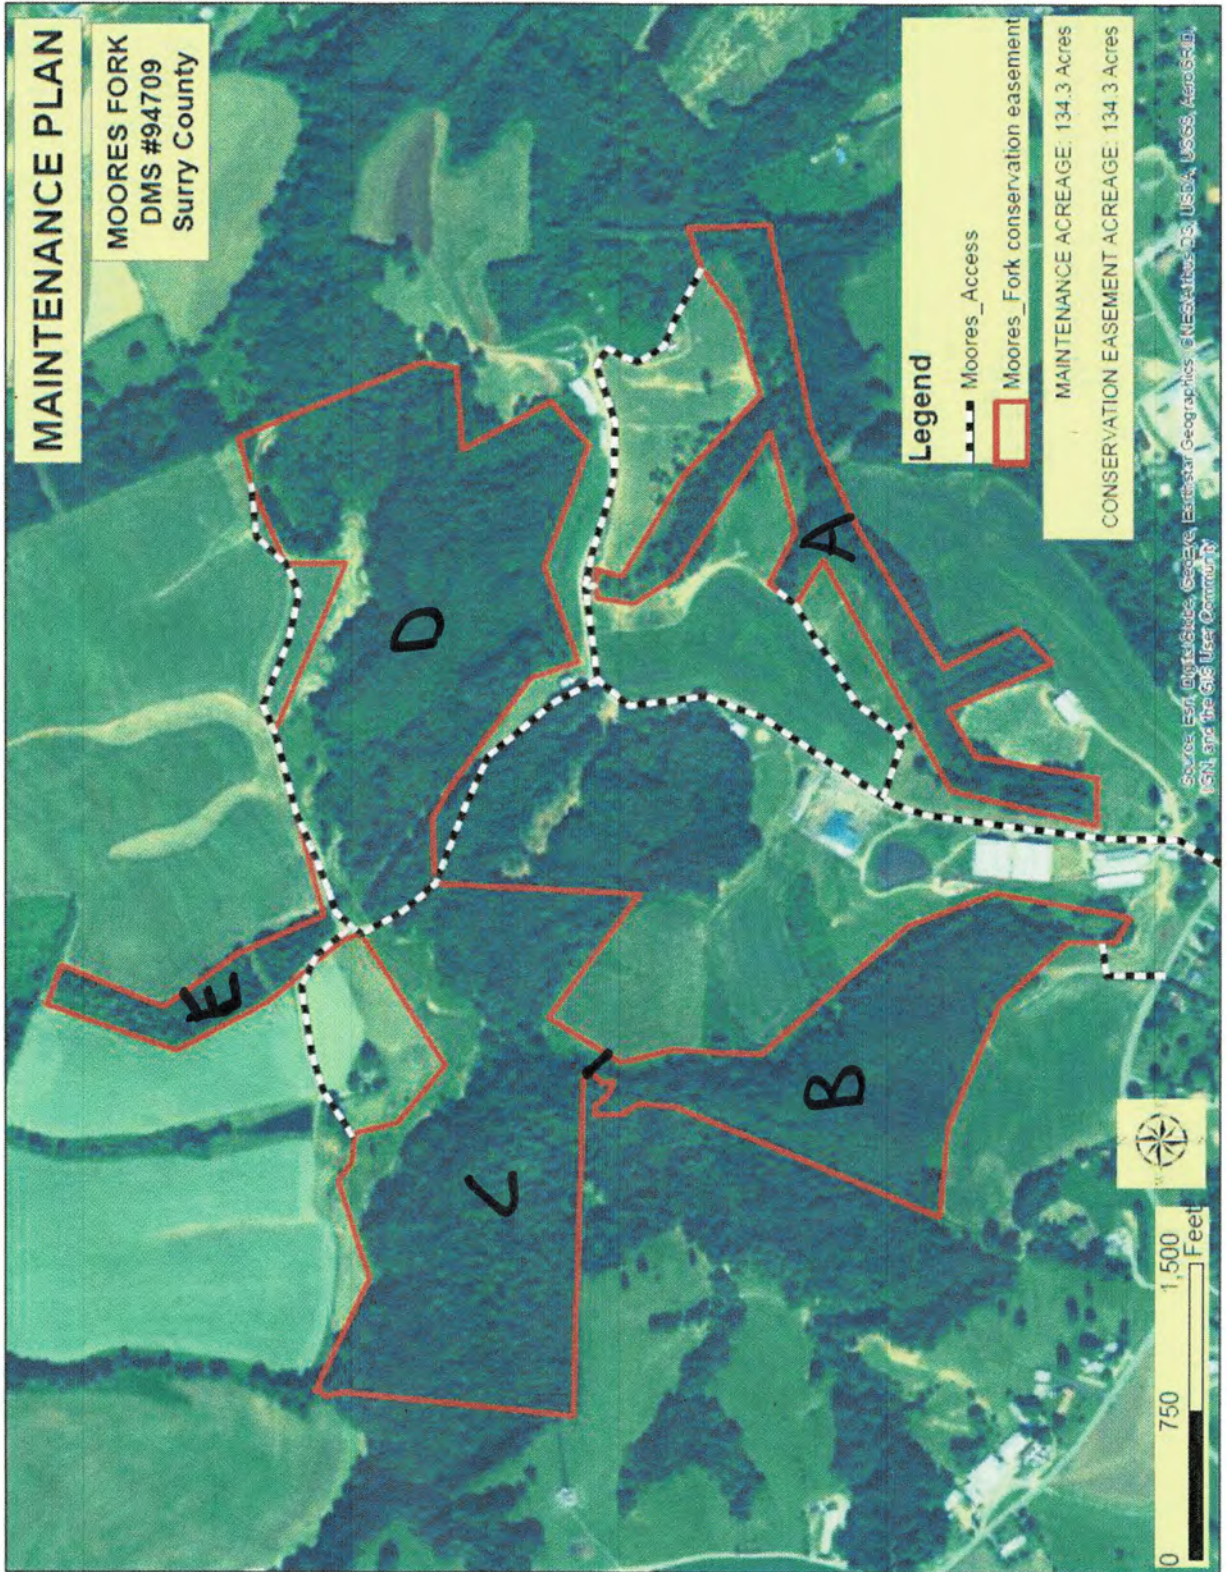
EFL Management Units

- **Management Area A-** July 5th, 6th, and 11th was spent spraying in Management Area A. Invasive species found in the management area include Japanese honeysuckle, kudzu, Chinese privet, multi-flora rose and oriental bittersweet. There were large amounts of honeysuckle sprayed in the cove area on the south side, along with a small area of kudzu. Chinese privet was scattered throughout all of the area, some spots being denser with the species than others. The herbicide used to spray all species, except kudzu, was Rodeo. Rodeo was used at a rate of 5oz per gallon. The kudzu was controlled with Transline at an approximate rate of 10 oz per acre (half the amount allowed on a site in one year).

- **Management Area B-** July 10th and 11th was spent treating Management Area B. Invasive species found in the area include Japanese honeysuckle, kudzu, Chinese privet, multi-flora rose and oriental bittersweet. Honeysuckle and bittersweet had a well-established presence in the area. There was also a small patch of kudzu that was starting to work its way back into the forested area. Rodeo was used at a rate of 5oz per gallon. The kudzu was controlled with Transline at an approximate rate of 10 oz per acre. Several ailanthus and paulownia trees were treated via hack and squirt.

- **Management Area C-** Management Area C was treated on July 11th and 12th. Invasive species found in the management area include Japanese honeysuckle, kudzu, Chinese privet, multi-flora rose and oriental bittersweet. The area was not heavily populated with invasive species. The south side of the stream was more heavily populated, but was still sporadic. Rodeo was used at a rate of 5oz per gallon. The kudzu was controlled with Transline at an approximate rate of 10 oz per acre.

- **Management Area D-** Management Area D was treated on July 11th and 12th. Invasive species found in the management area include Japanese honeysuckle, kudzu, Chinese privet, multi-flora rose and oriental bittersweet. Invasive species populations in this area were sporadic but dense when found. Rodeo was used at a rate of 5oz per gallon. The kudzu was controlled with Transline at an approximate rate of 10 oz per acre. Some ailanthus trees were flagged to be hacked and squirted on the next application.

- **Management Area E-** Management Area E was treated on the afternoon of July 10th and 12th. Invasive species found in the management area include Japanese honeysuckle, kudzu, Chinese privet, multi-flora rose and Oriental bittersweet. The area was dense in honeysuckle, and bittersweet and had some dense areas of kudzu on the outer edges. Rodeo was used at a rate of 5oz per gallon. The kudzu was controlled with Transline at an approximate rate of 10 oz per acre.

- Kudzu was found to be more abundant than originally noted on the site assessment report. A map is attached to this memo noting the kudzu that was located and treated in the field.

- All kudzu locations identified in 2018 were treated with Transline on 7/24/2019. Each position was given a ranking with “3” noting a heavy infestation, “2” noting a moderate infestation, and “1” or “0” noting a light infestation/none found. A follow-up treatment will be conducted later in 2019 on areas ranked with a “3” or “2”.
