MONITORING YEAR 5

MOORES FORK STREAM MITIGATION PROJECT

Surry County, NC

DMS Project Number 94709

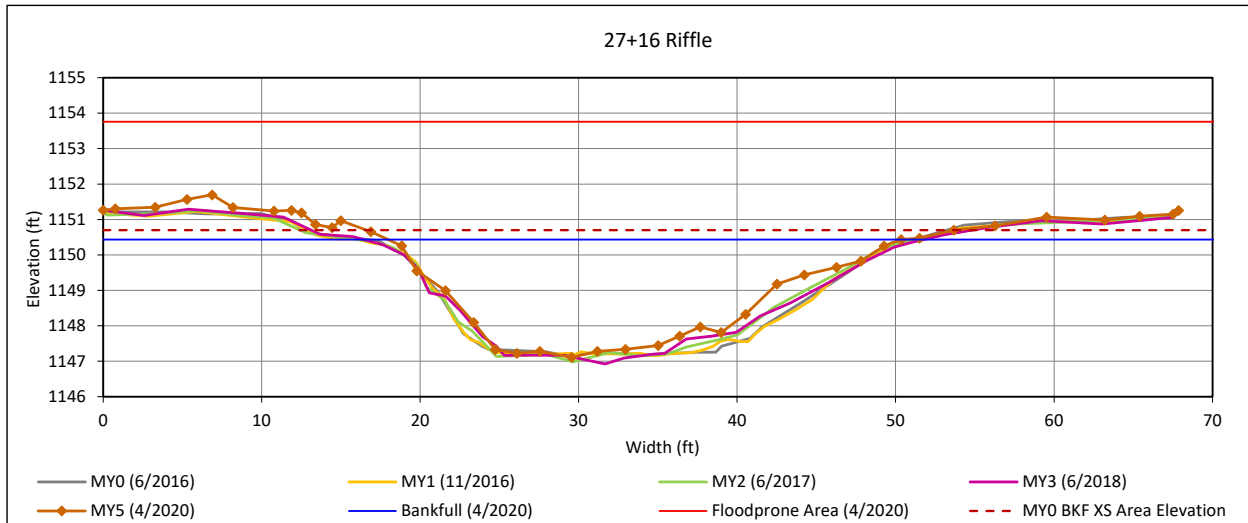
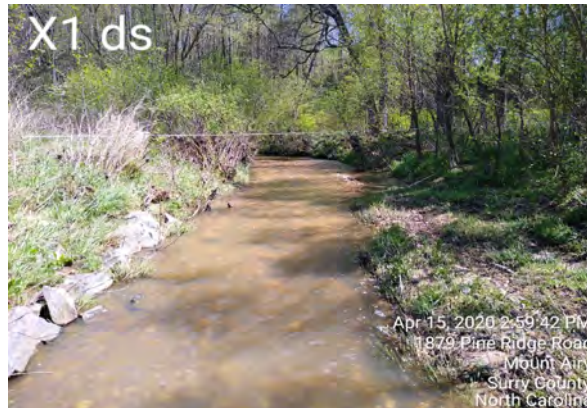
Cross-Section M1- Moore's Fork

65.3	x-section area (ft.sq.)
32.4	width (ft)
2.0	mean depth (ft)
3.3	max depth (ft)
33.6	wetted perimeter (ft)
1.9	hydraulic radius (ft)
16.0	width-depth ratio
145.0	W flood prone area (ft)
4.5	entrenchment ratio
0.9	low bank height ratio

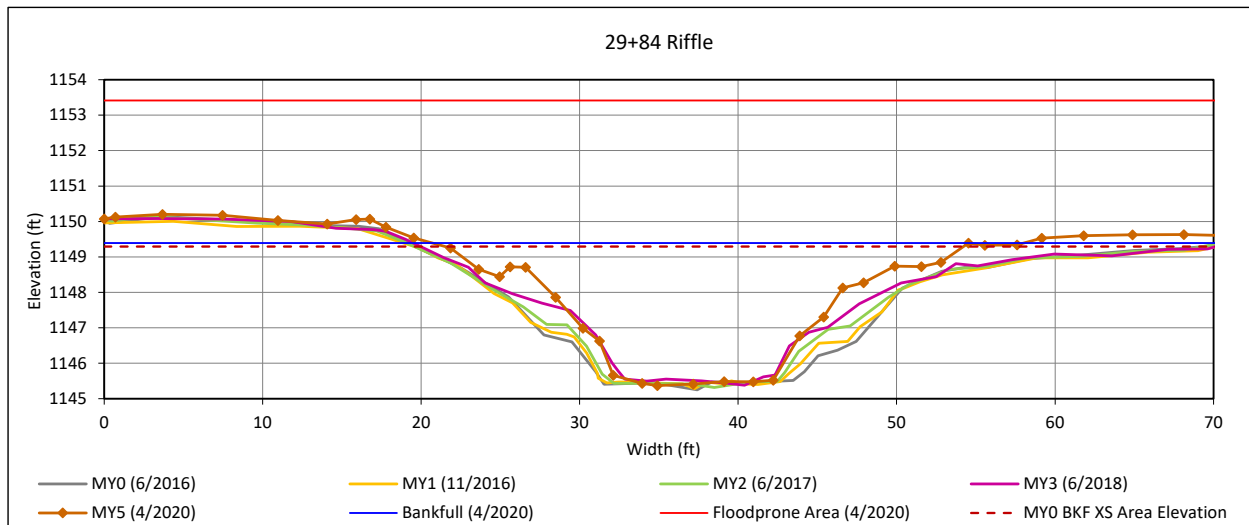
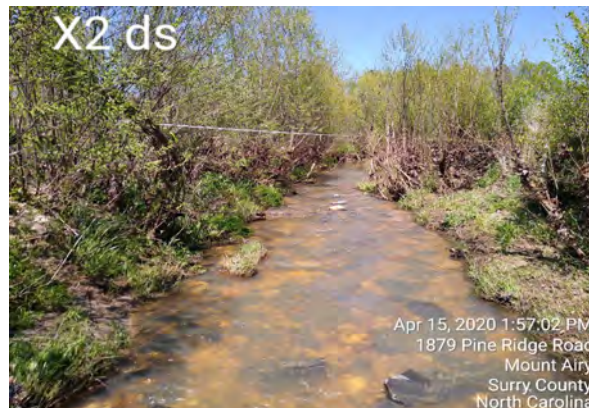
Cross-Section M2- Moores Fork

70.5	x-section area (ft.sq.)
33.8	width (ft)
2.1	mean depth (ft)
4.0	max depth (ft)
35.8	wetted perimeter (ft)
2.0	hydraulic radius (ft)
16.2	width-depth ratio
145.0	W flood prone area (ft)
4.3	entrenchment ratio
1.0	low bank height ratio

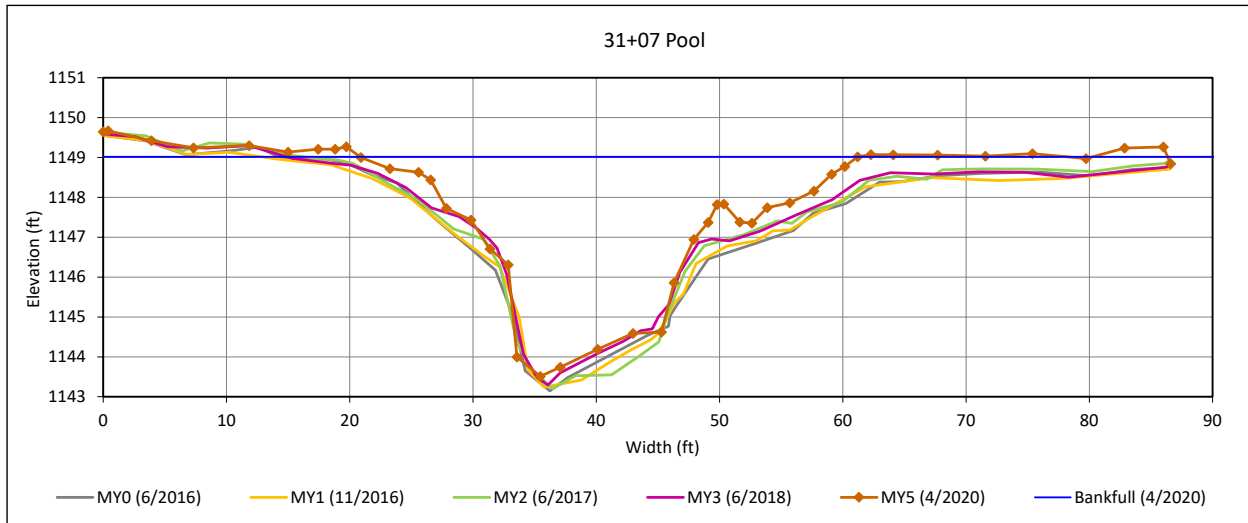
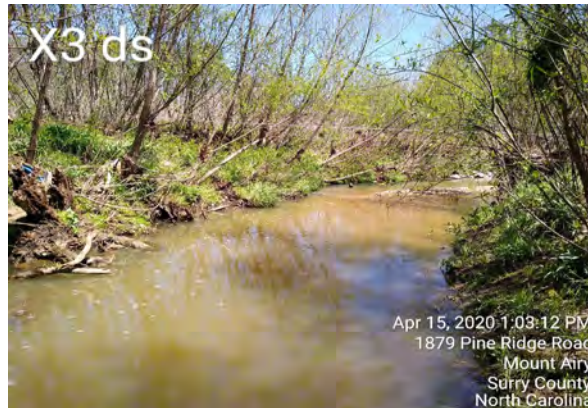
Cross-Section M3- Moores Fork

95.5	x-section area (ft.sq.)
40.4	width (ft)
2.4	mean depth (ft)
5.5	max depth (ft)
44.1	wetted perimeter (ft)
2.2	hydraulic radius (ft)
17.1	width-depth ratio

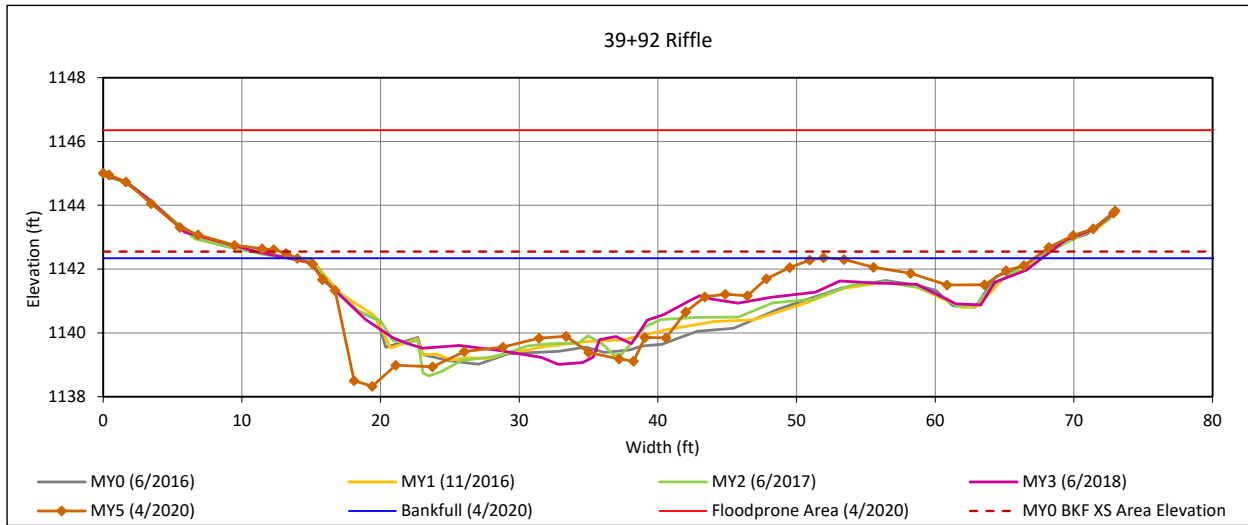
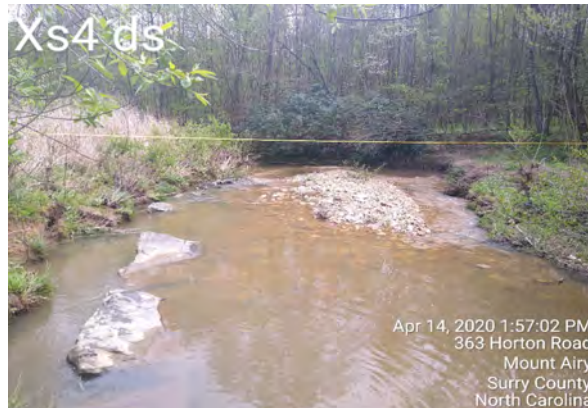
Cross-Section M4- Moores Fork

89.9	x-section area (ft.sq.)
52.4	width (ft)
1.7	mean depth (ft)
4.0	max depth (ft)
55.6	wetted perimeter (ft)
1.6	hydraulic radius (ft)
30.5	width-depth ratio
124.0	W flood prone area (ft)
2.4	entrenchment ratio
0.95	low bank height ratio

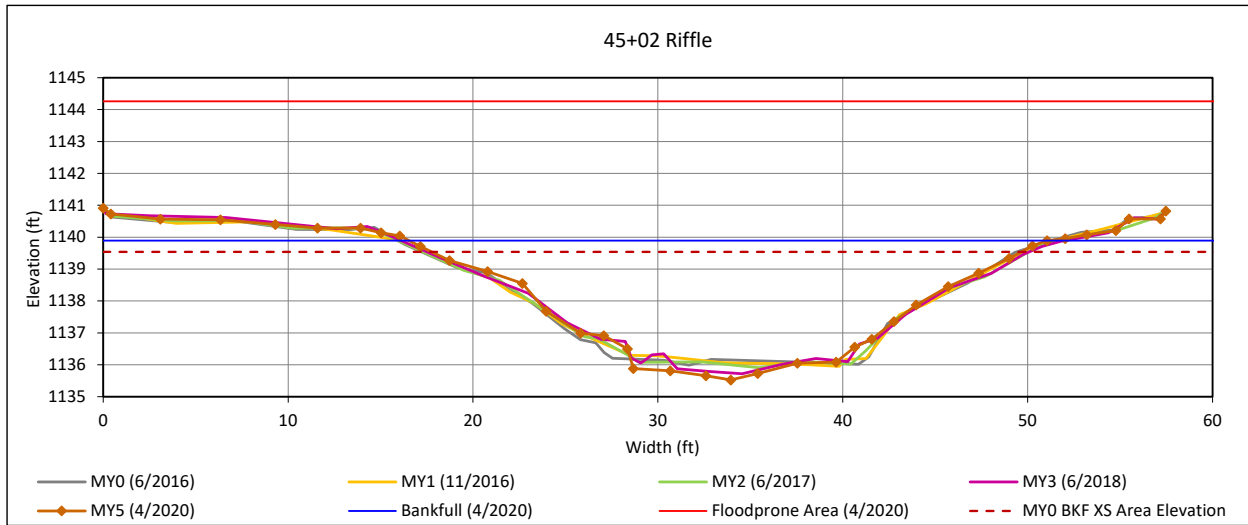
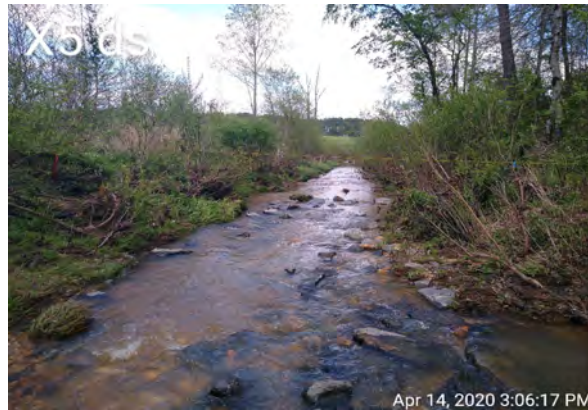
Cross-Section M5- Moores Fork

84.7	x-section area (ft.sq.)
34.5	width (ft)
2.5	mean depth (ft)
4.4	max depth (ft)
36.2	wetted perimeter (ft)
2.3	hydraulic radius (ft)
14.1	width-depth ratio
124.0	W flood prone area (ft)
3.6	entrenchment ratio
1.1	low bank height ratio

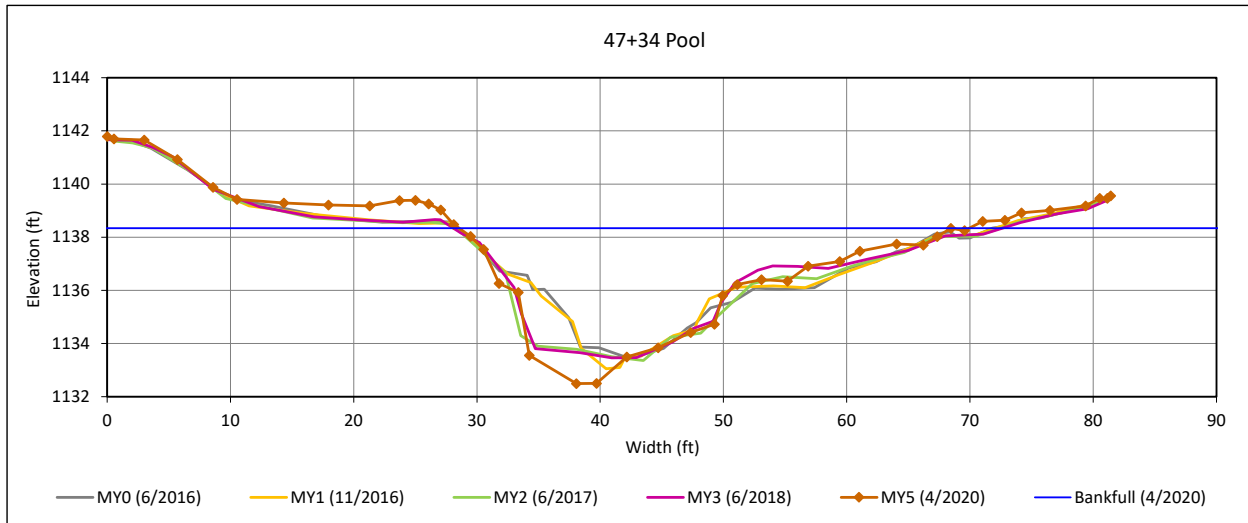
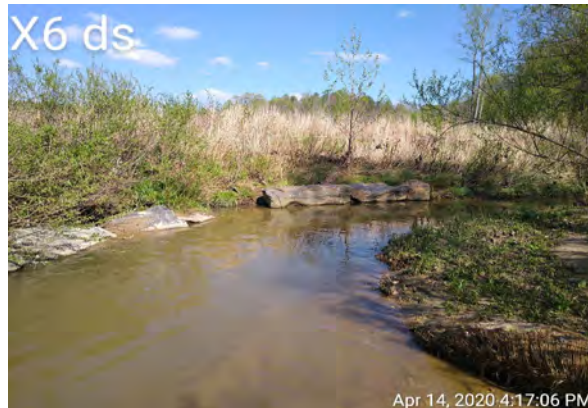
Cross-Section M6- Moores Fork

107.7	x-section area (ft.sq.)
39.9	width (ft)
2.7	mean depth (ft)
5.8	max depth (ft)
43.7	wetted perimeter (ft)
2.5	hydraulic radius (ft)
14.8	width-depth ratio

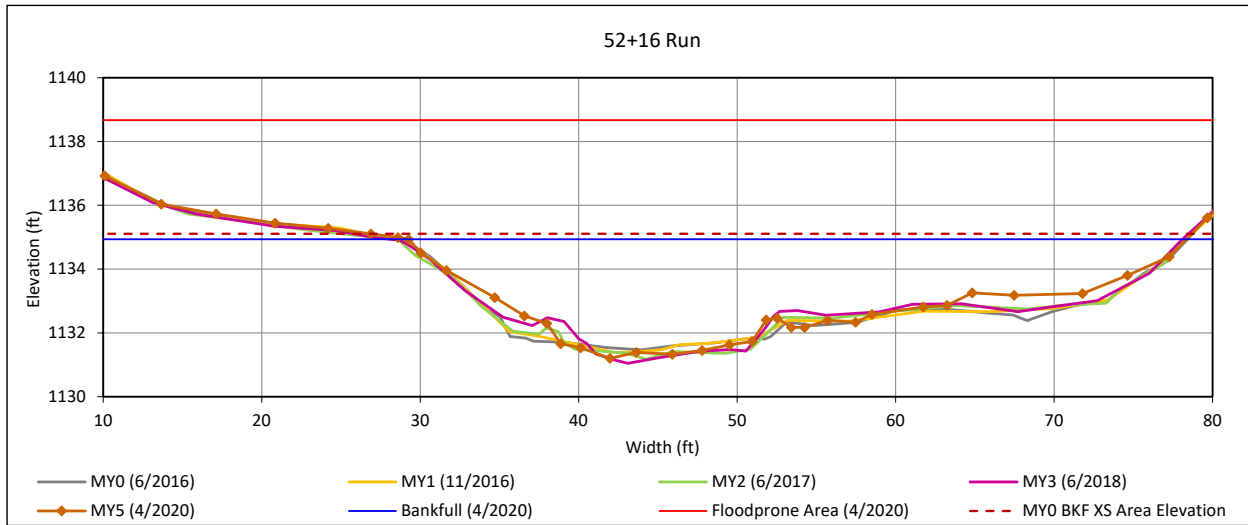
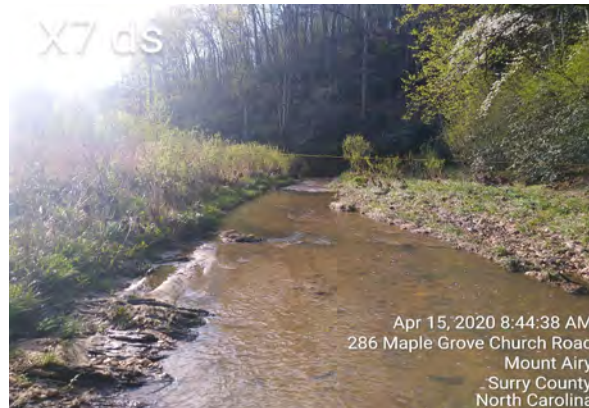
Cross-Section M7- Moores Fork

109.7	x-section area (ft.sq.)
49.1	width (ft)
2.2	mean depth (ft)
3.7	max depth (ft)
50.4	wetted perimeter (ft)
2.2	hydraulic radius (ft)
22.0	width-depth ratio
124.0	W flood prone area (ft)
2.5	entrenchment ratio
1.0	low bank height ratio

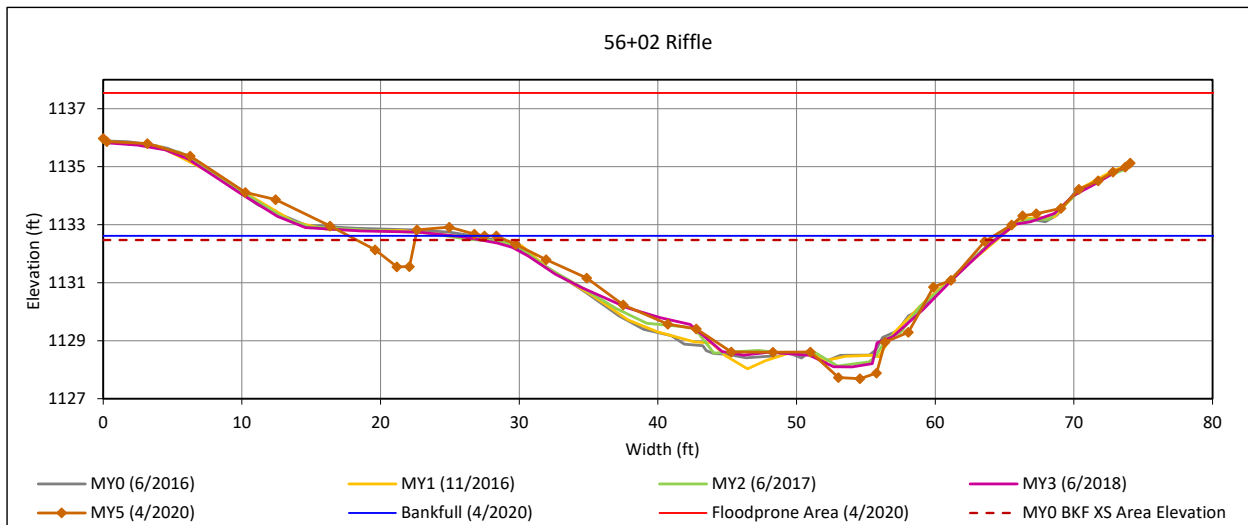
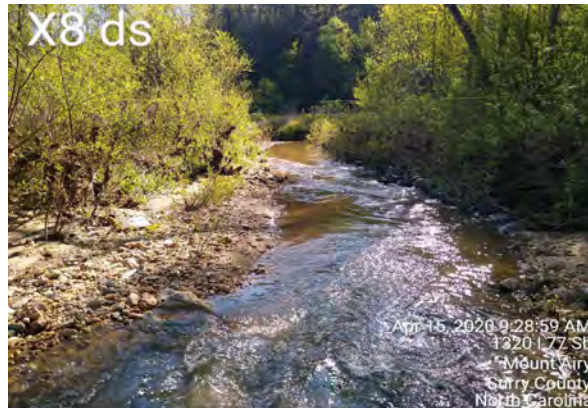
Cross-Section M8- Moores Fork

96.6	x-section area (ft.sq.)
35.9	width (ft)
2.7	mean depth (ft)
4.9	max depth (ft)
38.2	wetted perimeter (ft)
2.5	hydraulic radius (ft)
13.3	width-depth ratio
124.0	W flood prone area (ft)
3.5	entrenchment ratio
1.0	low bank height ratio

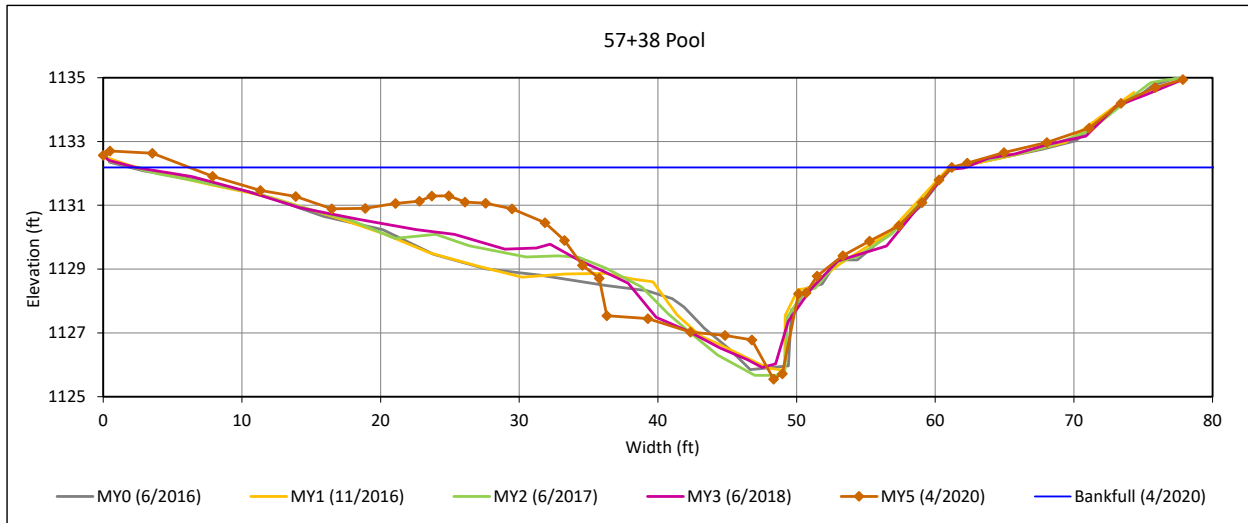
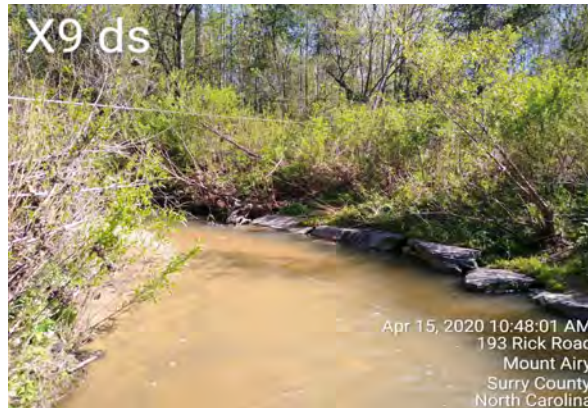
Cross-Section M9- Moores Fork

133.3	x-section area (ft.sq.)
55.0	width (ft)
2.4	mean depth (ft)
6.6	max depth (ft)
59.2	wetted perimeter (ft)
2.3	hydraulic radius (ft)
22.7	width-depth ratio

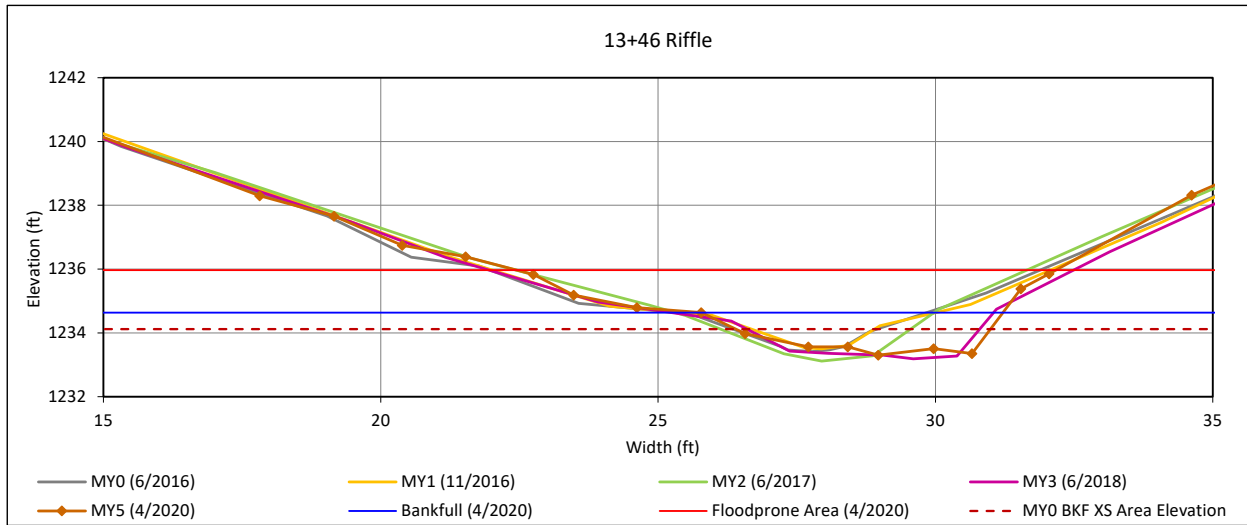
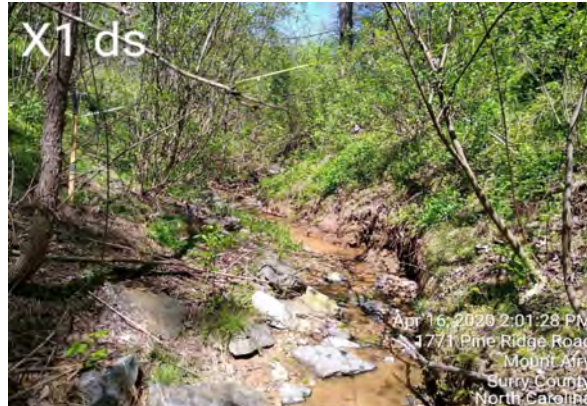
Cross-Section ST1- Silage Trib

- 5.1 x-section area (ft.sq.)
- 5.4 width (ft)
- 0.9 mean depth (ft)
- 1.3 max depth (ft)
- 6.7 wetted perimeter (ft)
- 0.8 hydraulic radius (ft)
- 5.8 width-depth ratio
- 9.7 W flood prone area (ft)
- 1.8 entrenchment ratio
- 1.6 low bank height ratio

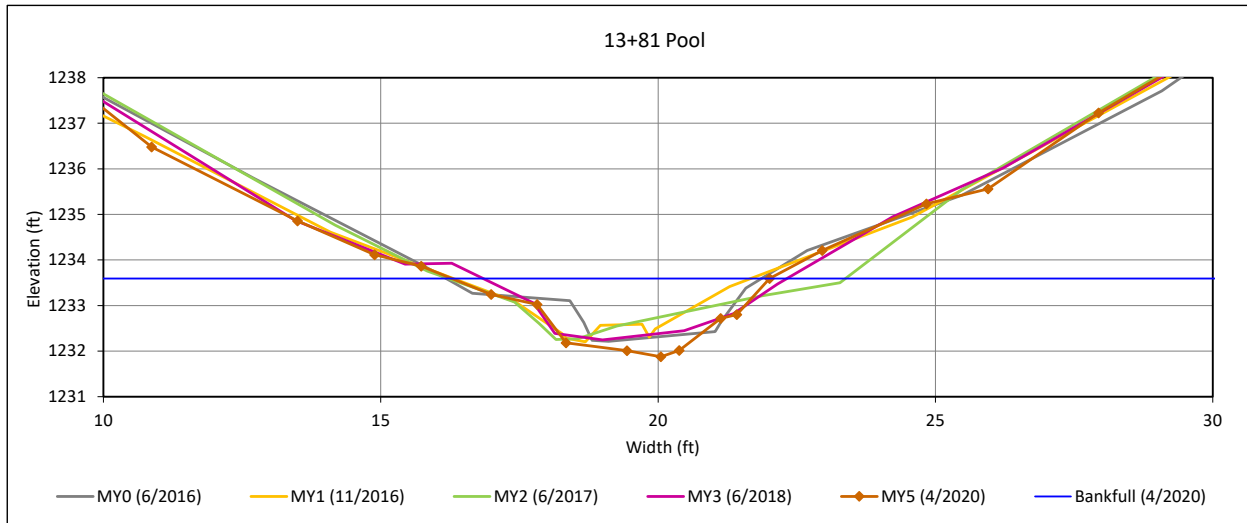
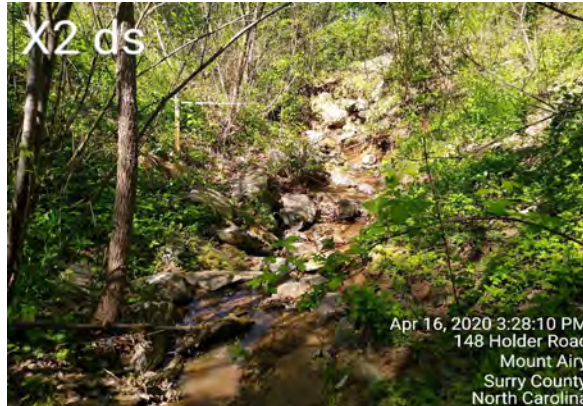
Cross Section ST2- Silage Trib

- 5.6 x-section area (ft.sq.)
- 5.7 width (ft)
- 1.0 mean depth (ft)
- 1.7 max depth (ft)
- 7.0 wetted perimeter (ft)
- 0.8 hydraulic radius (ft)
- 5.8 width-depth ratio

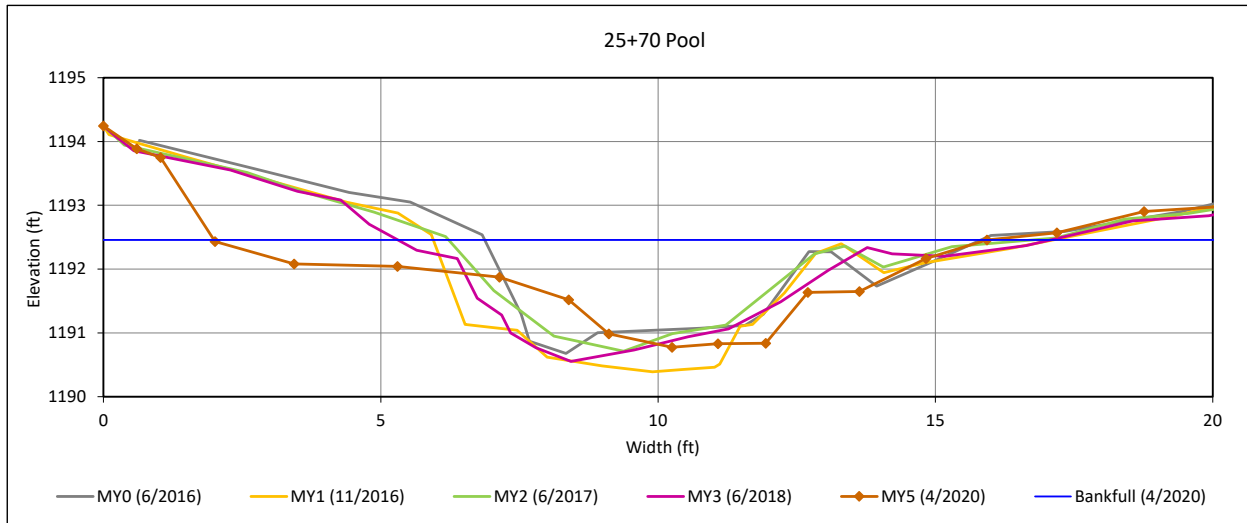
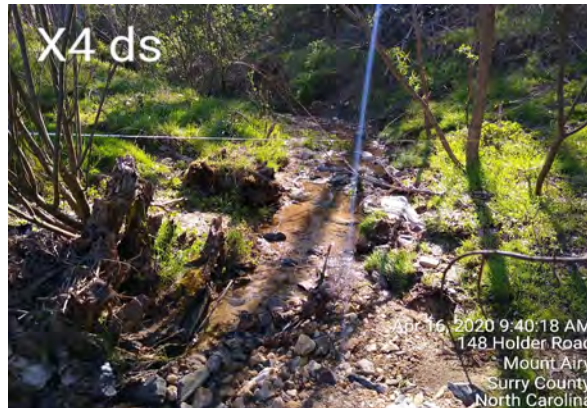
Cross-Section ST4 - Silage Trib

- 10.8 x-section area (ft.sq.)
- 13.9 width (ft)
- 0.8 mean depth (ft)
- 1.7 max depth (ft)
- 14.7 wetted perimeter (ft)
- 0.7 hydraulic radius (ft)
- 17.9 width-depth ratio

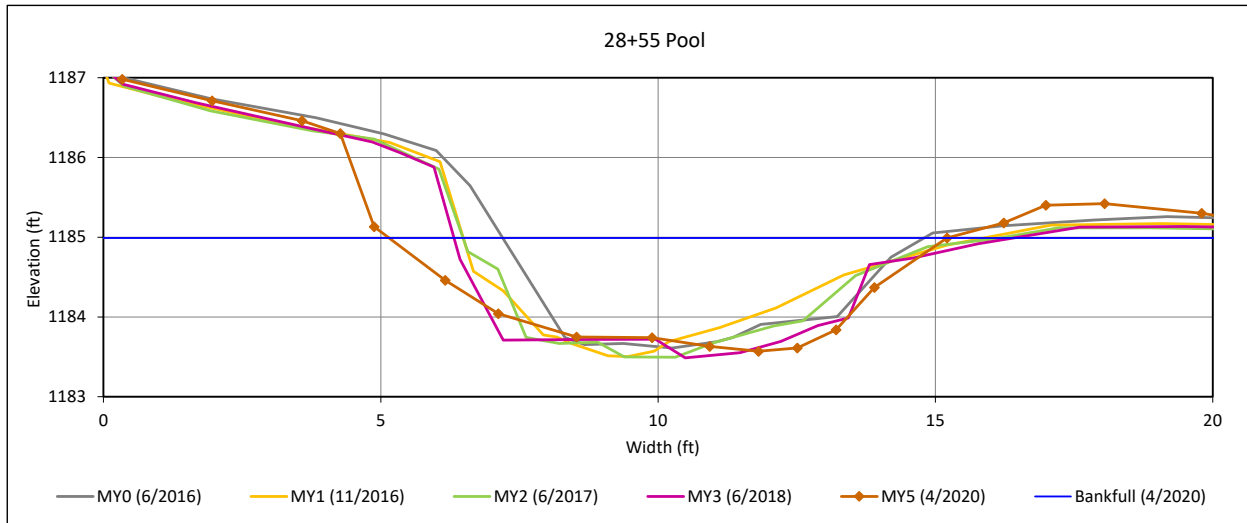
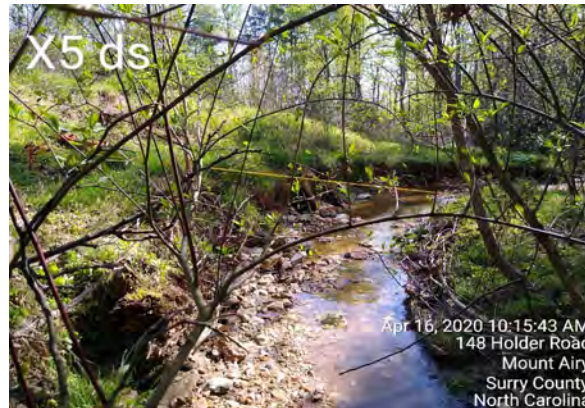
Cross-Section ST5 - Silage Trib

- 9.7 x-section area (ft.sq.)
- 10.1 width (ft)
- 1.0 mean depth (ft)
- 1.4 max depth (ft)
- 10.7 wetted perimeter (ft)
- 0.9 hydraulic radius (ft)
- 10.5 width-depth ratio

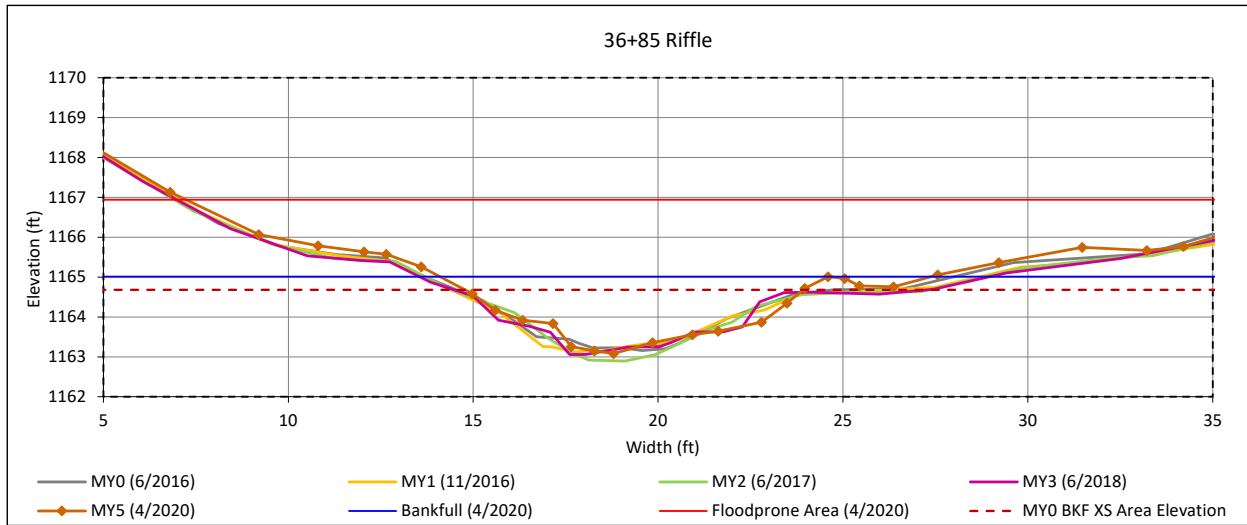
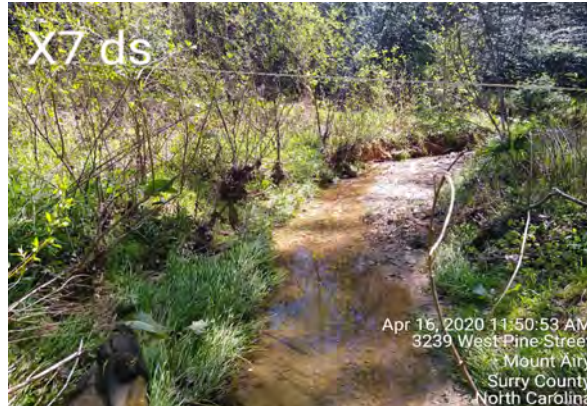
Cross-Section ST7- Silage Trib

- 12.0 x-section area (ft.sq.)
- 10.5 width (ft)
- 1.1 mean depth (ft)
- 1.9 max depth (ft)
- 11.5 wetted perimeter (ft)
- 1.0 hydraulic radius (ft)
- 9.2 width-depth ratio
- 34.0 W flood prone area (ft)
- 3.2 entrenchment ratio
- 1.2 low bank height ratio
