# MONITORING YEAR 6 ANNUAL REPORT

## MOORES FORK STREAM MITIGATION PROJECT

Surry County, NC

DMS Project Number 94709

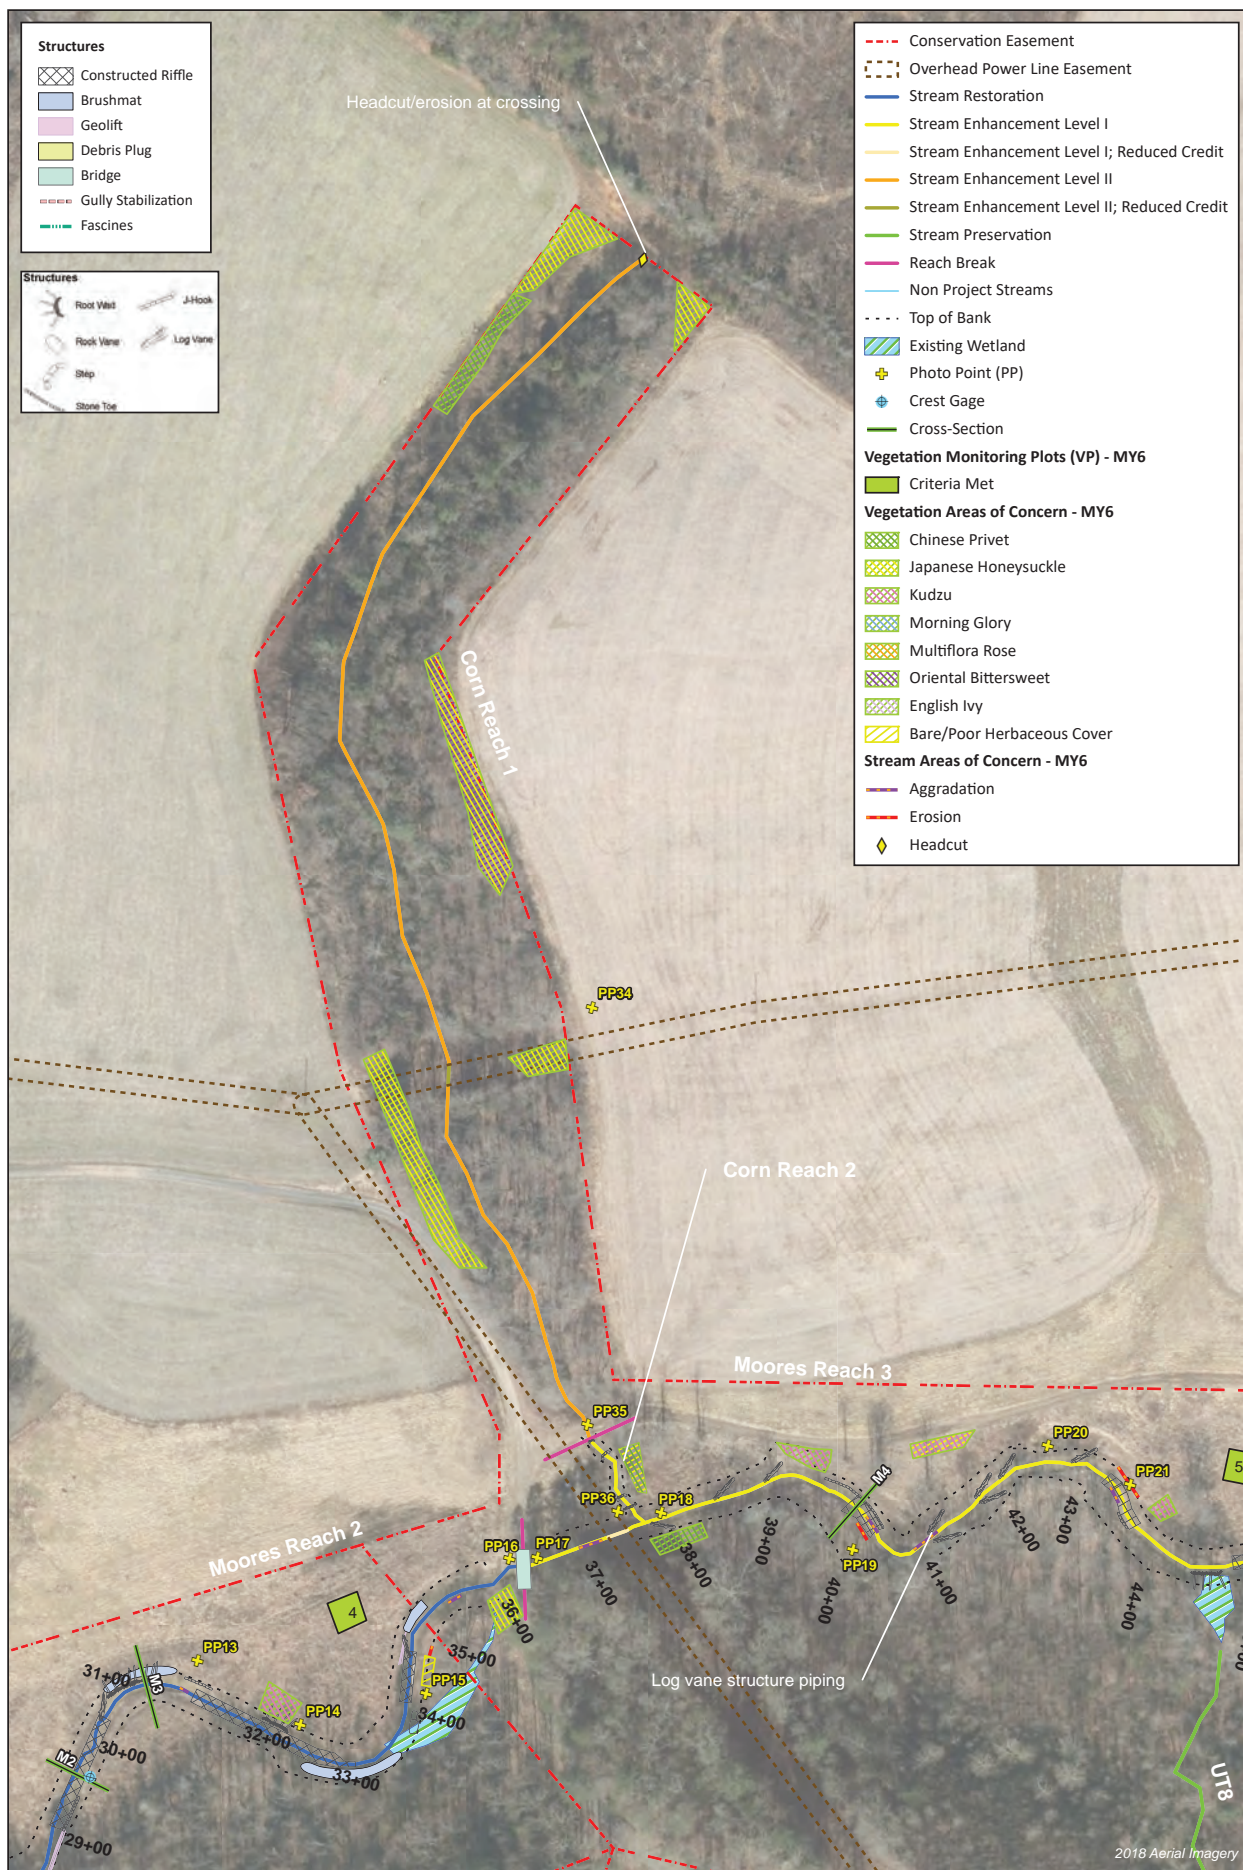
Figure 3.1 Current Condition Plan View (Sheet 1 of 6)  
 Moores Fork Stream Mitigation Project  
 DMS Project No. 94709  
 Monitoring Year 6 - 2021

The remaining stream areas of concern include localized instances of bank instability and sediment deposition. Along Moores Fork, new or expanded areas of bank instability were noted in MY6 (STA 23+40, 34+90, 40+00, and 43+10) where woody vegetation has failed to take hold along the banks. Areas of stream instability seem to be isolated and are not prevalent along Moores Fork.

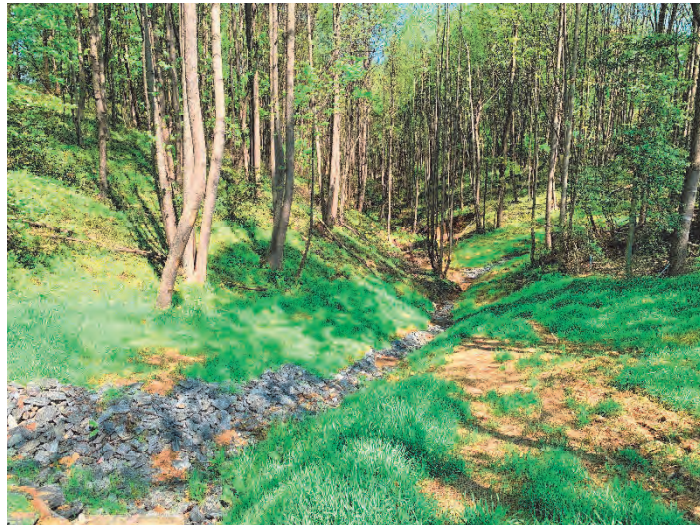
**PP67** – UT1, looking downstream (04/20/2021)

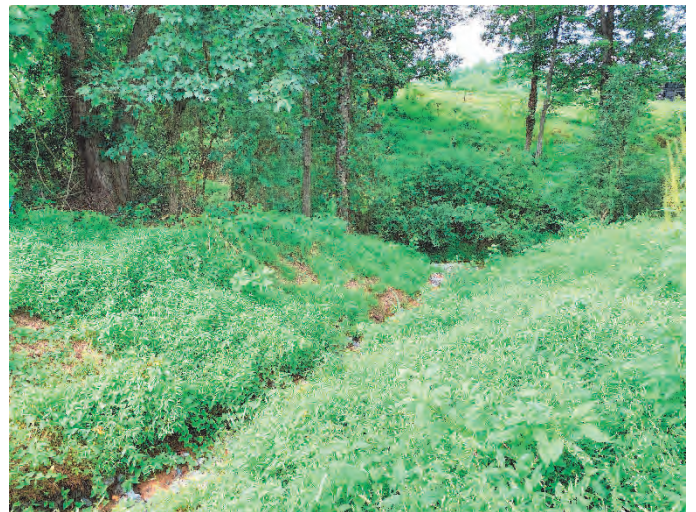
Silage Reach 1 STA 10+40 gully stabilization – 9/8/2021

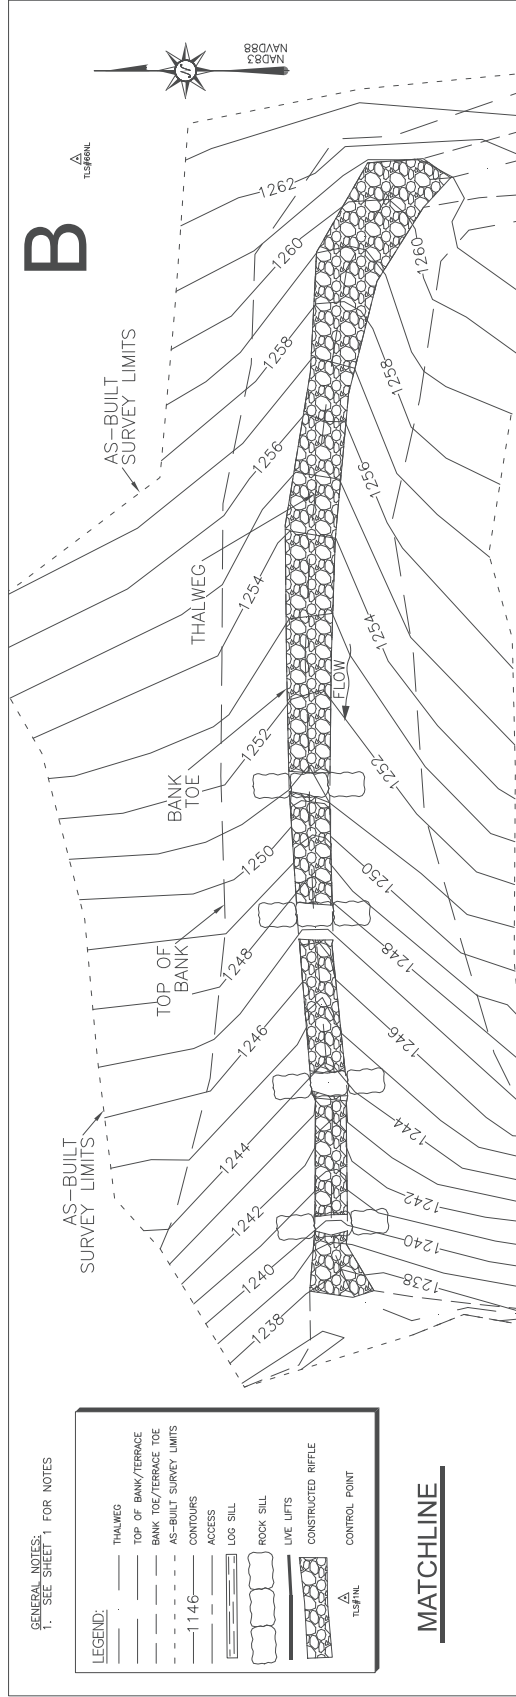
# MOORES FORK REPAIR AREA 3A & 3B

\*ALL DISTURBED AREAS WITHIN THE LIMITS OF CONSTRUCTION WERE PLANTED WITH BARE ROOT PLANTS.

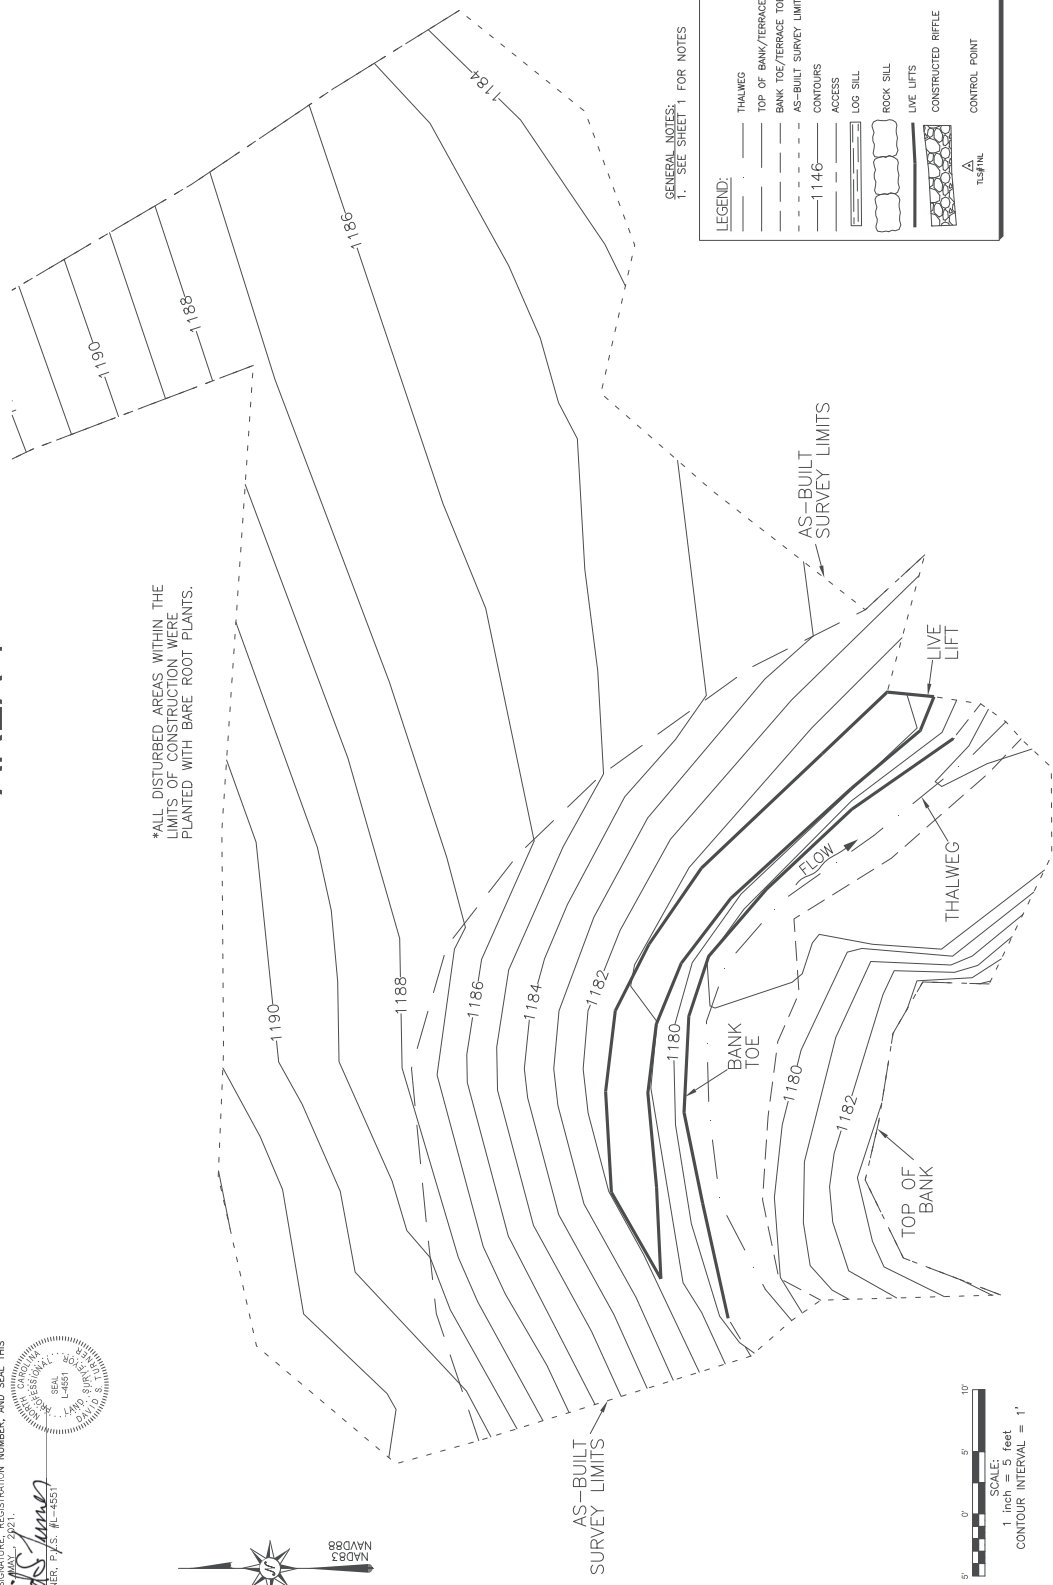
# MOORES FORK REPAIR AREA 4

\*ALL DISTURBED AREAS WITHIN THE LIMITS OF CONSTRUCTION WERE PLANTED WITH BARE ROOT PLANTS.

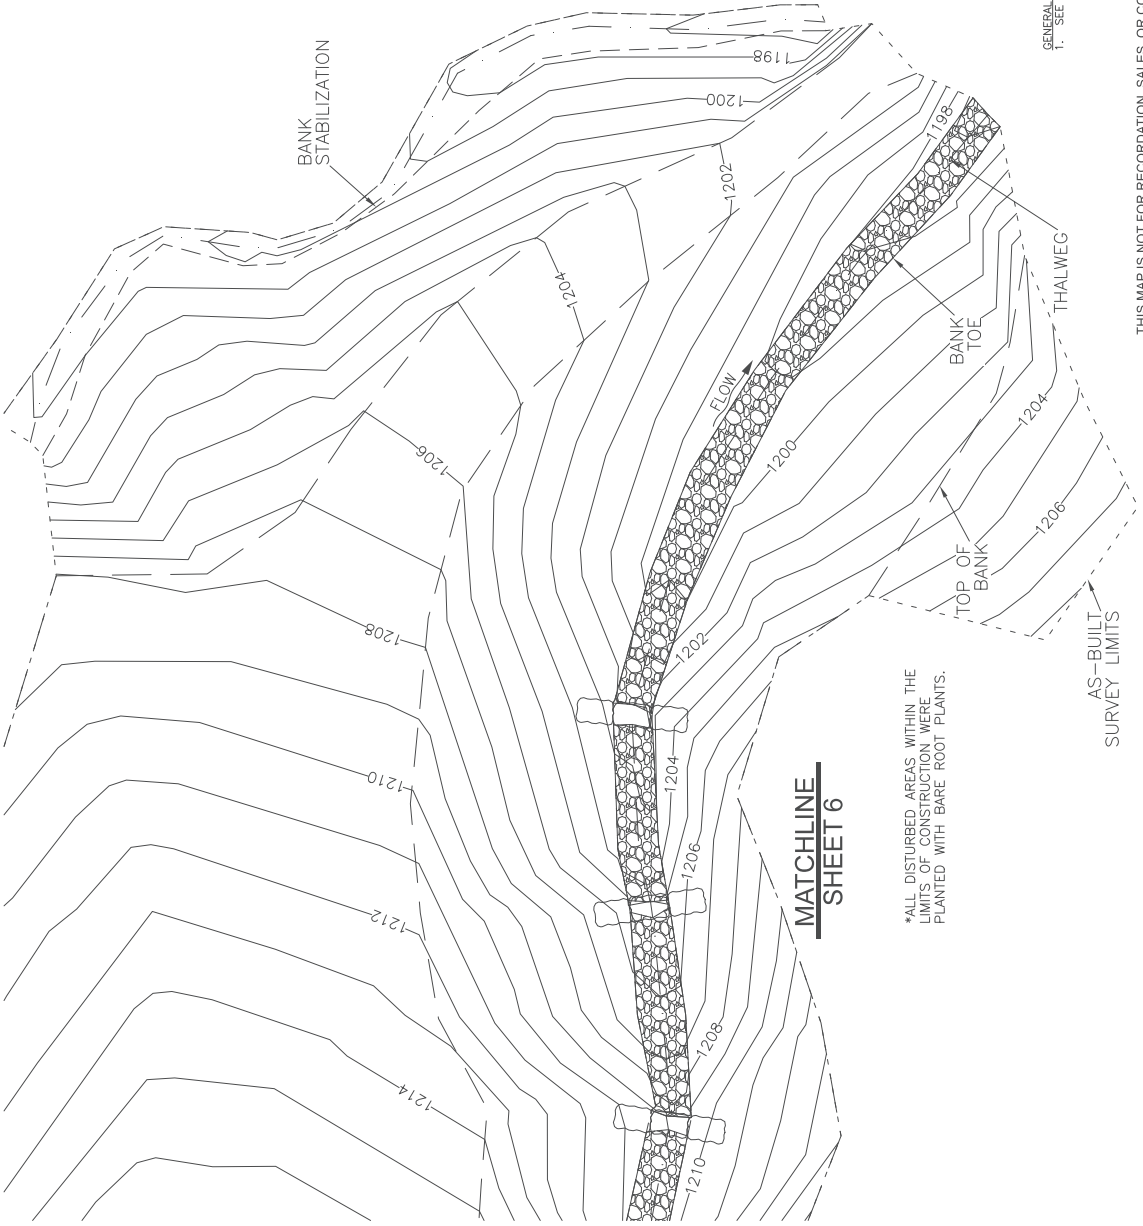
# MOORES FORK REPAIR AREA 5.1A

\*ALL DISTURBED AREAS WITHIN THE LIMITS OF CONSTRUCTION WERE PLANTED WITH BARE ROOT PLANTS.

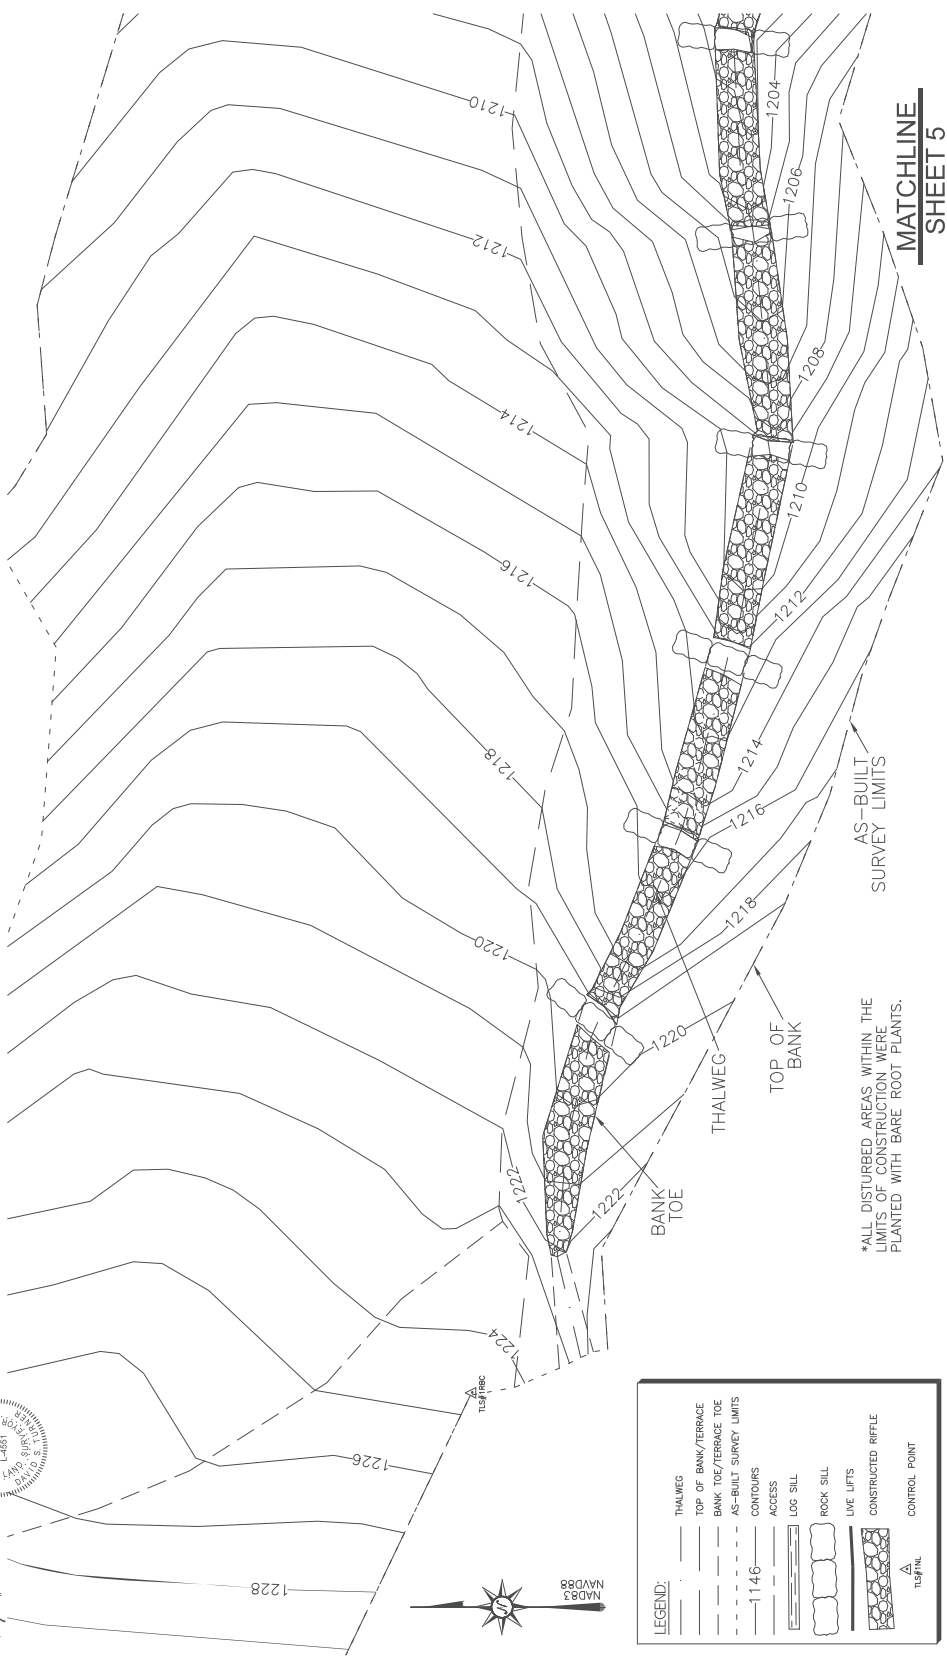
# MOORES FORK REPAIR AREA 5.2A

\*ALL DISTURBED AREAS WITHIN THE LIMITS OF CONSTRUCTION WERE PLANTED WITH BARE ROOT PLANTS.

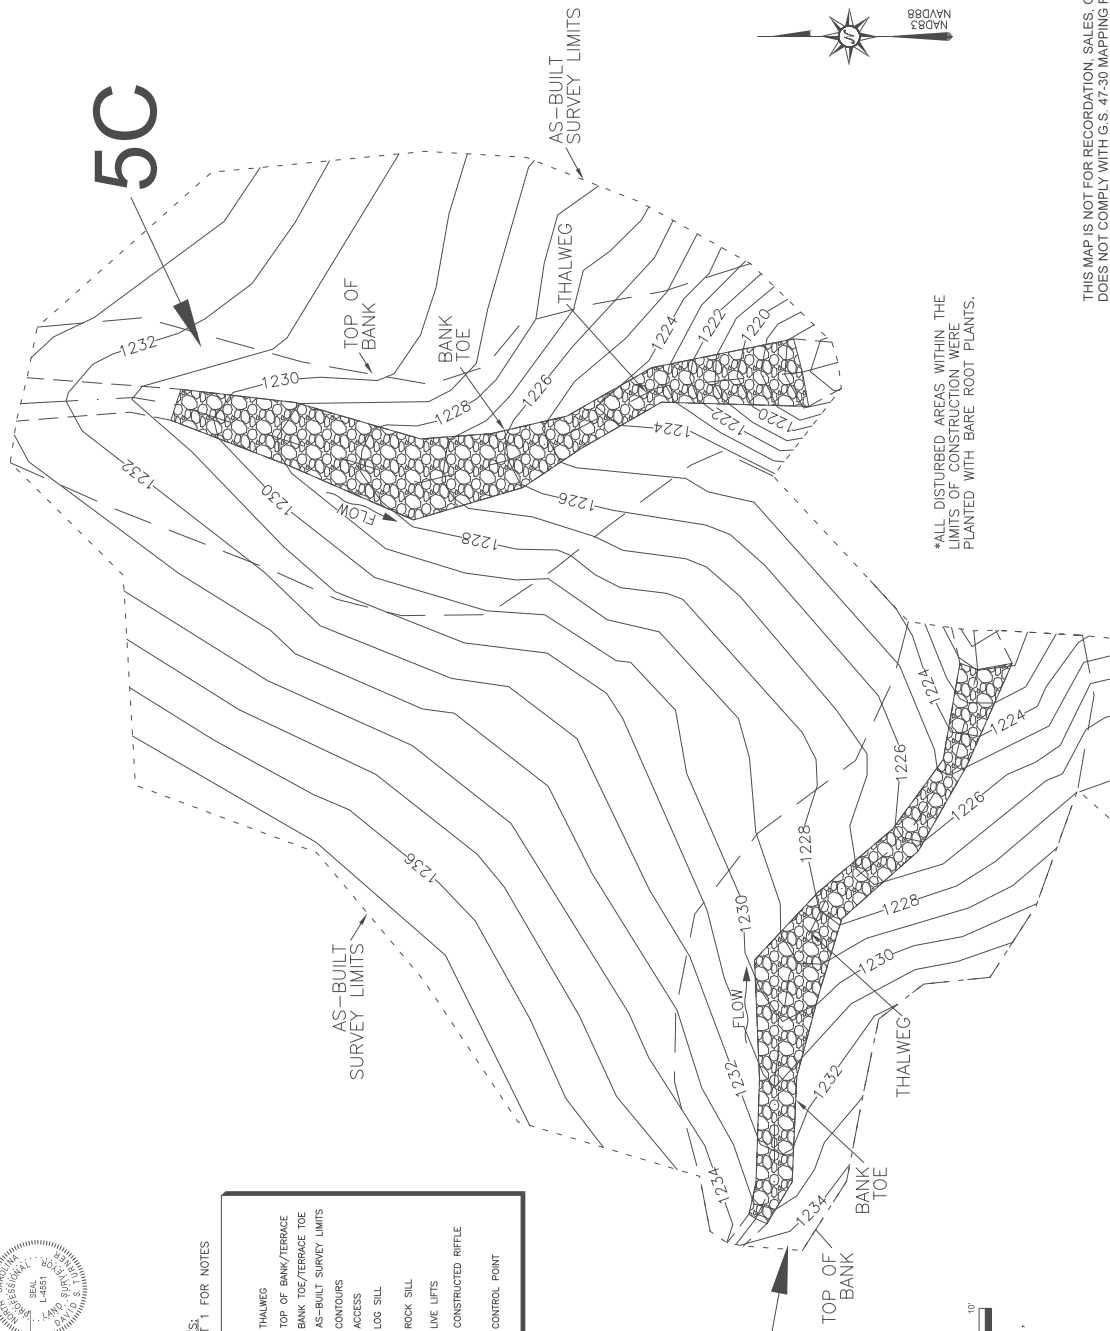
# MOORES FORK REPAIR AREA 5B & 5C

\*ALL DISTURBED AREAS, WITHIN THE LIMITS OF CONSTRUCTION, WERE PLANTED WITH BARE ROOT PLANTS.

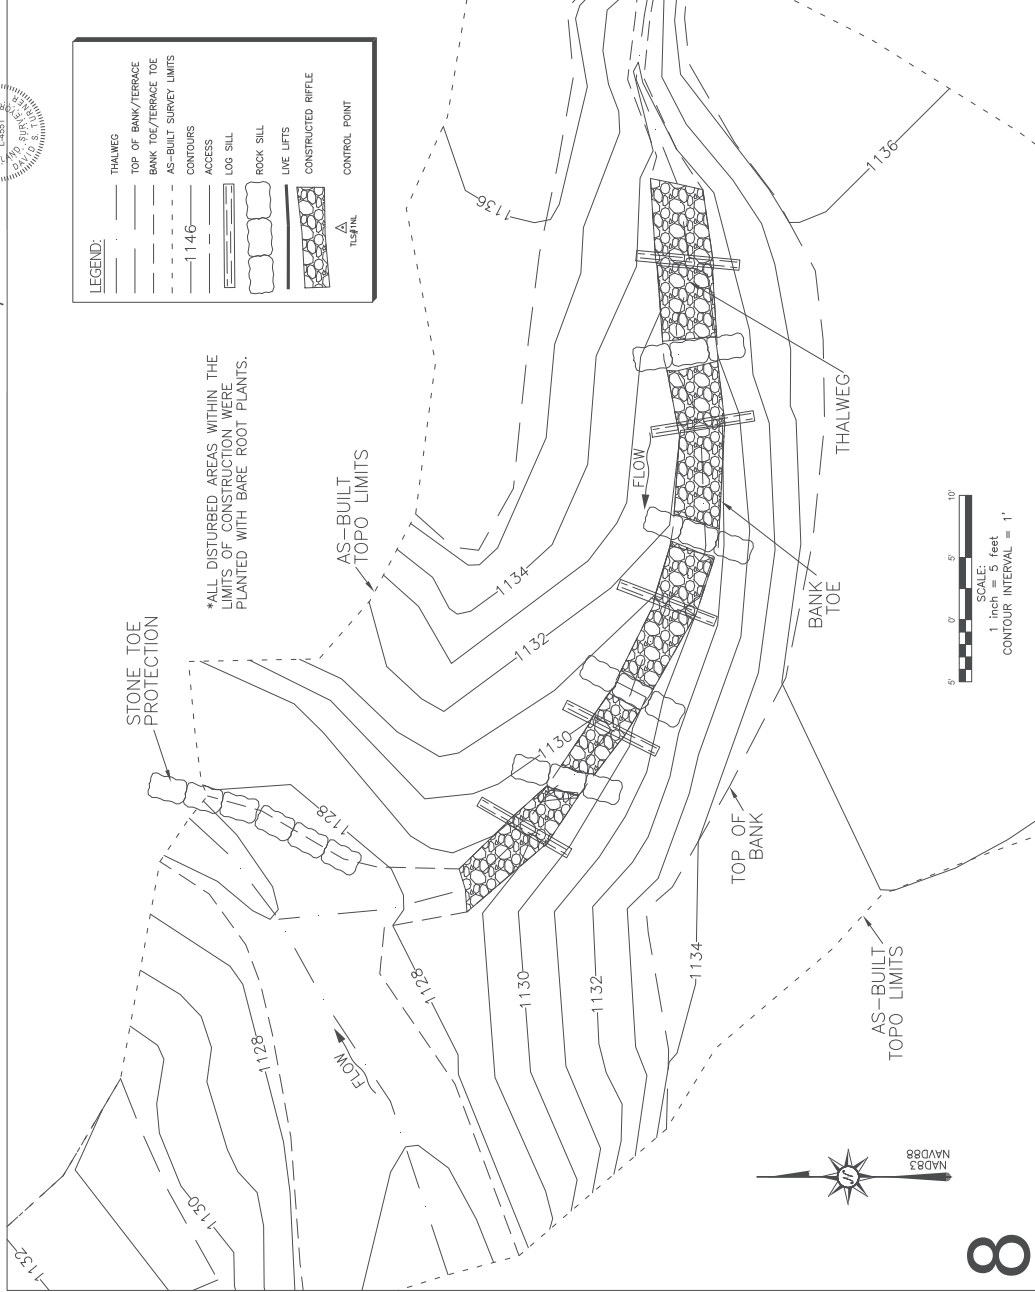
# MOORES FORK REPAIR AREAS 7 & 8

\*ALL DISTURBED AREAS WITHIN THE LIMITS OF CONSTRUCTION WERE PLANTED WITH BARE ROOT PLANTS.

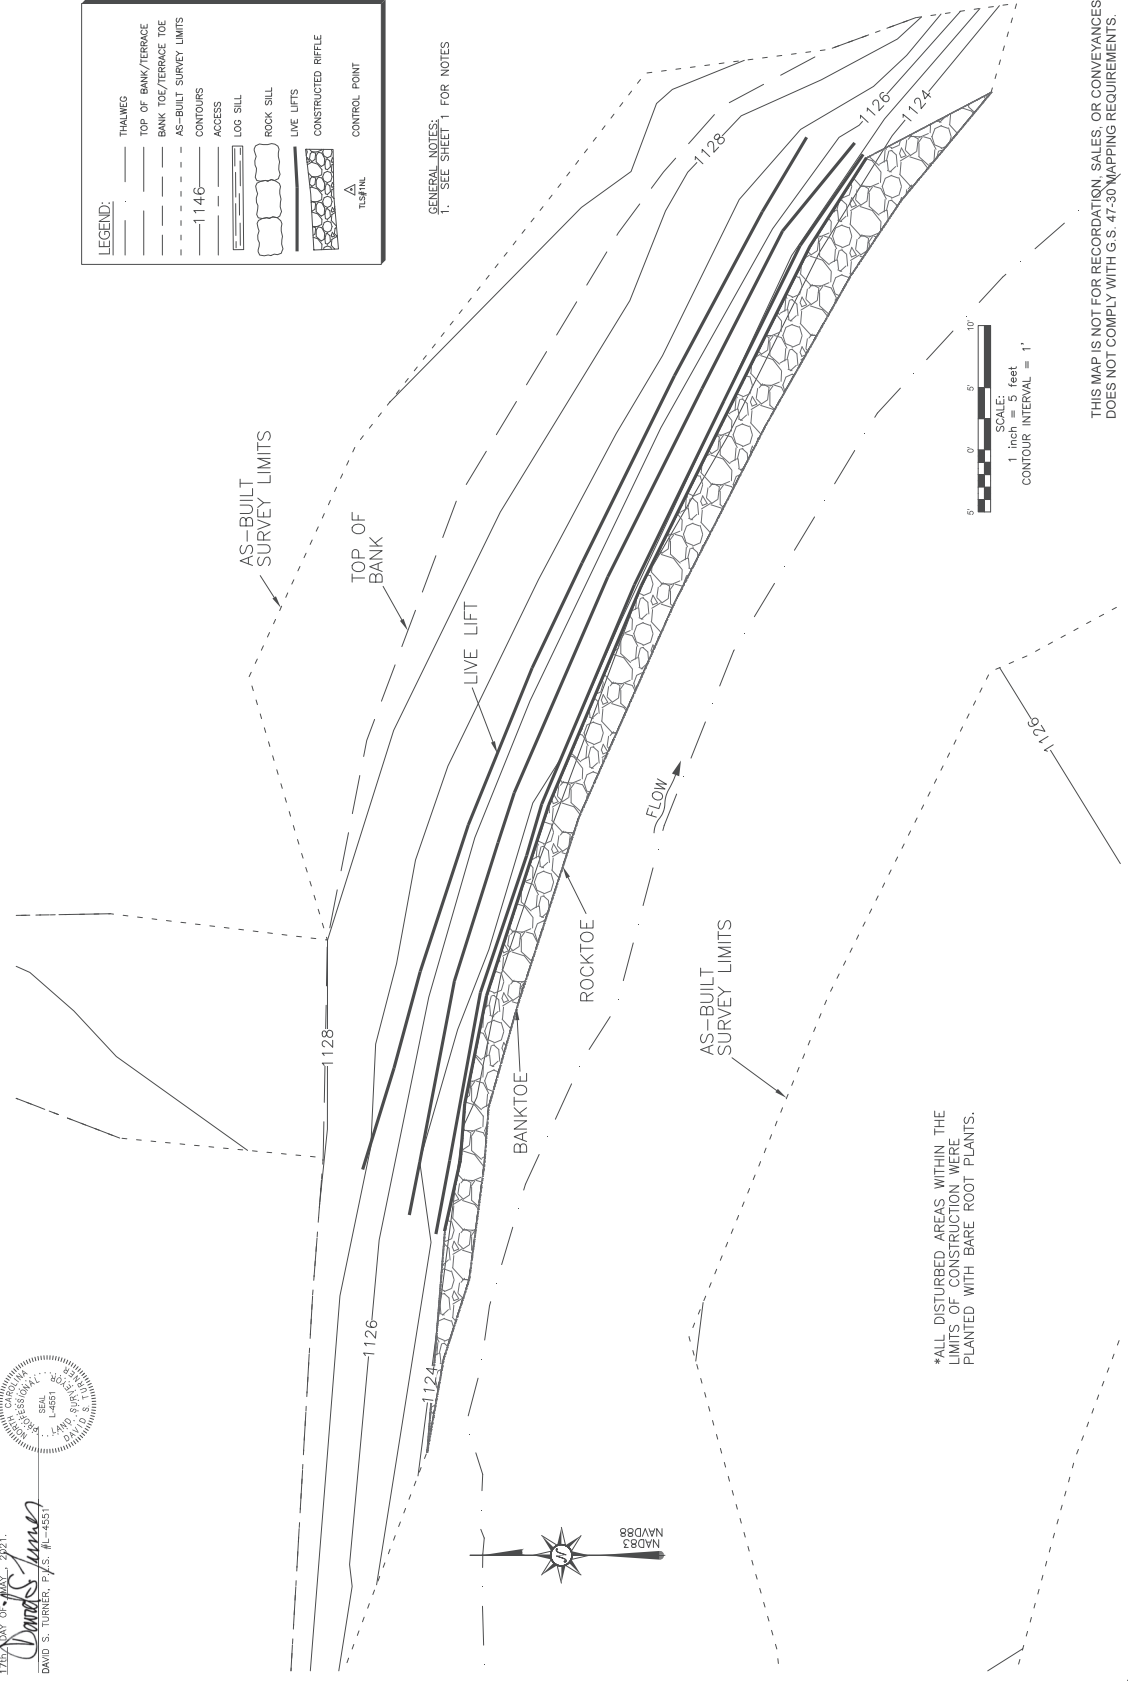
# MOORES FORK REPAIR AREA 9

\*ALL DISTURBED AREAS WITHIN THE LIMITS OF CONSTRUCTION WERE PLANTED WITH BARE ROOT PLANTS.
