# MONITORING YEAR 7 ANNUAL/CLOSEOUT REPORT

## MOORES FORK STREAM MITIGATION PROJECT

DMS Project Number 94709

Data Collection Period: April-September 2022

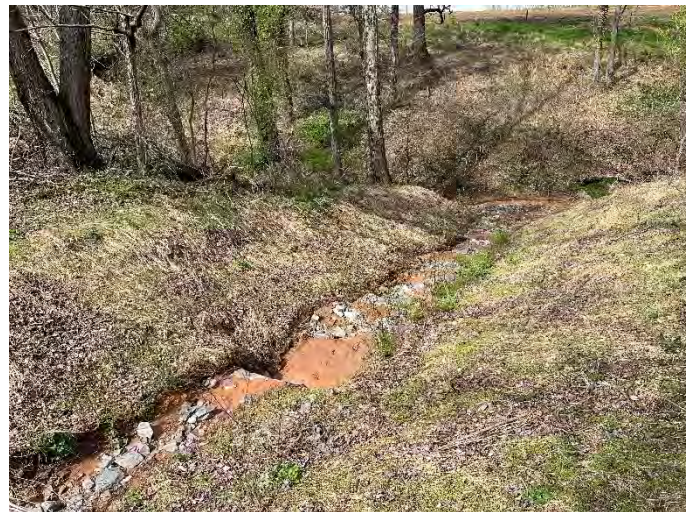
Silage Reach 1 STA 10+40 gully stabilization – 4/06/2022
