Morgan Creek Stream Restoration Site

Year 1 Final Monitoring Report
Project ID Number: 16-D06027

Prepared by:
Equinox Environmental Consultation and Design, Inc.

Submitted to:
NCDENR - Ecosystem Enhancement Program

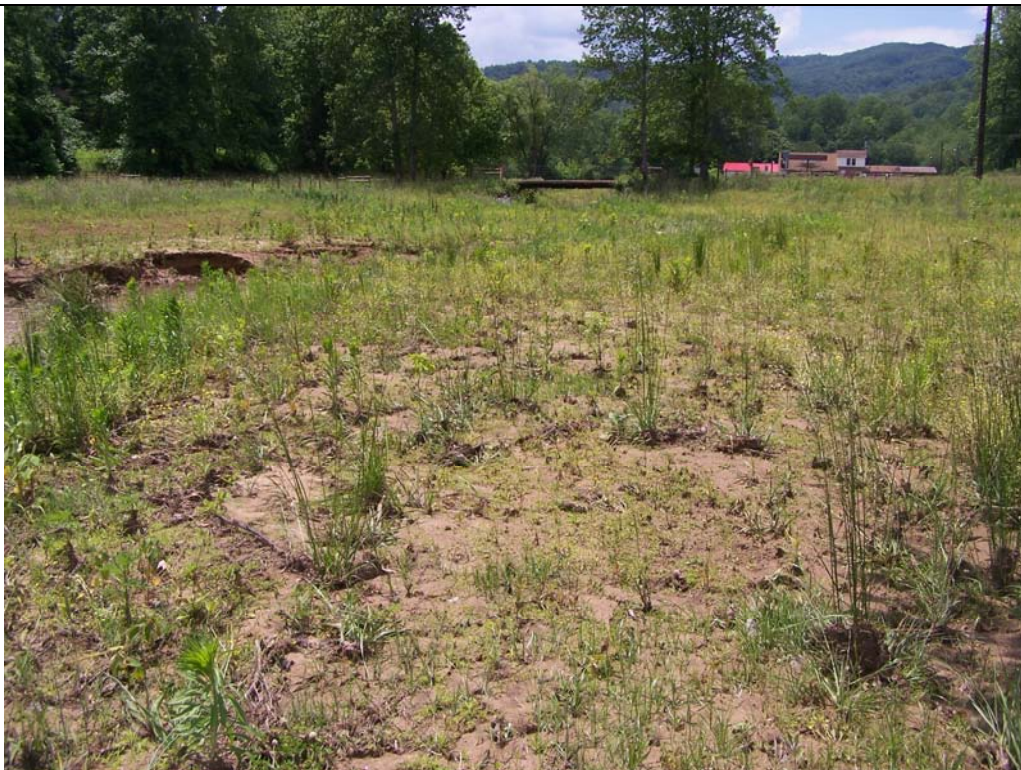
Wrack lines and deposition along Morgan Creek from bankfull event in May 2009

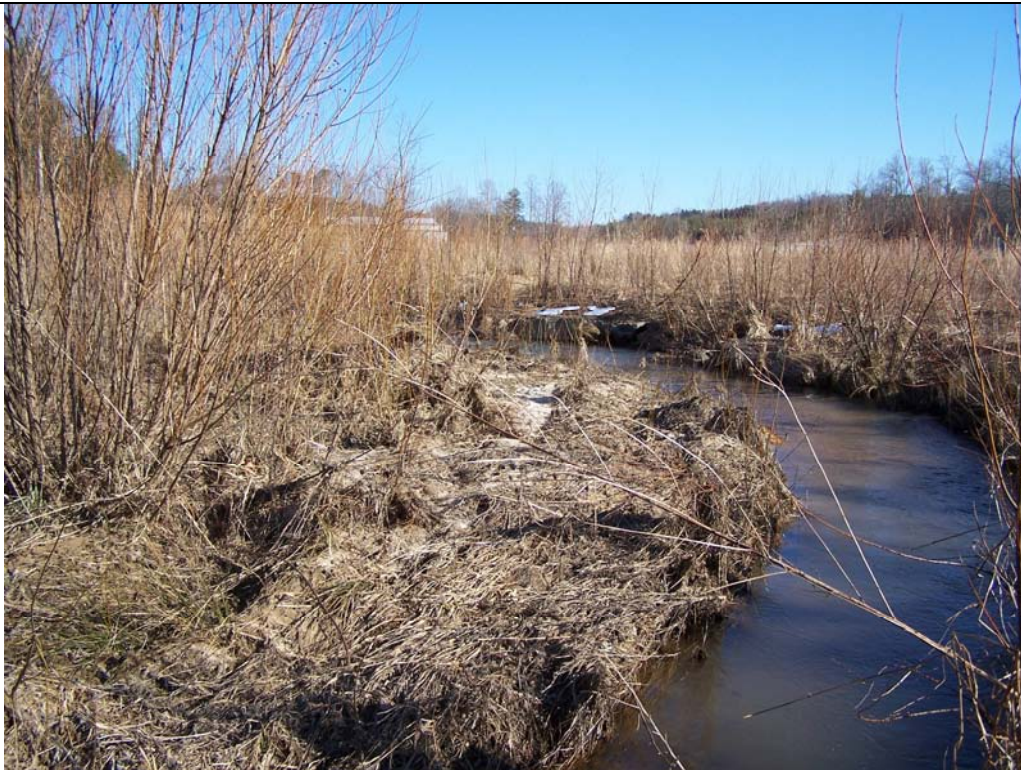
Wrack lines and deposition along Morgan Creek from bankfull event in May 2009

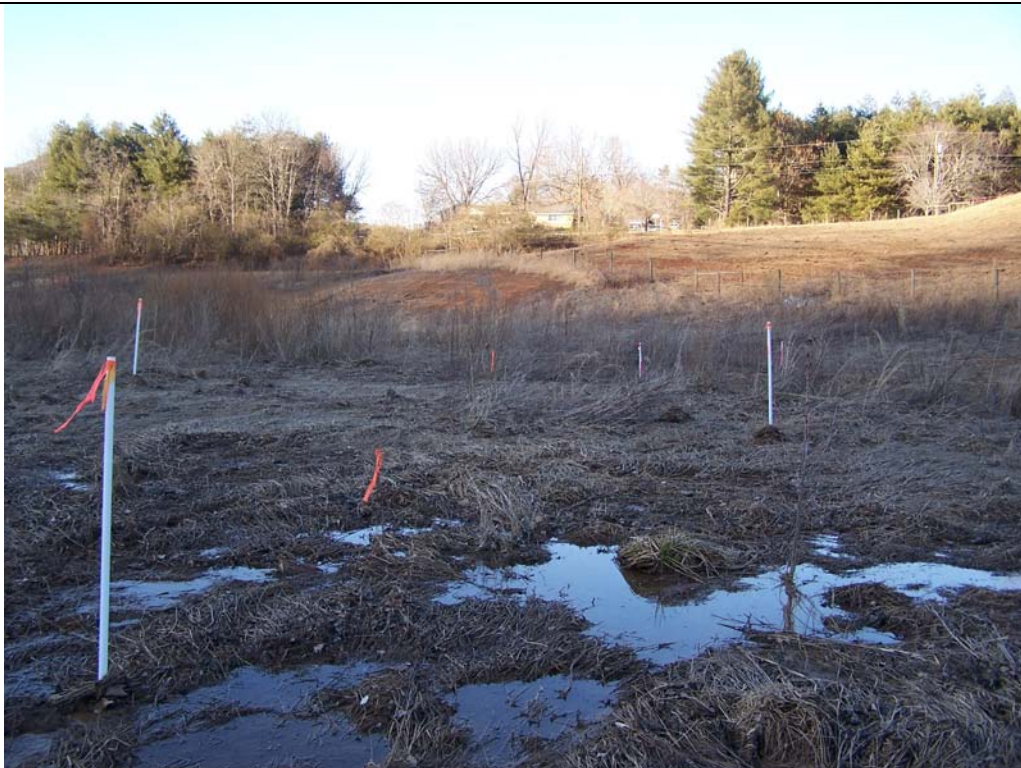
Wrack lines and deposition along Morgan Creek from bankfull event in January 2010

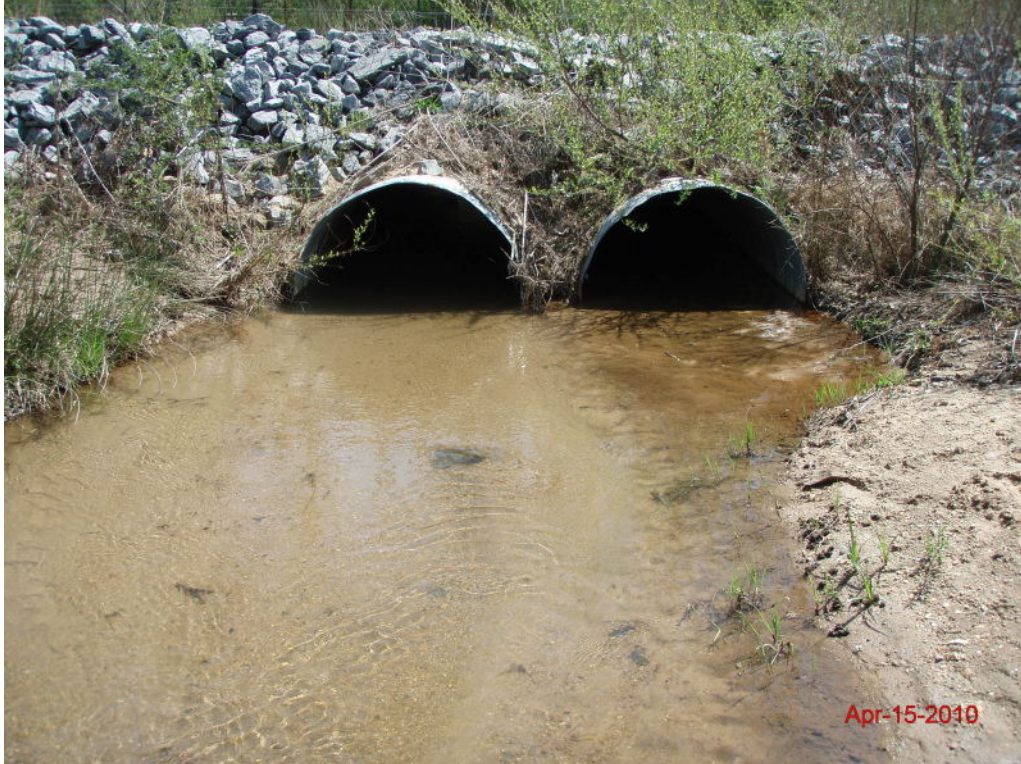
SPA4 Morgan Creek Sta. 1001+50 – Pool Aggradation

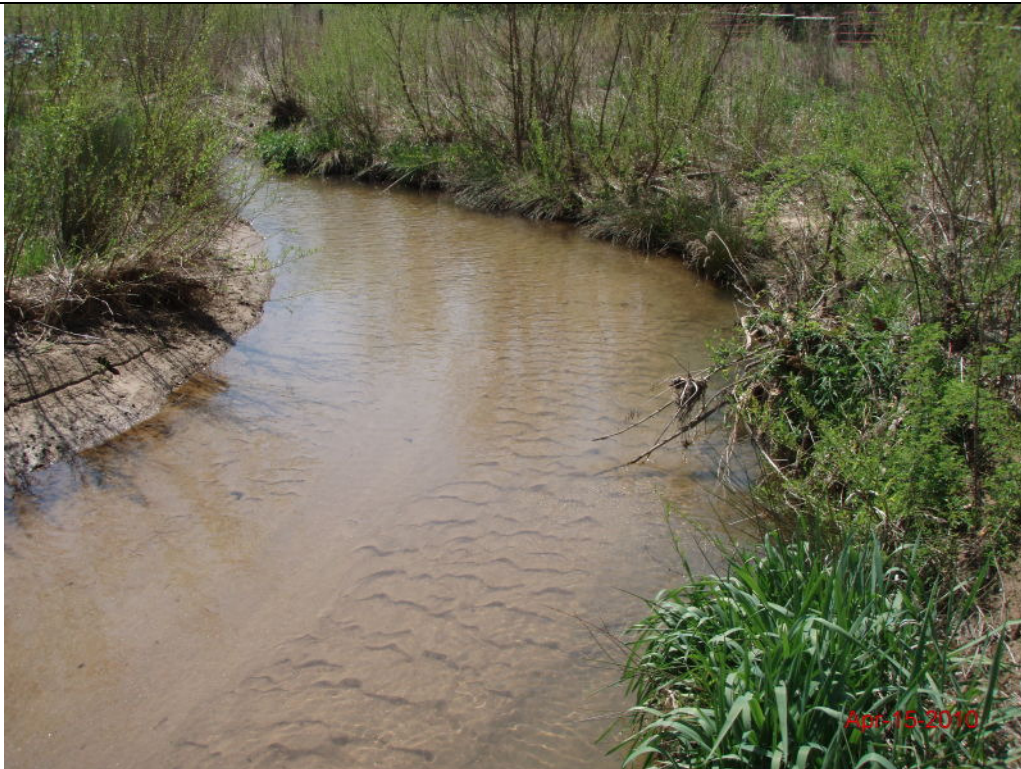
SPA7 Morgan Creek Sta. 1005+05 – Pool Aggradation

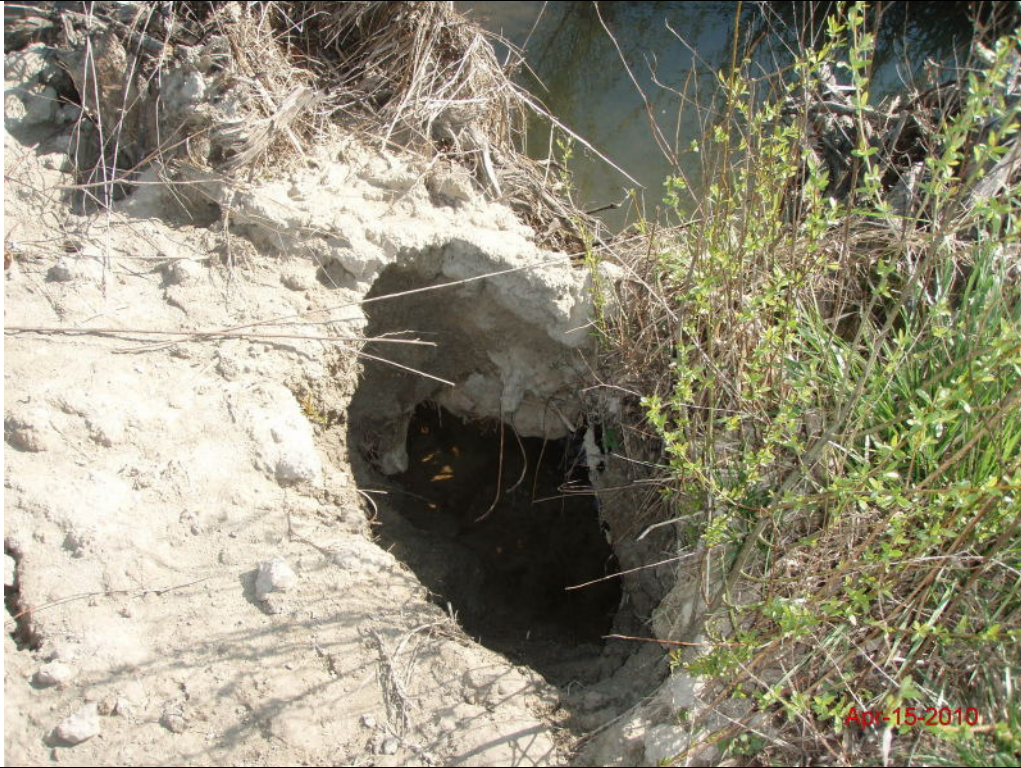
SPA13 Morgan Creek Sta. 1014+50 – Stressed Bank

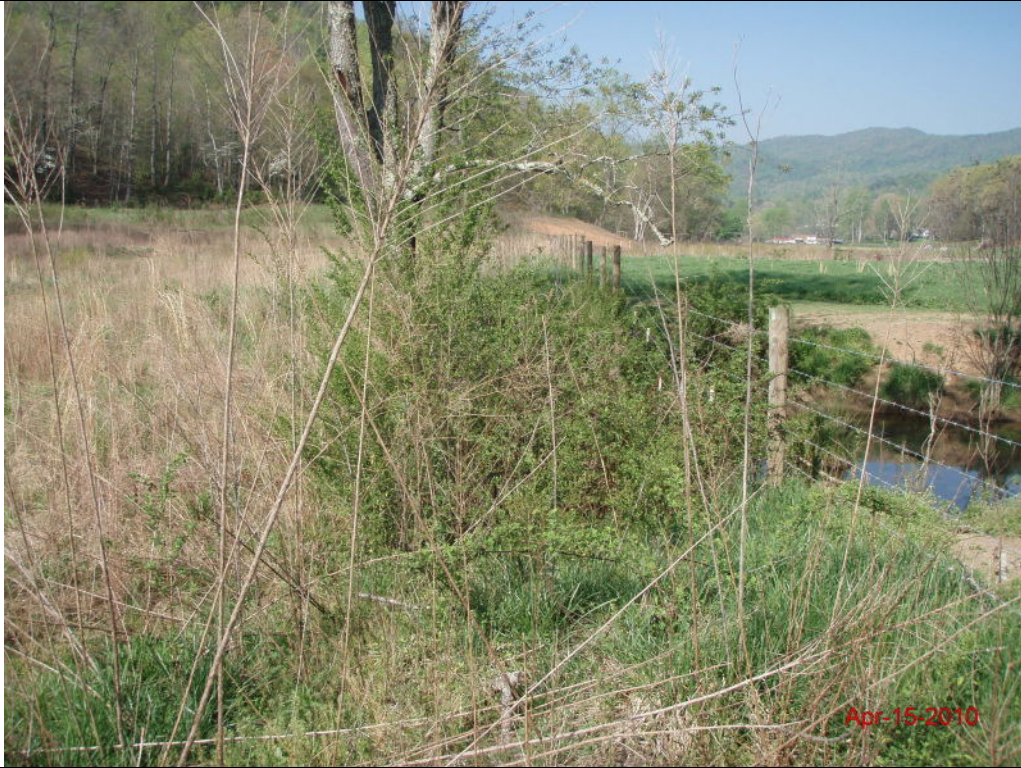
Morgan Creek – Isolated Area of privet (*Ligustrum sp.*) and multiflora rose (*Rosa multiflora*)

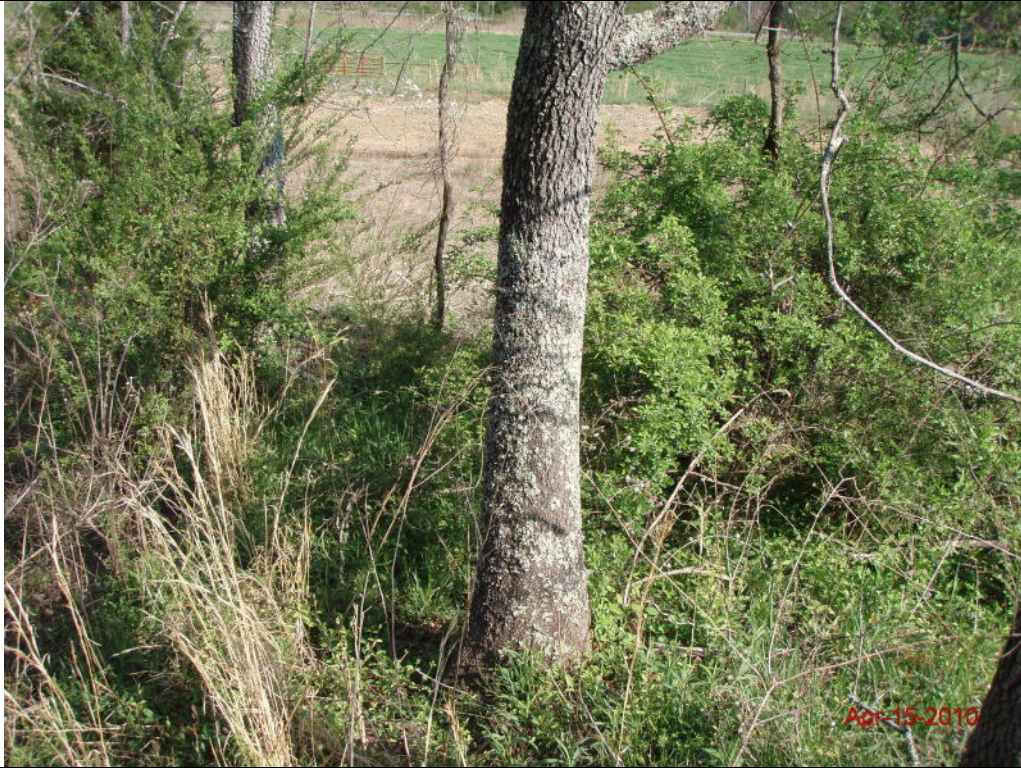
UT5 – Isolated Area of privet (*Ligustrum sp.*), multiflora rose (*Rosa multiflora*), and Japanese honeysuckle (*Lonicera japonica*)

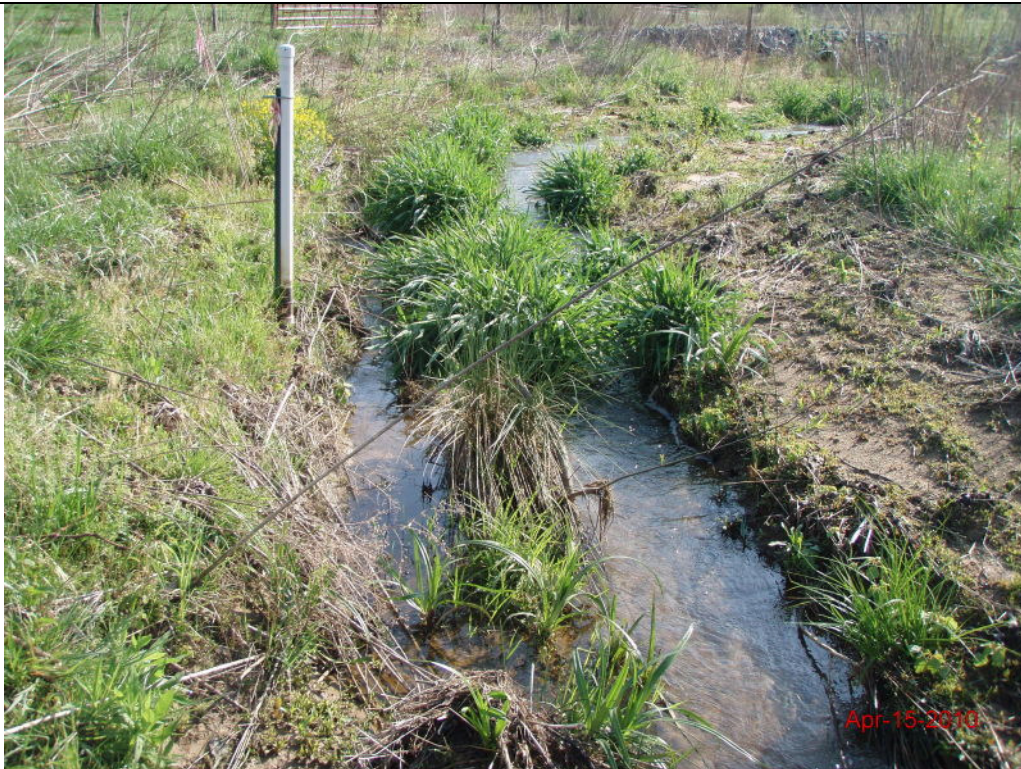
SPA17 UT6 Sta. 7003+00 – Riffle Aggradation

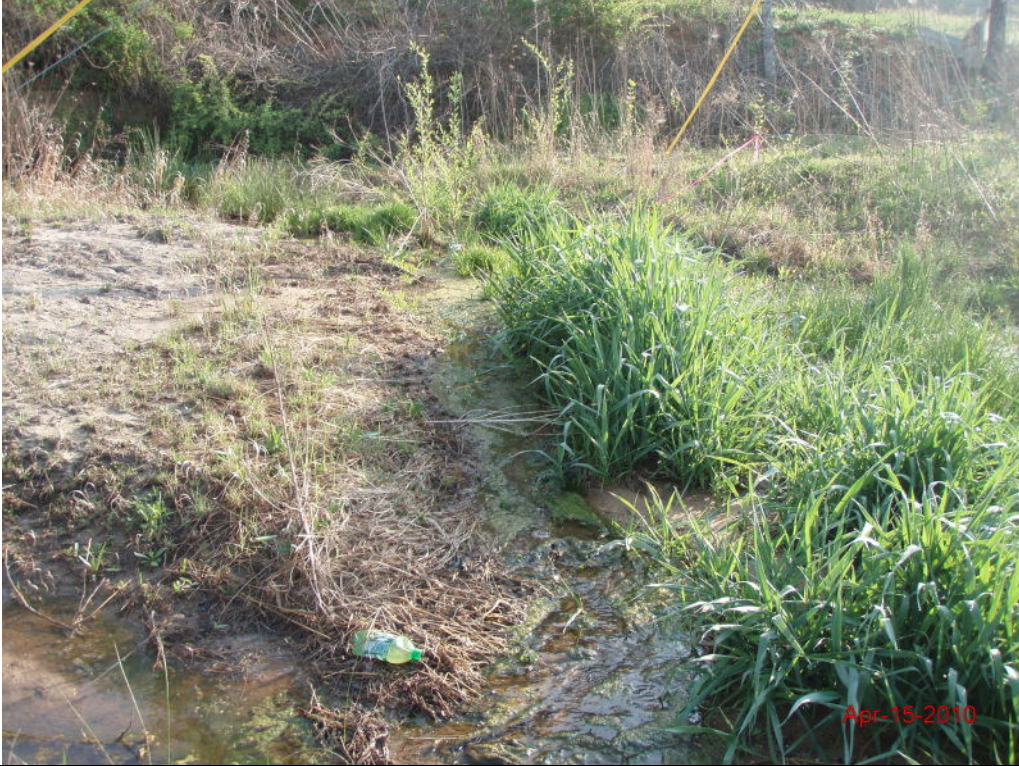
SPA19 UT7 Sta. 8000+40 – Riffle Aggradation

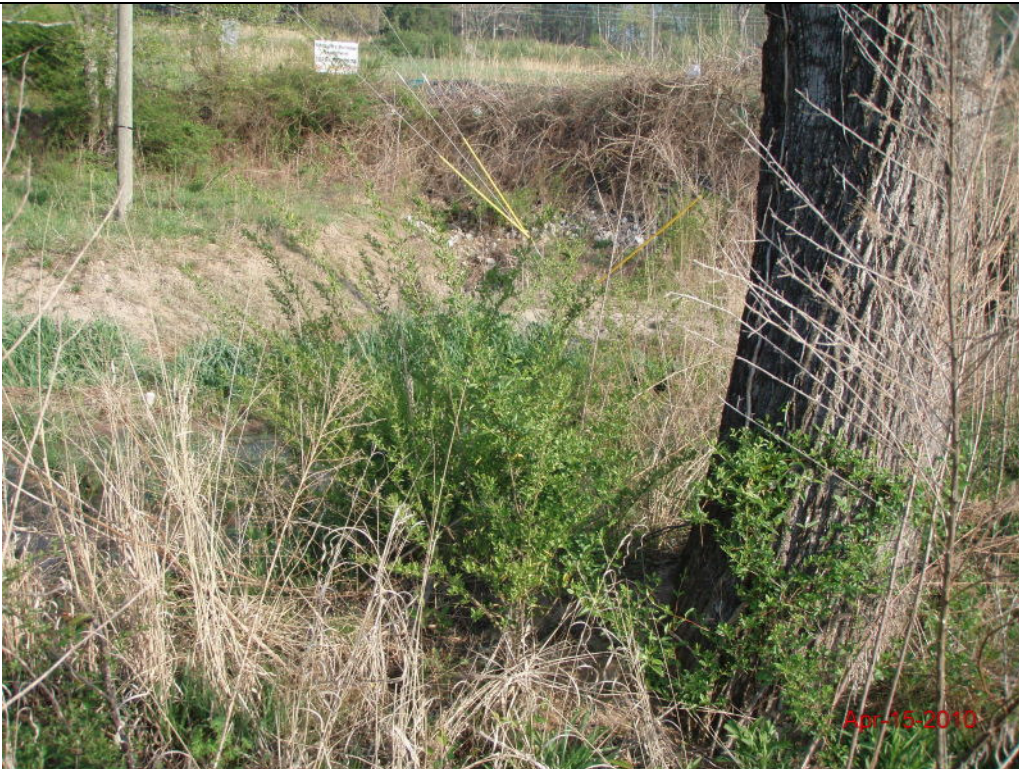
UT7 – Isolated Area of privet (*Ligustrum sp.*) and Japanese honeysuckle (*Lonicera japonica*)
