Morgan Creek Stream Restoration Site

Year 5 Final Monitoring Report

Project ID Number: 16-D06027

Equinox Environmental Consultation and Design, Inc.

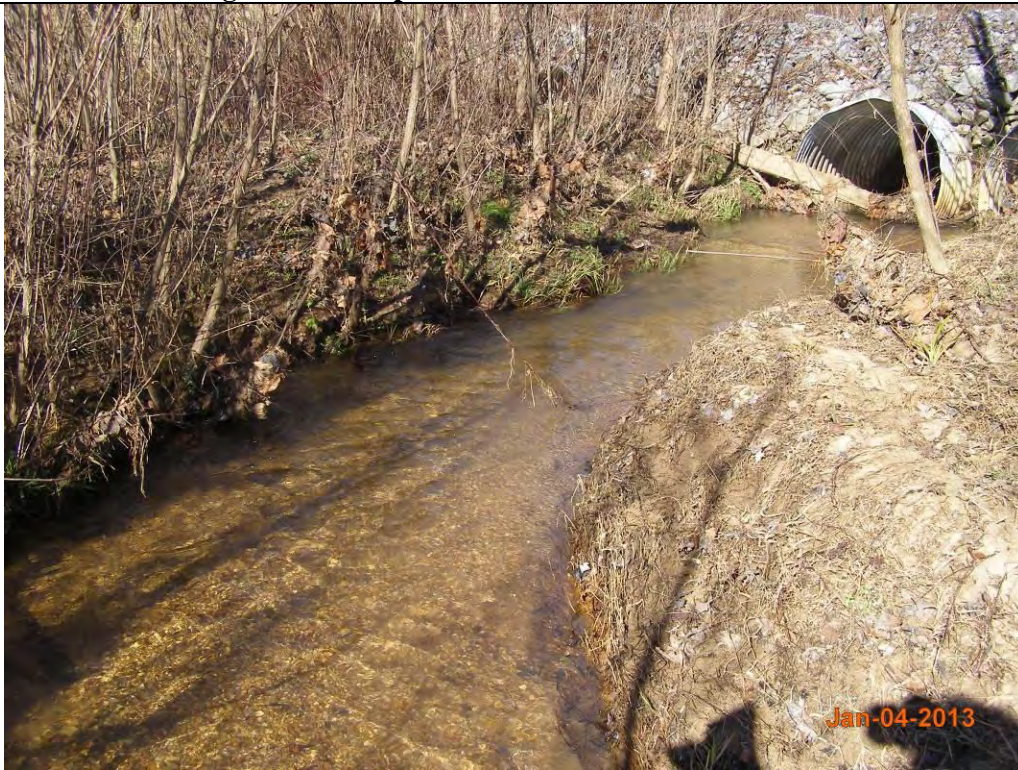
SPA 4 Morgan Creek Sta. 1003+25 – Reduced pool depth due to aggradation
