Morgan Creek Stream Restoration Site

Haywood County, North Carolina

EEP Contract #: D06035-A

MONITORING REPORT 2009 (YEAR 1)

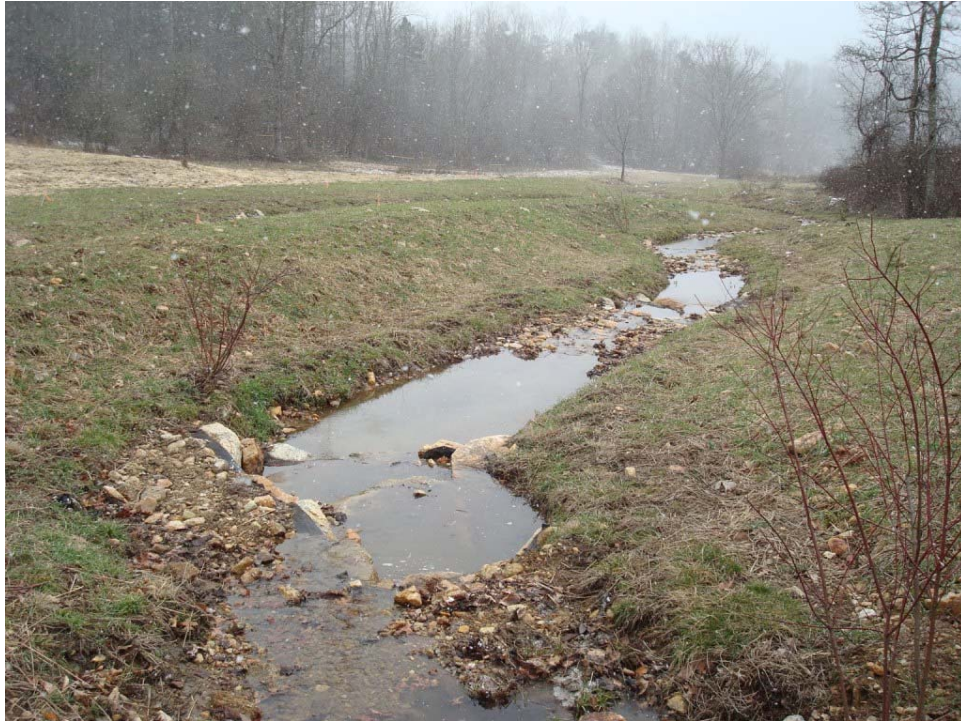
Photo Point 8
Lower North Branch from pipe outfall, facing downstream

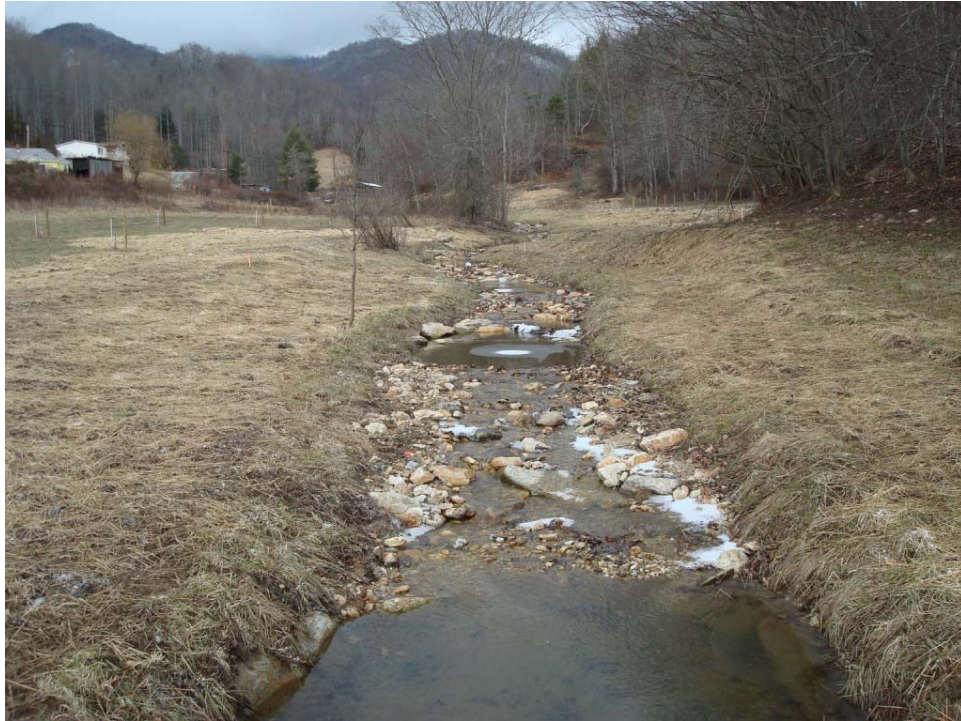
Photo Point 9
Piped crossing at easement break, facing upstream

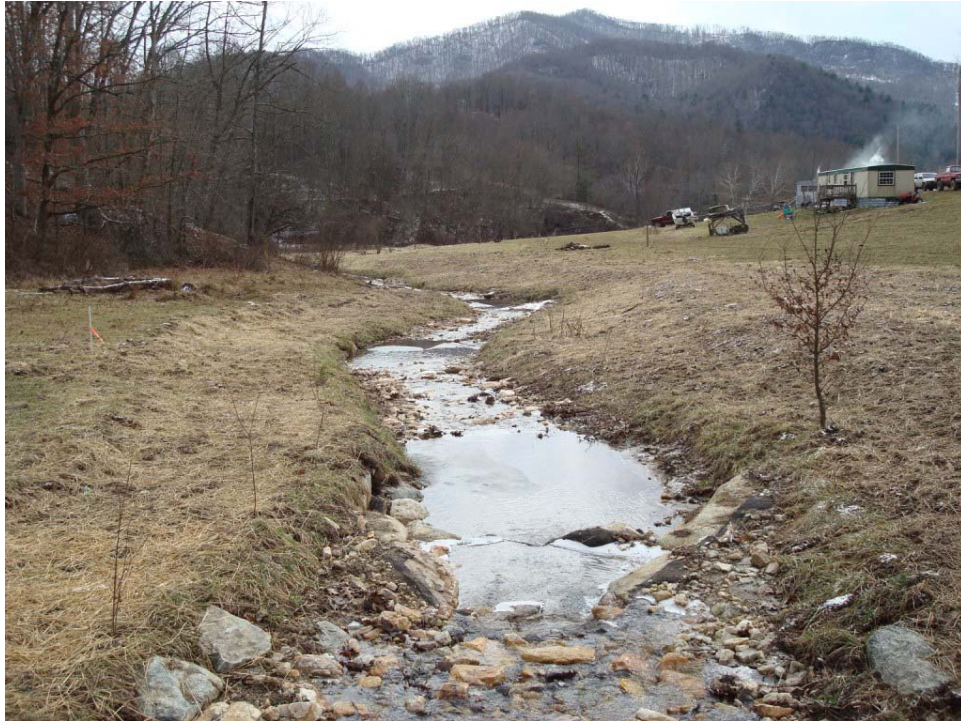
Photo Point 9
Piped crossing at easement break, facing downstream

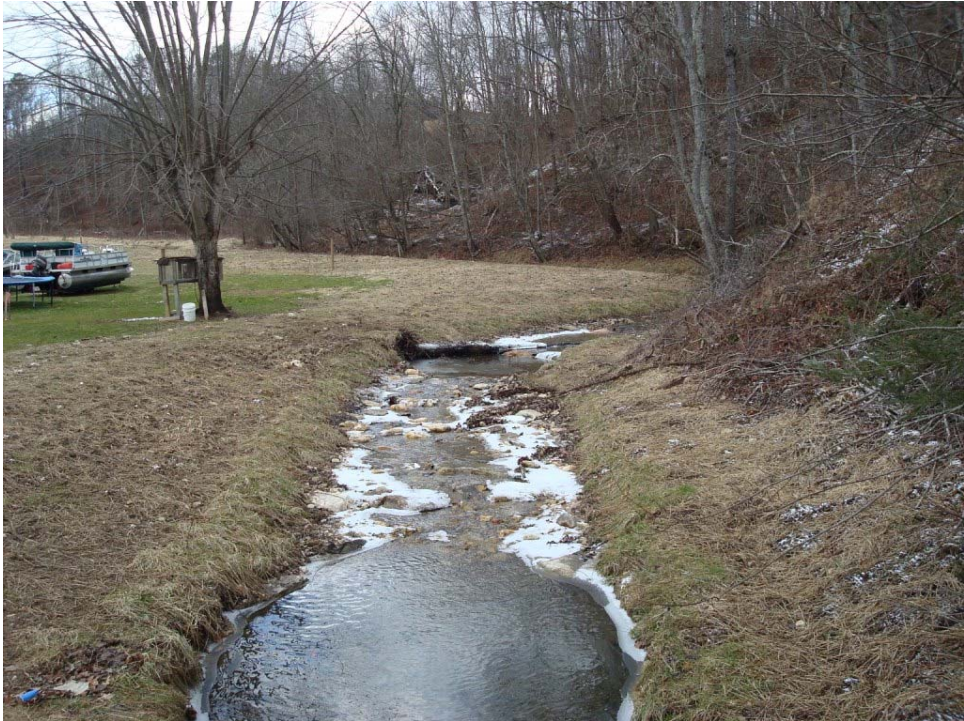
Photo Point 10
Morgan Creek from D/S pipe inlet, facing upstream

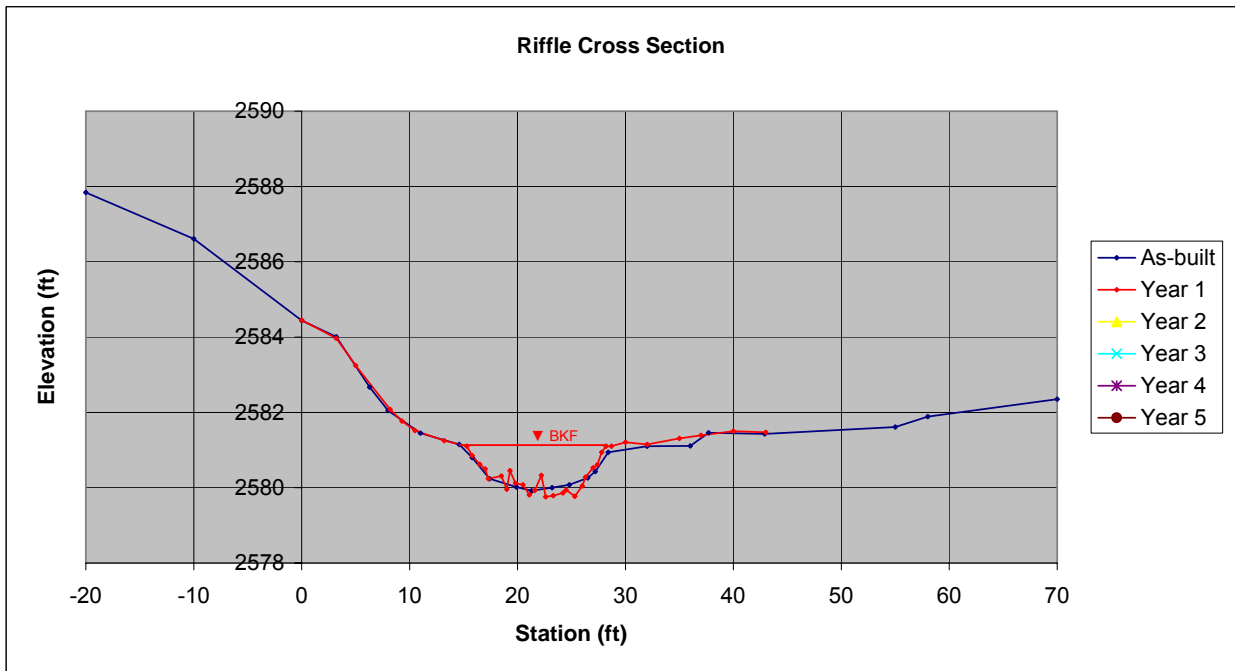
Haywood County, NC
 Riffle Cross Section RF1
 Reach 1 - Morgan Creek - Sta 15+21.4

As-Built		Year 1		Year 2		Year 3		Year 4		Year 5	
Date	1/8/09	Date	10/6/09	Date	0/0/0	Date	0/0/0	Date	0/0/0	Date	0/0/0
Area	12.2	Area	11.4	Area	0.0	Area	0.0	Area	0.0	Area	0.0
Bkf W	13.8	Bkf W	12.9	Bkf W	10	Bkf W	10	Bkf W	10	Bkf W	10
Dmean	0.9	Dmean	0.9	Dmean	0.0	Dmean	0.0	Dmean	0.0	Dmean	0.0
Dmax	1.2	Dmax	1.3	Dmax	0.0	Dmax	0.0	Dmax	0.0	Dmax	0.0
W/d	15.6	W/d	14.6	W/d	0.0	W/d	0.0	W/d	0.0	W/d	0.0

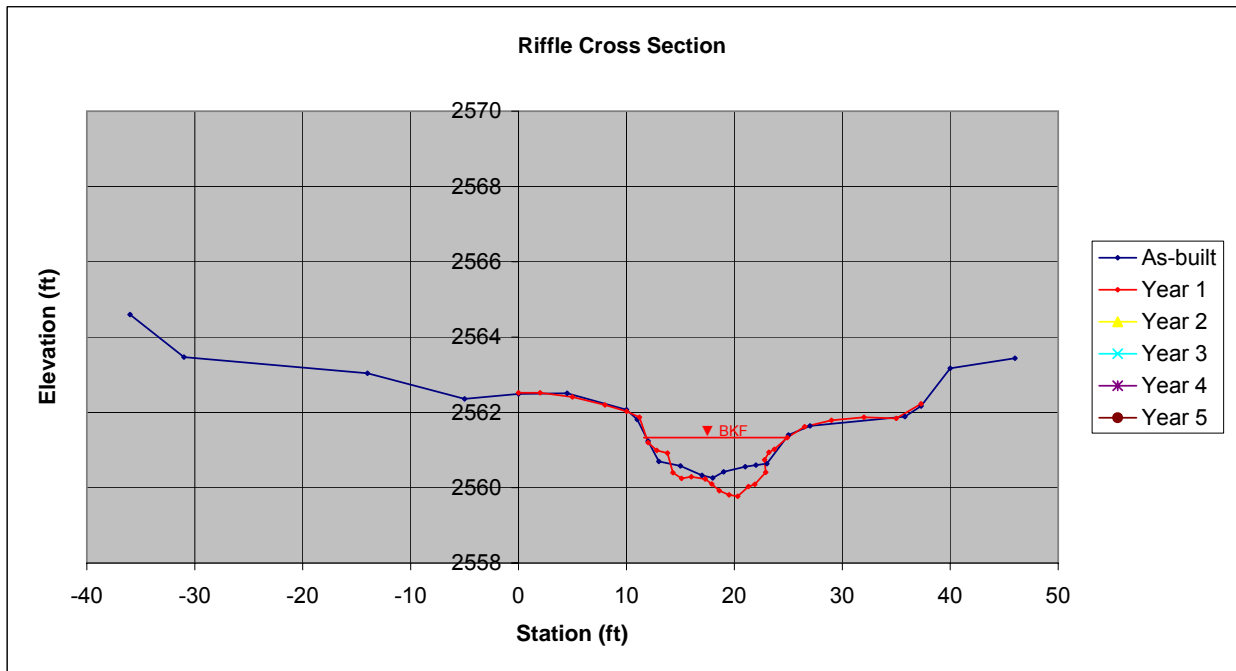
Morgan Creek Stream Restoration Site
 Haywood County, NC
 Riffle Cross Section RF2
 Reach 1 - Morgan Creek - Sta 20+74.6

As-Built		Year 1		Year 2		Year 3		Year 4		Year 5	
Date	1/8/09	Date	10/6/09	Date	0/0/0	Date	0/0/0	Date	0/0/0	Date	0/0/0
Area	10.2	Area	12.0	Area	0.0	Area	0.0	Area	0.0	Area	0.0
Bkf W	13.5	Bkf W	13.3	Bkf W	10	Bkf W	10	Bkf W	10	Bkf W	10
Dmean	0.8	Dmean	0.9	Dmean	0.0	Dmean	0.0	Dmean	0.0	Dmean	0.0
Dmax	1.1	Dmax	1.6	Dmax	0.0	Dmax	0.0	Dmax	0.0	Dmax	0.0
W/d	17.9	W/d	14.8	W/d	0.0	W/d	0.0	W/d	0.0	W/d	0.0

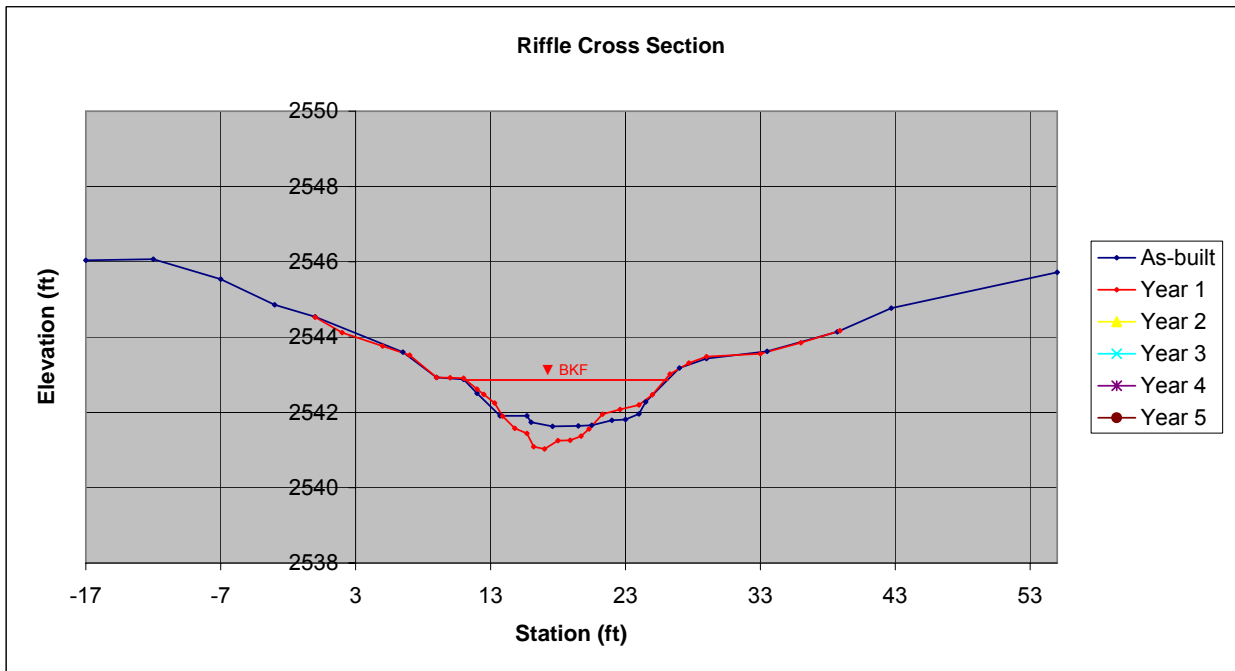
Morgan Creek Stream Restoration Site
 Haywood County, NC
 Riffle Cross Section RF3
 Reach 1 - Morgan Creek - Sta 25+60.4

As-Built		Year 1		Year 2		Year 3		Year 4		Year 5	
Date	1/8/09	Date	10/6/09	Date	0/0/0	Date	0/0/0	Date	0/0/0	Date	0/0/0
Area	13.3	Area	15.3	Area	0.0	Area	0.0	Area	0.0	Area	0.0
Bkf W	15	Bkf W	14.6	Bkf W	10	Bkf W	10	Bkf W	10	Bkf W	10
Dmean	0.9	Dmean	1.0	Dmean	0.0	Dmean	0.0	Dmean	0.0	Dmean	0.0
Dmax	1.3	Dmax	1.9	Dmax	0.0	Dmax	0.0	Dmax	0.0	Dmax	0.0
W/d	16.9	W/d	14.0	W/d	0.0	W/d	0.0	W/d	0.0	W/d	0.0

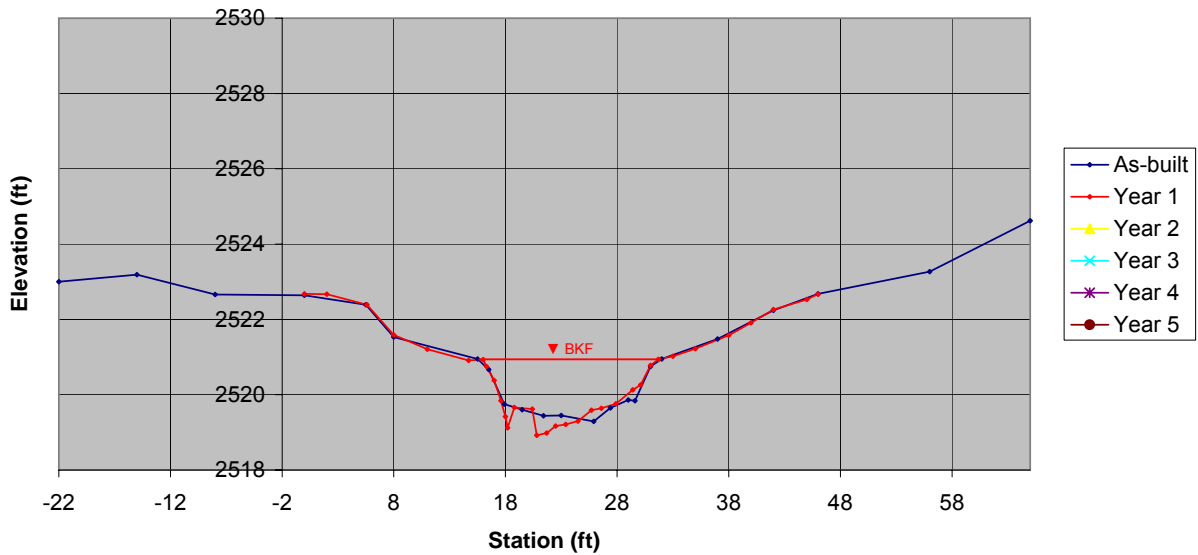
Haywood County, NC
 Riffle Cross Section RF4
 Reach 4 - Morgan Creek - Sta 33+24.4

As-Built		Year 1		Year 2		Year 3		Year 4		Year 5	
Date	1/8/09	Date	10/6/09	Date	0/0/0	Date	0/0/0	Date	0/0/0	Date	0/0/0
Area	18.7	Area	19.1	Area	0.0	Area	0.0	Area	0.0	Area	0.0
Bkf W	16.5	Bkf W	15.7	Bkf W	10	Bkf W	10	Bkf W	10	Bkf W	10
Dmean	1.1	Dmean	1.2	Dmean	0.0	Dmean	0.0	Dmean	0.0	Dmean	0.0
Dmax	1.7	Dmax	2.0	Dmax	0.0	Dmax	0.0	Dmax	0.0	Dmax	0.0
W/d	14.5	W/d	12.9	W/d	0.0	W/d	0.0	W/d	0.0	W/d	0.0

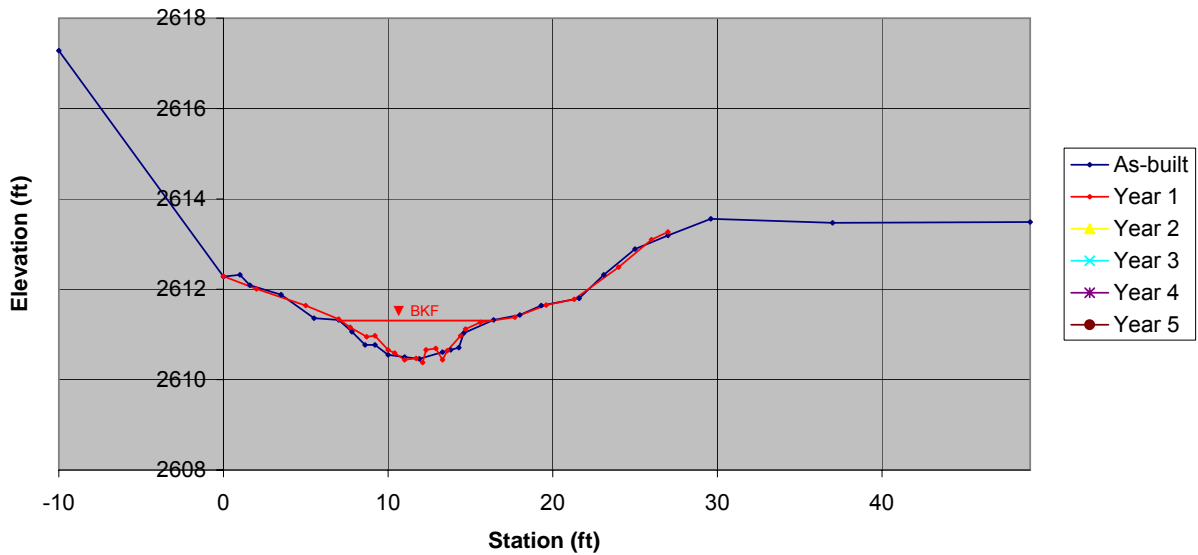
Haywood County, NC
 Riffle Cross Section RF5
 Reach 2 - North Branch - Sta 10+85.4

As-Built		Year 1		Year 2		Year 3		Year 4		Year 5	
Date	1/8/09	Date	10/6/09	Date	0/0/0	Date	0/0/0	Date	0/0/0	Date	0/0/0
Area	5.0	Area	4.5	Area	0.0	Area	0.0	Area	0.0	Area	0.0
Bkf W	9.4	Bkf W	8.6	Bkf W	10	Bkf W	10	Bkf W	10	Bkf W	10
Dmean	0.5	Dmean	0.5	Dmean	0.0	Dmean	0.0	Dmean	0.0	Dmean	0.0
Dmax	0.9	Dmax	1.0	Dmax	0.0	Dmax	0.0	Dmax	0.0	Dmax	0.0
W/d	17.7	W/d	16.5	W/d	0.0	W/d	0.0	W/d	0.0	W/d	0.0
