South Muddy Creek Stream Restoration Project Year 1 Monitoring Report

NCEEP Project Number – 737

Project Info: Monitoring Year: 1 of 5
 Year of Data Collection: 2012
 Year of Completed Construction: 2011
 NCEEP Project Manager: Paul Wiesner
 Submission Date: November 30th, 2012

Report Prepared and Submitted by Michael Baker Engineering, Inc.

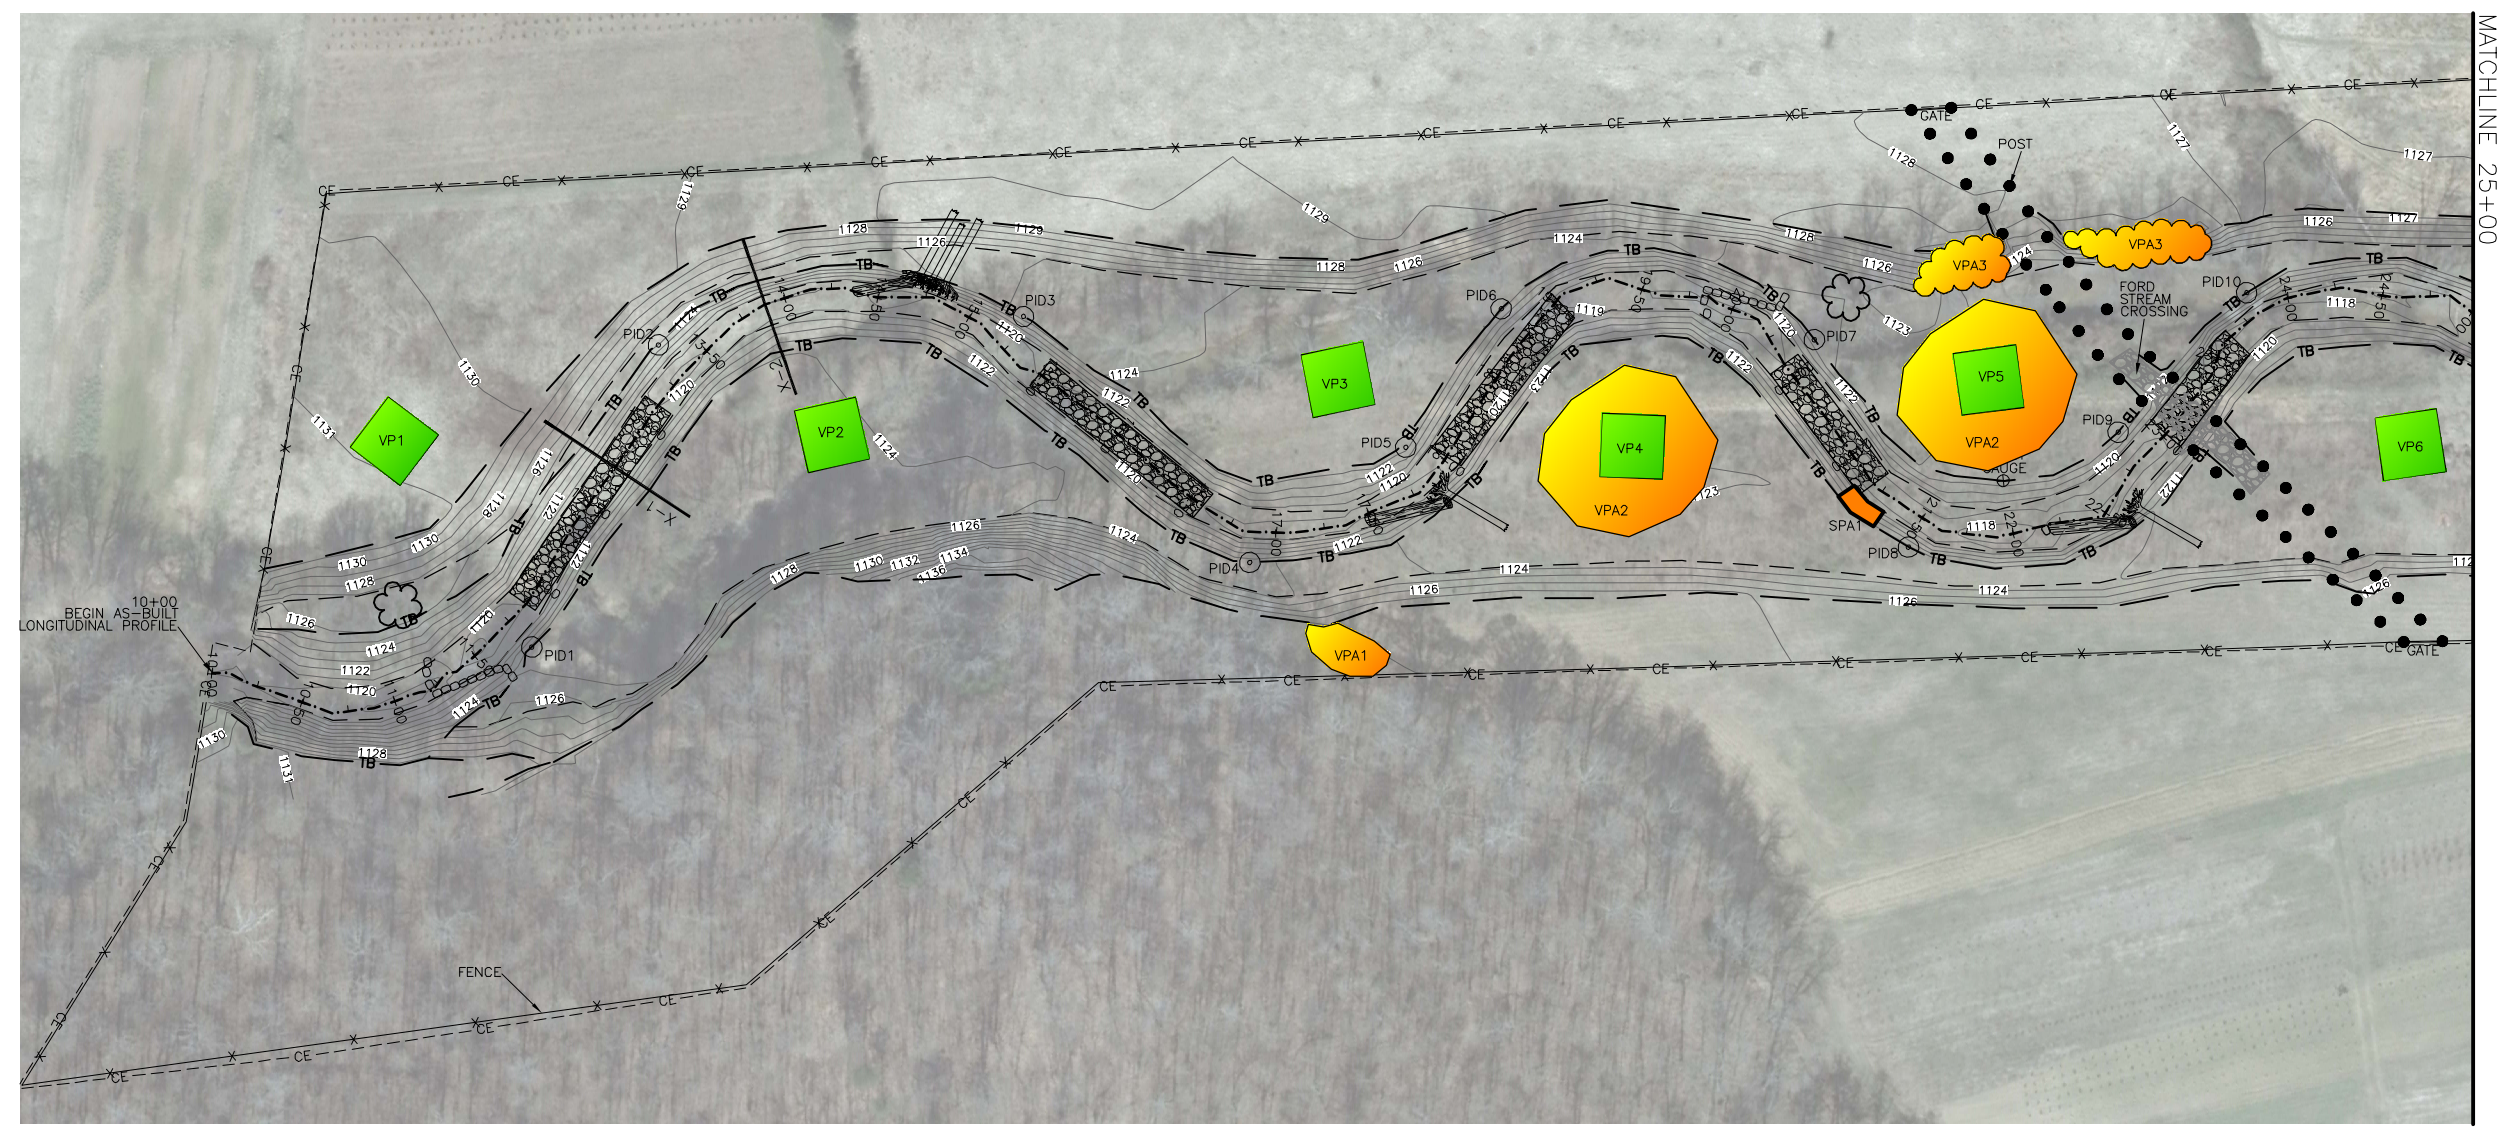
SOUTH MUDDY CREEK
 CURRENT CONDITION PLAN VIEW
 YEAR 1 MONITORING
 STA. 10+00-25+00

Invasive areas of concern were observed and documented accordingly in Table 6a and as vegetation problem areas (VPAs) in Figure 2 and Table 6b (Appendix B). Ten discrete areas of invasive species were documented throughout the site and totaled approximately 1 acre, or 5.7% of the total easement acreage. A more detailed summary of the results for the vegetation condition assessment can be found in Appendix B which includes a technical memorandum, current condition planview (CCPV) figures, supporting data tables, and photo logs; the contents of Appendix B was submitted to NCEEP in June 2012 and served as the interim visual site assessment report.

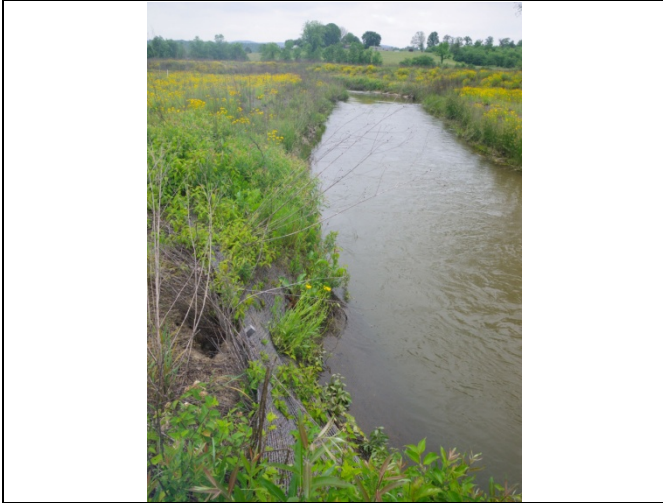
SPA1 – Right bank separating/overhanging from poor compaction and scour along toe of bank (looking upstream)

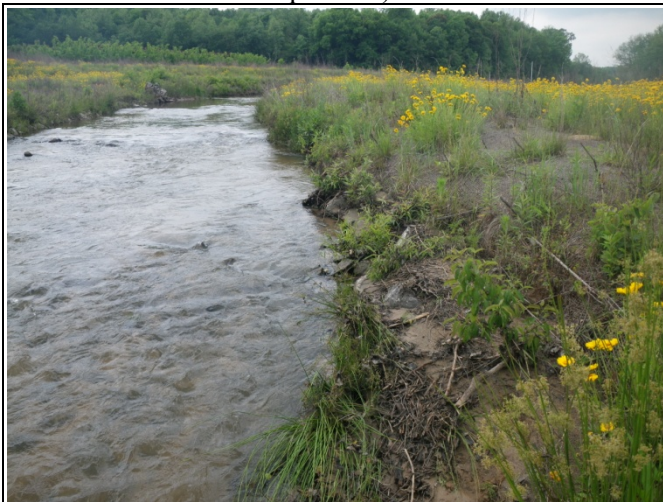
SPA3 – Localized scour along left bank from eddying within the riffle (looking upstream)

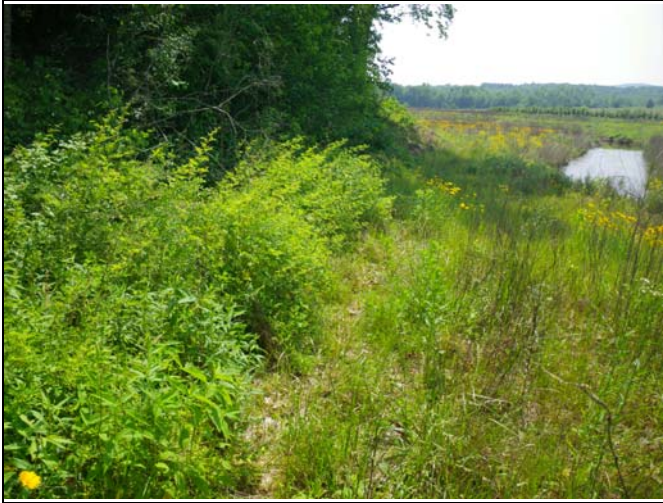
VPA1 – Multiflora Rose

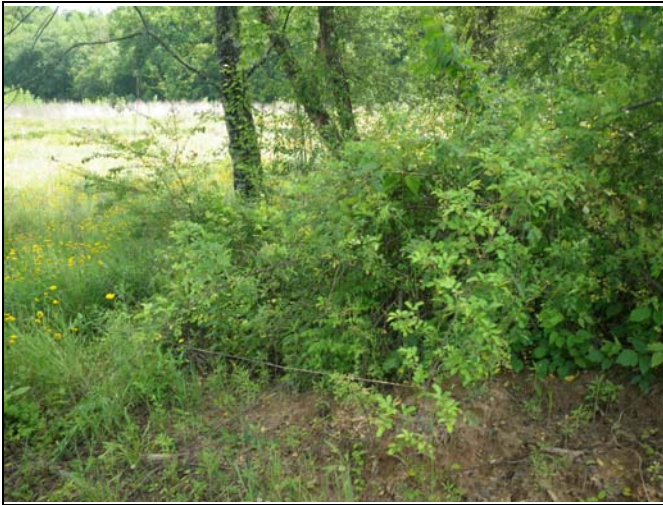
VPA3 – Multiflora Rose and Chinese Privet

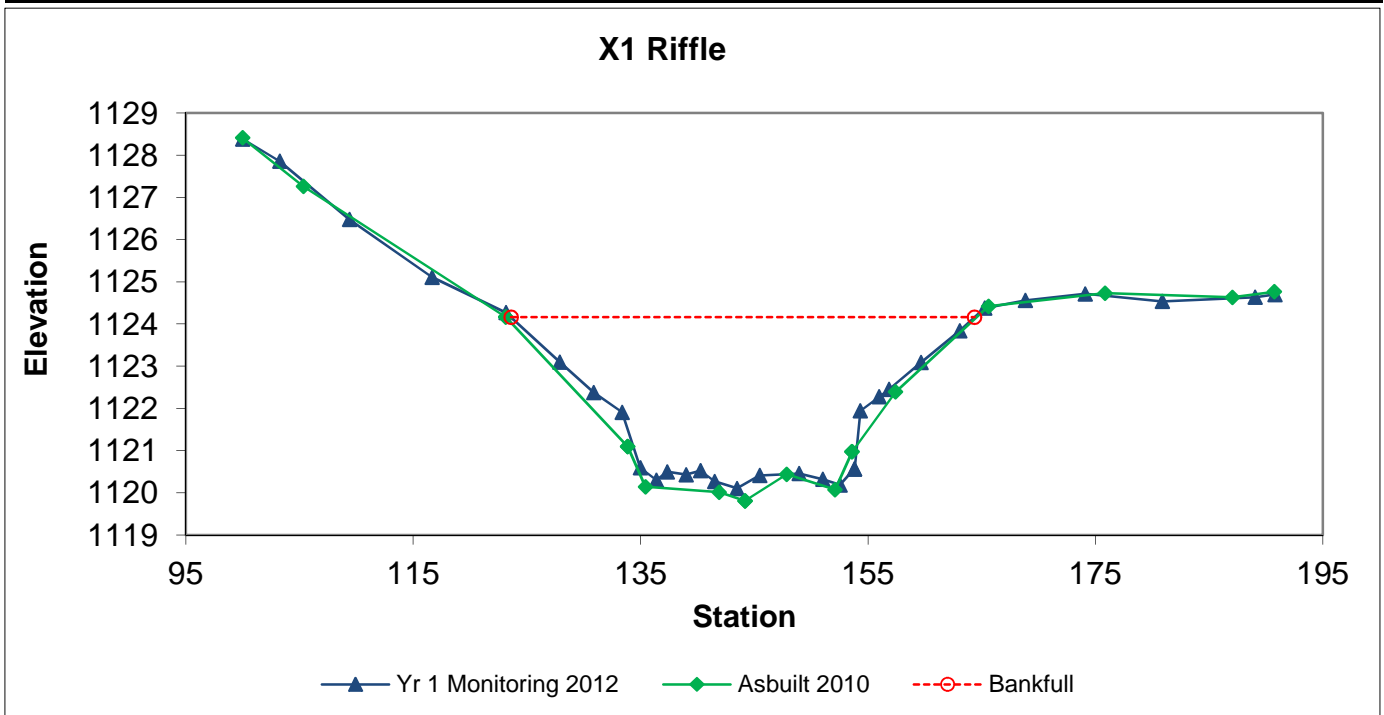
Permanent Cross Section X1

The four permanent cross-sections in Appendix D show that there has been little adjustment to stream dimension within the Project reach since construction. In general, riffles appeared to have narrowed in width slightly while pools appeared to have slightly increased in (maximum) depth. The longitudinal profile indicates that the bed features are generally stable and that grade control structures (constructed riffles and j-hooks) continue to help maintain the overall profile desired. Pool lengths and depths appear to have been maintained with minor localized adjustments. Aggradation is evident within the downstream limits of the Project reach profile, primarily along the meander bend beginning at station 36+00 where the maximum depth of the pool has aggraded approximately two feet. The maintenance or stability of pools (from scour) throughout the remainder of the Project reach upstream as indicated by the profile, and the shift from finer to coarser bed load material as indicated by the pebble count data, suggests that this aggraded area is localized and may be due to the transport and deposition of finer particles from further upstream (where the sediment sample was collected). The bed load material analysis shown in Figure 5 of Appendix D illustrates this stable transition whereby larger pebbles are making up a greater percentage of the bed material since construction was completed and the baseline condition pebble count was conducted prior to the apparent flush of fines downstream. Scour within the aggraded meander bend, from larger, subsequent storm flows, should flush the aggraded material downstream and help to re-establish a deeper pool over time. The site was found to have had at least two bankfull events based on crest gauge readings. Information on these events is provided in Table 12 of Appendix E.

Feature	Stream Type	BKF Area	BKF Width	BKF Depth	Max BKF Depth	W/D	BH Ratio	ER	BKF Elev	TOB Elev
Riffle	C	100.5	40.78	2.46	4.06	16.54	1.1	2.2	1124.16	1124.72

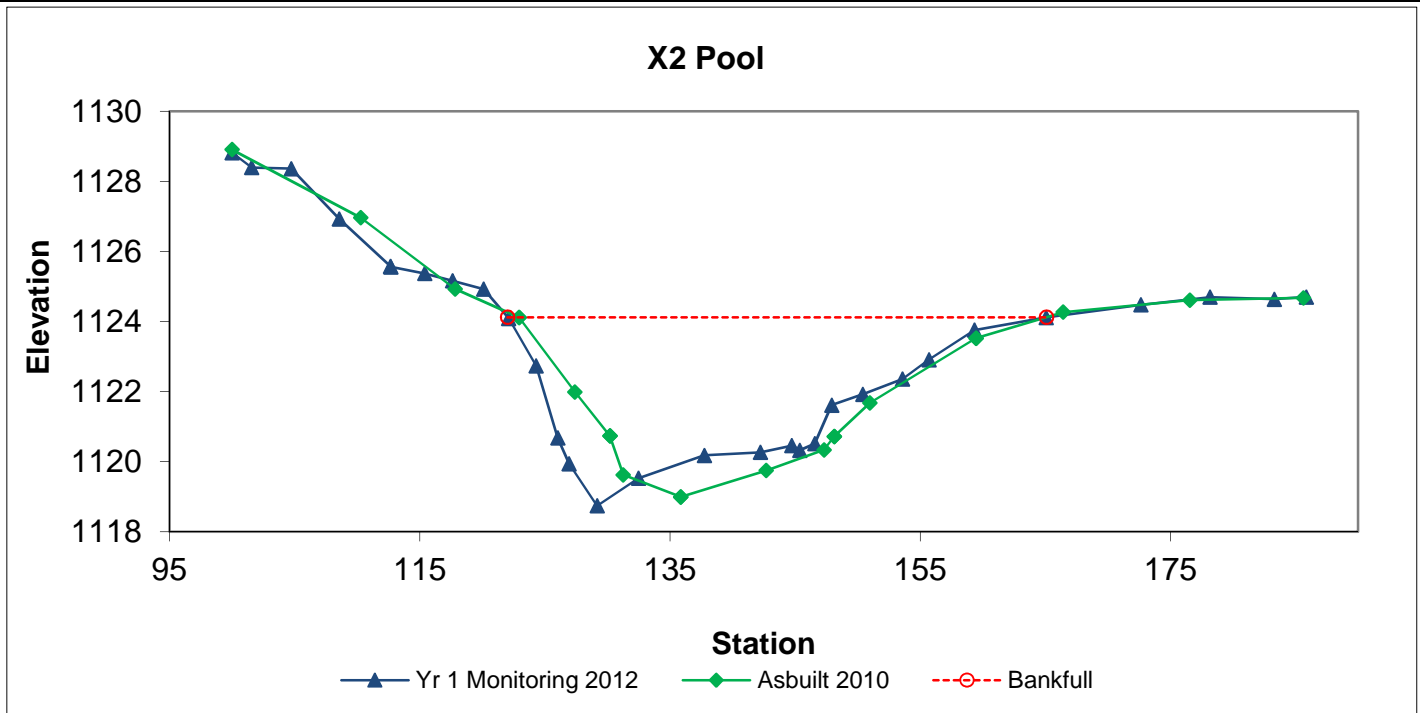
Permanent Cross Section X2

Feature	Stream Type	BKF Area	BKF Width	BKF Depth	Max BKF Depth	W/D	BH Ratio	ER	BKF Elev	TOB Elev
Pool		115.8	43.06	2.69	5.38	16.01	1.1	2	1124.12	1124.7

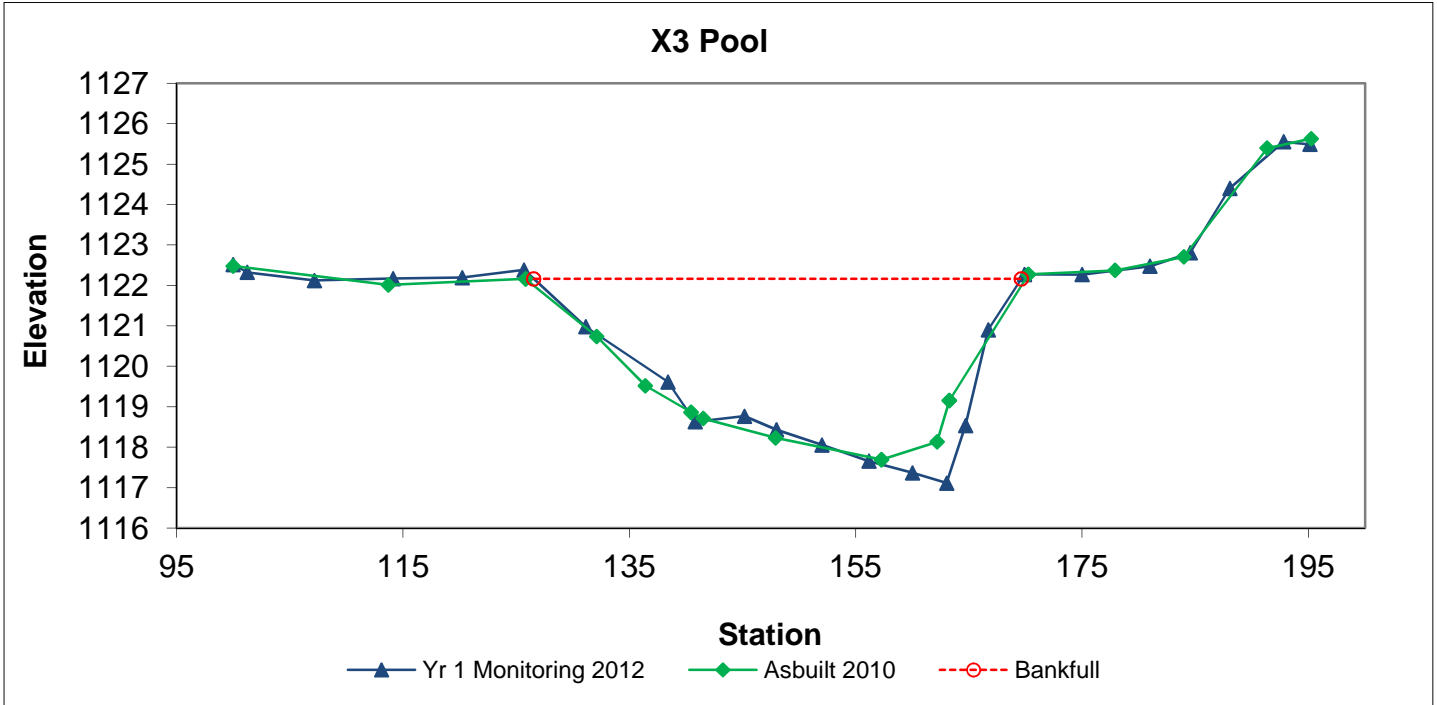
Permanent Cross Section X3

Feature	Stream Type	BKF Area	BKF Width	BKF Depth	Max BKF Depth	W/D	BH Ratio	ER	BKF Elev	TOB Elev
Pool		129	43.08	2.99	5.05	14.39	1	2.2	1122.2	1122.27

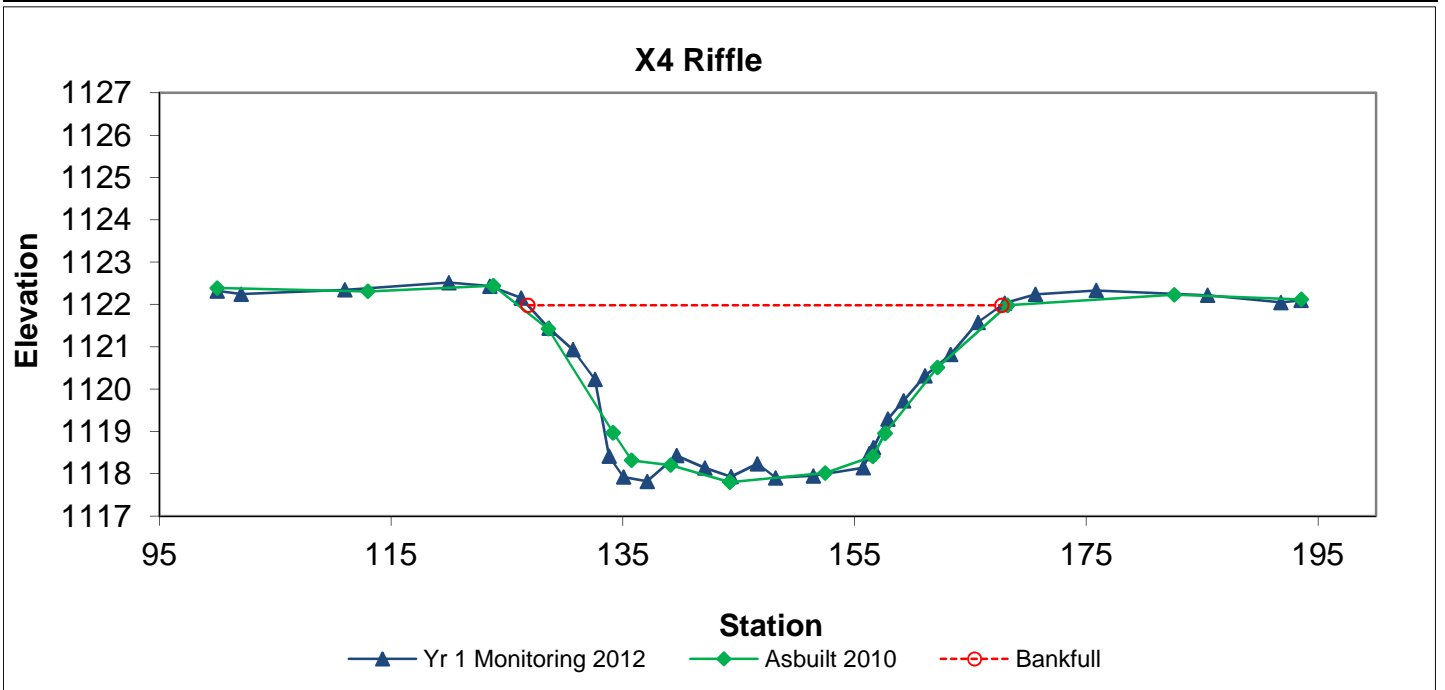
Permanent Cross Section X4

Feature	Stream Type	BKF Area	BKF Width	BKF Depth	Max BKF Depth	W/D	BH Ratio	ER	BKF Elev	TOB Elev
Riffle	C	113.3	40.89	2.77	4.16	14.75	1	2.3	1121.98	1122.03

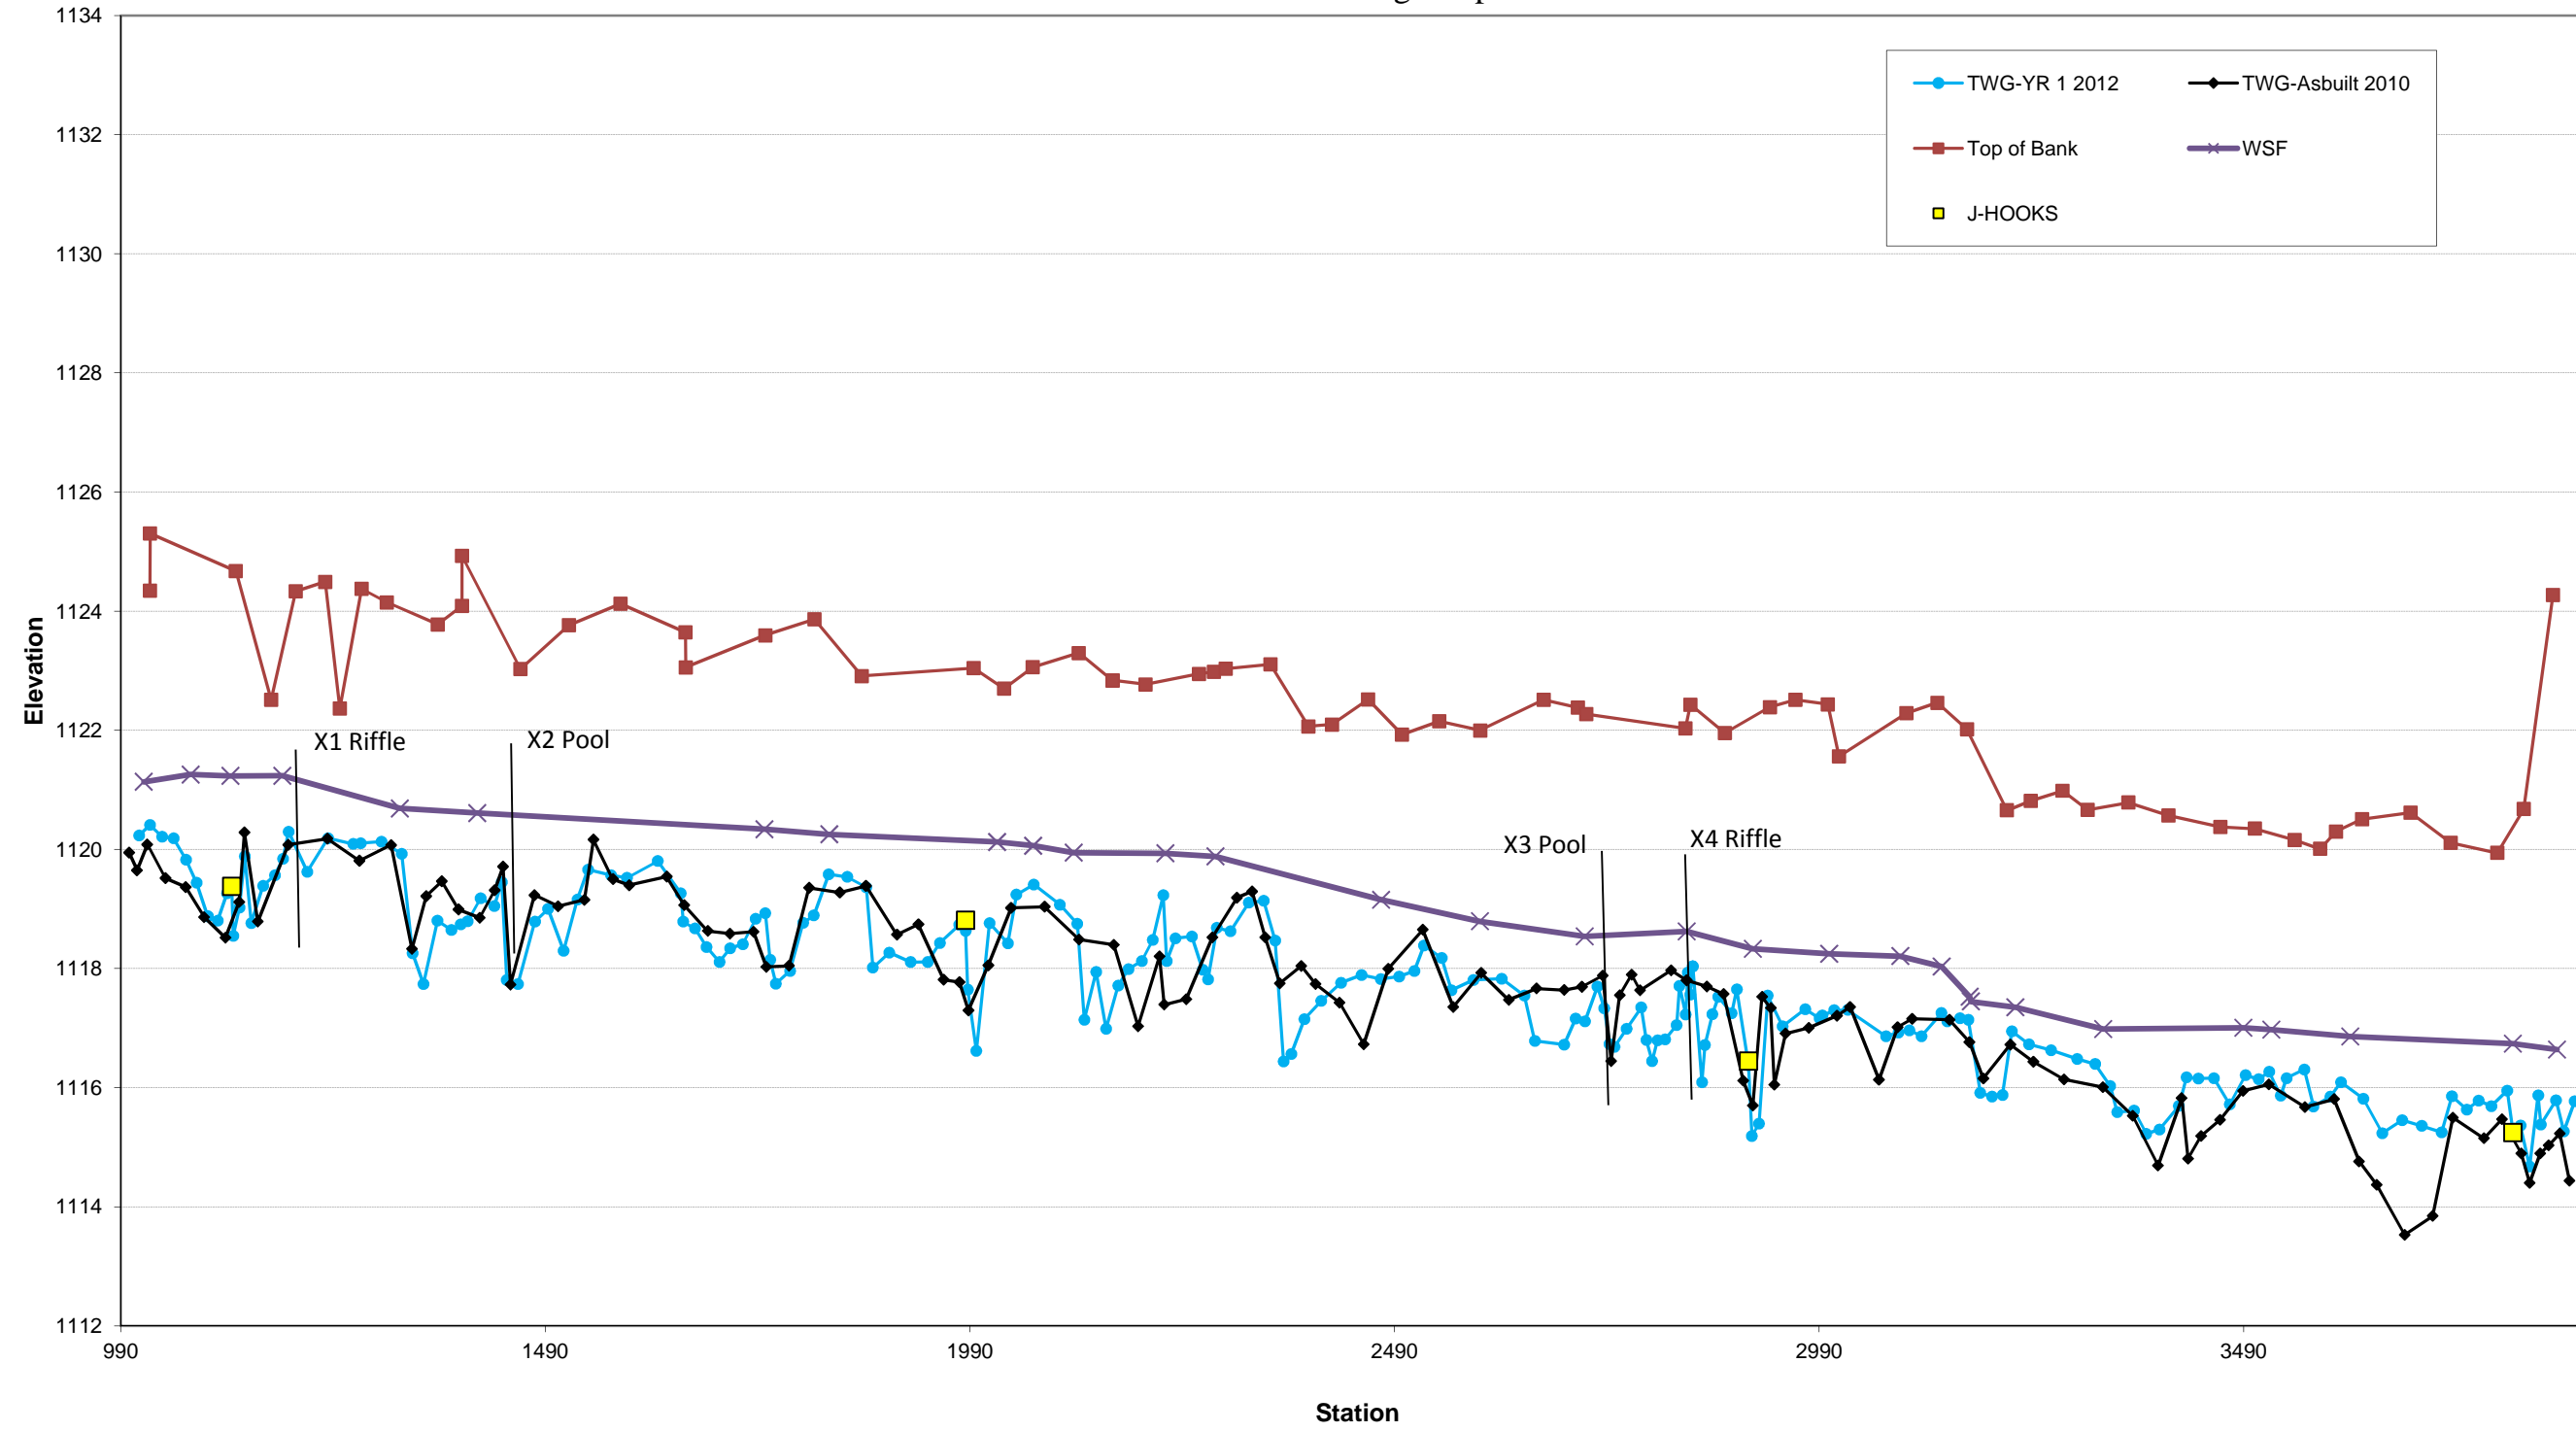
**South Muddy Creek
Profile Chart**
Year 1 Monitoring - September 2012

One longitudinal profile was surveyed for the entire project length of the Project reach and is provided in Figure 4 of Appendix D. Longitudinal profiles will be replicated annually during the five year monitoring period.

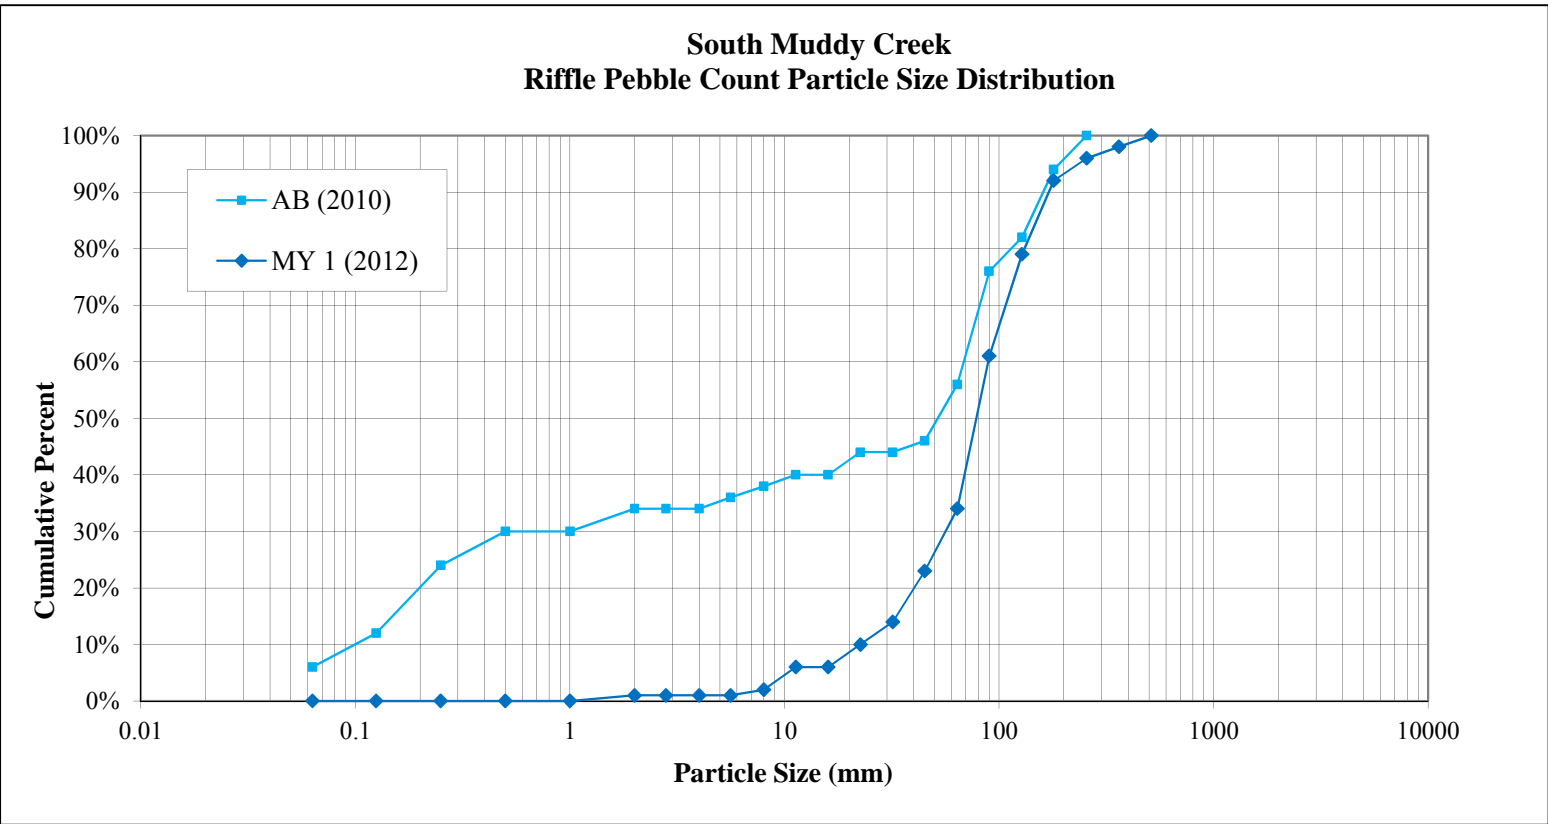
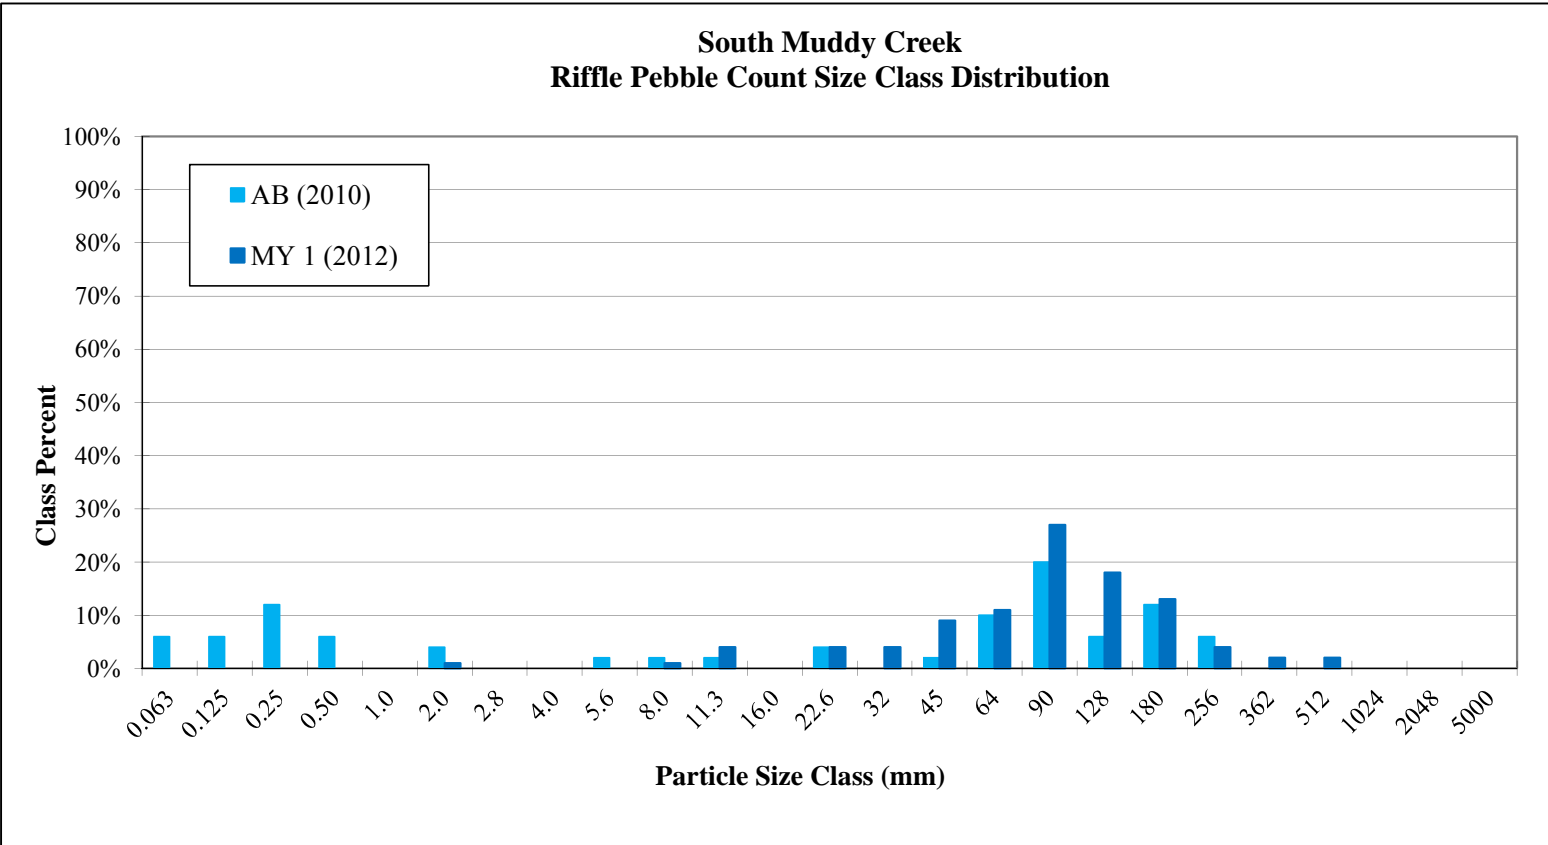
Figure 5. Riffle Pebble Count Size Class Distribution with Annual Overlays

Bed load material analysis consists of a pebble count taken in the same constructed riffle (at cross-section X4) during annual geomorphic surveys of the Project site. This sample, combined with evidence provided by changes in cross-section and profile data will reveal changes in sediment gradation that occur over time as the stream adjusts to upstream sediment loads. Significant changes in sediment gradation will be evaluated with respect to stream stability and watershed changes. Bed material distribution data is located in Figure 5 of Appendix D.

Cummulative	
Channel materials (mm)	
D ₁₆ =	34.5
D ₃₅ =	64.8
D ₅₀ =	78.3
D ₈₄ =	145.9
D ₉₅ =	234.4
D ₁₀₀ =	362 - 512

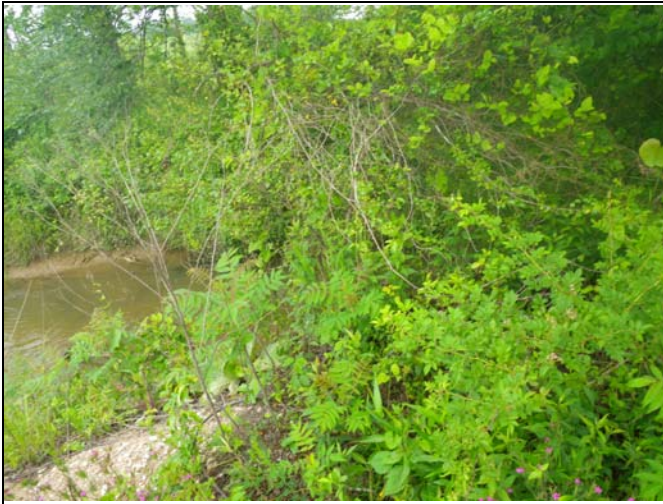
VPA6 – Kudzu persisting after treatment

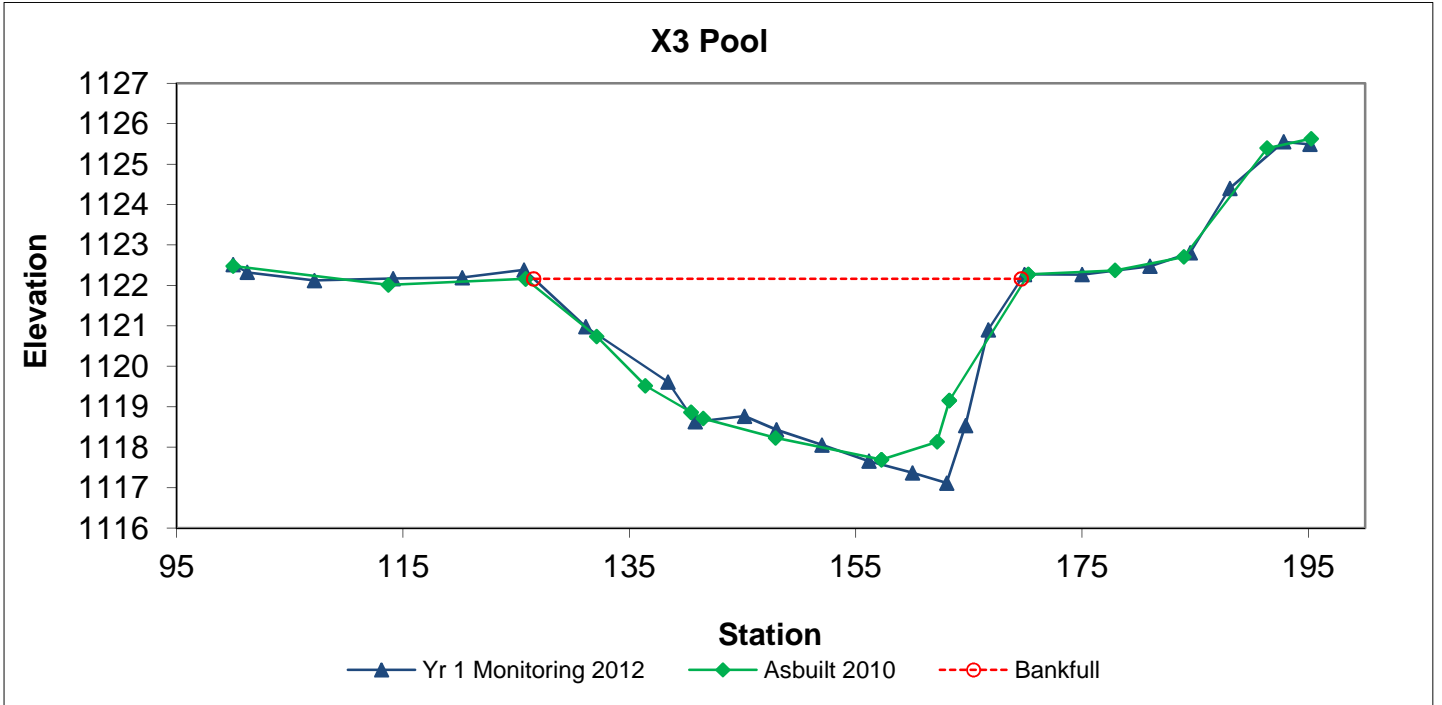
Permanent Cross Section X3

Feature	Stream Type	BKF Area	BKF Width	BKF Depth	Max BKF Depth	W/D	BH Ratio	ER	BKF Elev	TOB Elev
Pool		129	43.08	2.99	5.05	14.39	1	2.2	1122.2	1122.27

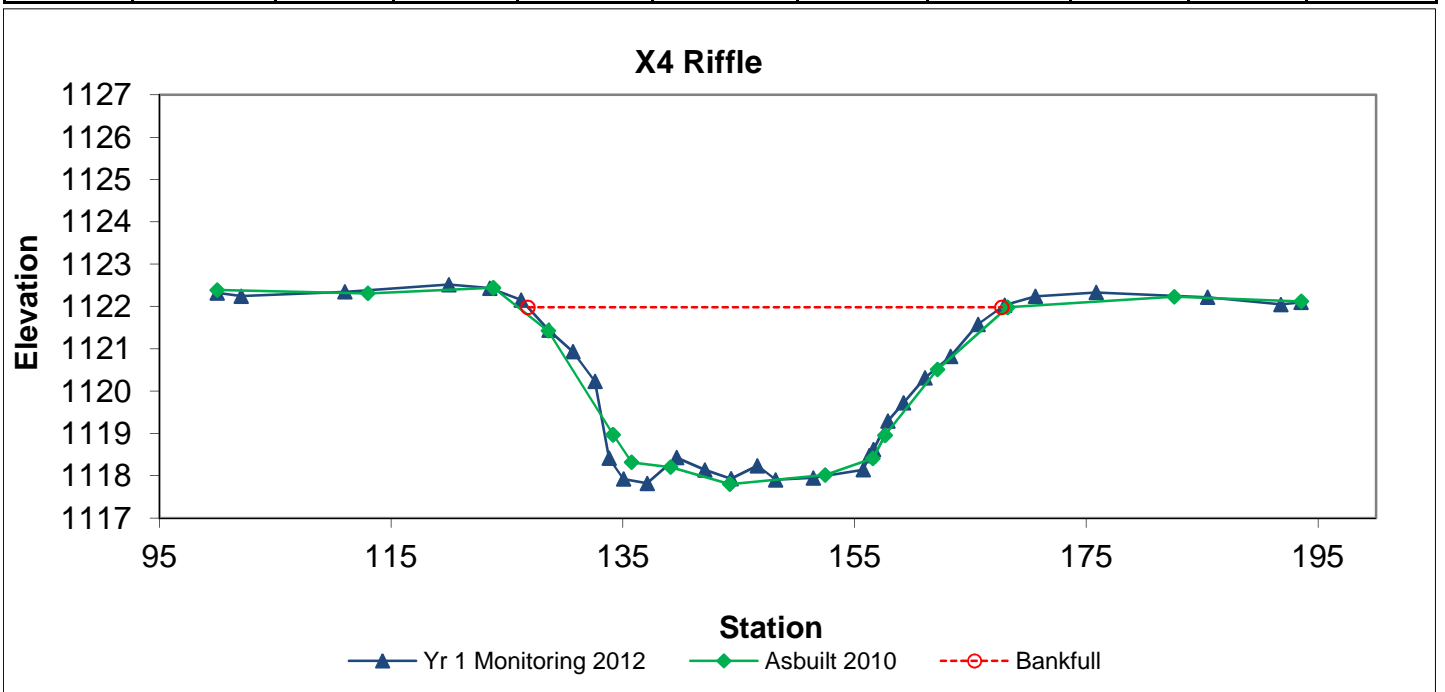
Permanent Cross Section X4

Feature	Stream Type	BKF Area	BKF Width	BKF Depth	Max BKF Depth	W/D	BH Ratio	ER	BKF Elev	TOB Elev
Riffle	C	113.3	40.89	2.77	4.16	14.75	1	2.3	1121.98	1122.03
