South Muddy Creek Stream Restoration Project Year 2 Monitoring Report

NCEEP Project Number – 737

Site Assessment Report – Monitoring Year 2

South Muddy Creek (Randolph/Duncan Properties) Stream Restoration
Project
McDowell County, North Carolina
May 2013

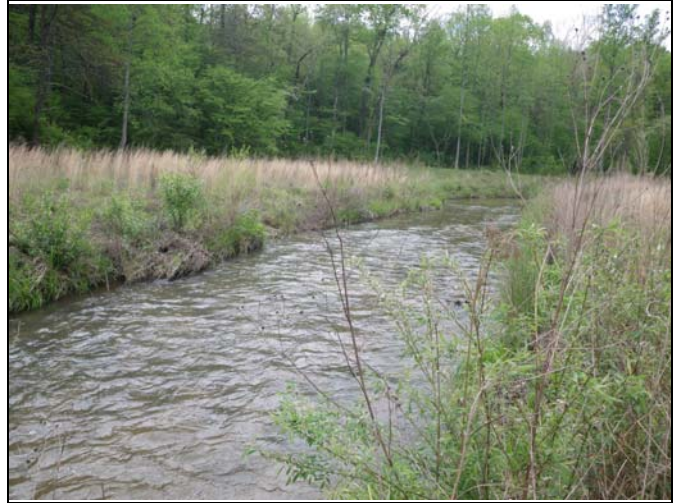
South Muddy Creek PID 2 –Constructed Riffle,

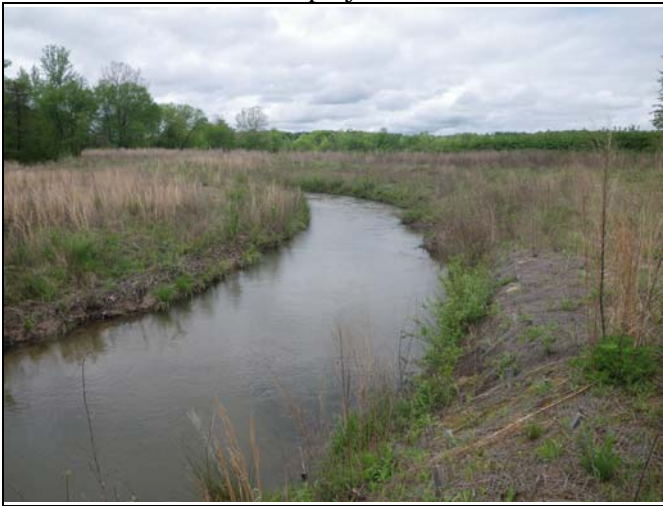
South Muddy Creek PID 3 – Log Vane in Meander

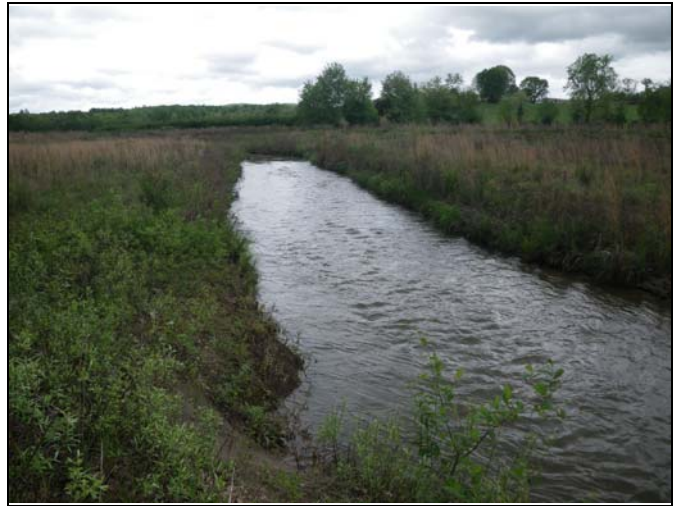
South Muddy Creek PID 4 – Constructed Riffle

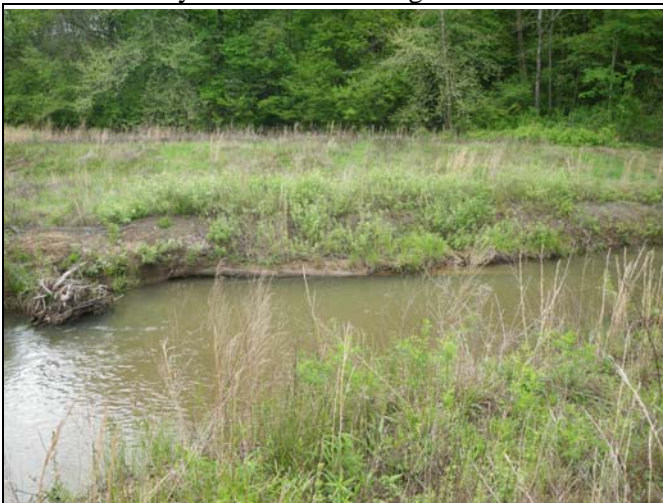
South Muddy Creek PID 5 – Log Vane in Meander

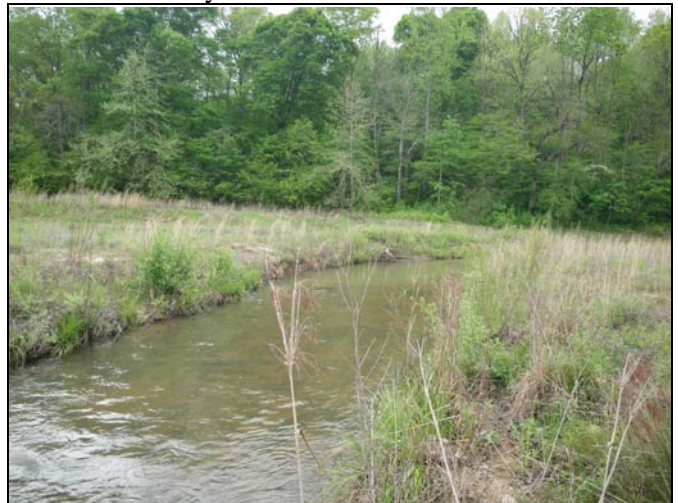
South Muddy Creek PID 6 – Constructed Riffle

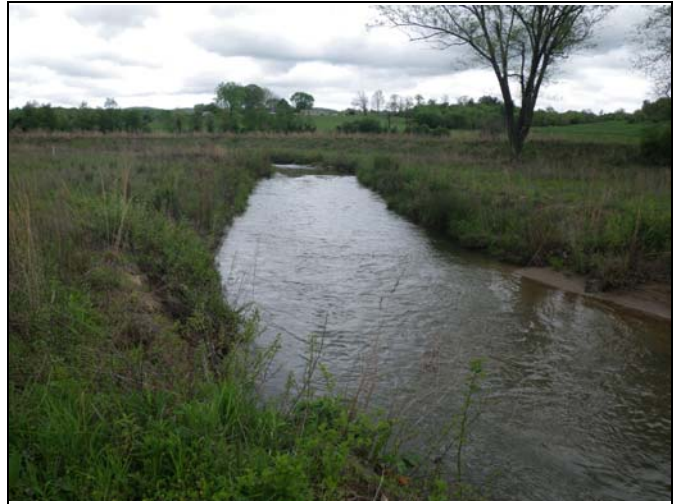
South Muddy Creek PID 8 – Constructed Riffle

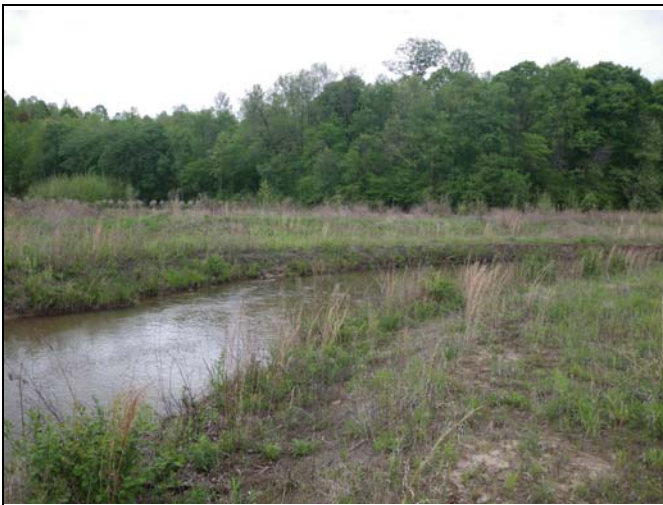
South Muddy Creek PID 9 – Log Vane in Meander

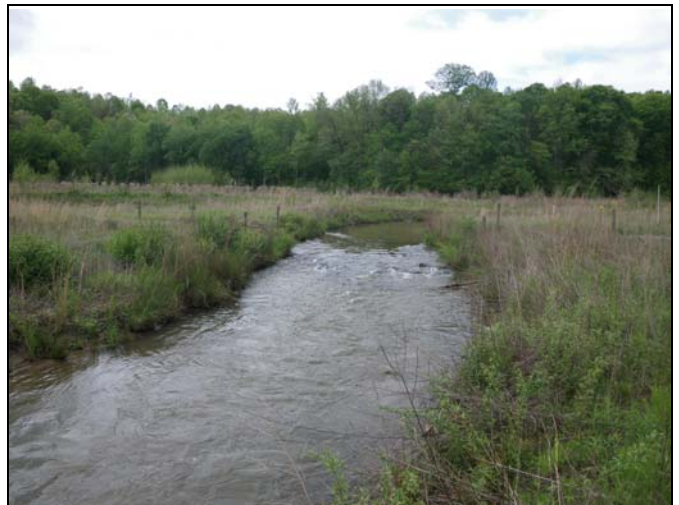
South Muddy Creek PID 10 – Stream Crossing

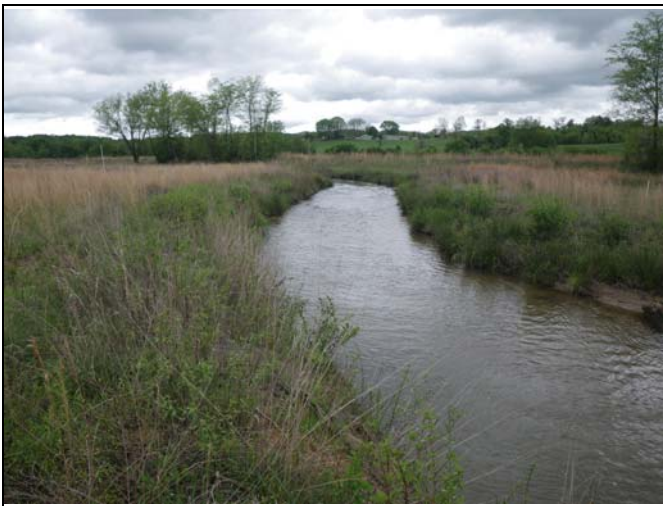
South Muddy Creek PID 11 – Constructed Riffle

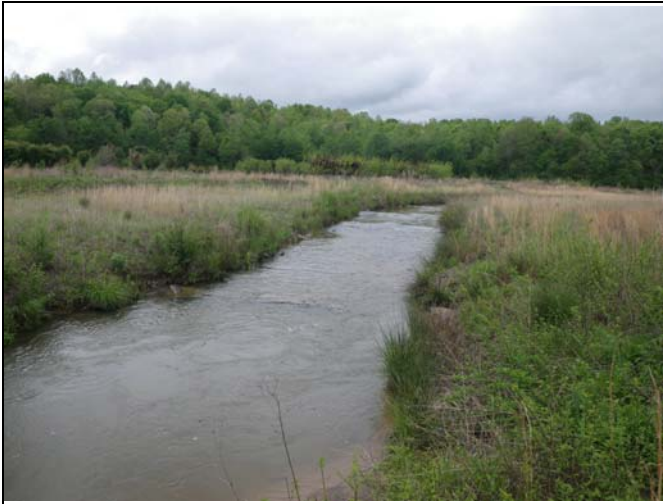
South Muddy Creek PID 13 – Constructed Riffle

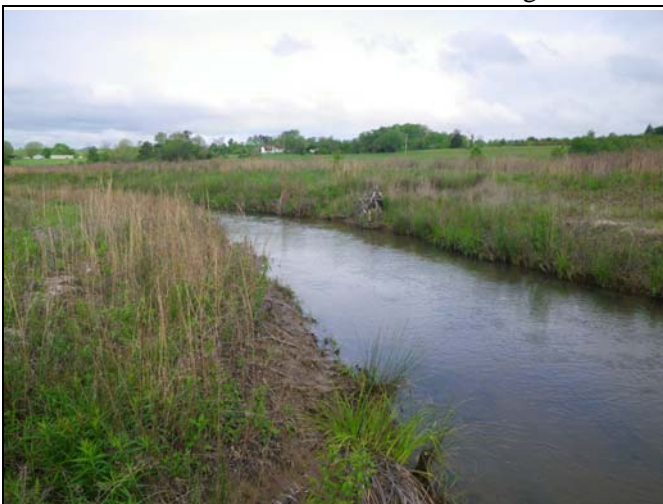
South Muddy Creek PID 17 – Log Vane in Meander

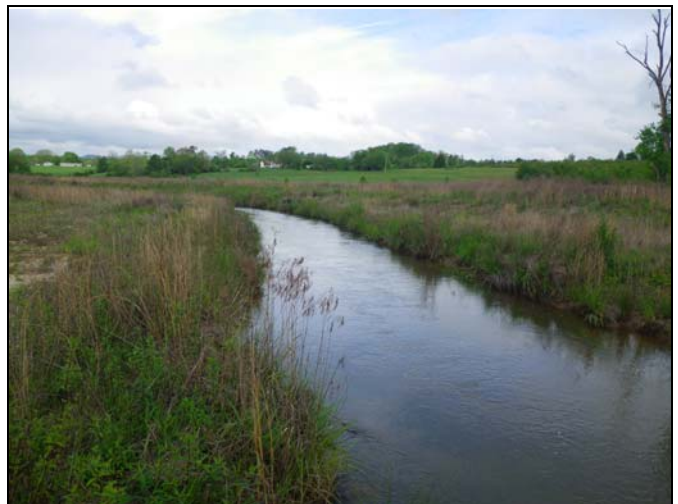
South Muddy Creek PID 18 – Constructed Riffle
