# South Muddy Creek Stream Restoration Project Year 3 Monitoring Report

**McDowell County, North Carolina**

**NCEEP Project Number – 737**

Project Info:           Monitoring Year: 3 of 5  
                              Year of Data Collection: 2014  
                              Year of Completed Construction: 2011  
                              NCEEP Project Manager: Mathew Reid  
                              Submission Date: November 28, 2014

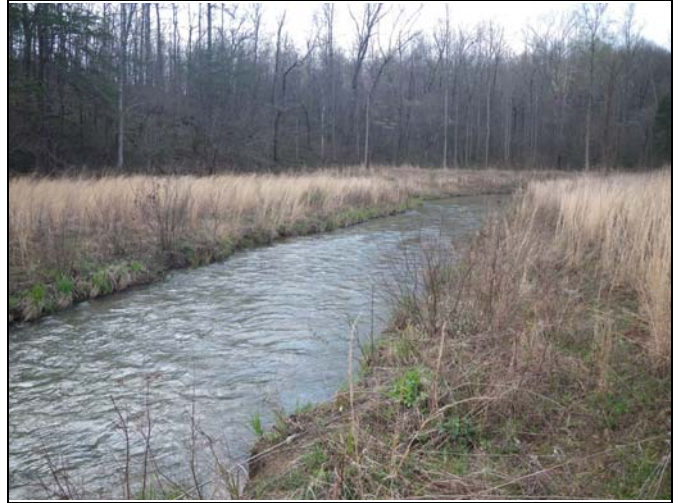
South Muddy Creek PID 2 –Constructed Riffle,

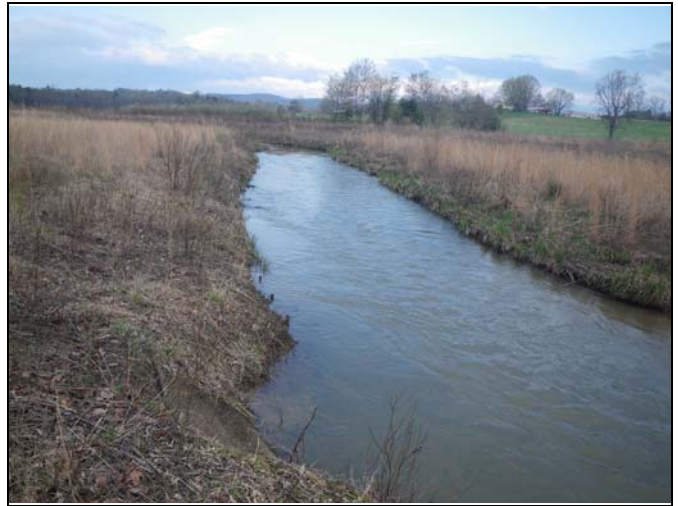
South Muddy Creek PID 4 – Constructed Riffle

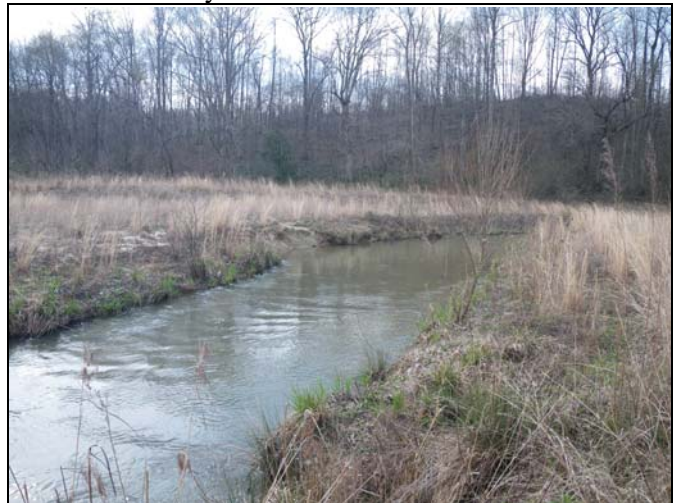
South Muddy Creek PID 6 – Constructed Riffle

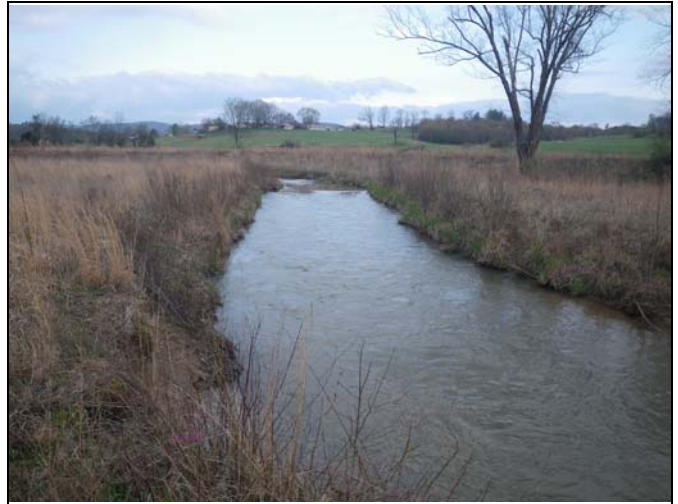
South Muddy Creek PID 8 – Constructed Riffle

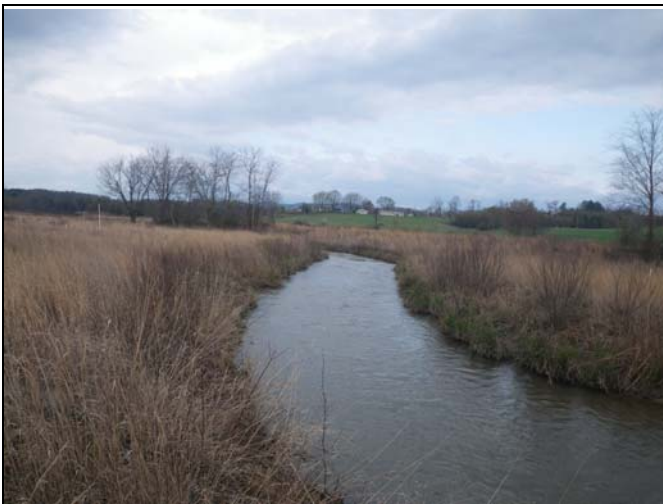
South Muddy Creek PID 11 – Constructed Riffle

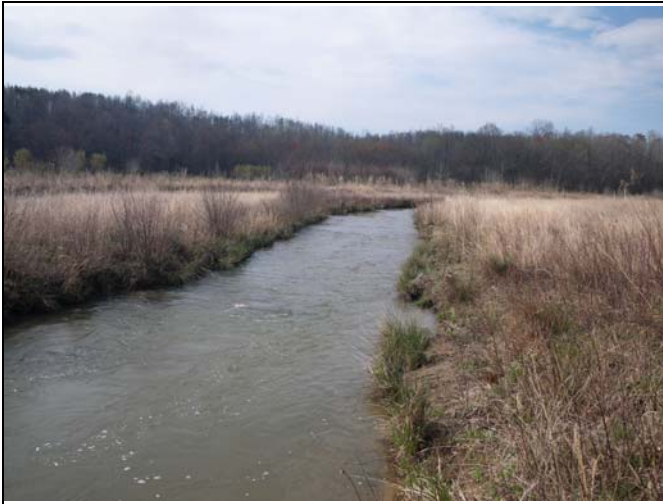
South Muddy Creek PID 13 – Constructed Riffle

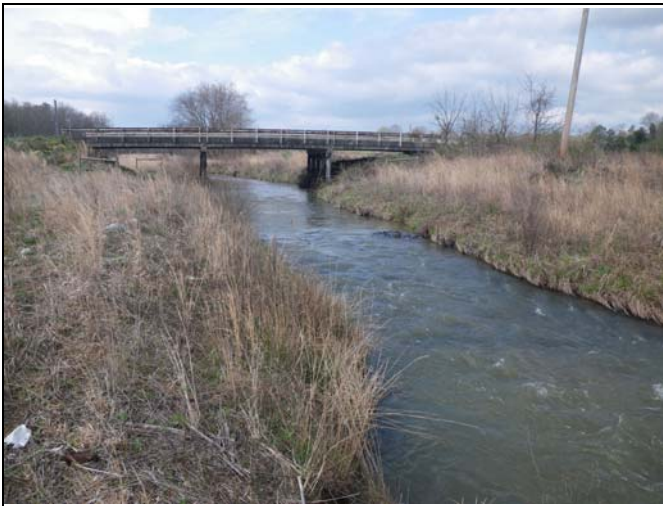
South Muddy Creek PID 15 – Constructed Riffle downstream of Sain Road crossing

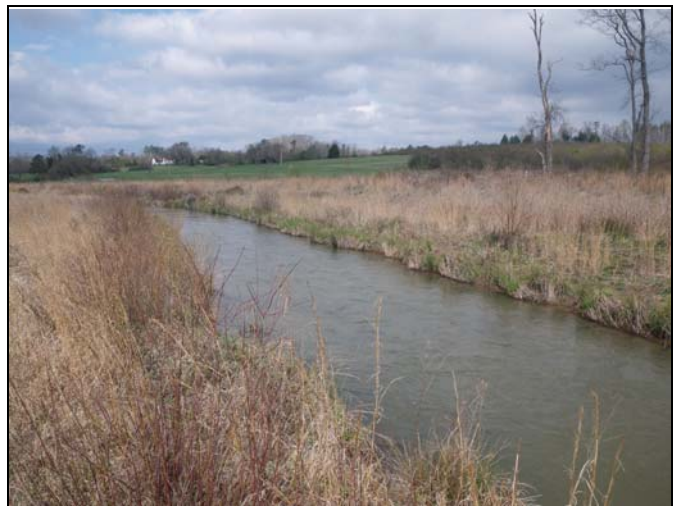
South Muddy Creek PID 18 – Constructed Riffle
