# South Muddy Creek Stream Restoration Project Year 4 Monitoring Report

**McDowell County, North Carolina**

**NCDMS Project Number – 737**

# **Site Assessment Report – Monitoring Year 4**

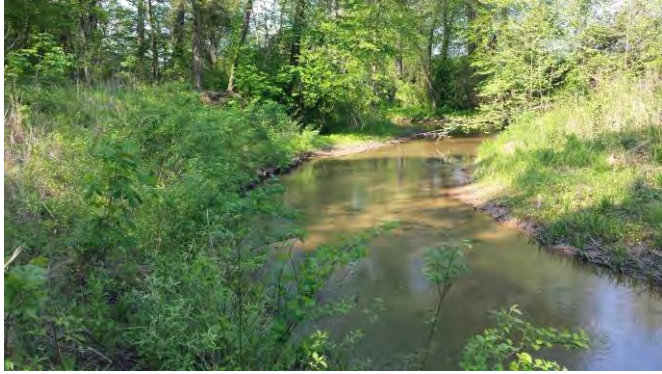
South Muddy Creek PID 1 – J-Hook near upstream end of project

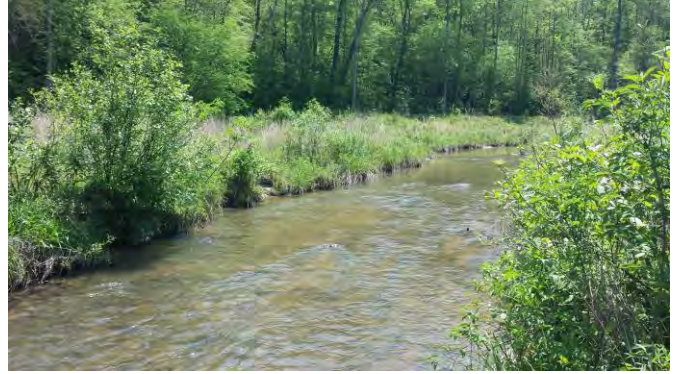
South Muddy Creek PID 2 –Constructed Riffle,

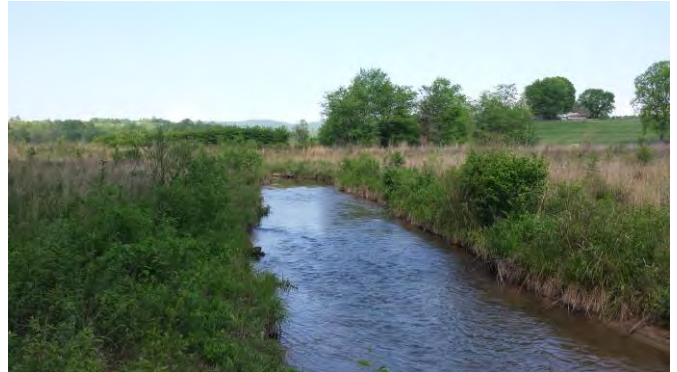
South Muddy Creek PID 4 – Constructed Riffle

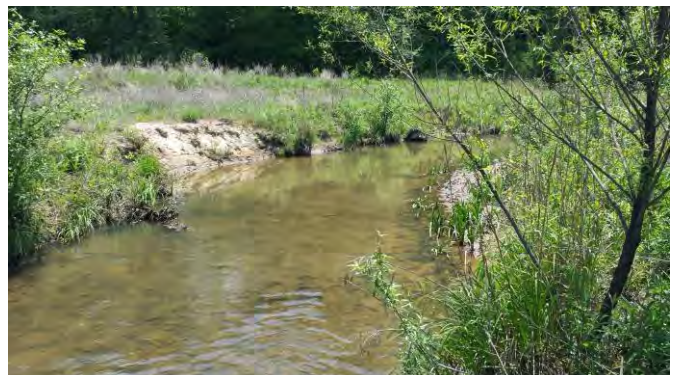
South Muddy Creek PID 6 – Constructed Riffle

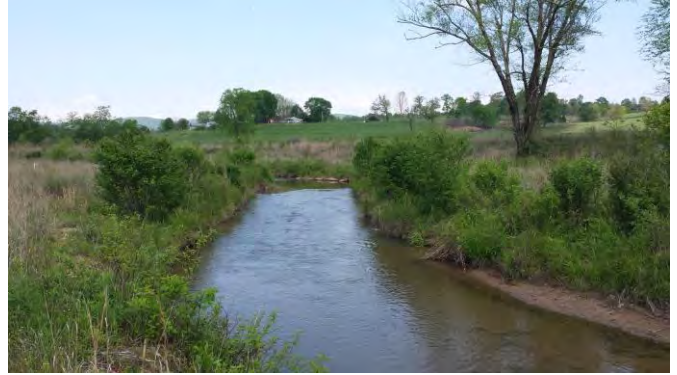
South Muddy Creek PID 8 – Constructed Riffle

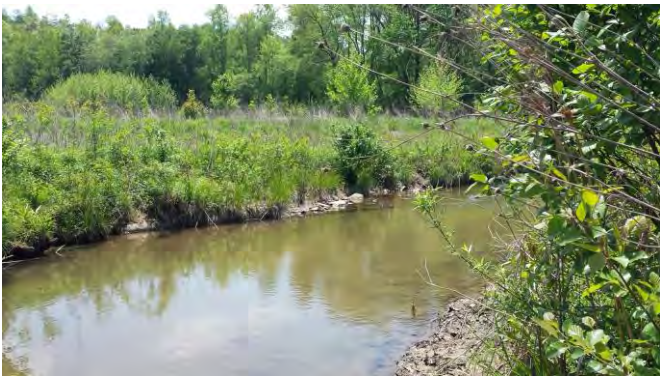
South Muddy Creek PID 9 – Log Vane in Meander

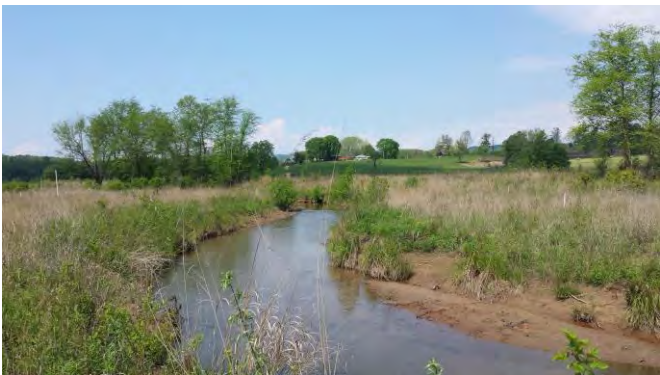
South Muddy Creek PID 11 – Constructed Riffle

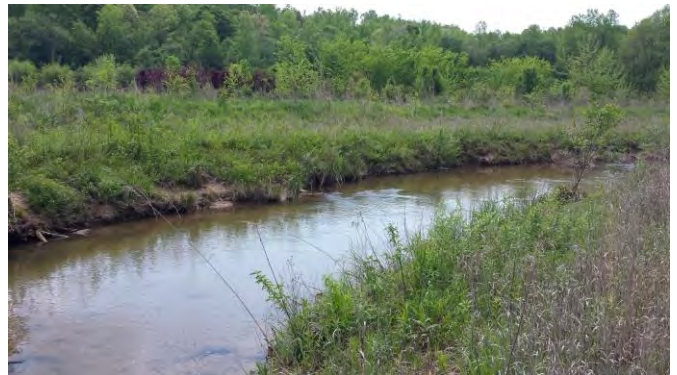
South Muddy Creek PID 12 – Log Vane and Root Wad in Meander

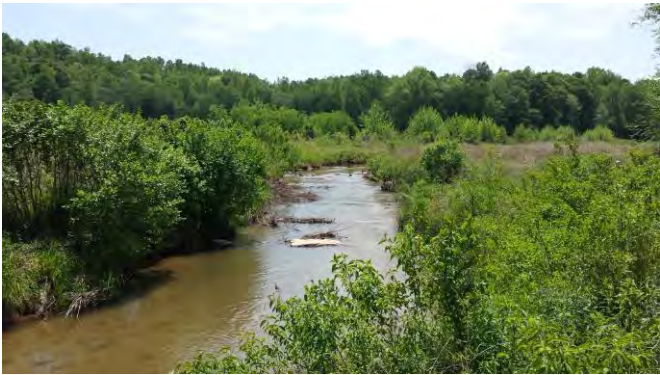
South Muddy Creek PID 13 – Constructed Riffle

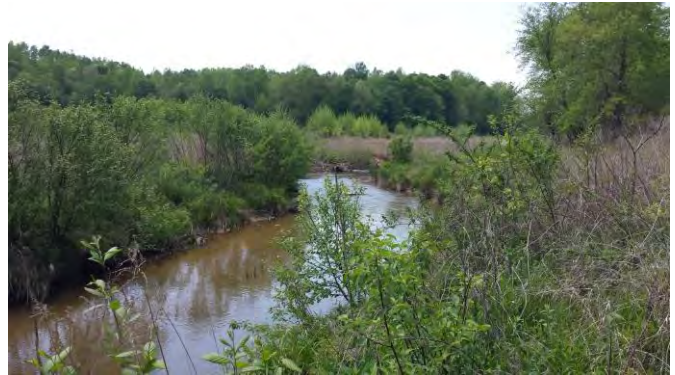
South Muddy Creek PID 14 – Immediately upstream of Sain Road crossing

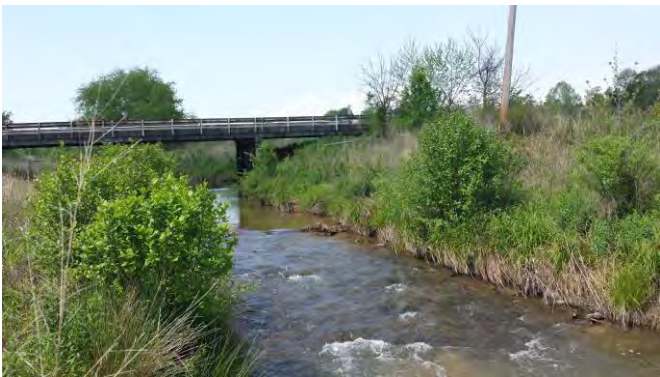
South Muddy Creek PID 15 – Constructed Riffle downstream of Sain Road crossing

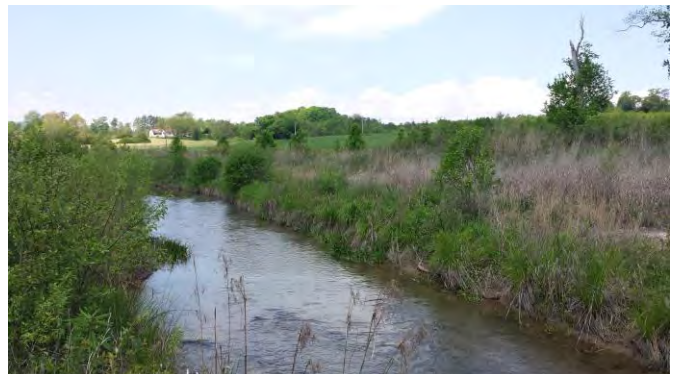
South Muddy Creek PID 18 – Constructed Riffle

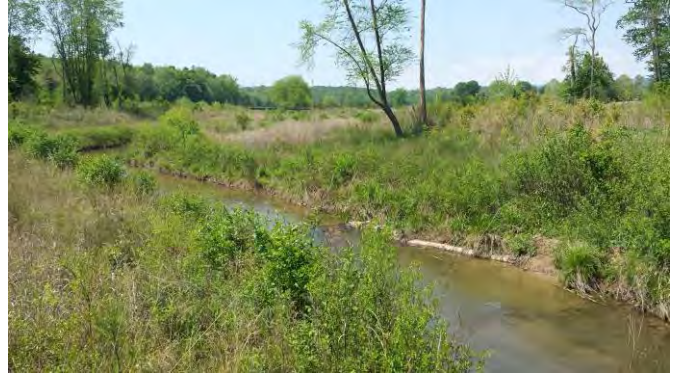
South Muddy Creek PID 20 – J-Hook near downstream  
end of project
