# South Muddy Creek Stream Restoration Project Year 5 Monitoring Report

**McDowell County, North Carolina**

**NCDMS Project Number – 737**

# **Site Assessment Report – Monitoring Year 5**

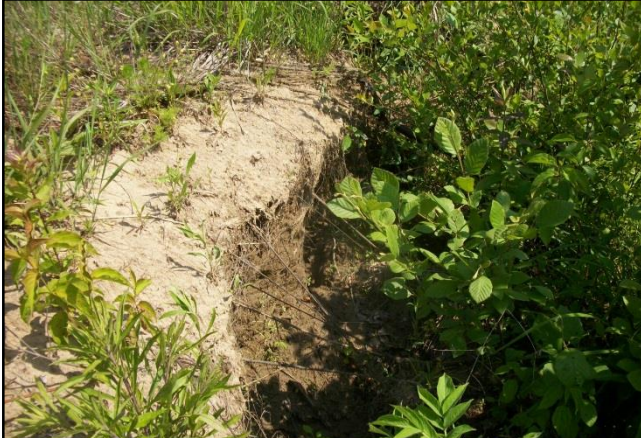
SPA4-1 – Localized scour along right bank behind rootwad and compromising the structures (5-25-16).

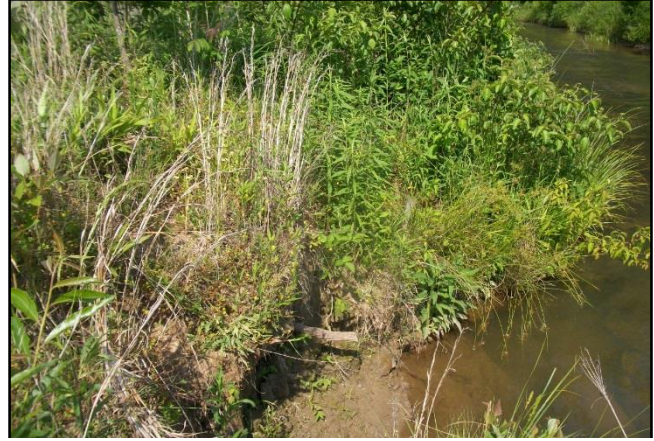
SPA 5-1 – Localized area of scour on left bank (5-25-16))
