# **MUDDY RUN STREAM RESTORATION PROJECT**

## **MONITORING REPORT**

### **MONITORING YEAR 1**

DUPLIN COUNTY, NORTH CAROLINA, PROJECT # 95018

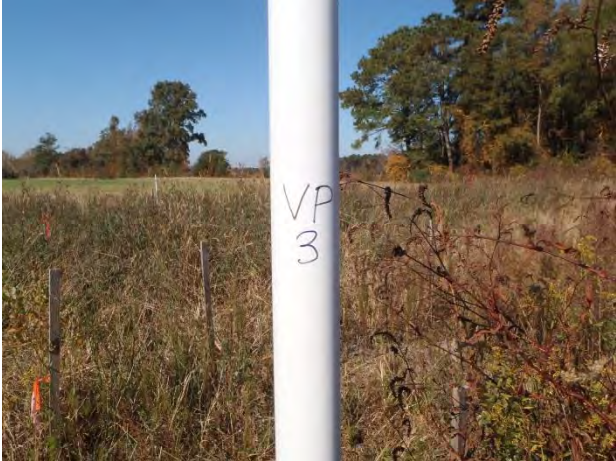
Vegetation Plot 3 (11/12/2014)

| <b>Feature Category</b> | <b>Station Numbers</b> | <b>Suspected Cause</b> | <b>Photo Number</b> |
|---|---|--|---|
| <b>Missing outside rows of trees</b> | Sta 2+00 - 10+100 | Improper planting due to damaged easement signage during construction. Recommend planting approximately 200 trees in two rows on outer edge of easement. | VP3 |

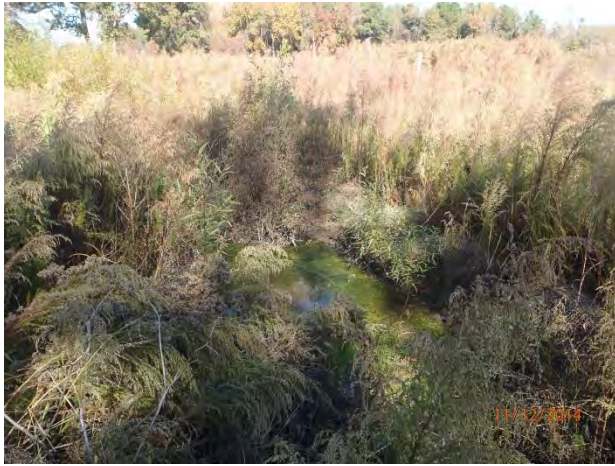
| <b>Feature Issue</b> | <b>Station # / Range</b> | <b>Suspected Cause</b> | <b>Photo Number</b> |
|--|---|---|---|
| <b>Pool Widening/ LB Erosion</b> | 20+90 | Channel adjustment- does not appear to be worsening; recommend monitoring | SP1 |

SP1 Pool widening at Sta 20+90

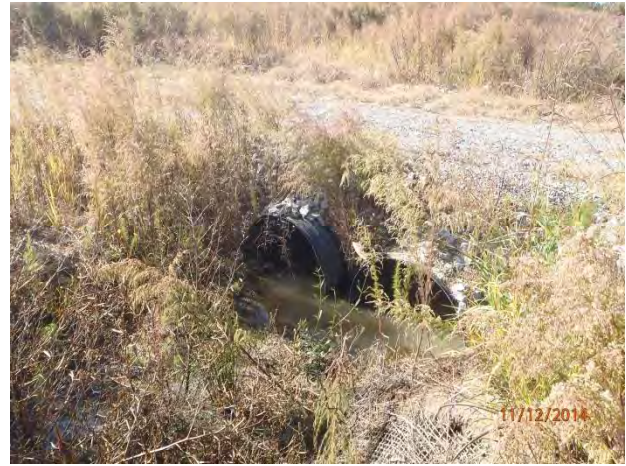
| <b>Feature Issue</b> | <b>Station # / Range</b> | <b>Suspected Cause</b> | <b>Photo Number</b> |
|--|---|---|---|
| <b>Minor RB Erosion</b> | 21+50 | Channel adjustment and sparse bank vegetation; recommend monitoring | SP2 |

SP2 Minor RB Erosion at STA 21+50

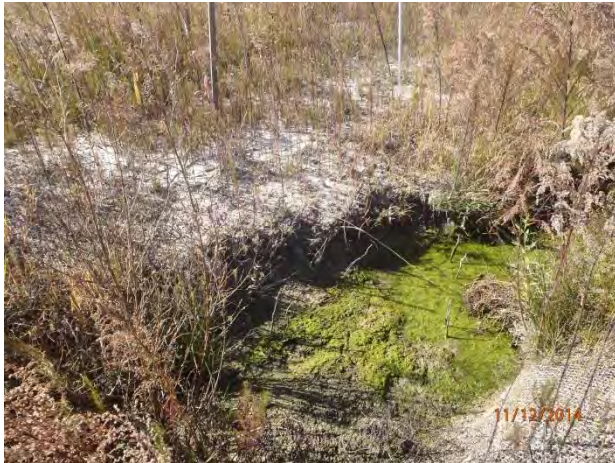
| <b>Feature Issue</b> | <b>Station # / Range</b> | <b>Suspected Cause</b> | <b>Photo Number</b> |
|--|---|---|---|
| <b>Minor LB Erosion</b> | 25+70 | Channel adjustment and sparse bank vegetation; recommend monitoring | SP3 |

SP3 Minor LB Erosion at STA 25+70

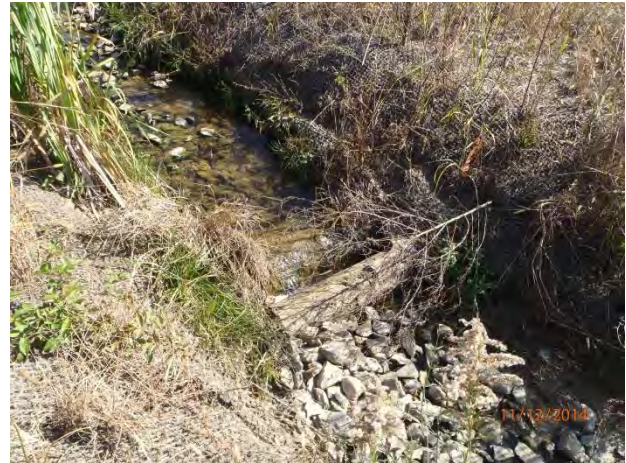
| <b>Feature Issue</b> | <b>Station # / Range</b> | <b>Suspected Cause</b> | <b>Photo Number</b> |
|--|---|---|---|
| <b>Minor Bed Erosion</b> | 47+15 - 47+45 | Log weir is undercut, but bed is stable; recommend monitoring | SP4 |

SP4 Minor Bed Erosion at Sta 47+15 - 47+45

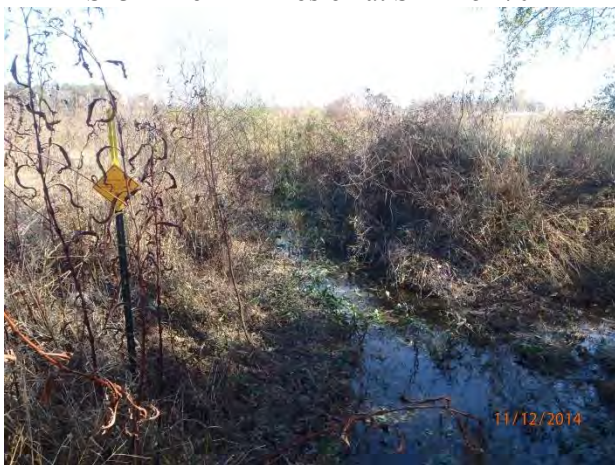
| <b>Feature Issue</b> | <b>Station # / Range</b> | <b>Suspected Cause</b> | <b>Photo Number</b> |
|--|---|---|---|
| <b>Minor RB Rill Erosion below matting</b> | 5+60 | Sparse bank vegetation establishment after construction; recommend monitoring | SP5 |

SP5 Minor RB Erosion at Sta 5+60

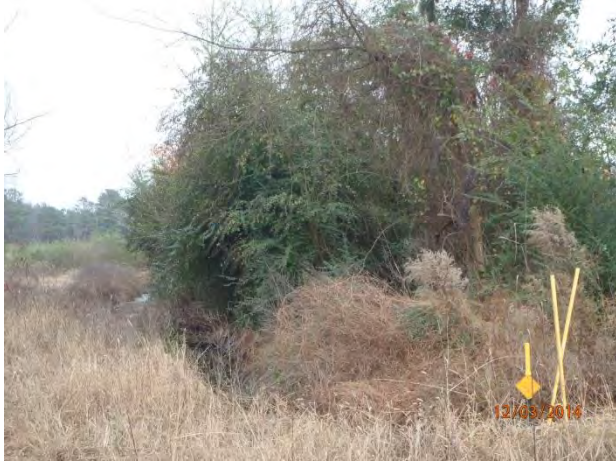
| <b>Feature Category</b> | <b>Station Numbers</b> | <b>Suspected Cause</b> | <b>Photo Number</b> |
|---|---|--|---|
| <b>Invasive/Exotic Populations</b> | Reach 1B- See Plan View | Ligustrum: encroachment from outside easement. Recommend continued clearing and stump treatment. | VP1 |

VP1- Invasive population: *Ligustrum* along Reach 1B

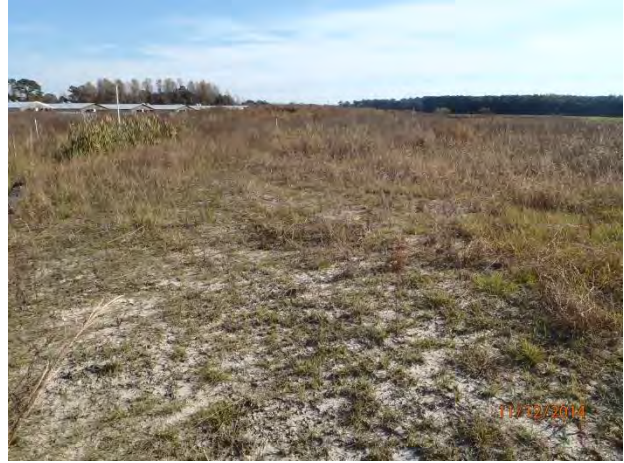
| <b>Feature Category</b> | <b>Station Numbers</b> | <b>Suspected Cause</b> | <b>Photo Number</b> |
|---|---|--|---|
| <b>Sparsely vegetated floodplain</b> | Sta 16+50 | Seeds sowed in low fertility soil areas. Recommend continued monitoring | VP2 |

VP2 Sparse LB Riparian Vegetation at Sta 16+50
