MUDDY RUN STREAM RESTORATION PROJECT

MONITORING REPORT

MONITORING YEAR 2

DUPLIN COUNTY, NORTH CAROLINA, PROJECT # 95018

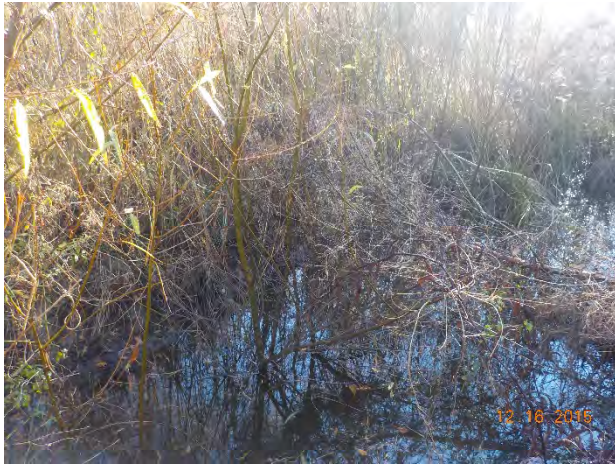
SP1 Pool widening at Sta 20+90

Table 7. Stream Problem Areas			
Muddy Run Stream Restoration Project - Project # 95018			
Feature Issue	Station # / Range	Suspected Cause	Photo Number
Pool Widening/ LB Erosion	20+90	Channel adjustment- minor erosion on banks; recommend livestaking.	SP1
Minor Bed Erosion	47+15 - 47+40	Log weir is undercut, but bed is stable; recommend monitoring	SP2

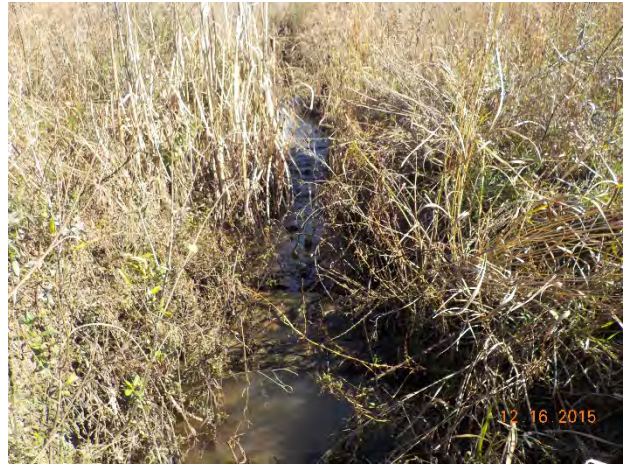
SP2 Minor Bed Erosion at Sta 47+15 - 47+45.
